CPAT Report No. 1488

Offa's and Wat's Dykes in Wrexham

Monument Condition Survey

Client name: Cadw
 CPAT Project No: 2102
 Project Name: Wrexham Dykes
 County/LPA: Wrexham
 CPAT Report No: 1488
 Event PRN: Offa's Dyke - PRN 140167; Wat's Dyke - PRN 140168
 Report status: Final
 Confidential: Yes

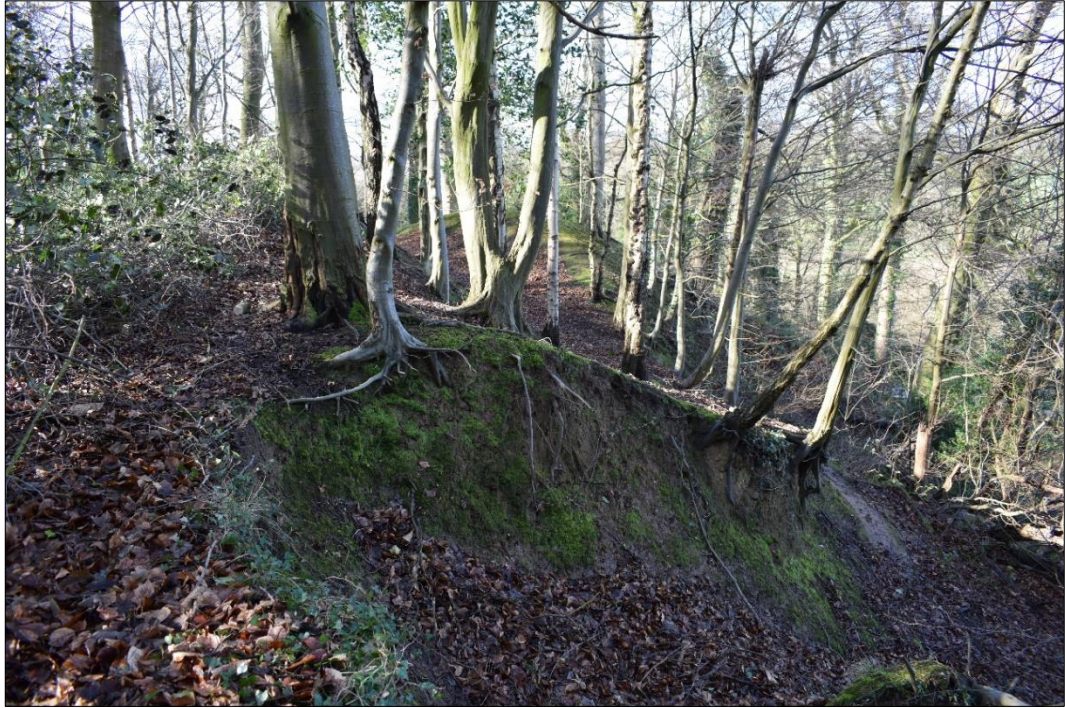
- 4.24. This section of the dyke was lost to a landslip as recently as the late 1980s which is the reason why it lies between two scheduled and upstanding sections (SAMs De017 and De152). The landslip has exposed a section of possible bank at the north end of the southern scheduled area.

Wat's Dyke Unit 7: View from the north-east showing the section of possible bank within SAM De152 exposed by the landslip. CPAT 4311-0004

4.26. No action for lost section, but there is potential for investigation of the exposed bank section, perhaps as part of a community project with the National Trust.

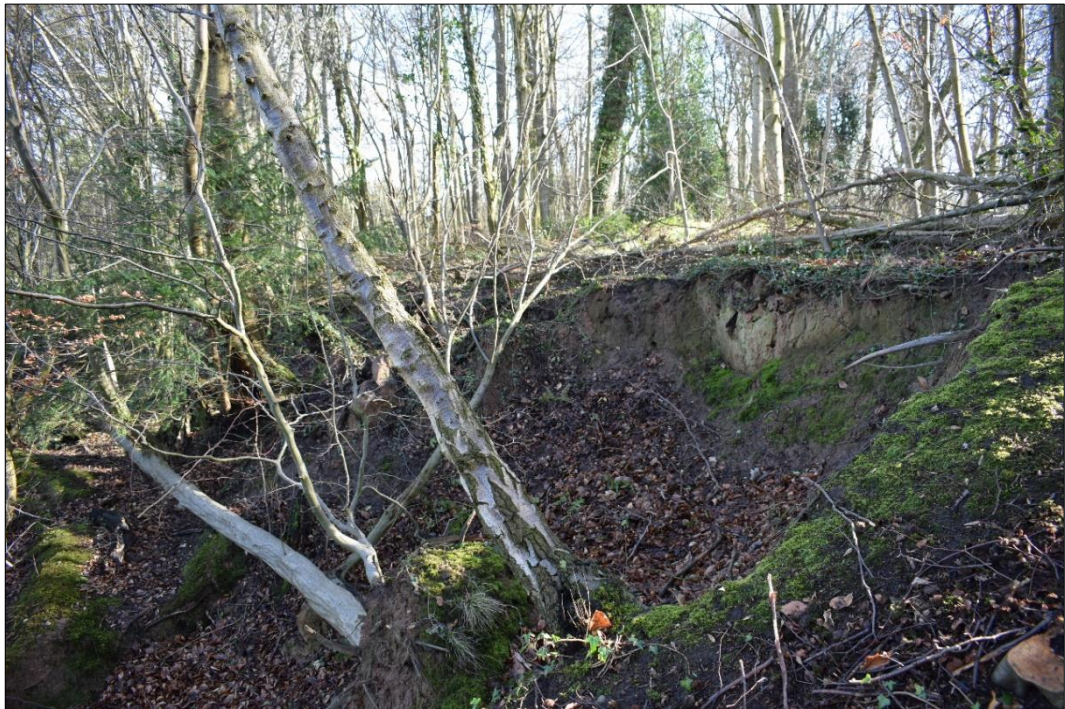
Wat's Dyke Unit 7: View from the south-west showing the area of the landslip. CPAT 4311-0005

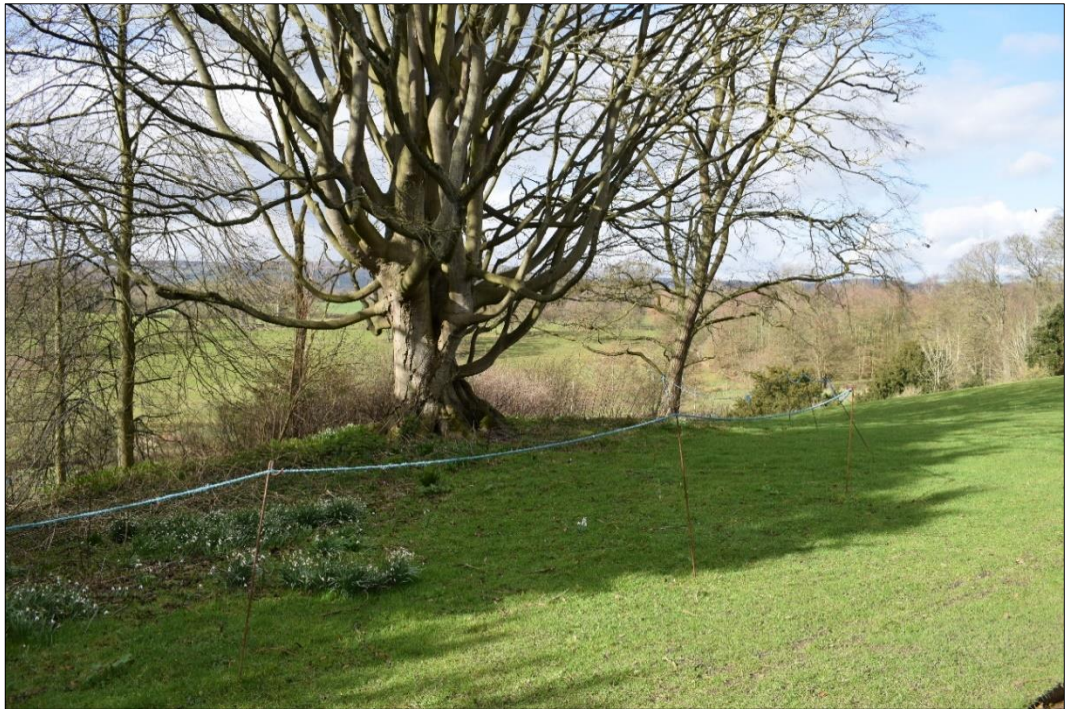
Wat's Dyke Unit 8: View from the south-east of possible remnant couterescarp in the lawned area in front of the house. Tree CPAT 4311-0016

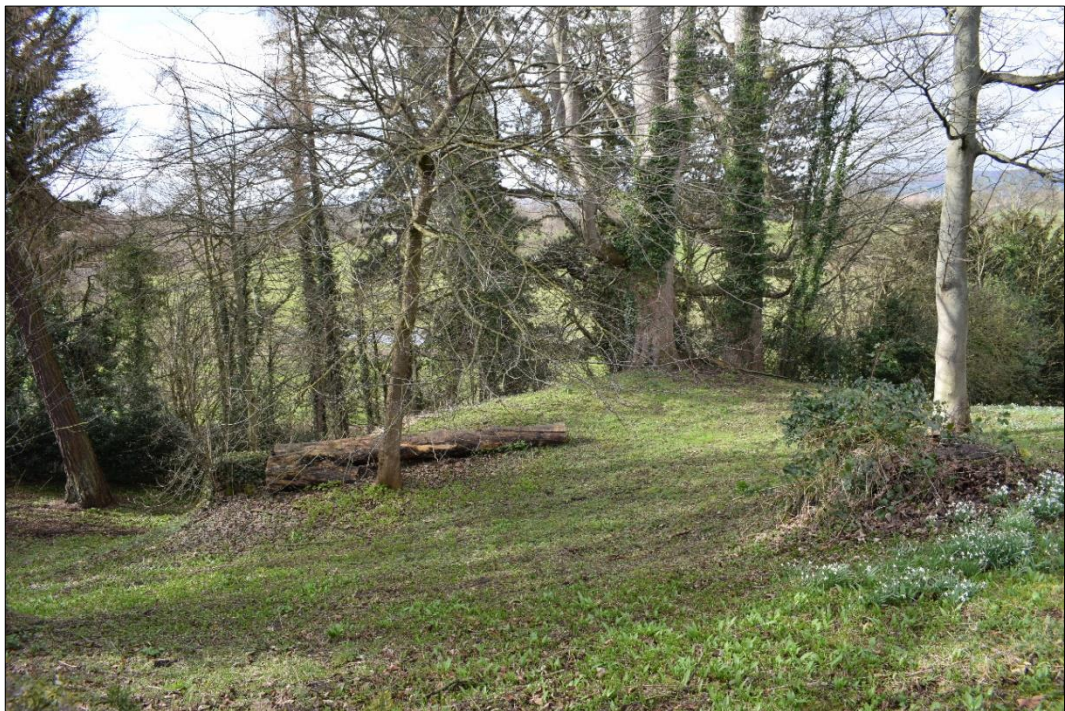
Wat's Dyke Unit 8: View from the east of possible remnant ditch and couterescarp in the lawned area in front of the stables. CPAT 4311-0015

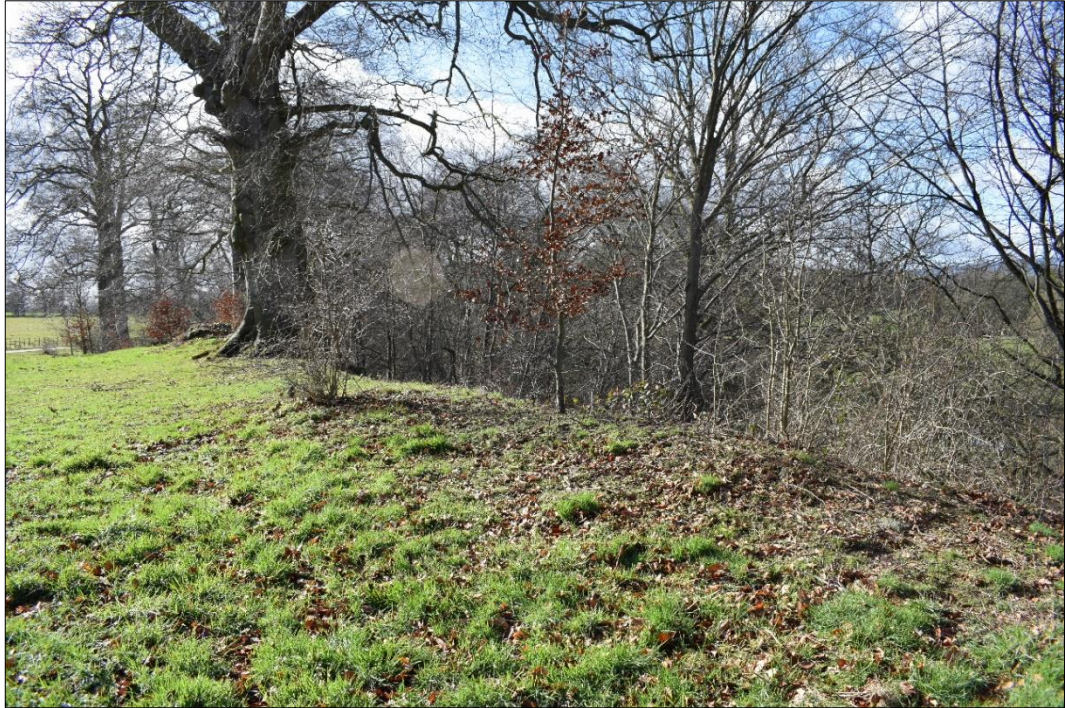
- 4.31. Generally good condition especially alongside the drive. In the woodland at the north end there is minor damage from burrowing animals, and some scrub and large trees.

- 4.34. Mature trees within woodland and one in particular on bank alongside the drive, they have potential to damage the earthwork.

Wat's Dyke Unit 9: View from the north-east showing the low bank alongside the drive CPAT 4311-0009.

- 4.35. Manage trees and scrub at north end. There is an opportunity for community engagement with National Trust volunteers to conduct a trial excavation to investigate possible bank and ditch.

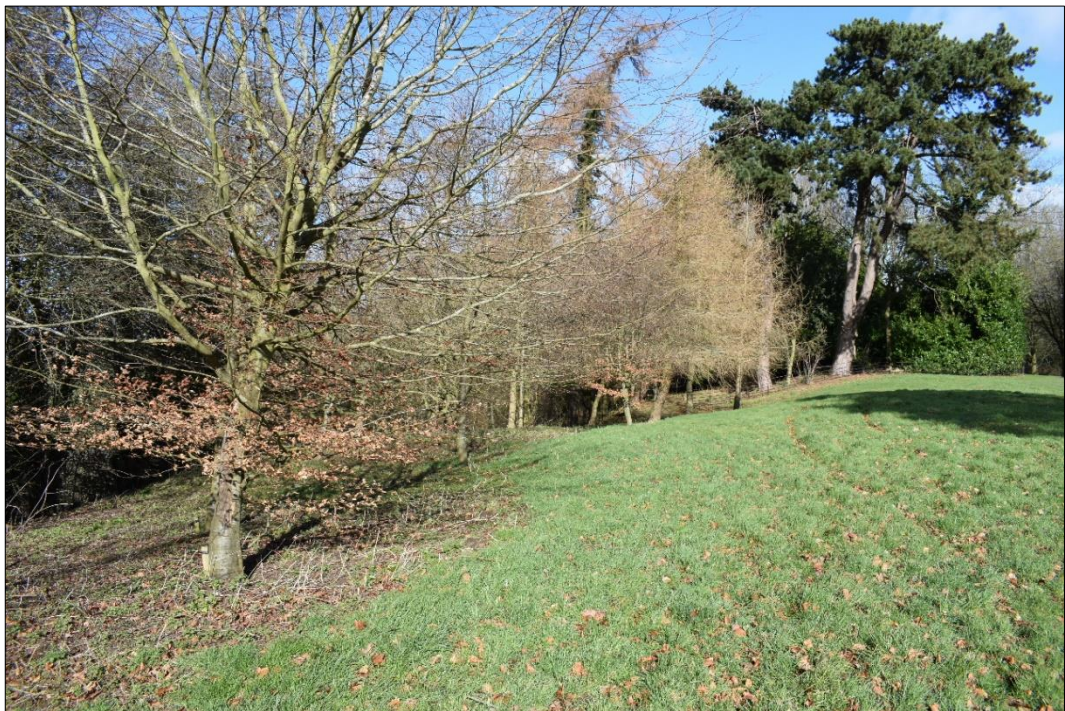
Wat's Dyke Unit 9: View from the south showing the scarp which may indicate the eastern edge of the ditch. CPAT 4311-0009.

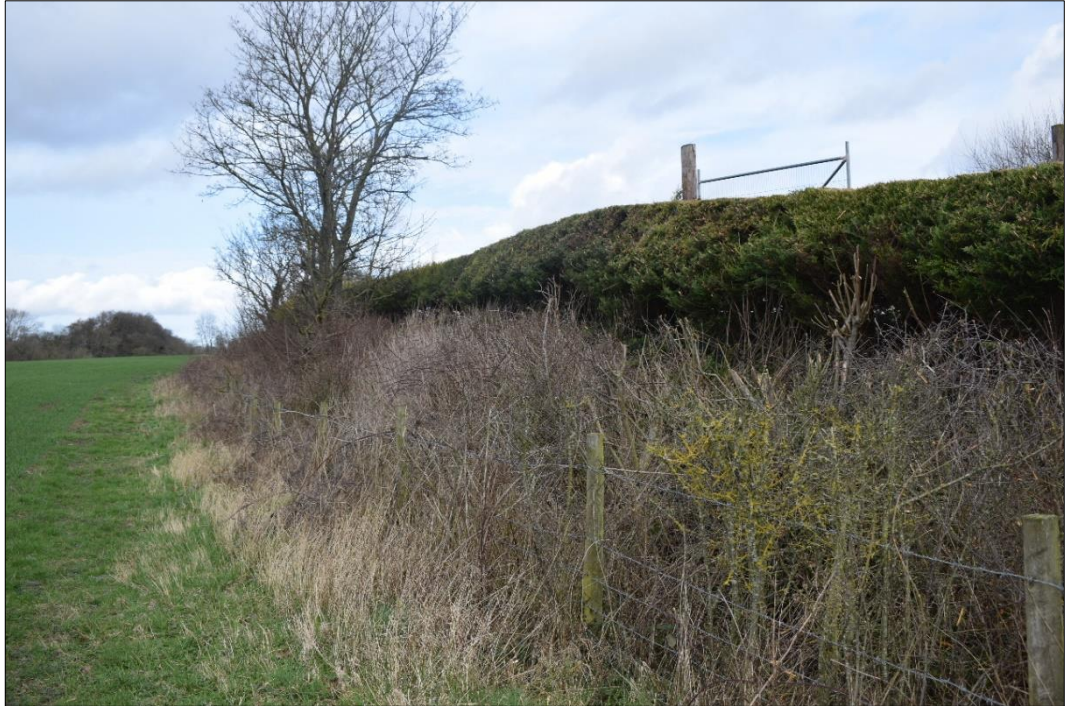
- 4.38. Modern well maintained coniferous hedge on the top of the scarp, while an old hedge has been grubbed out at the base to be replaced by a fence, but is regrowing on the slope of the scarp.

Wat's Dyke Unit 10: View from the south-west of boundaries (Issue 1) along the line of the dyke. CPAT 4317-0046

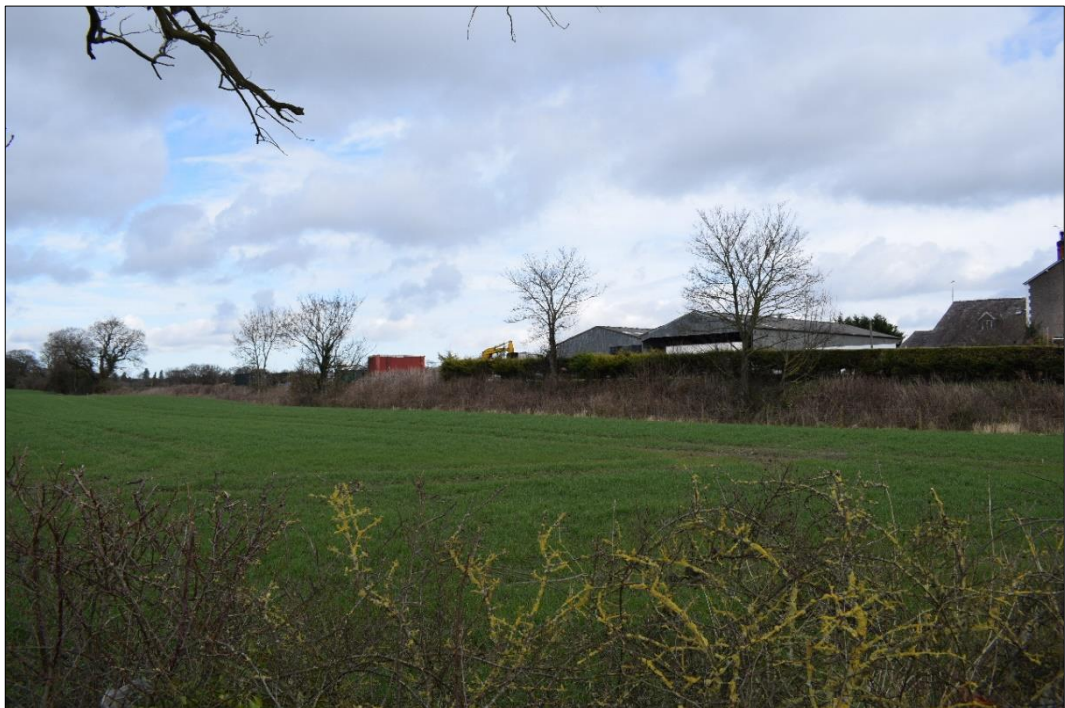
Wat's Dyke Unit 10: View from the west showing the arable rotation (Issue 2).
CPAT 4317-0055

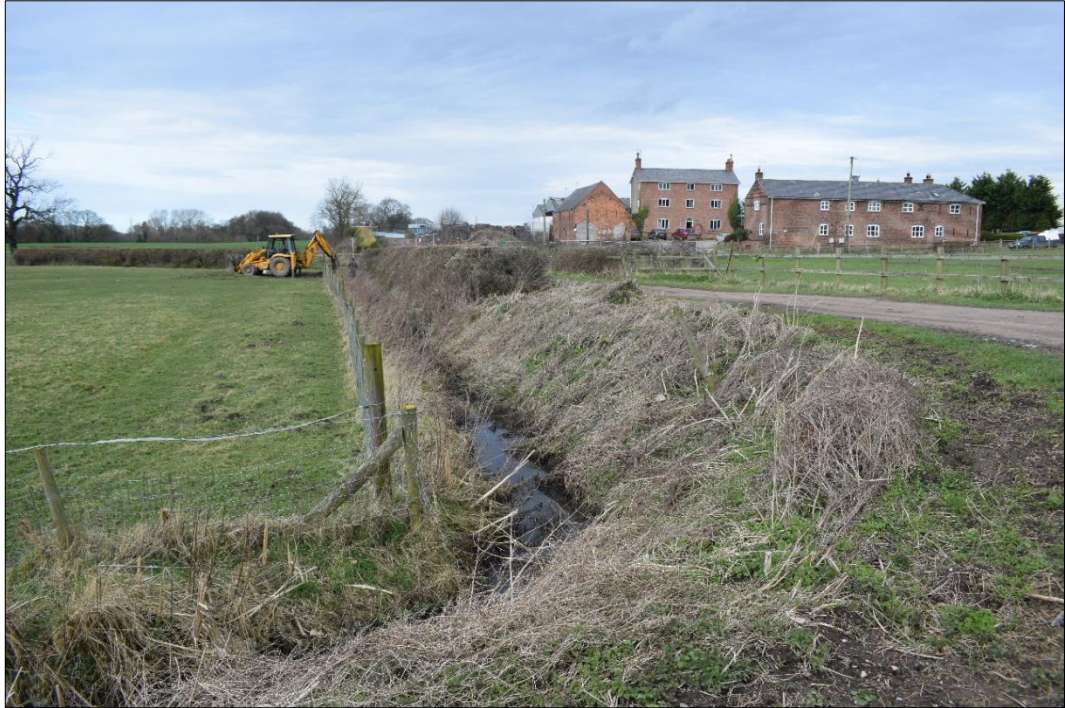
- 4.42. While the appearance of the dyke has clearly been modified significantly, to the extent that the earthworks are no longer prominent, the surviving remains are not really currently affected by the minor issues noted, consisting of drainage, stock erosion and a field boundary.

Wat's Dyke Unit 11: View from the south, showing the drainage ditch (Issue 1) following the line of the ditch, with the track along the line of the bank. CPAT 4317-0057

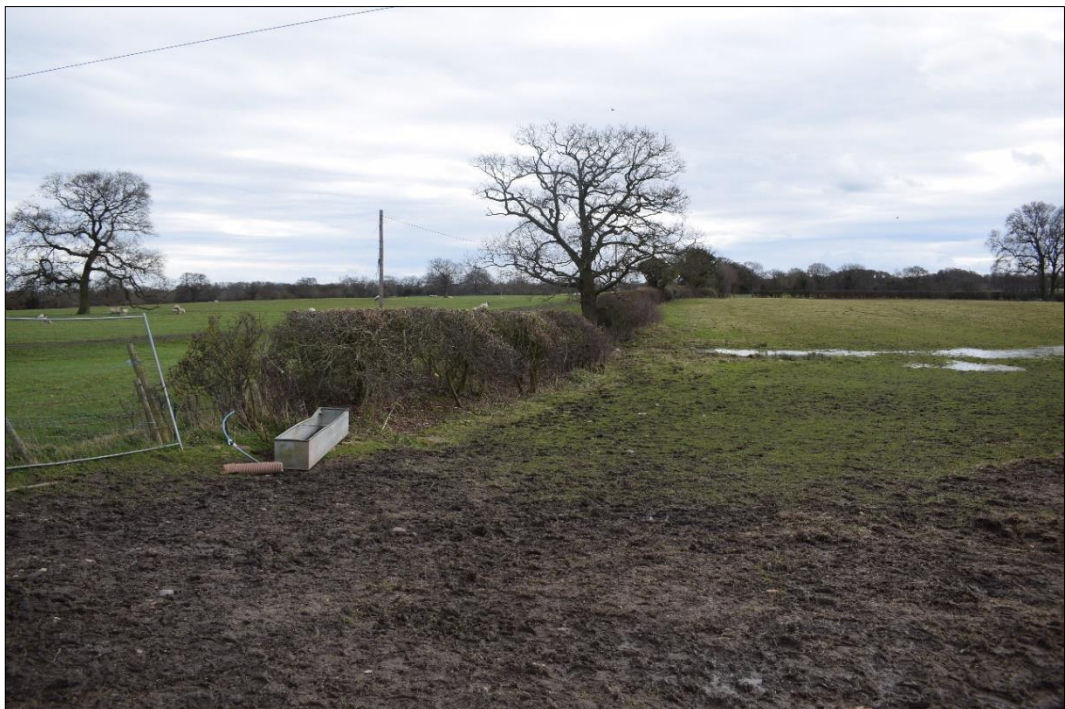
Wat's Dyke Unit 11: View from the north, looking towards SAM De153, showing stock trampling (Issue 2) and the field boundary (Issue 3). CPAT 4317-0062

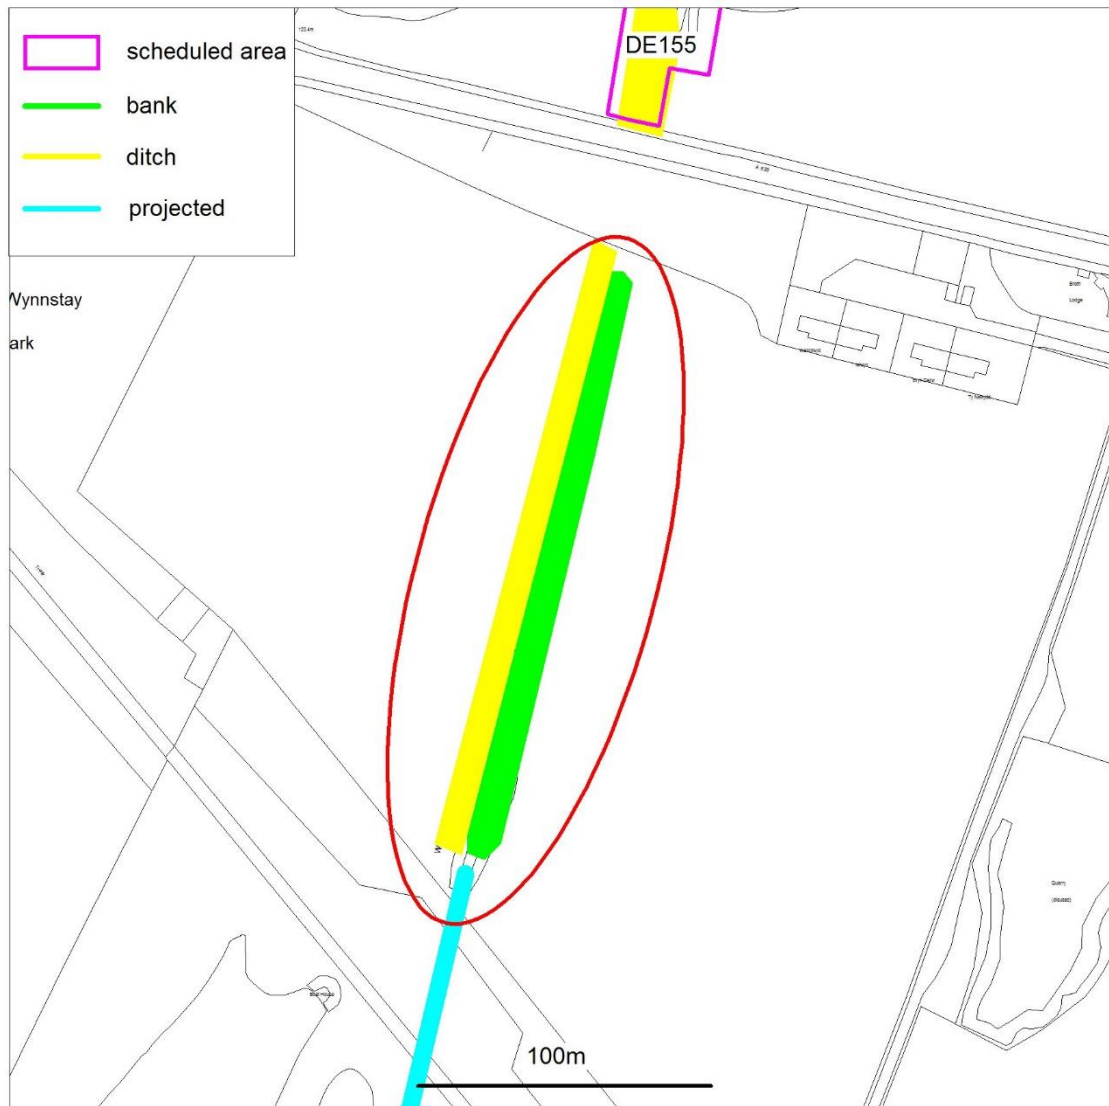
Wat's Dyke Unit 13: cropmarks recorded in 2015
