CPAT Report No. 1487

Brecon Gaer (Br001)

Archaeological investigation and recording

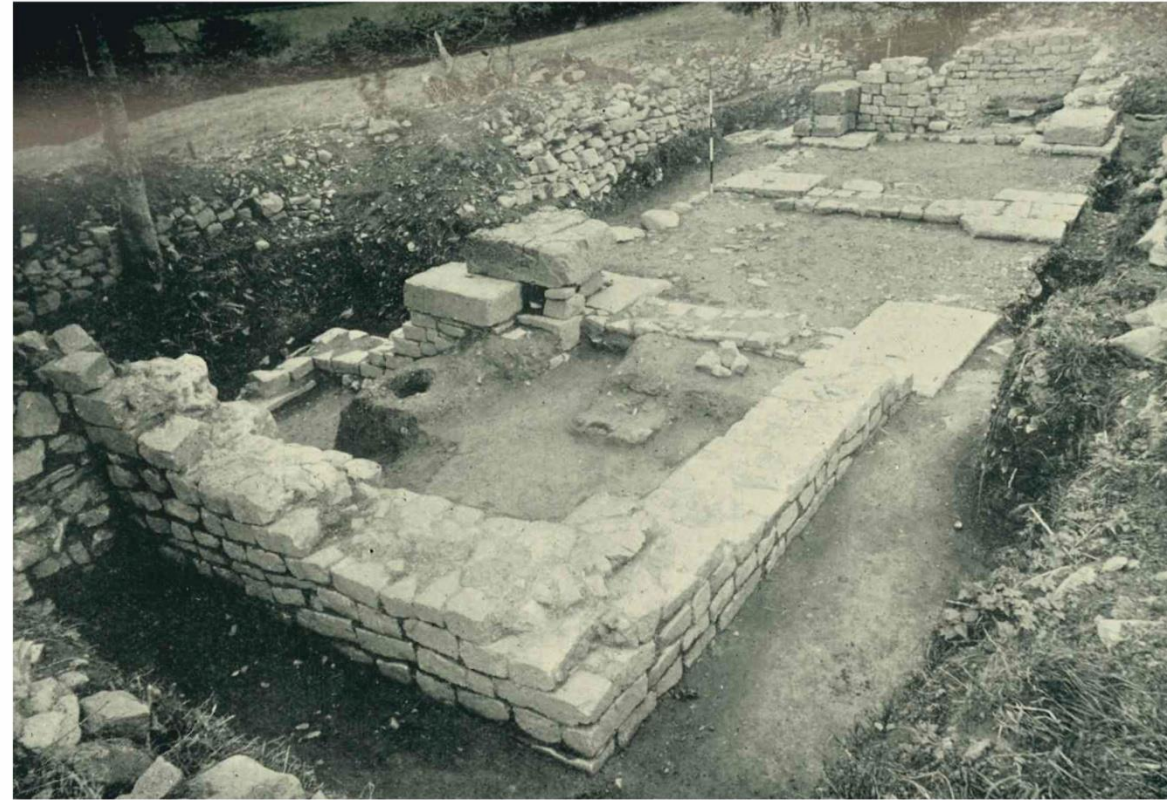
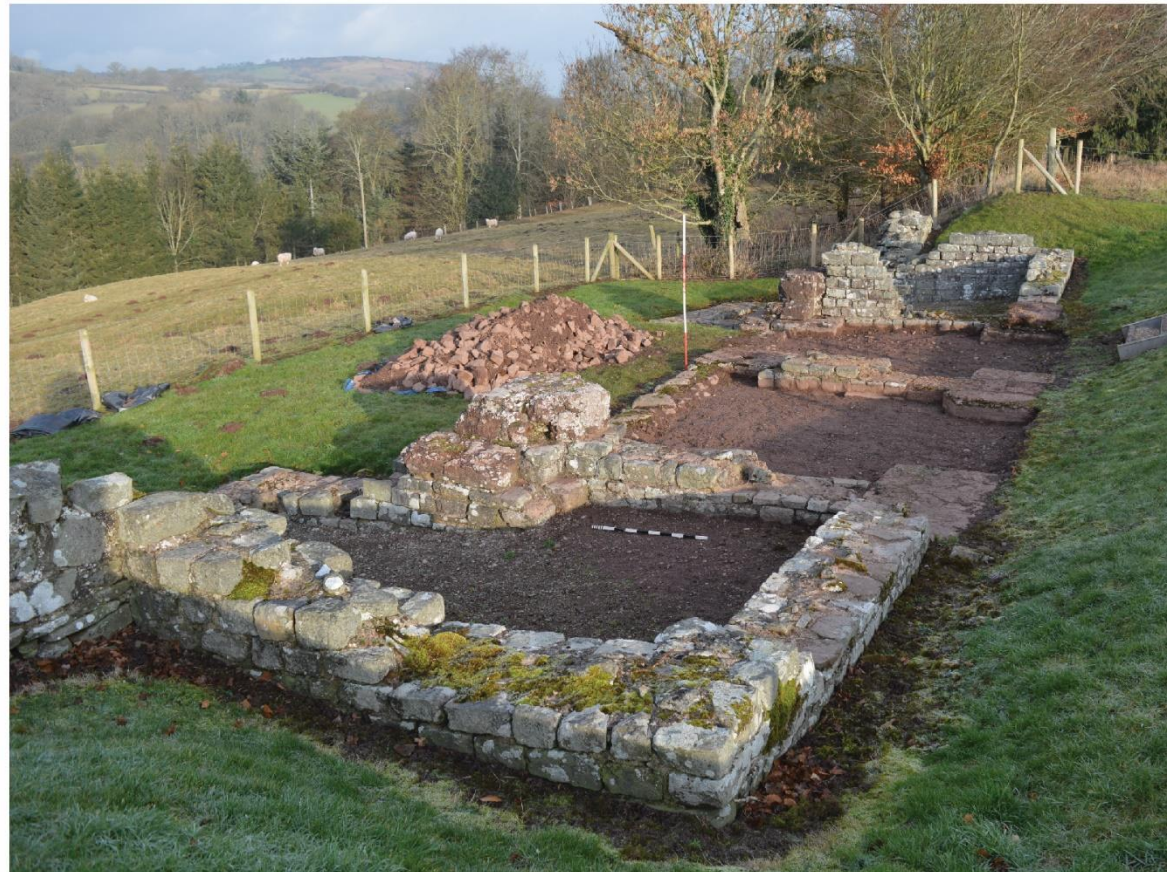
Fig. 9 The West Gate from the south c. 1925 (Wheeler 1926) and 2017 (Photo CPAT 4291-0046)

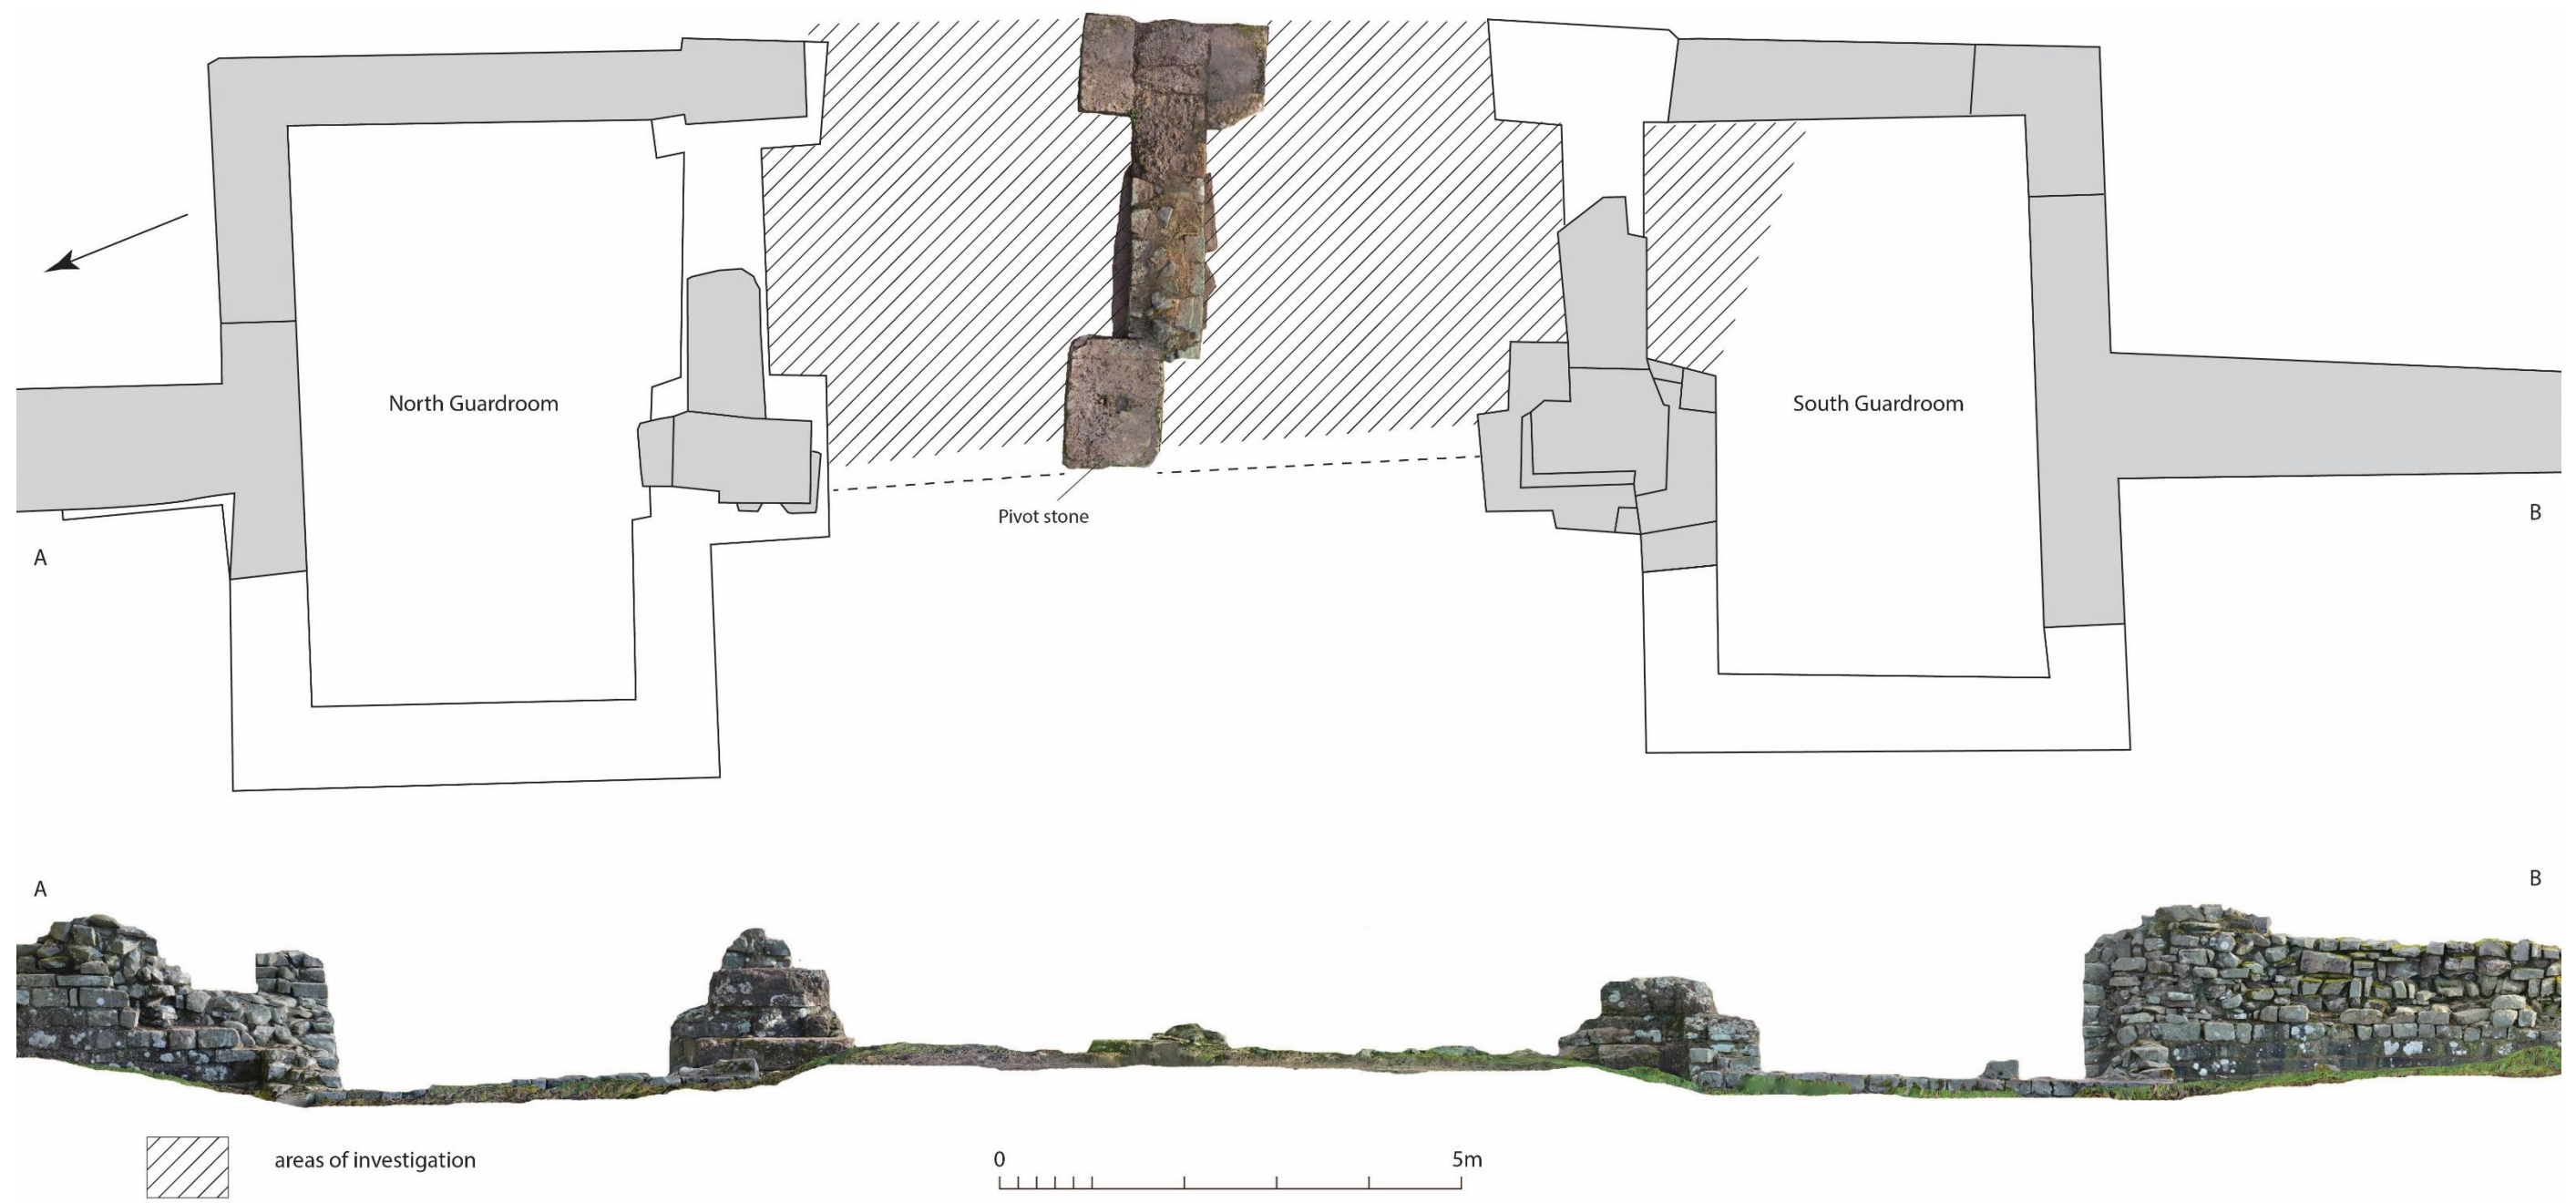
Fig. 10 West Gate: Plan and photogrammetric section, showing the areas of investigation

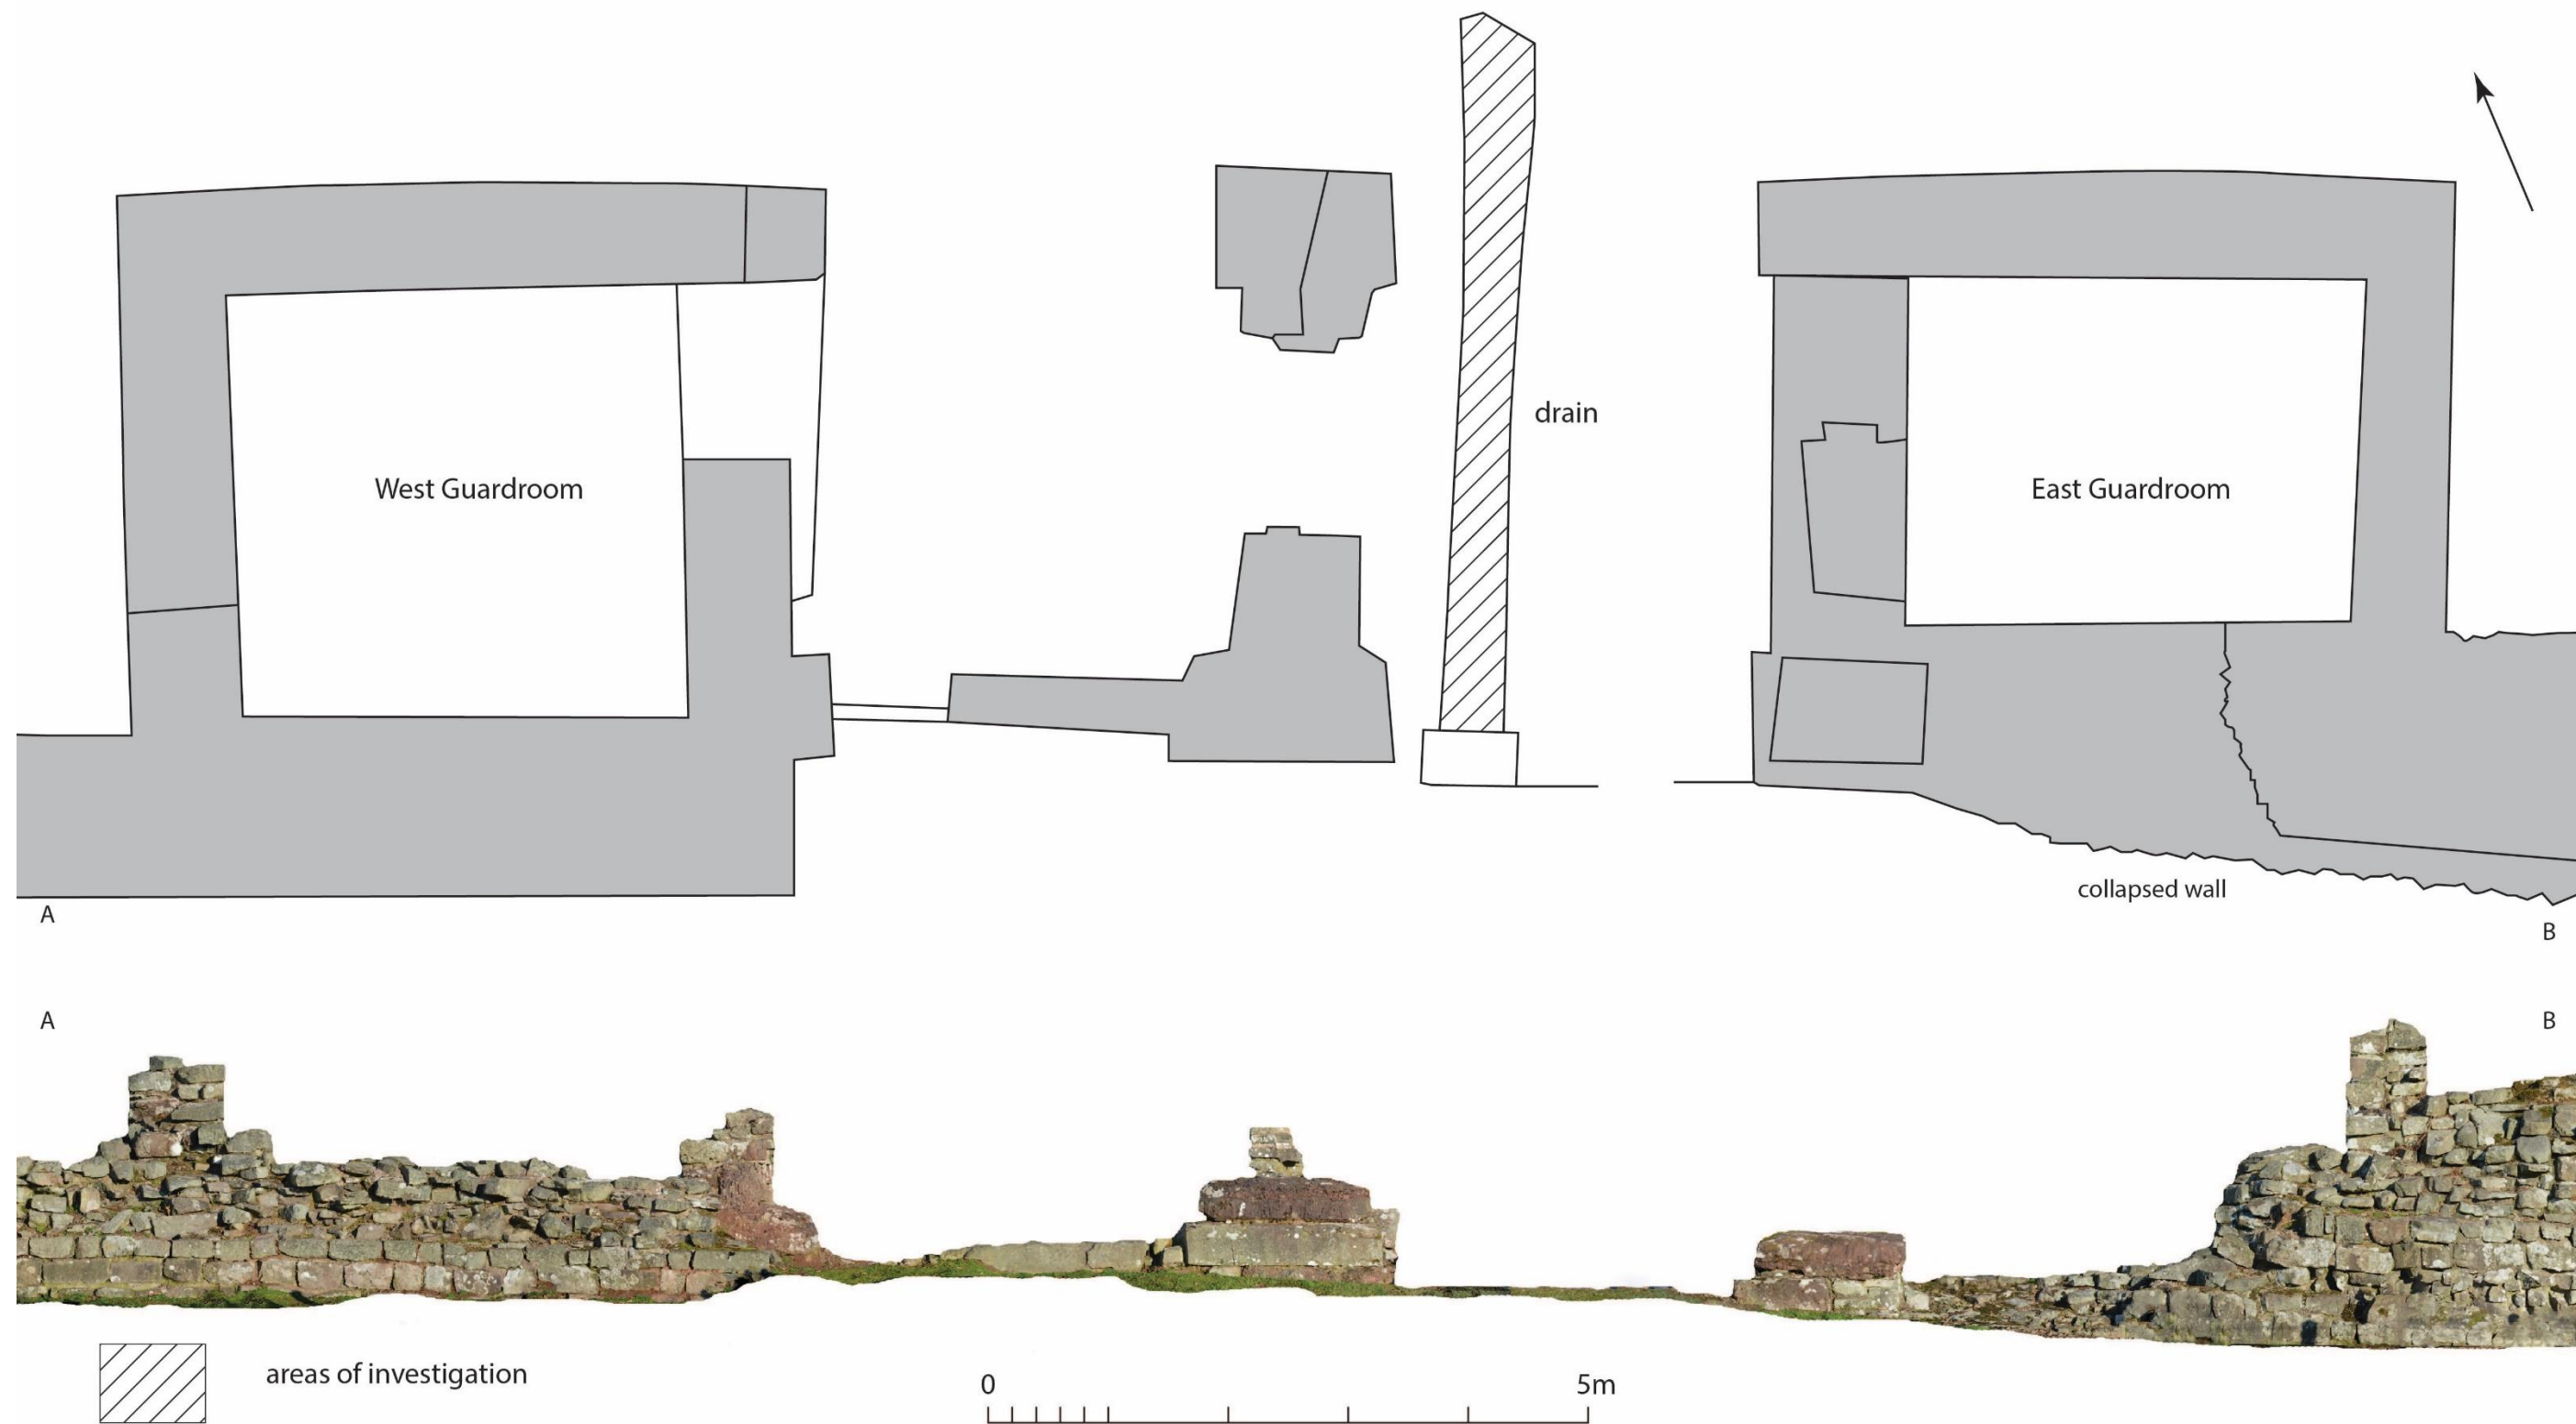
Fig. 17 South Gate: Plan and photogrammetric section

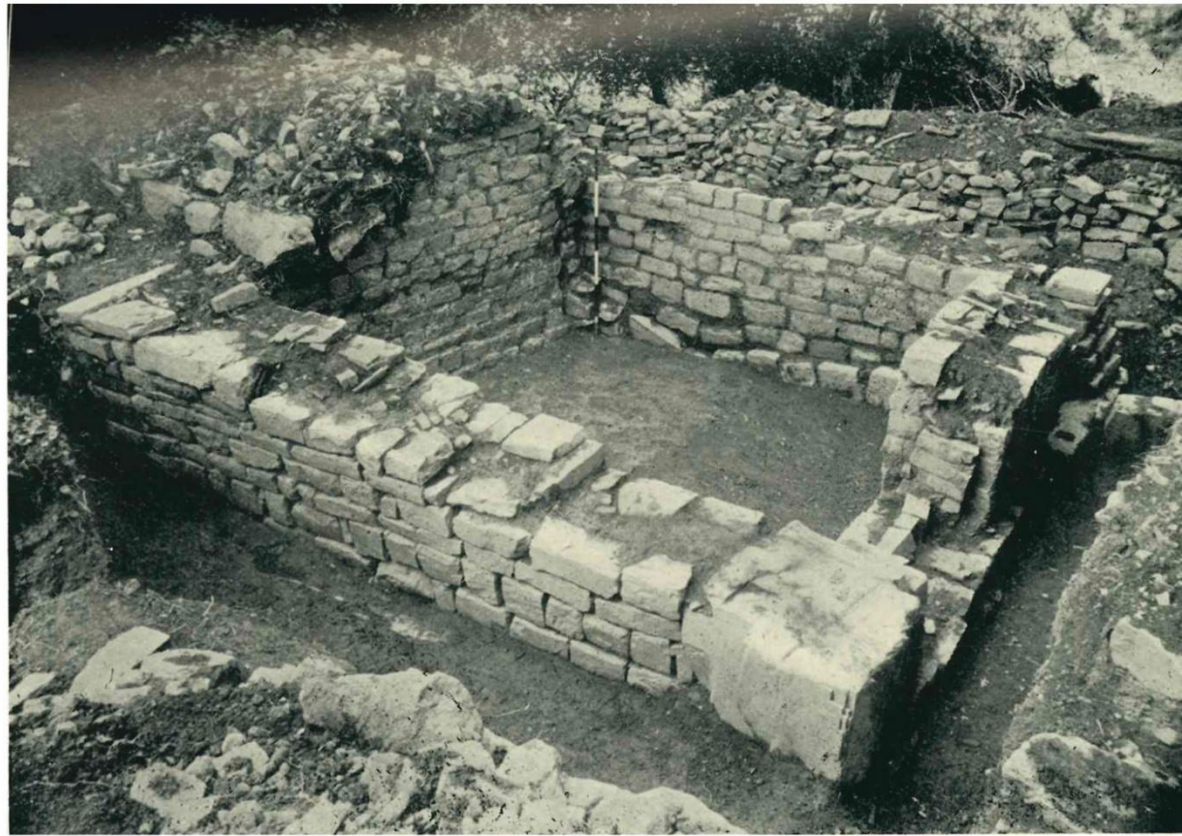
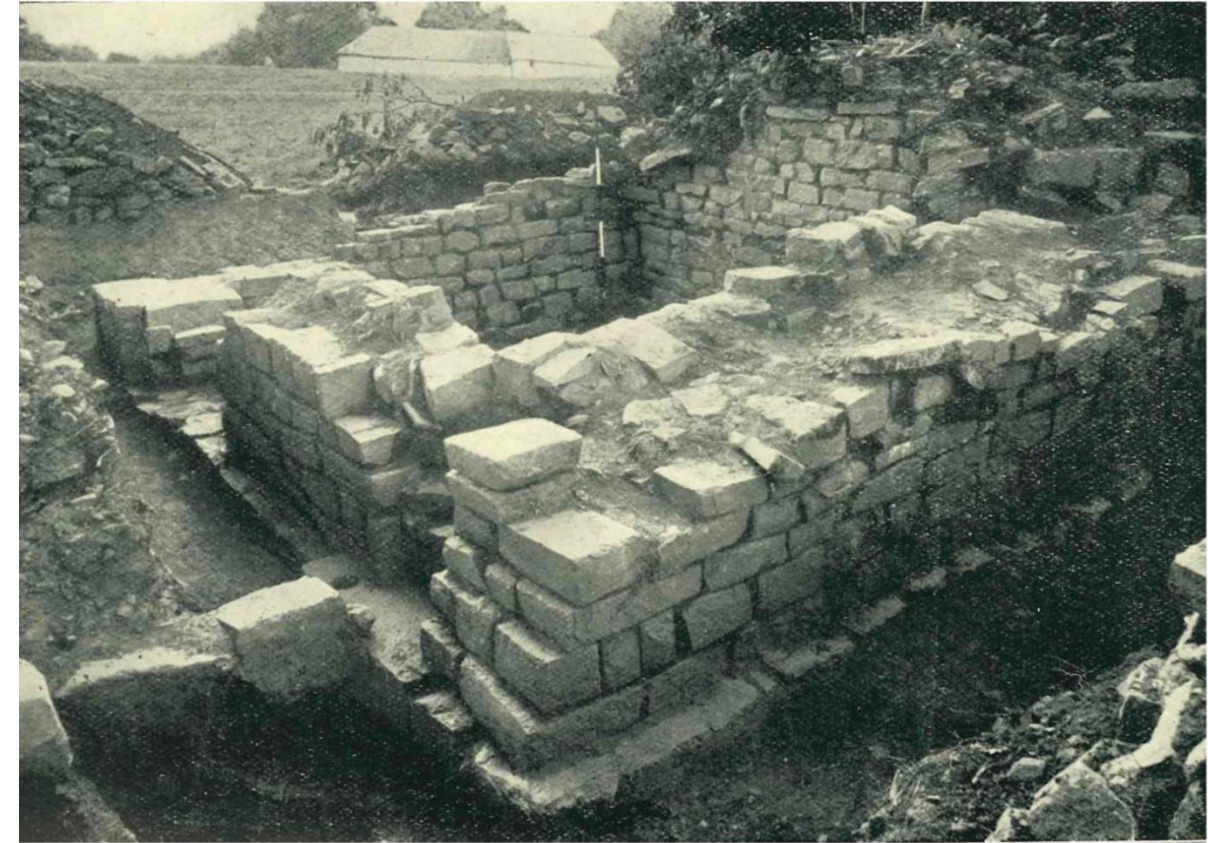
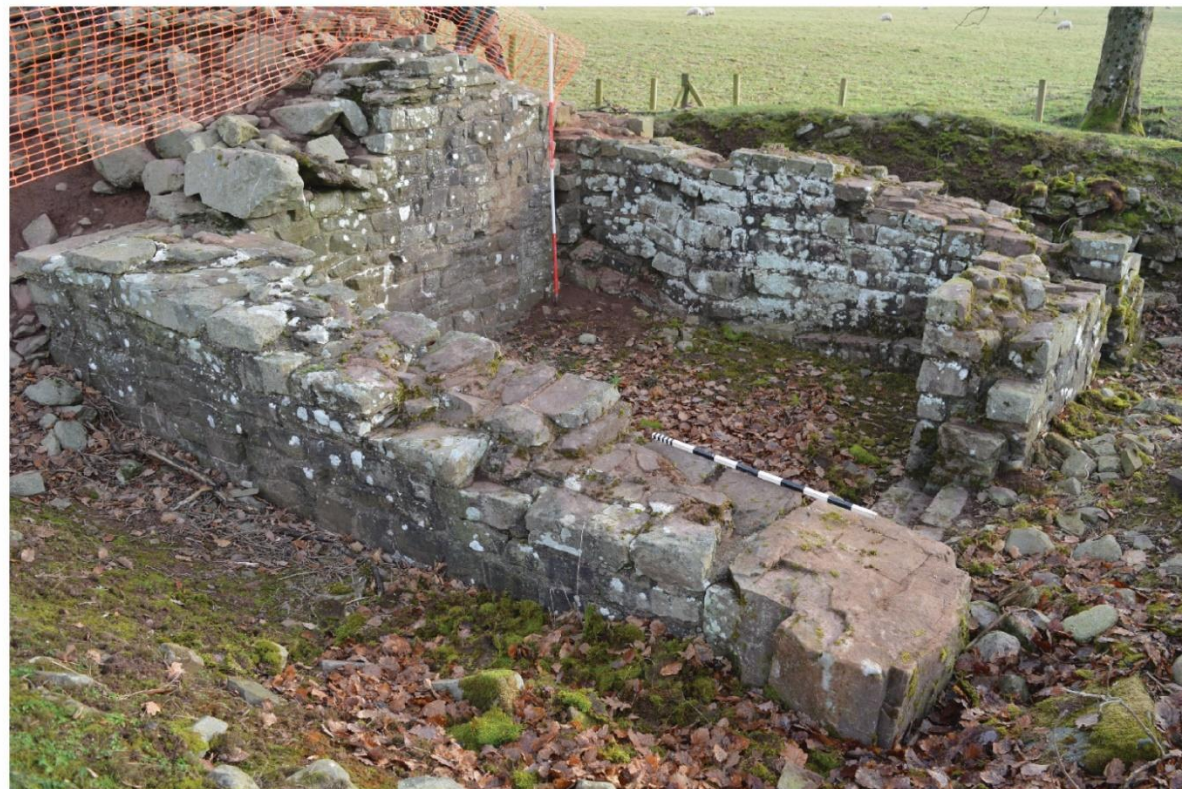
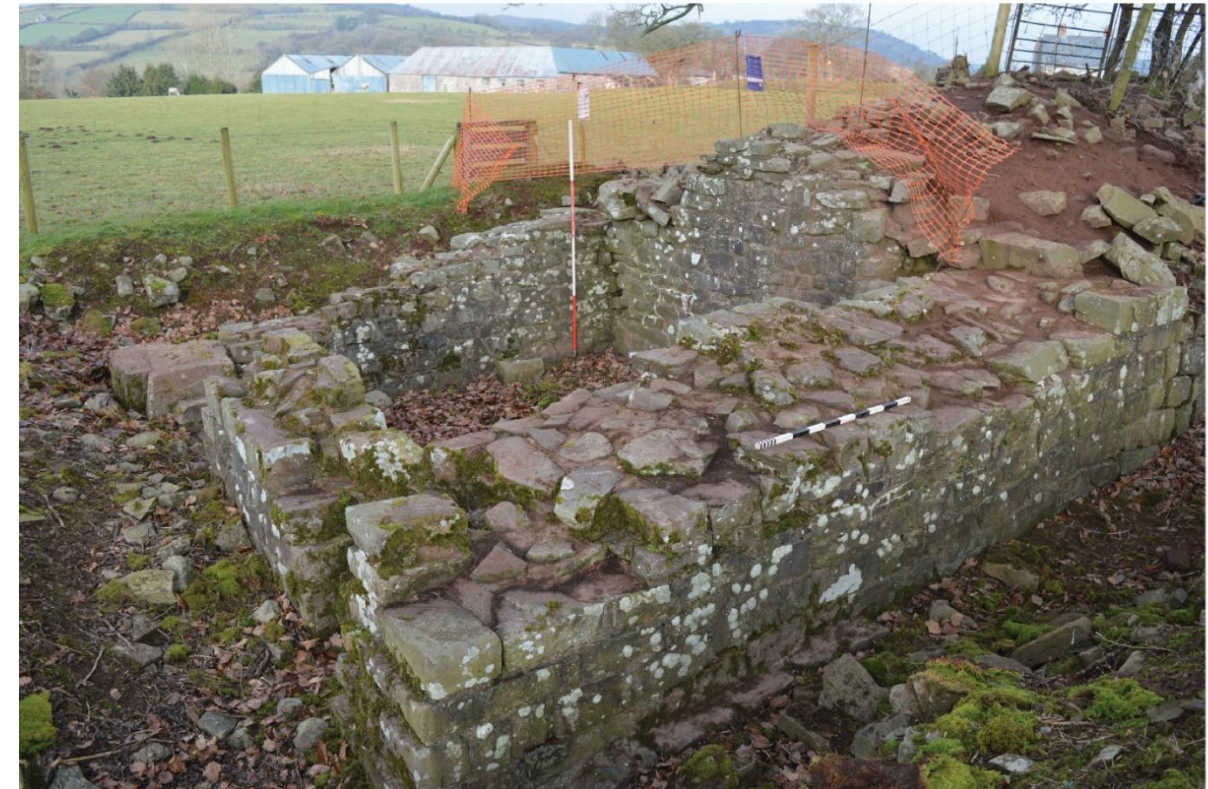
Fig. 24 East Gate: North Guardroom, view from the west c. 1925 (Wheeler, 1926) and 2017 (Photo CPAT 4291-0060)

Fig. 25 East Gate: North Guardroom, view from the south-east c. 1925 (Wheeler, 1926) and 2017 (Photo CPAT 4291-0062)

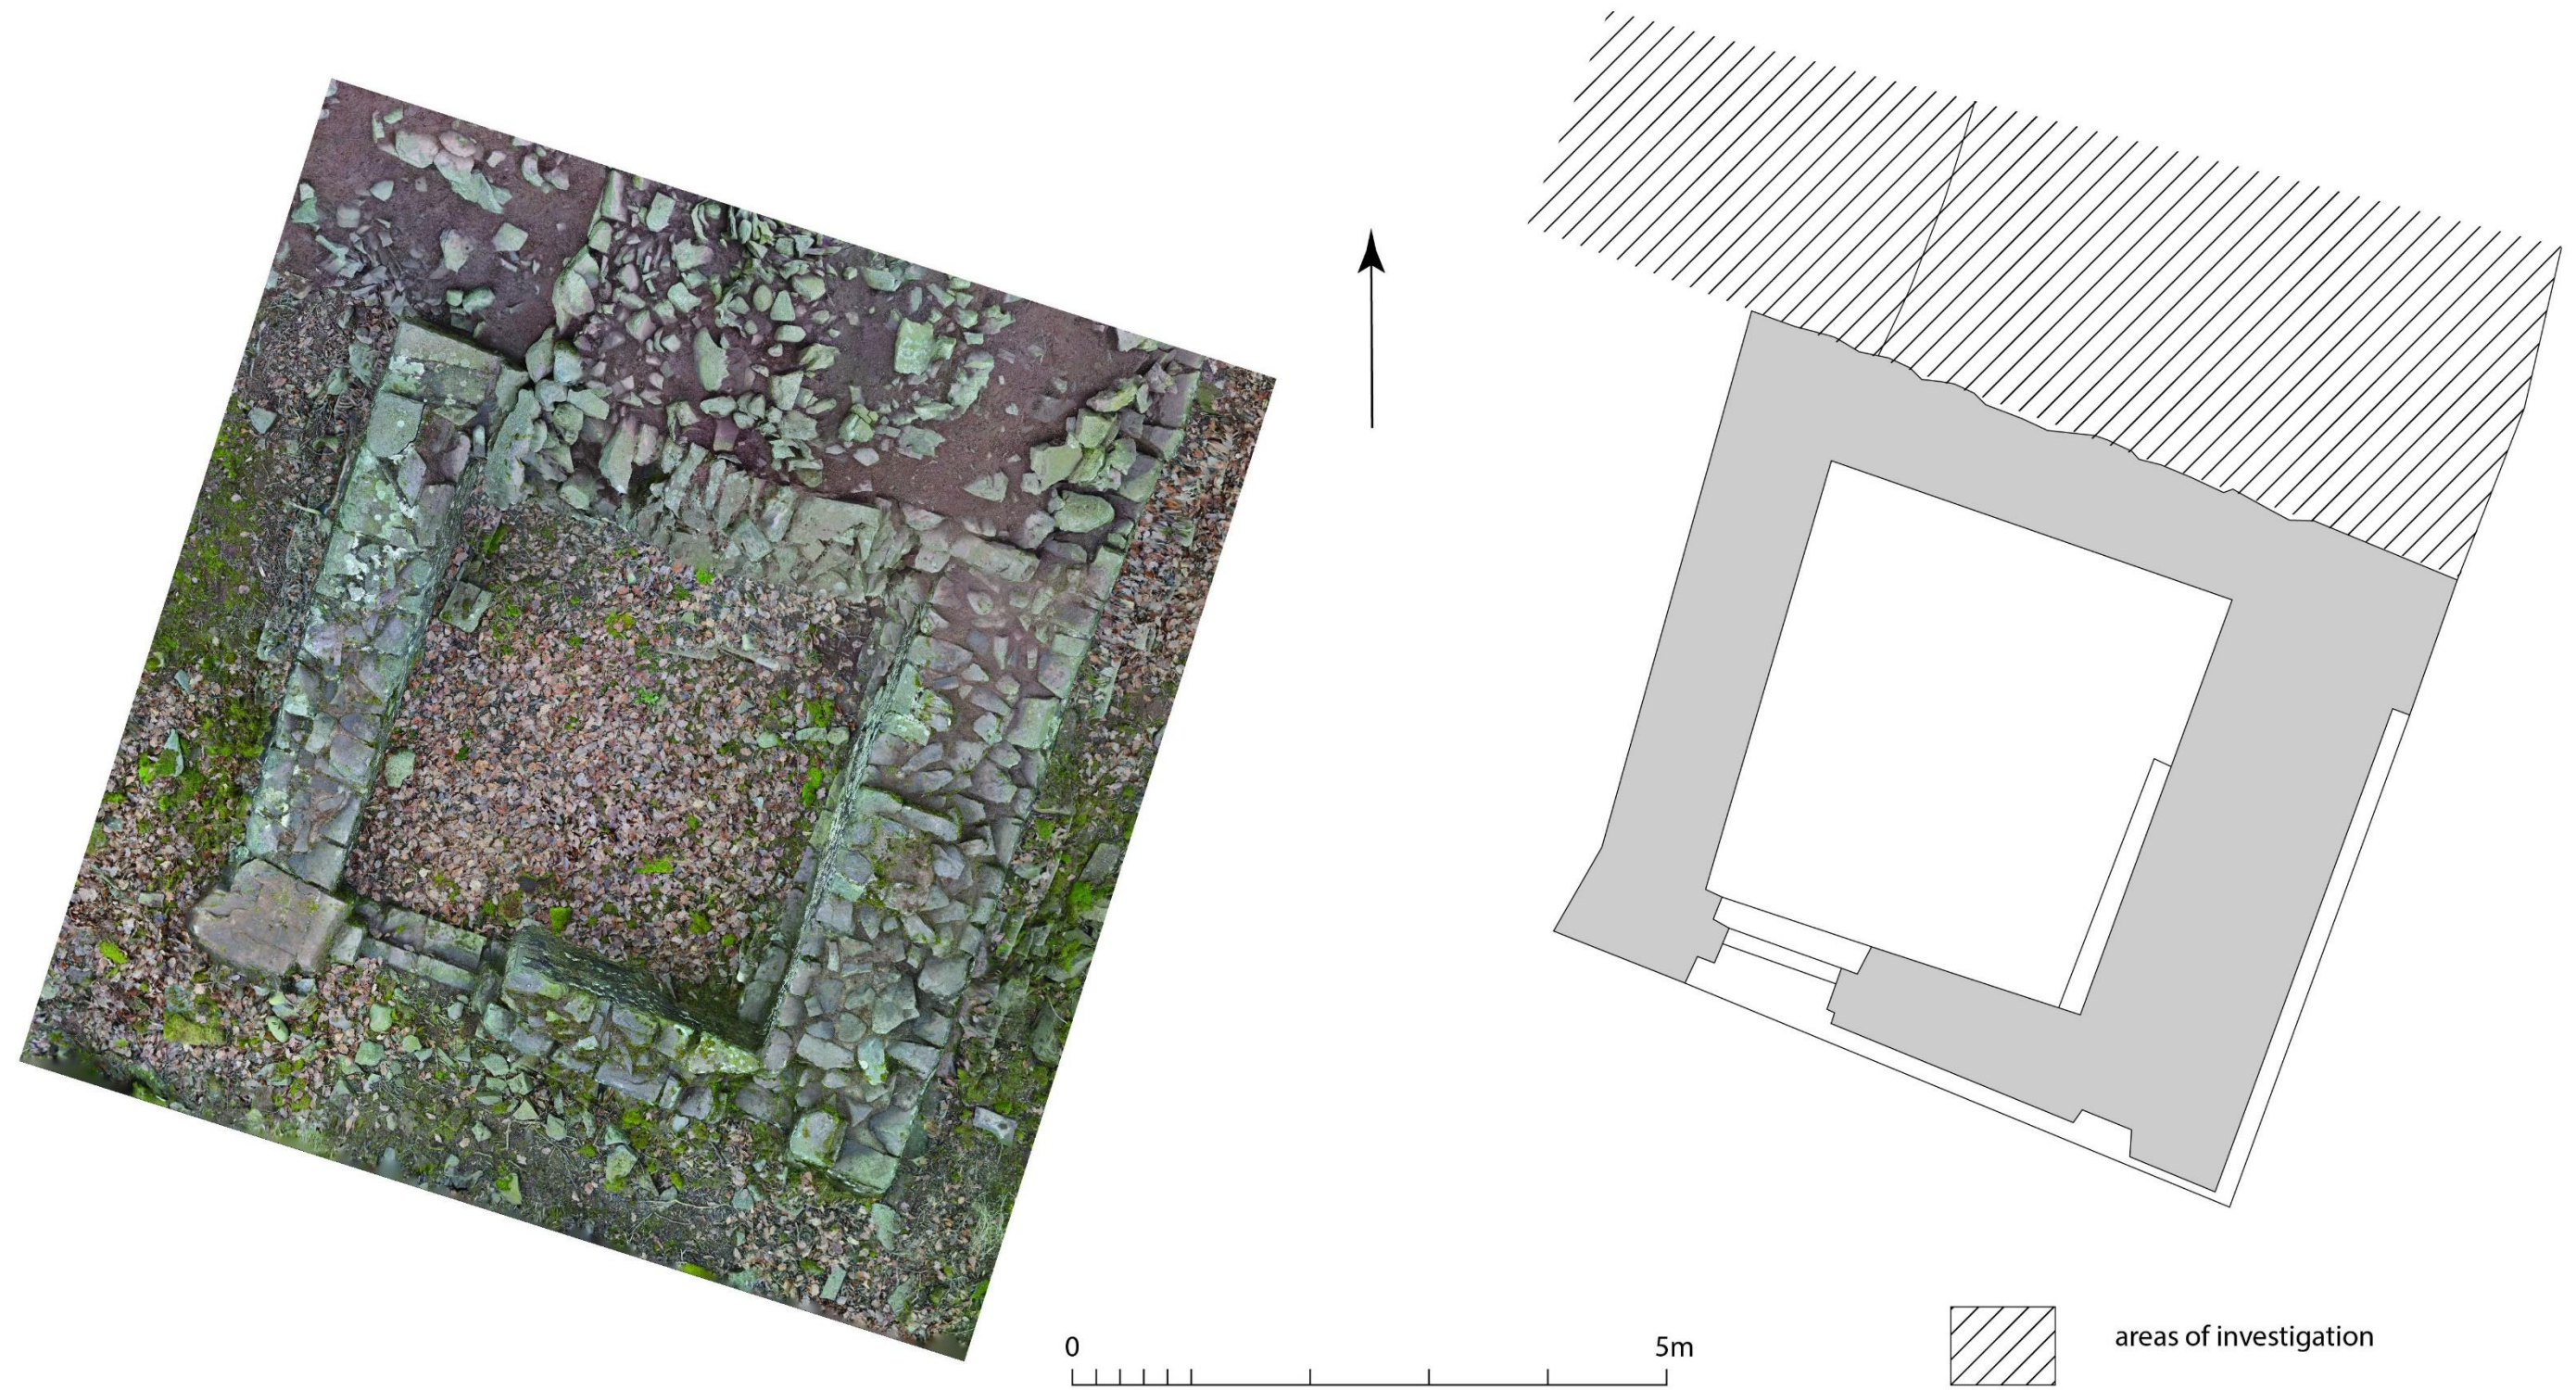
Fig. 26 East Gate: North Guardroom, photogrammetric and surveyed plans

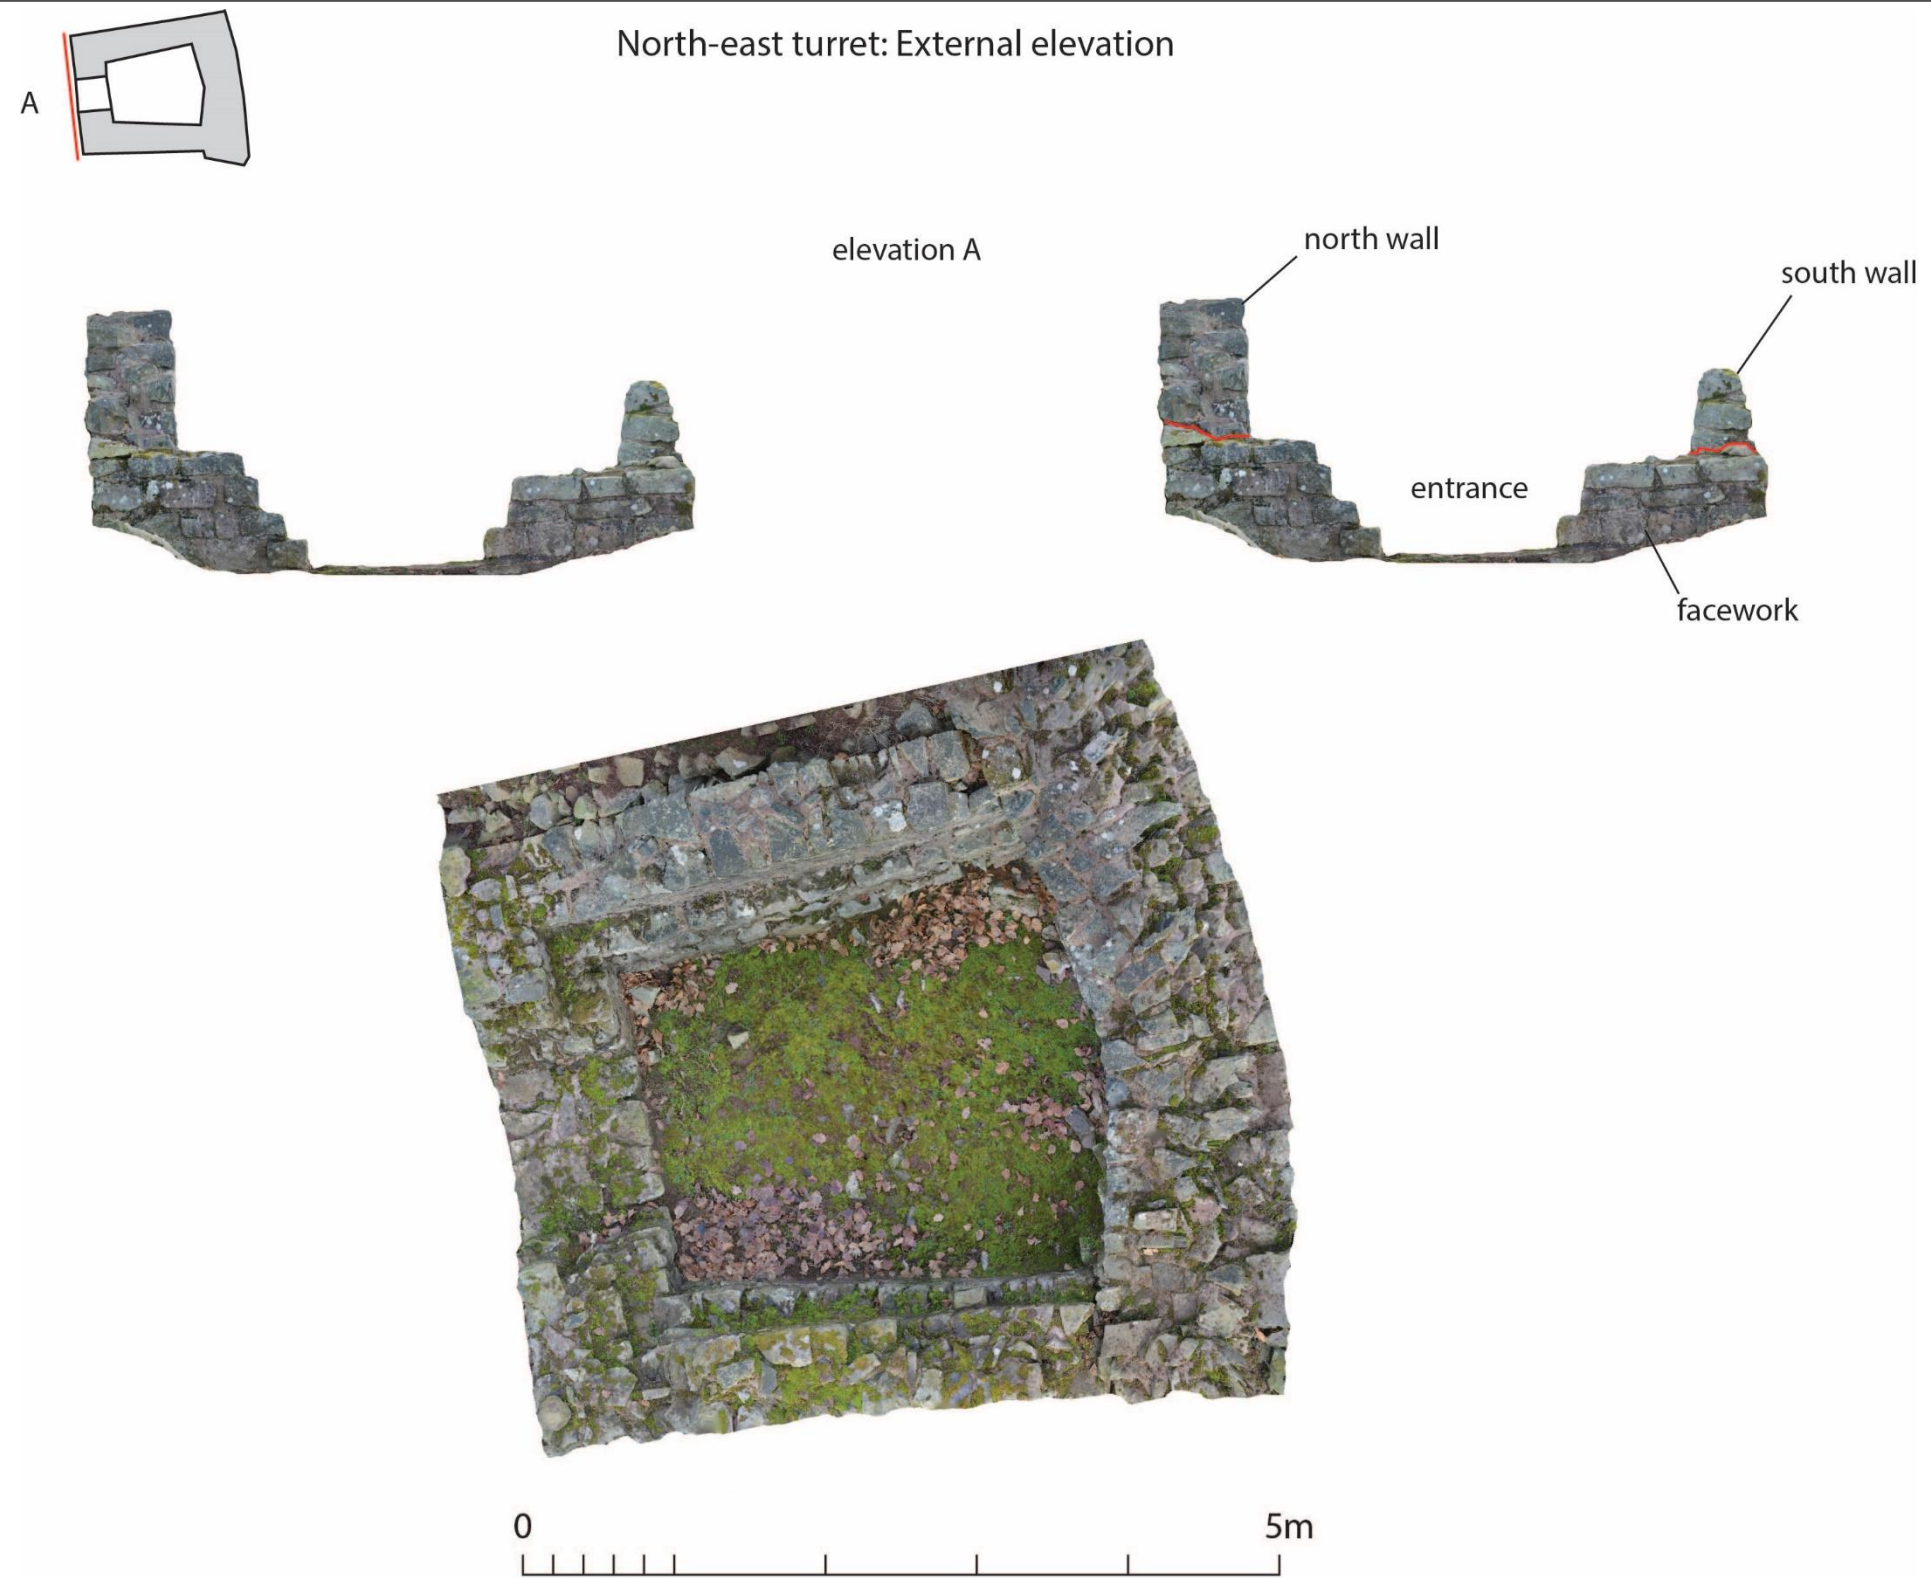
- 3.17. At first view the fabric of the tower appeared to be basically unaltered, although the MoW recorded comprehensive rebuilding of the north elevation and 50% of the east elevation of the tower in June 1970; they noted that the walls were completed in July. The remaining elevations of the tower had been repointed and the exposed upper faces of the structure sealed to prevent weather damage, which has served to mask the extent of the repaired masonry, but there seems to be no reason to suppose the team altered their usual practice of taking down the walls to remove roots and other vegetation and then rebuilding them to the same overall appearance using new mortar. It does, however, appear that the work here was completed to a slightly less rigorous standard than had previously been the case.

Fig. 29 North-east turret: photogrammetric plan and west external elevation

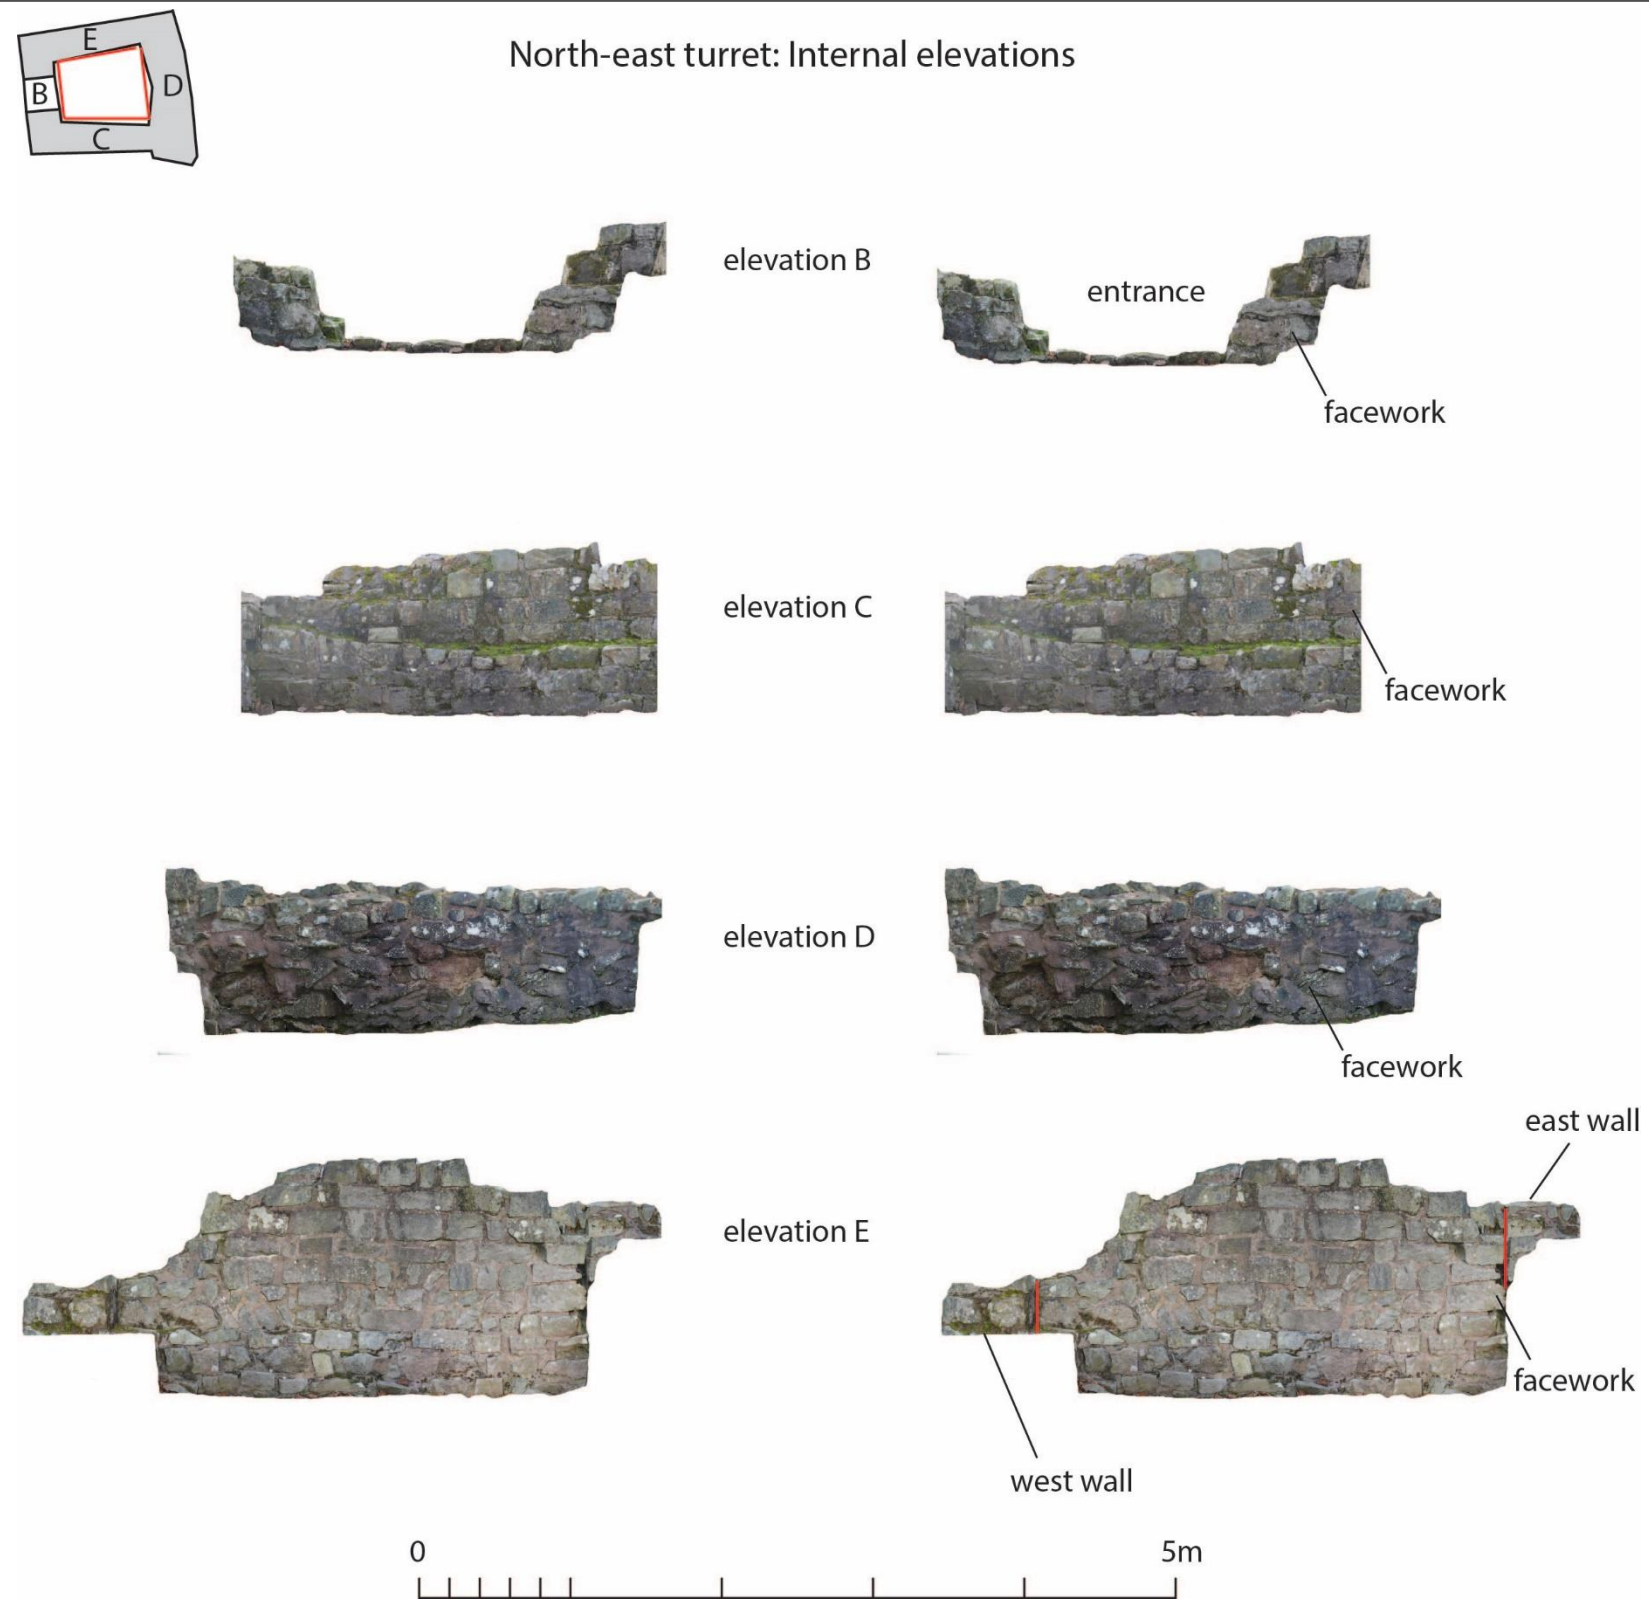
- 3.18. According to the MoW reports the earth bank adjoining the turret was excavated, presumably to make repairs to the wall core, in summer 1970; localised rebuilding of the wall face in the north-east corner followed the removal of some trees. The north-east corner was dug out and underpinned during this phase of the work. It is worth noting that the Casey (1971, 74-76) showed that the turret had been filled with material as part of the late refortification of the site and a section of the internal revetment wall relating to that phase can still be seen to the east of the turret.

Fig. 30 North-east turret: internal photogrammetric elevations
