CPAT Report No. 1604

Stanage Park Lake, Knighton, Powys

Archaeological Evaluation

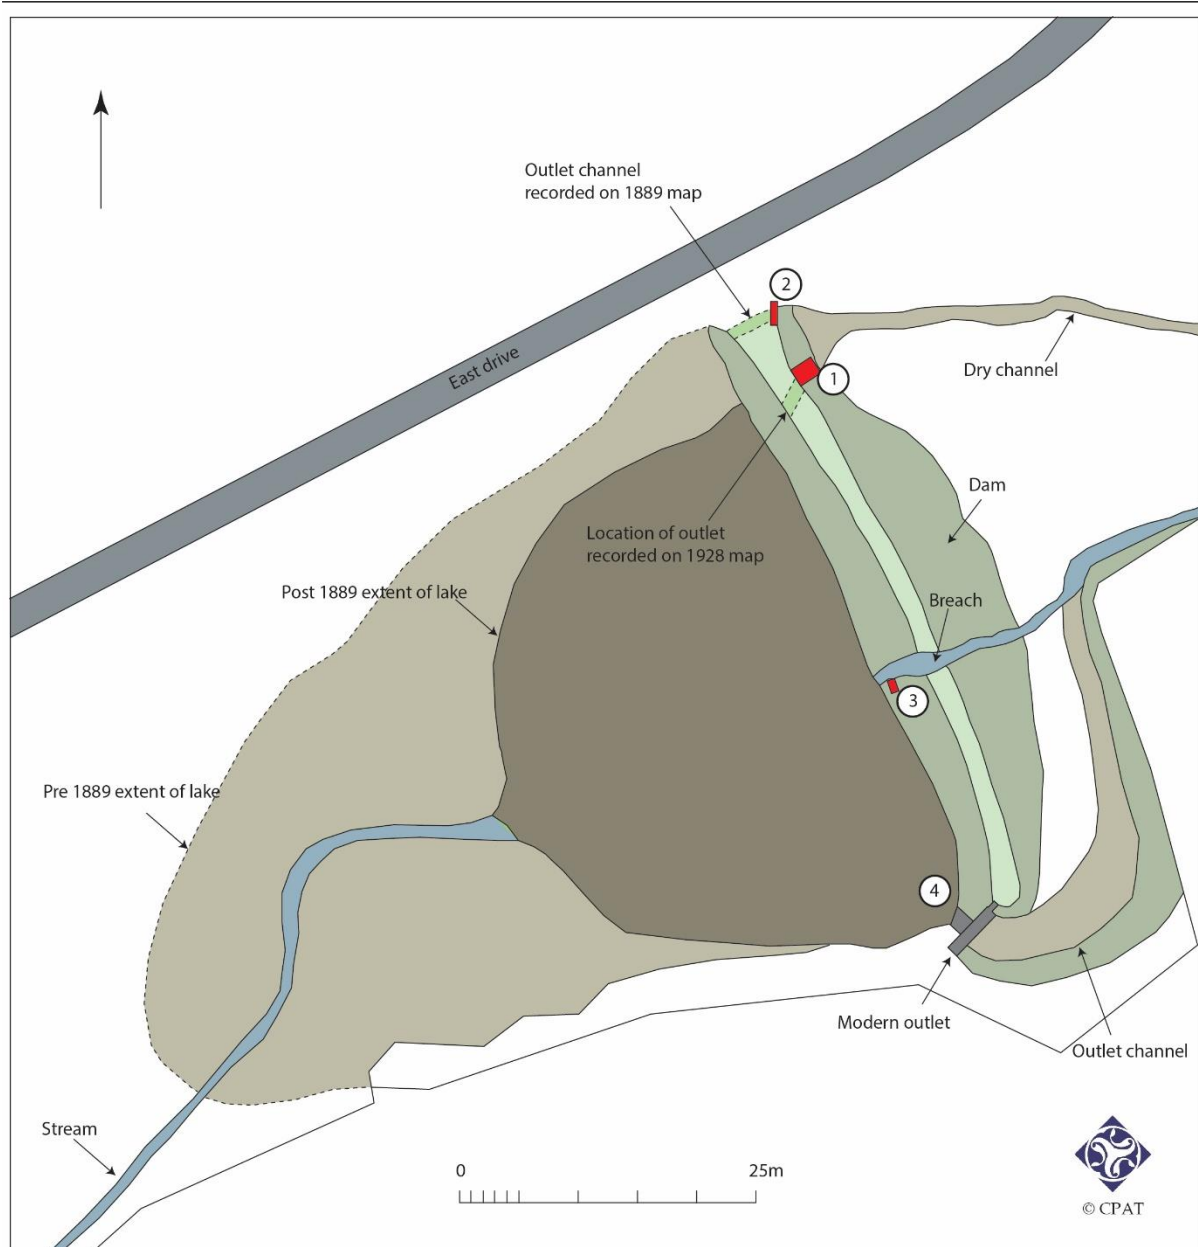
Fig. 7 Plan of lake showing evaluation trenches (marked in red) and features investigated (numbered)

- 3.1. The evaluation targeted three areas of the dam structure. All groundworks were carried out by Will Logan and Rob Billington, with the kind assistance of Johnathan Coltman-Rogers, owner of Stanage Park and Mike Garner of Garner Southall Partnership.
- 3.2. Two trenches (Fig. 7, 1 and 2) were excavated at the northern end of the dam in order to locate two outlets recorded on 1st and 3rd edition Ordnance Survey 25" mapping. The location of these trenches was informed by the location of the outlet channels which formed a Y-shape to the east, indicating that there were two outlets. Preliminary augering was also carried out, which did not provide any indication as to the location of either outlet but did reveal the makeup of the dam construction and the natural landform underlying it.

- 3.3. Trench 1 (Fig. 7, 1) measured approximately 1.2m by 1.5m and was positioned to locate an outlet recorded on the 1928 Ordnance Survey 25" map, but also inferred by the shape of the channel located to the east of the dam. Underlying the topsoil (101) was a firm reddish silt 0.2m in thickness. Underlying 102 a compact, light grey silt deposit (103) was revealed extending across the entire trench but also appearing to fill a steep sided cut [104], >0.2m deep and >0.9m in width, broadly orientated north-east. The south-east side of the cut fell outside of the excavated area. The fill contained a number of very large pieces of sandstone and part of an iron door hinge. Underlying 103 and cut by 104 was a light orangey brown silt (105) containing moderate sub-angular stones.

3.4. Trench 2 (Fig. 7, 2) measured 2m by 0.5m and was located approximately 5m to the north of Trench 1 in order to determine the form of an outlet recorded on the Ordnance Survey 25" map of 1889, but also inferred by the shape of the channel to the east. Removal of the topsoil (201) revealed a compacted, friable reddish brown silt (204) and degraded sandstone deposition. Cutting this was a V-shaped ditch [203] 0.9m in width and 0.37m deep, oriented broadly east-west and running across the north end of the dam. The line of the ditch was also discernible as a faint depression in the top of the dam structure. Within the ditch was a firm mid-reddish brown clayey silting fill (202). Underlying 204 was a buried soil horizon composed of a greyish clayey silt, which formed the line of the natural slope underneath the dam.

- 3.5. Trench 3 (Fig. 7, 3) was excavated in order to investigate a series of timbers located to the south of a modern breach in the dam structure, which appeared to be part of a structure designed to strengthen and shore up the dam construction in the vicinity of the sluice. The breach itself was also investigated in order to determine if any trace of the sluice mechanism had survived.
