Tudno Castle Hotel, Vaughan Street, Llandudno

Level 2 Building Survey

Report No. 1532

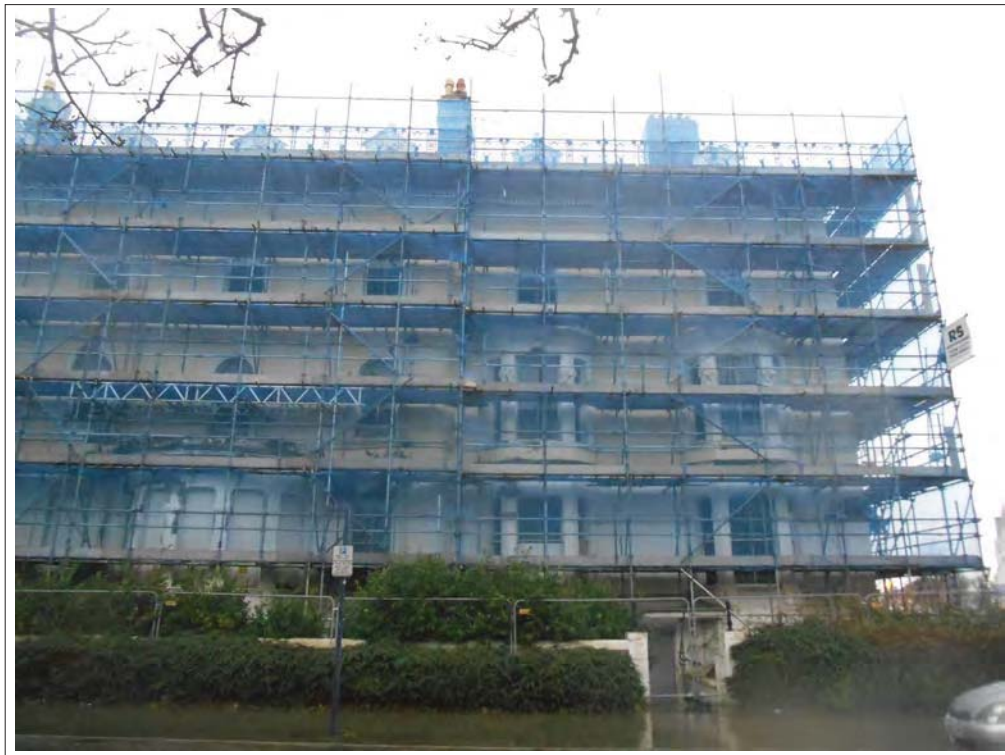
Plate 8. View of Mostyn Broadway elevation, looking S.

Plate 8: This photograph illustrates the first and second bays. Two round-headed sash windows with archivolt are located on the second floor. The basement, ground floor and first floor of the first bay contain canted three-light windows. While the first floor window contains a hipped roof over it, the ground floor window is further defined by a decorated stringcourse. The latter forms a pediment over the second bay ground floor window. A segmental pediment is located over the second floor window. At the time of the survey, all openings from the basement, first and second floor were blocked either by concrete or by wooden boards.

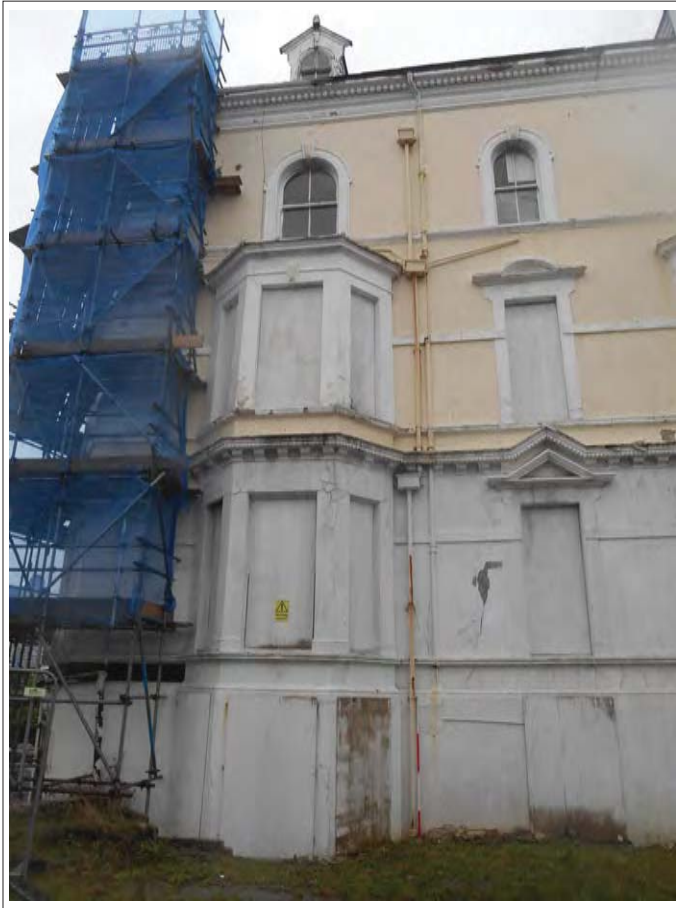
Plate 9. View of eastern elevation, looking NW.

Plate 9: This photograph illustrates the third bay. A round-headed sash window is located on the second floor, while the remaining windows are canted three-light windows. Resembling the first bay, the second floor window was a hipped roof over it and the ground floor window is further garnished by a decorated stringcourse running over it. A quoin defines the edge of this projected area. All windows from the basement to the first floor included are currently blocked either by concrete or by wooden boards.

A building addition is also illustrated on this photograph. This addition was the space for toilet facilities on the basement area and for a kitchen on the first floor, at least during the last use of the building. A detailed examination of this addition from the view depicted on Plate 9 suggests that the existing wall was first constructed as a concrete masonry wall which was initially coated with light yellow render. A further event of rendering is observed on this wall. Given the materials used to construct the extension, it may be suggested that the latter dates to the early to mid-20th century. However, a detailed examination of historic maps suggests that an extension on this area already existed as early as 1890s (see Figure 2).

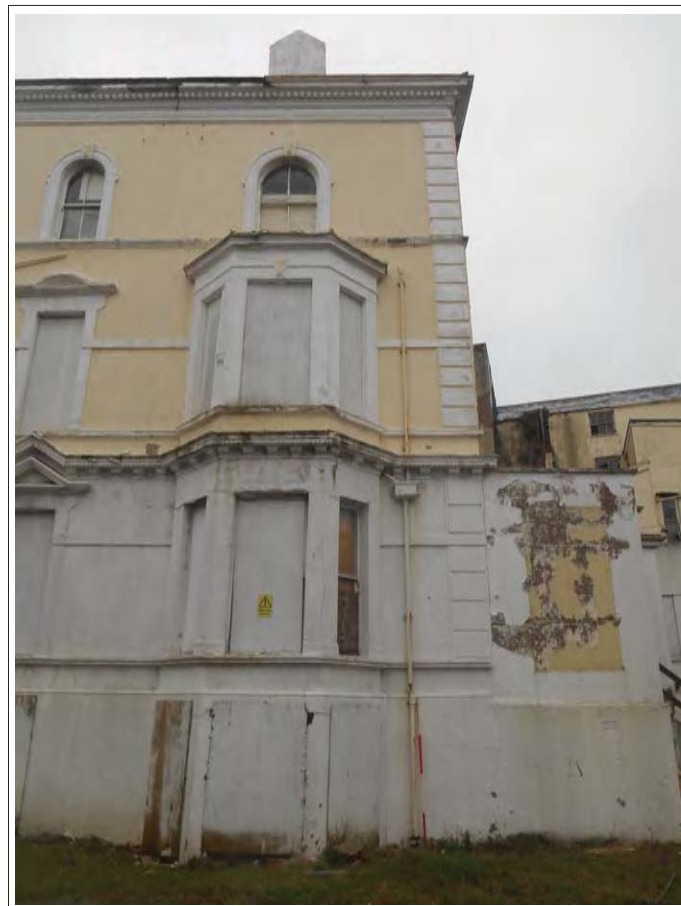
Plate 10. View of eastern elevation, looking NW.

Plate 10: This image depicts another face of the original building as well as the extension already introduced on Plate 9.

A close view of the extension allows defining multiple events of alteration. The oldest evidence is found with a flight of stairs. These stairs appear depicted in historical maps dating to the 1890s. However, this entrance was blocked at the time in which the extension ceased to be defined by a rectangular space to be defined as T-shape in plan. At this point, a window and a door are cut through the main wall. These elements still are visible to date however are currently blocked by wooden boards. The flight of stairs leading to the existing door is no longer in place. However, it may be noted that these stairs existed, at least, until the time in which the latest drawings for the side were made (see Figure 5).

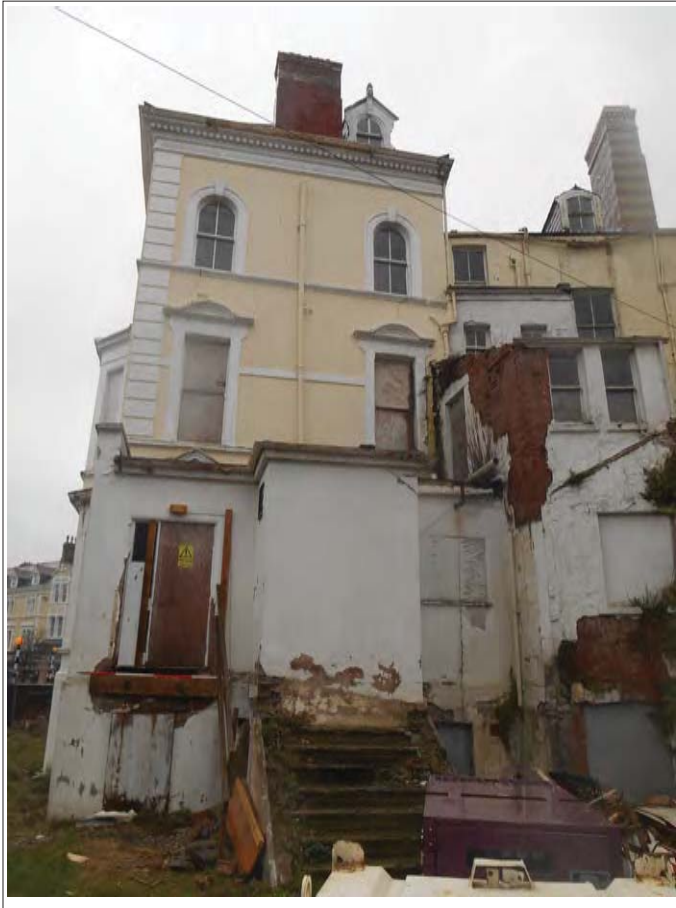
Plate 11. View of extension 1, looking NW.

Plate 11: This image depicts some of the original building layout as well as another extension which, judging from the brickwork and from historical maps (see below) can be dated to the early 1900s.

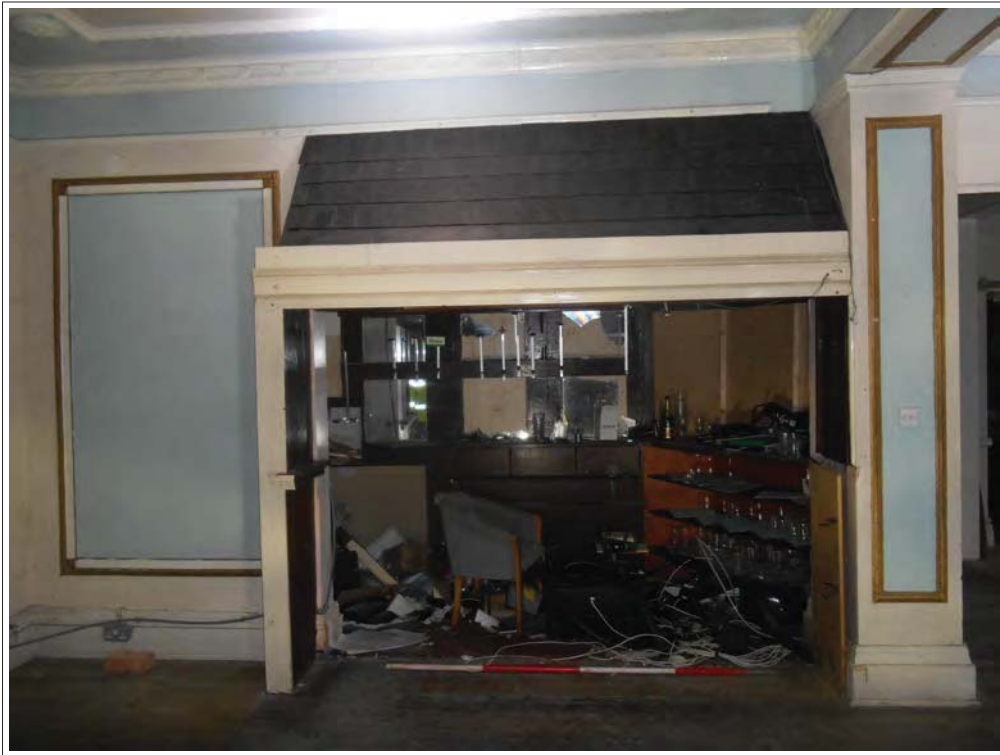
Plate 29: The bar appears to be a later addition to the space of the ground floor. All fittings, fixtures and appliances appear to be modern. The bar is covered by a single pitch slate roof.

Plate 29. Bar area, looking E.

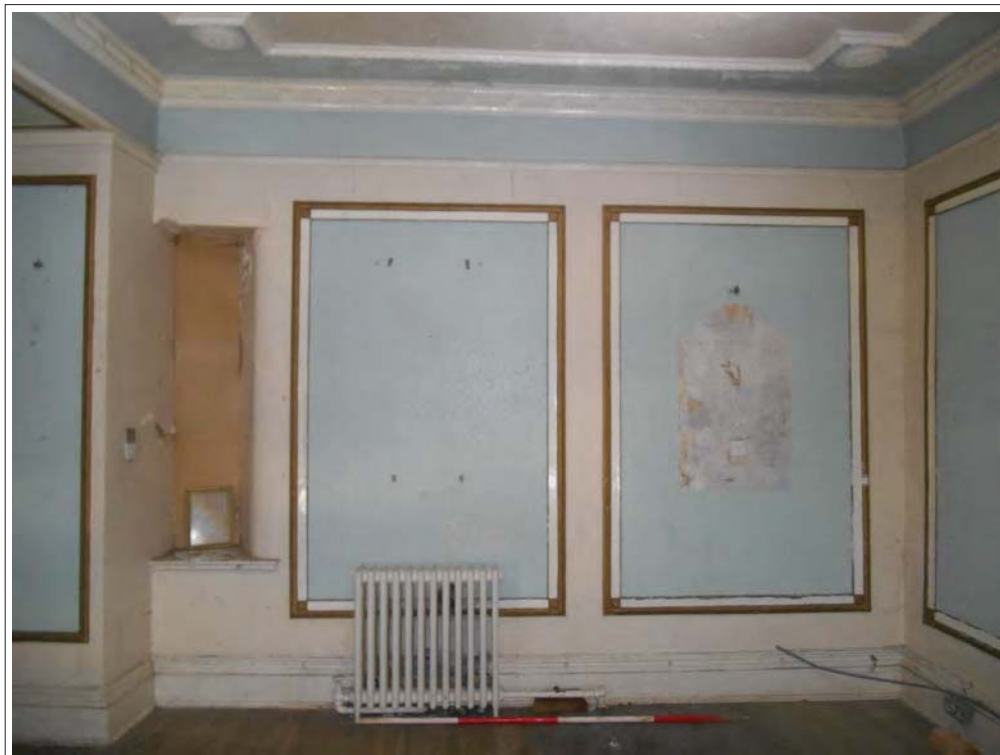
Plate 30: This plate illustrates a window opening currently blocked by wooden boards which had previously been partly obstructed by the construction of a projecting wall related to the bar area.

Plate 30. Detail of blocked window using projected wall, looking SW.

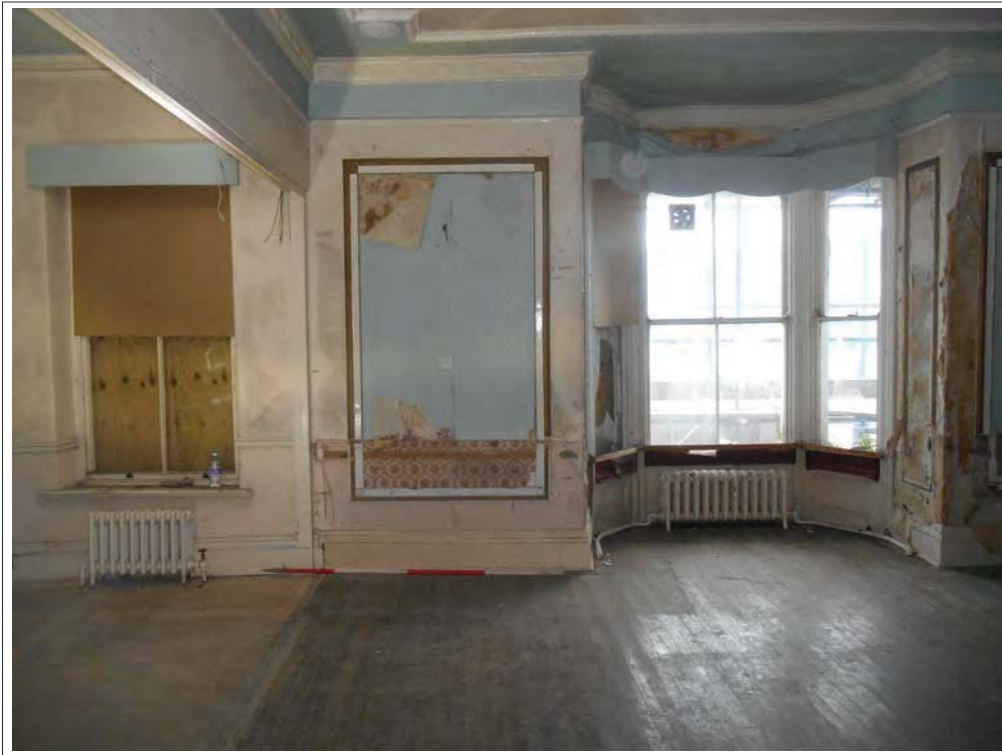
Plate 31: The decay of some of the decoration found within the bar area allows documenting earlier decoration events. Before painted following rococo style, the rectangular panels found on walls appear to have been covered with wall paper with floral geometric patterns. Moreover, this image also illustrates the existence of panel mouldings under canted three-light windows and scalloped curtain mouldings. A similar situation is portrayed in Plate 32 and 33.

Area A (Plates 32 and 33): As already noted, this area appears to respect the general decoration encountered throughout the ground floor. However, it is noted that, in contrast to the ballroom and bar, this area contains the characteristic rectangular panels on the walls without any further decoration within the panels. Moreover, similarly to that stated in Plate 31, resulting from decay, it is possible to observe previous decorative episodes characterised by wall paper floral geometric patterns.

Plate 33. Detail of wall evidencing different layers of decoration, looking NW.

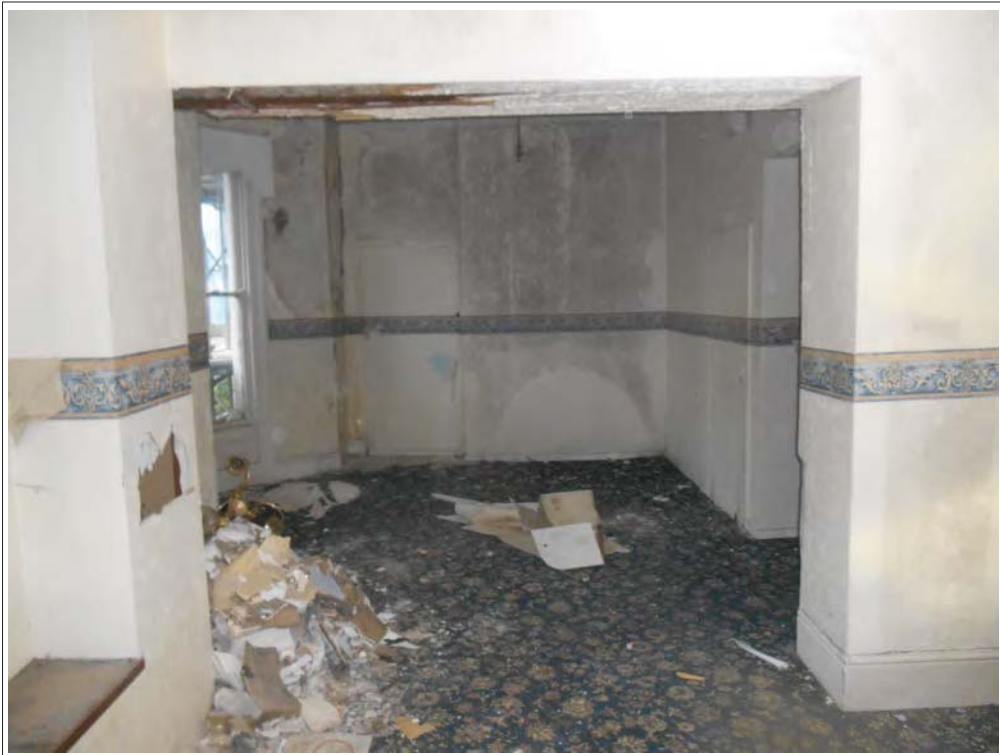
Plate 39: This image illustrates a blocked door which predates the wall decoration characteristic of this area. A similar situation is portrayed in Plate 43 and 44.

Plate 39. Blocked door predating current wall decoration, looking E.

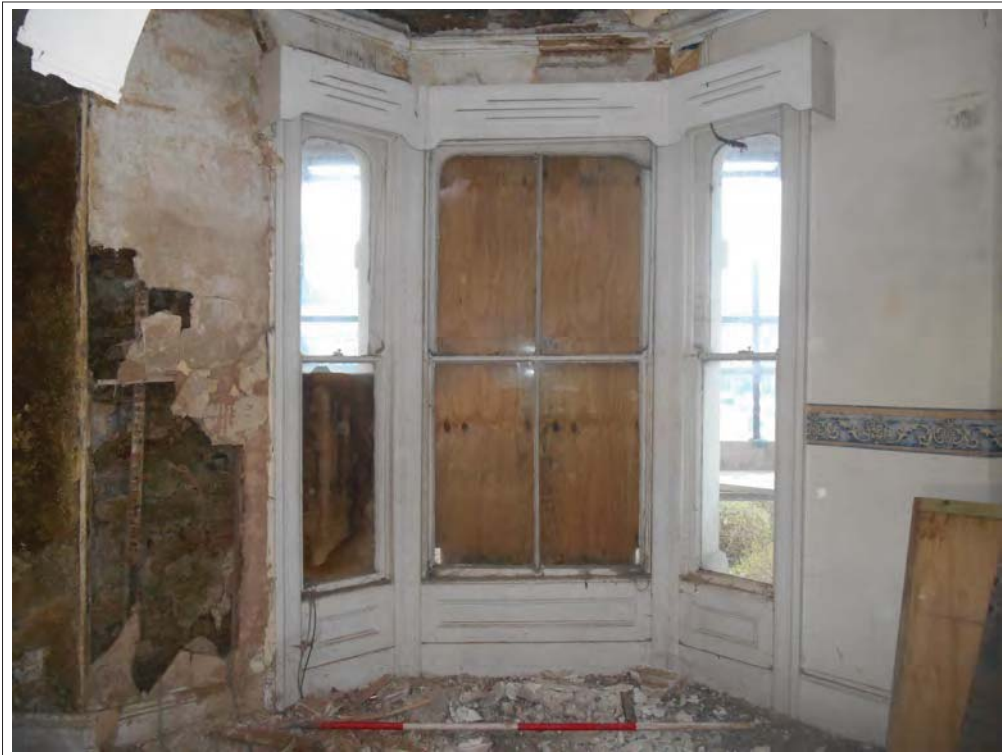
Plate 41: This image illustrates a canted three-light window with upper curved corners and step straight curtain mouldings. Contrastingly, plate 43 illustrates scalloped curtain mouldings.

Plate 41. Canted three-light window. Looking W.

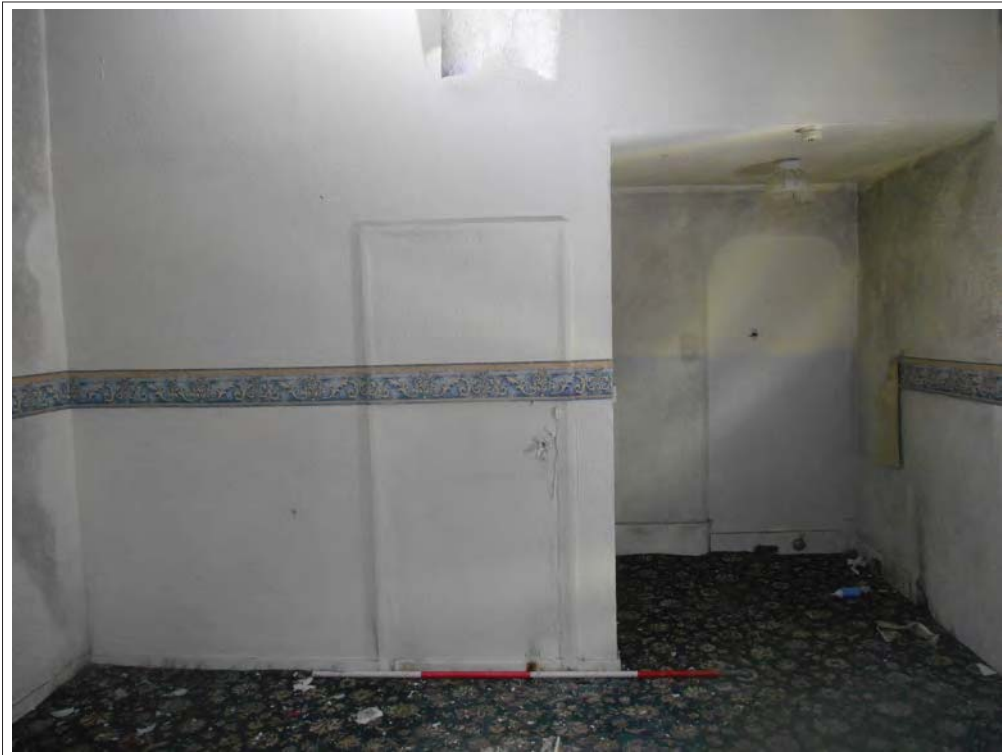
Plate 43. Blocked doors predating current wall decoration, looking SE.

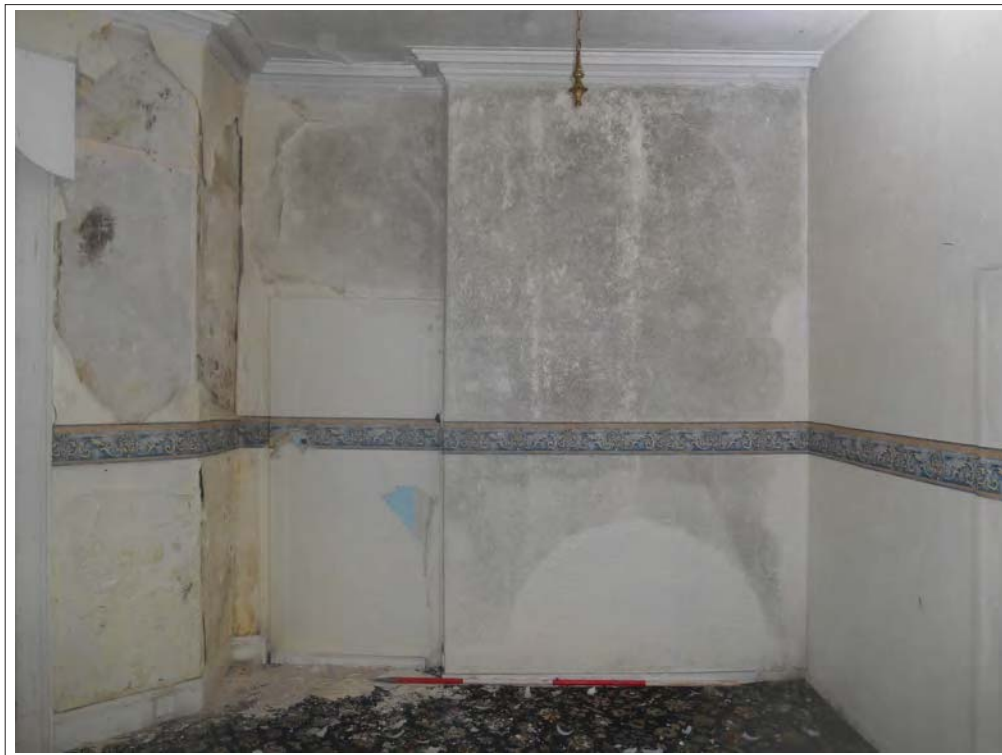
Plate 44. Blocked door predating current wall decoration, looking E.

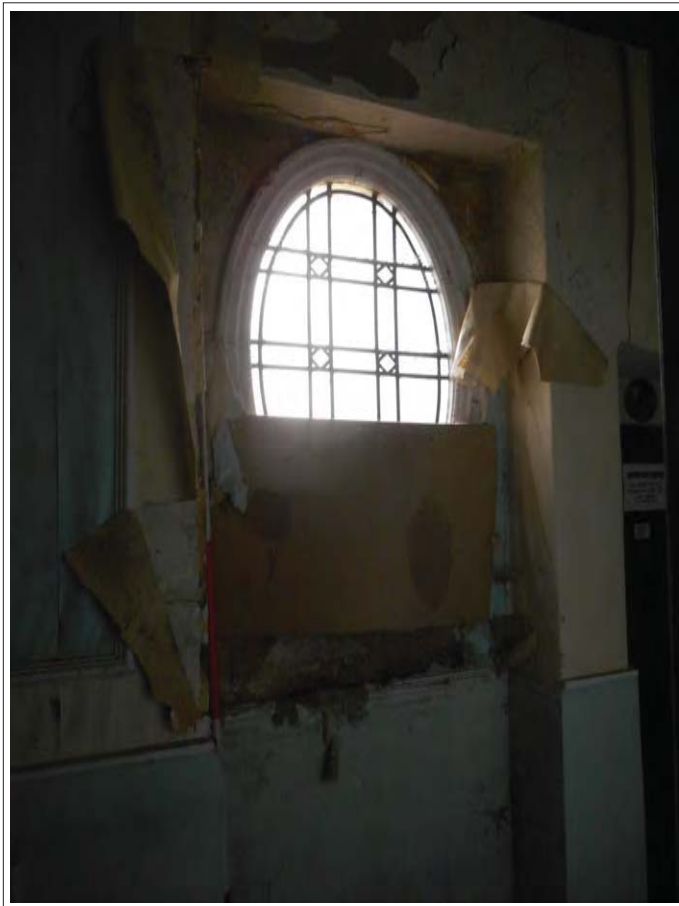
Plate 45: Detail of bull's eye window to light well. This window is decorated with iron grilled geometric patterns.

Plate 45. Decorated bull's eye window, looking SE.

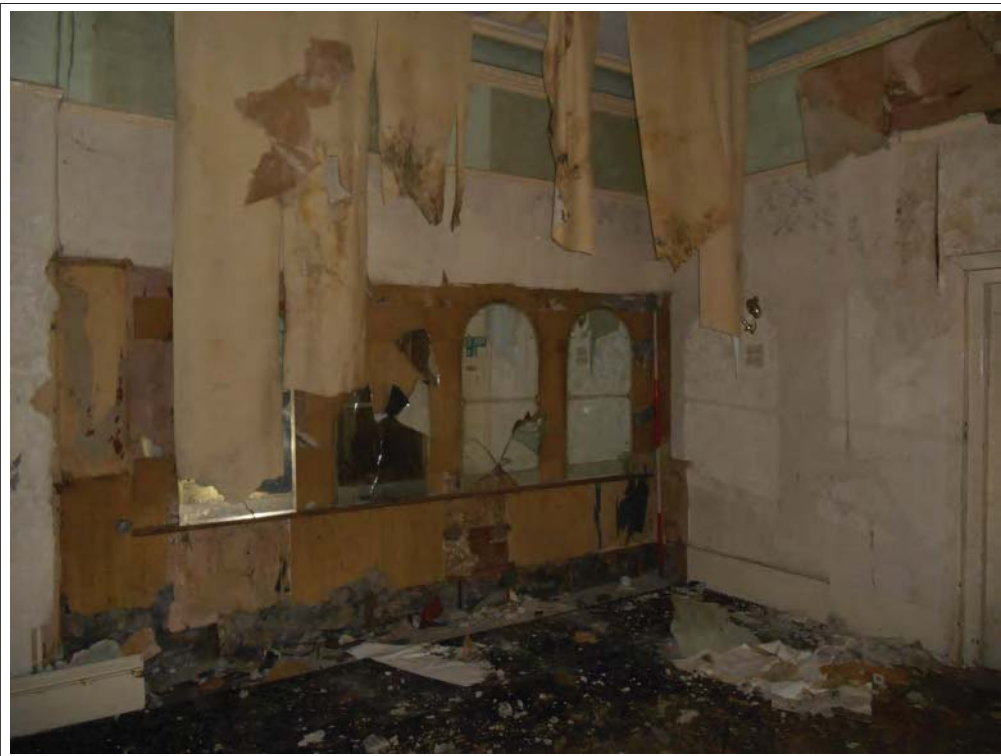
Plate 50 and 51: These images depict earlier decoration and original structural components displayed as result of decay. Plate 50 illustrates the existence of earlier floral patterned wall paper and Plate 51 displays the walls original brickwork.

Plate 50. Detail of wall paper and mirror decoration, looking ESE.

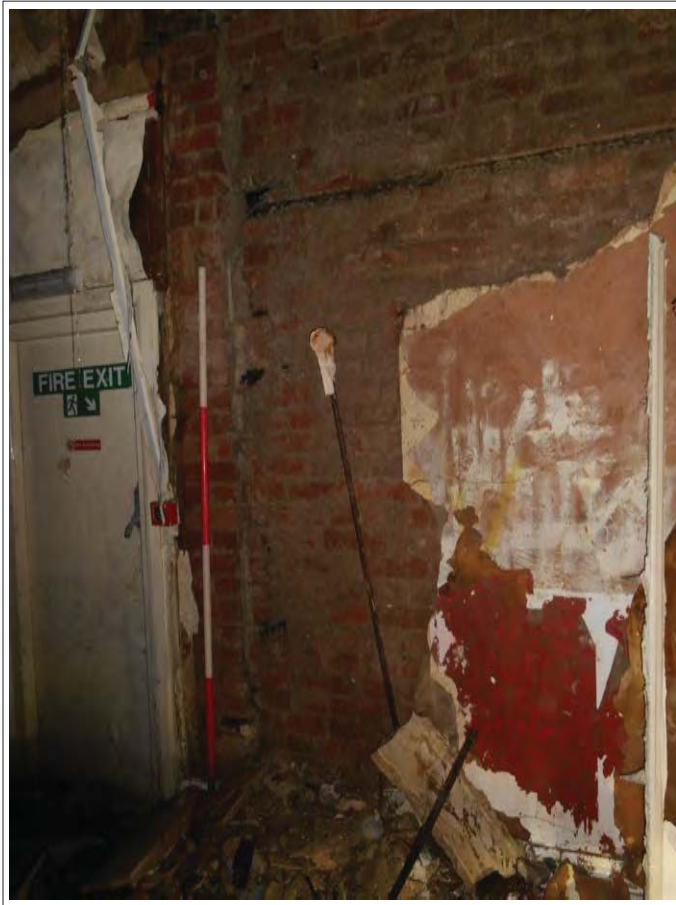
Plate 51. Original brickwork, looking S.

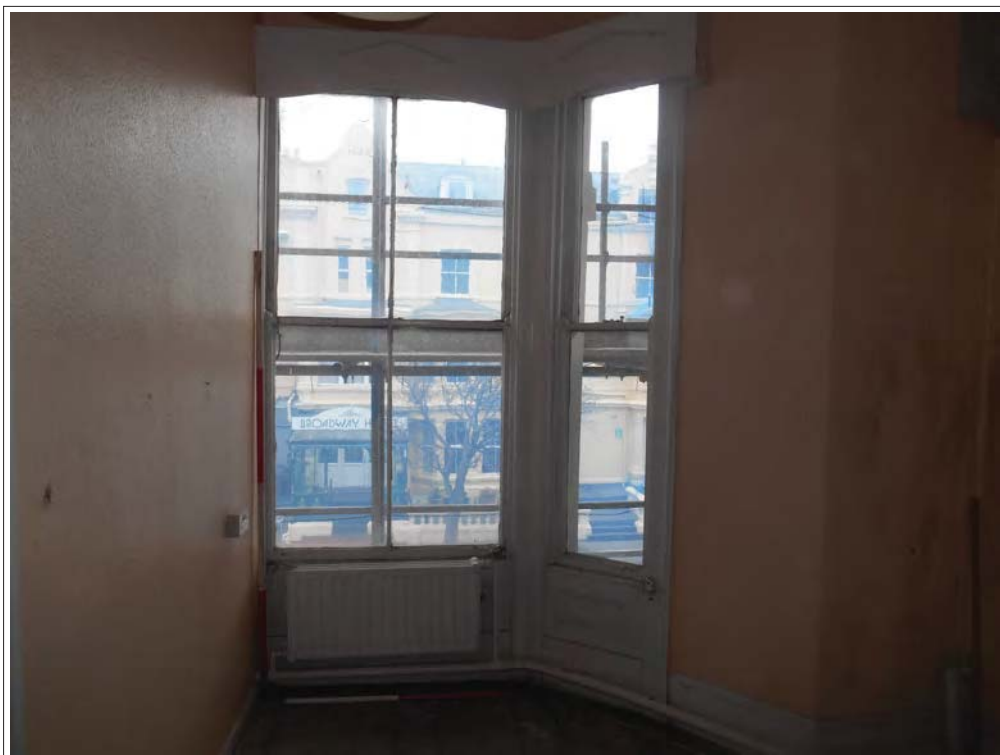
A major alteration event is observed in this room with the construction of an en-suite bathroom. Plates 68 and 70 evidence the division of the canted three-light window of this room by one of the bathroom walls. While two thirds of the window remain within the room, one third becomes the window opening for the bathroom. Furthermore, resulting from decay, it is possible to see the remains of the original fireplace in this room (see Plate 69). A similar situation is found in Room 7 (see Plate 71).

Plate 68. View of Room 8. Storeyed canted three-light window blocked by wall addition, looking N.

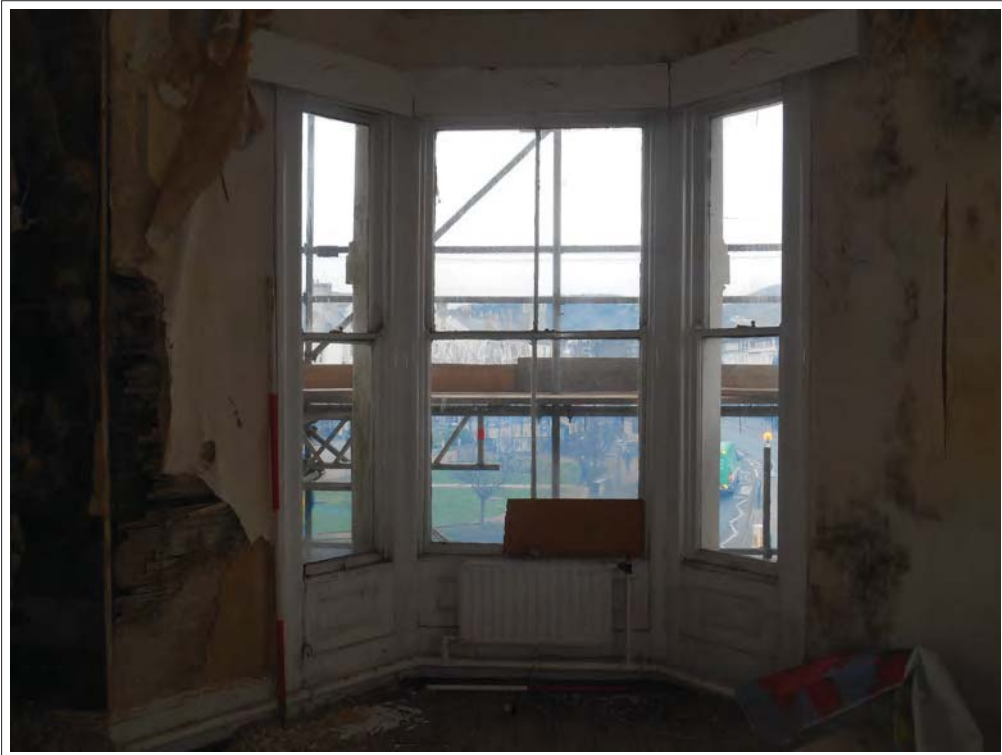
Plate 71. View of Room 7 with storeyed canted three-light window, looking W.

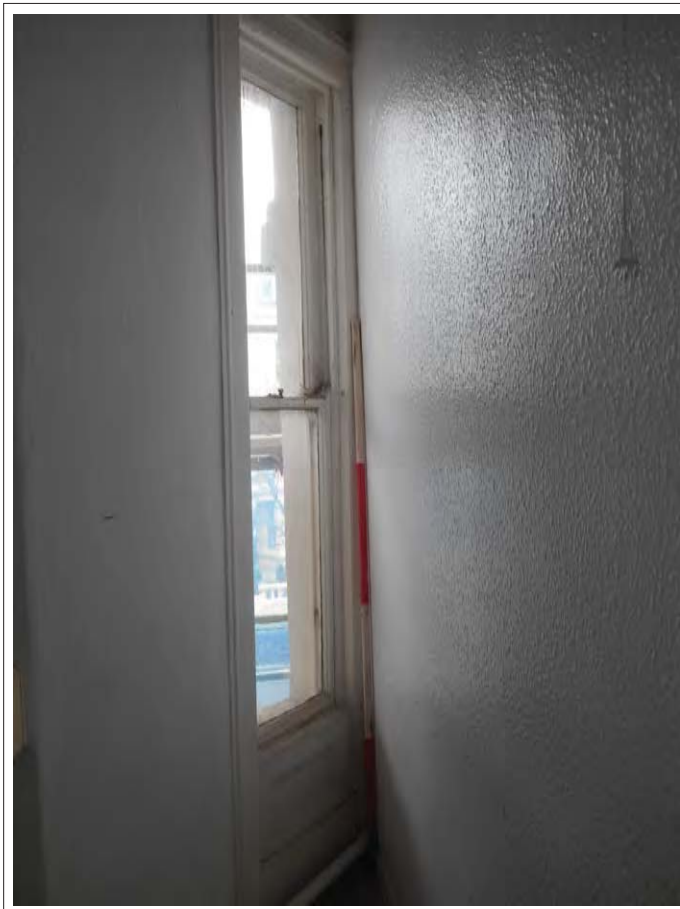
Plate 72. View of Room 7. Storeyed canted three-light window blocked by wall addition, looking N.

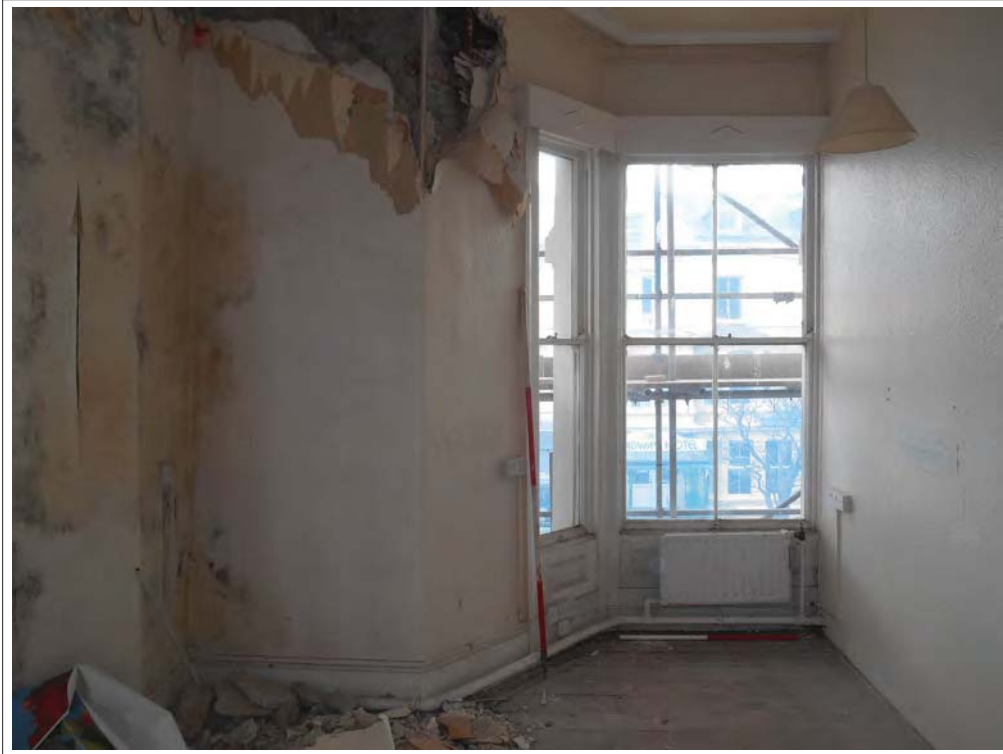
Plate 73. View of Room 7. Canted three-light window blocked by wall addition looking N.

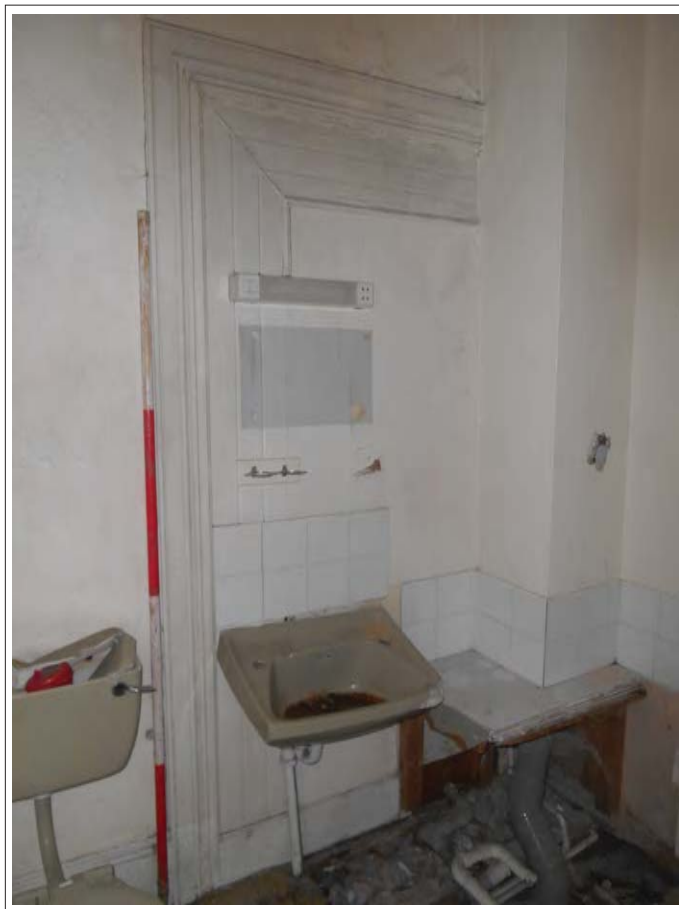
Plate 76. Detail of blocked door from Room 12, looking W.

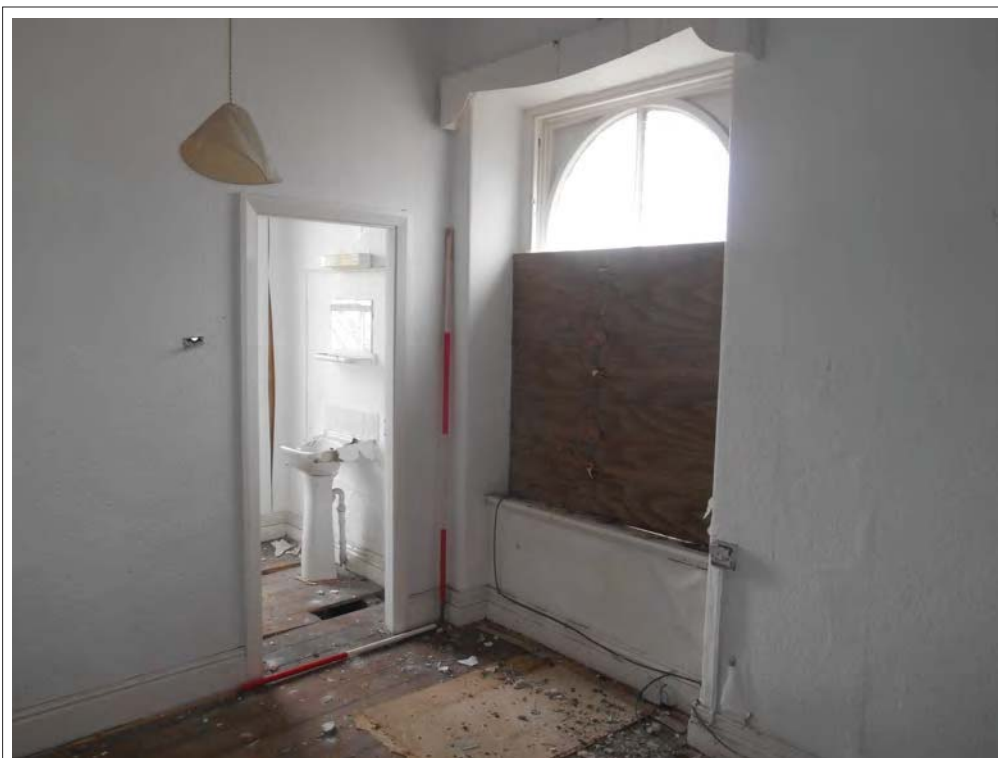
Plate 78. View of blocked round-headed sash window from Room 13 and en-suite bathroom, looking SE.

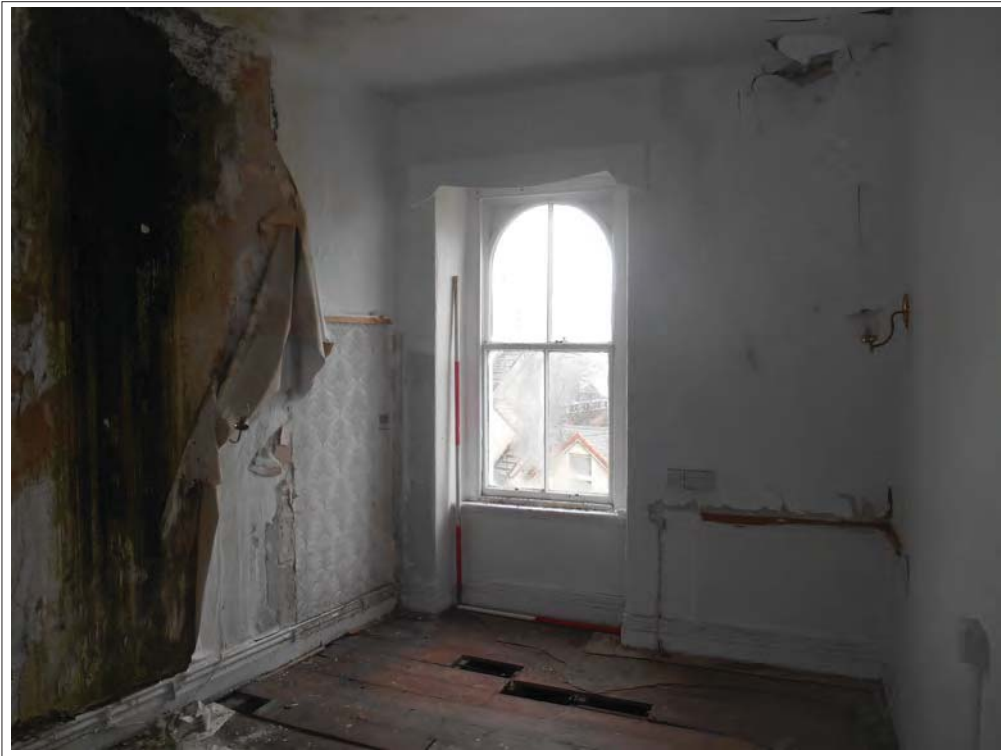
Plate 79. View of Room 12, with round-headed sash window and multiple layers of wall paper, looking NE.

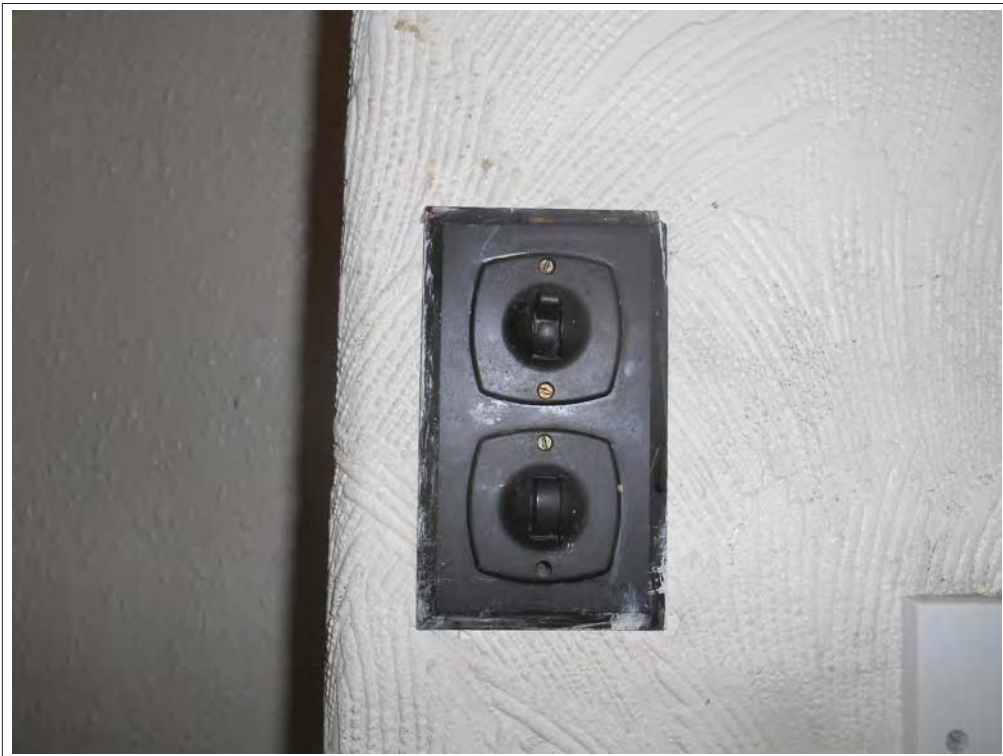
All electrical fittings observed in this floor postdate the 1960s. Nonetheless, a light switch dating to the late 1930s and one dating to the late 1960s were identified in Room 6 (see Plates 93 and 94).

Plate 94. Detail of electrical fitting from Room 6, looking S.

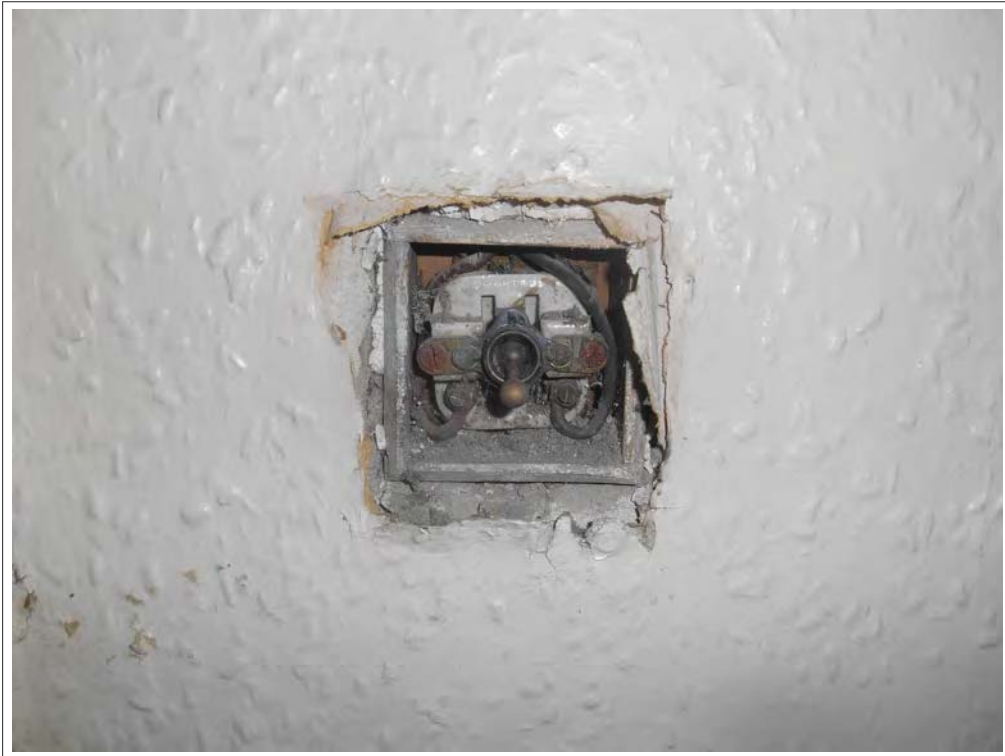
Plate 95. Detail of electrical fitting from Room 6, looking S.

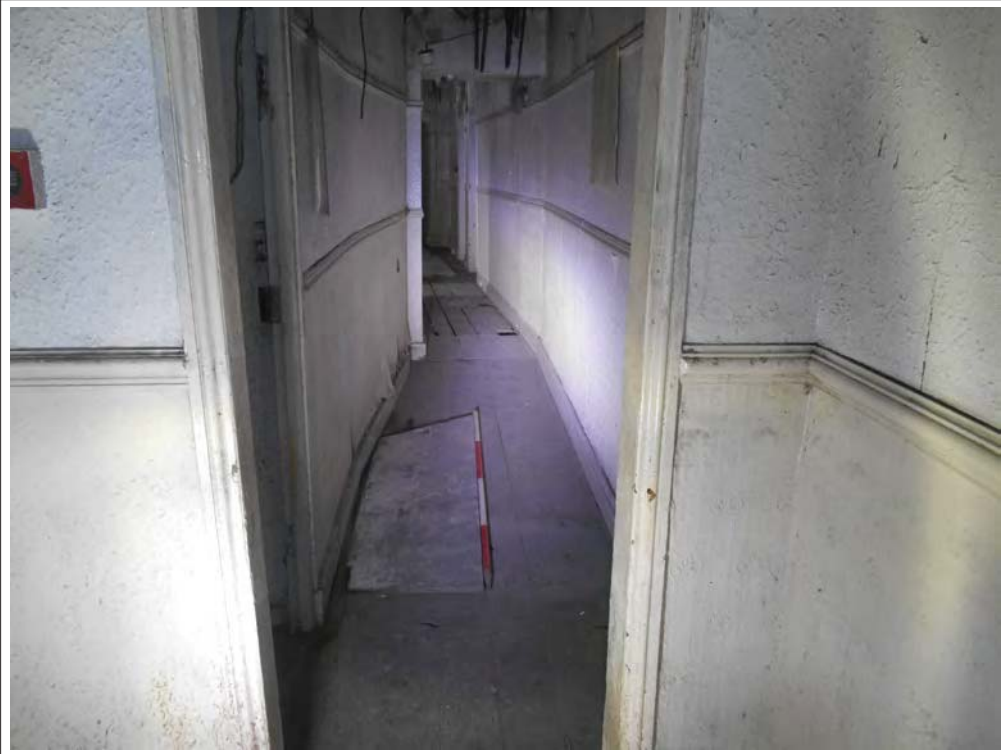
Plate 103. View of corridor, looking S.

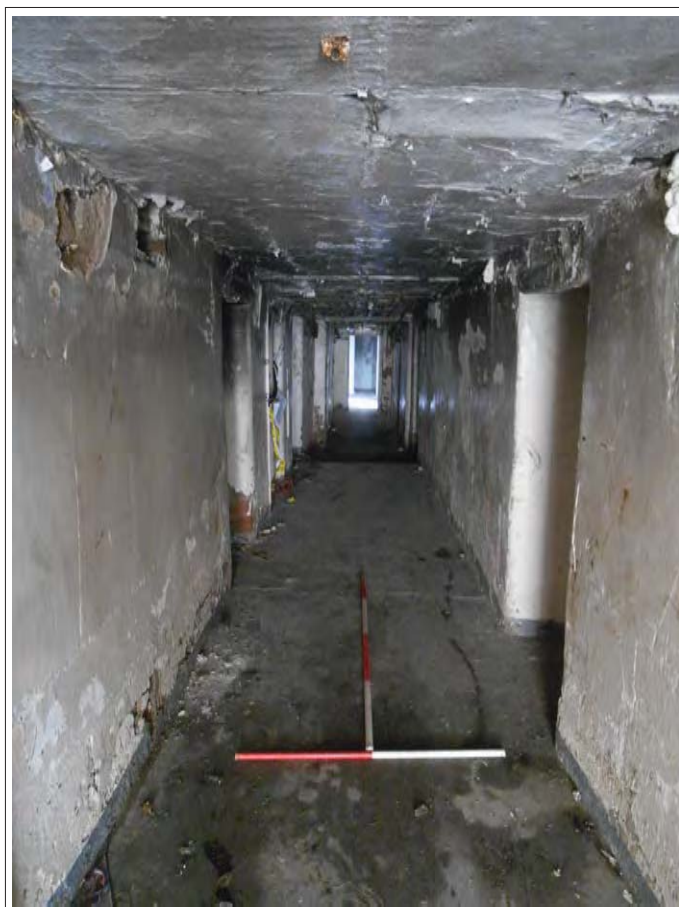
Plate 108: This image shows the view of the main basement corridor. Spaces are found at either side of it. All rooms N of corridor belong to the original layout of the hotel and despite having suffered multiple events of repair and alteration, they were originally hotel rooms. In contrast, rooms to the S of the corridor are established within the extension areas and mostly correspond to kitchen, cellars and other spaces reserved for the hotel staff.

Plate 108. View of basement corridor, looking W.

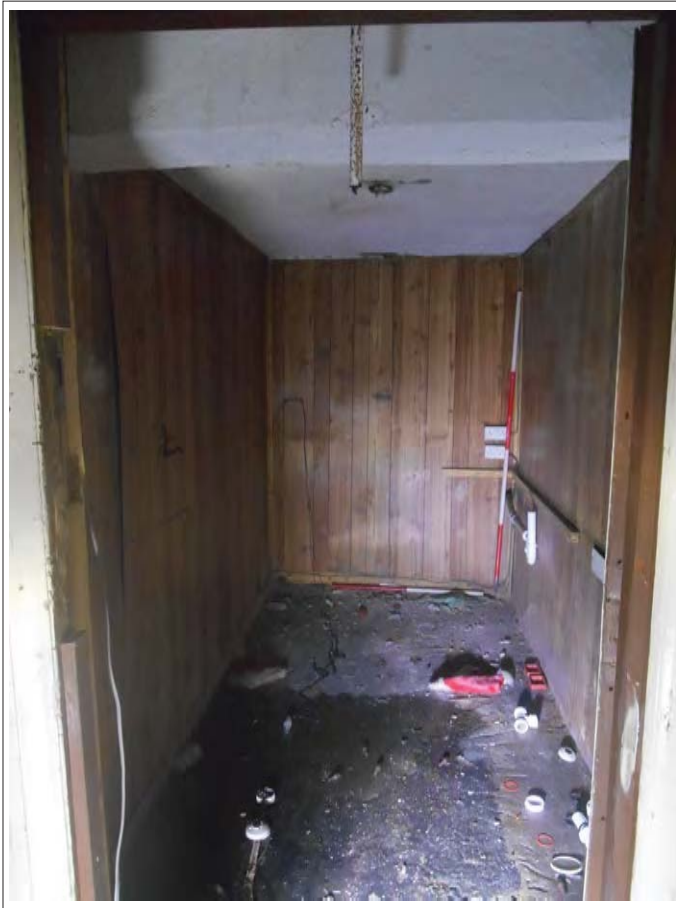
Plate 109: This image shows the layout of an addition created within one of the main basement rooms. This rectangular space has its walls covered by wooden boards and all its fittings and fixtures appear to be modern. The lack of material associated to this room make it difficult to determine its function.

Plate 109. View of room addition, looking ESE.

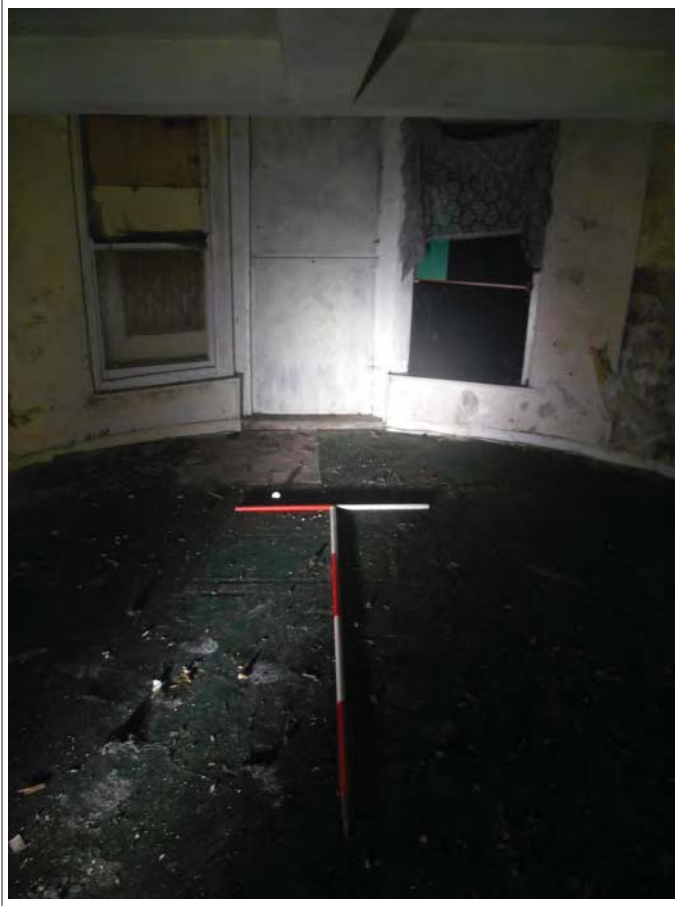
Plate 110: This image illustrates one of the canted five-light windows located within the area of the basement. This window is currently blocked off by wooden boards. While the room appear to have been painted white during its last stages of use, resulting from decay, it is possible to observe different events of wall paper decoration.

Plate 110. Canted five-light window currently blocked, looking NE.

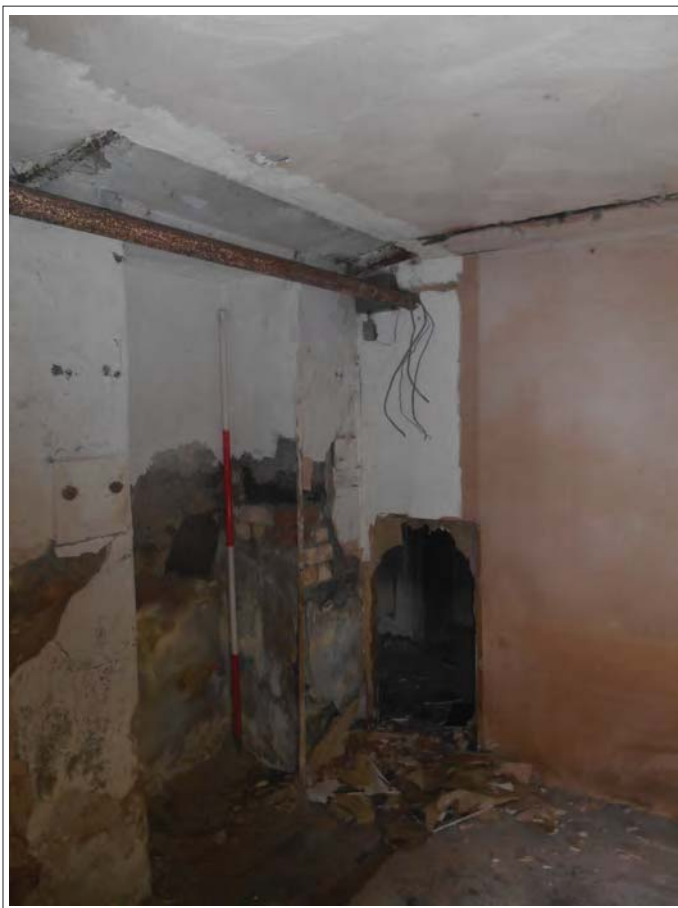
Plate 111 and 112: This image illustrates two spaces confined to communal toilet facilities. The only original element found within these spaces is a blocked centre bar sash window (see Plate 112). Plate 111 illustrates the first of these spaces. The walls of this toilet facilities have been decorated with striped wall paper. A horizontal band with floral patterns is located half way up the wall. During the visit, it was determined that this space had been created sometime during the late 20th century. Plate 112 illustrates the second of these spaces. While badly damaged, this space retains some of the original tiles.

Plate 112. View of wall addition, looking NE.
