Tudno Castle Hotel, Vaughan Street, Llandudno

Level 2 Building Survey

Report No. 1532

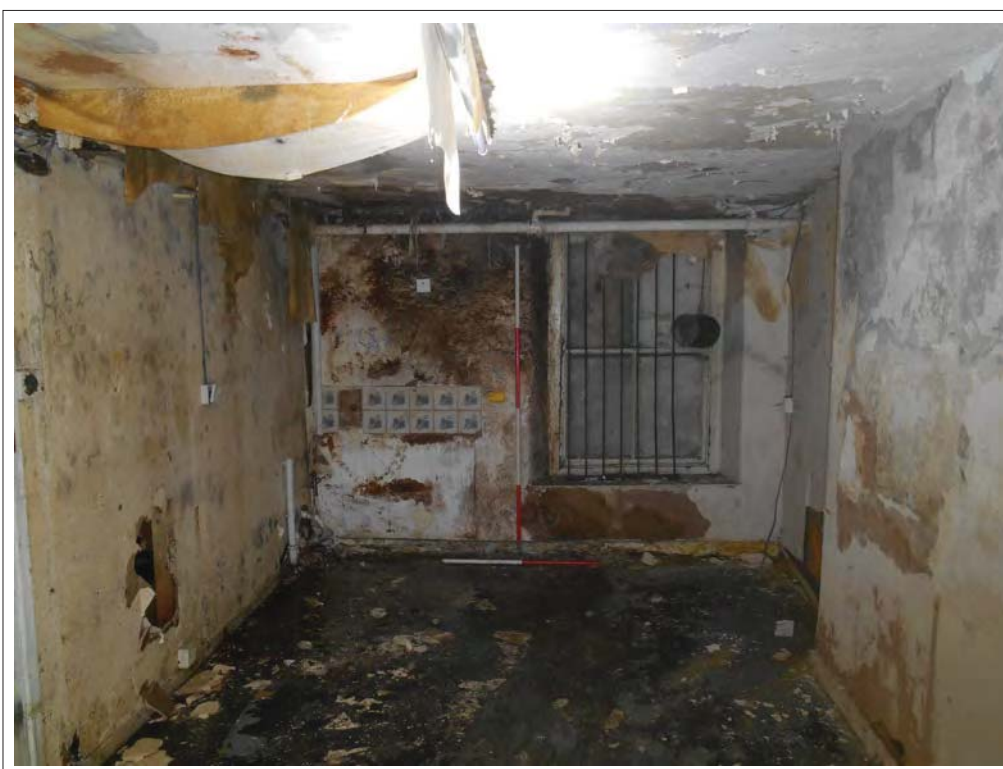
Plate 111 and 112: This image illustrates two spaces confined to communal toilet facilities. The only original element found within these spaces is a blocked centre bar sash window (see Plate 112). Plate 111 illustrates the first of these spaces. The walls of this toilet facilities have been decorated with striped wall paper. A horizontal band with floral patterns is located half way up the wall. During the visit, it was determined that this space had been created sometime during the late 20th century. Plate 112 illustrates the second of these spaces. While badly damaged, this space retains some of the original tiles.

Plate 113. Toilet facilities, looking NE.

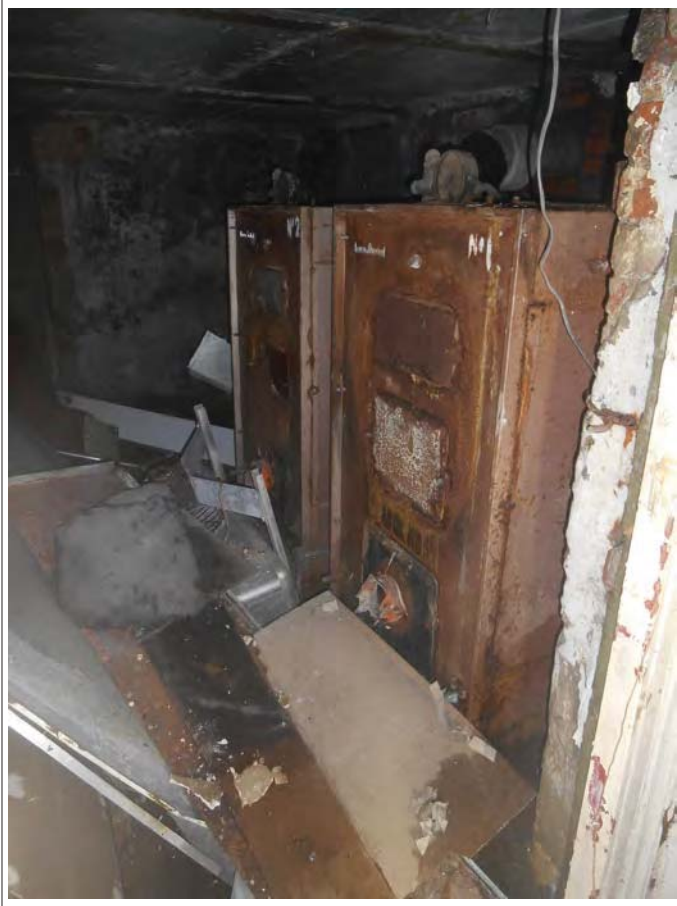
Plate 114. Meter room, looking SSW.

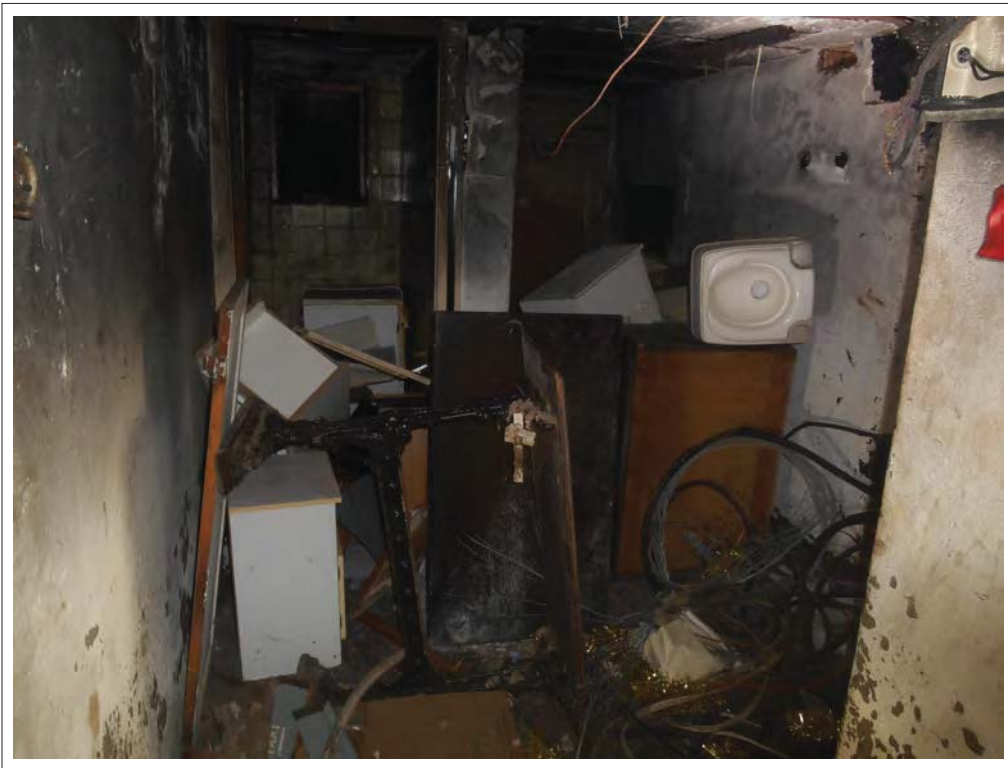
Plate 114: This image illustrates one of the rooms S of the main corridor. This room is nowadays used for storage purposes. However, it was difficult to determine whether this had been the original function of this space. Note that the back wall is covered by light yellow glazed tiles.

Plate 115. Storage room, looking S.

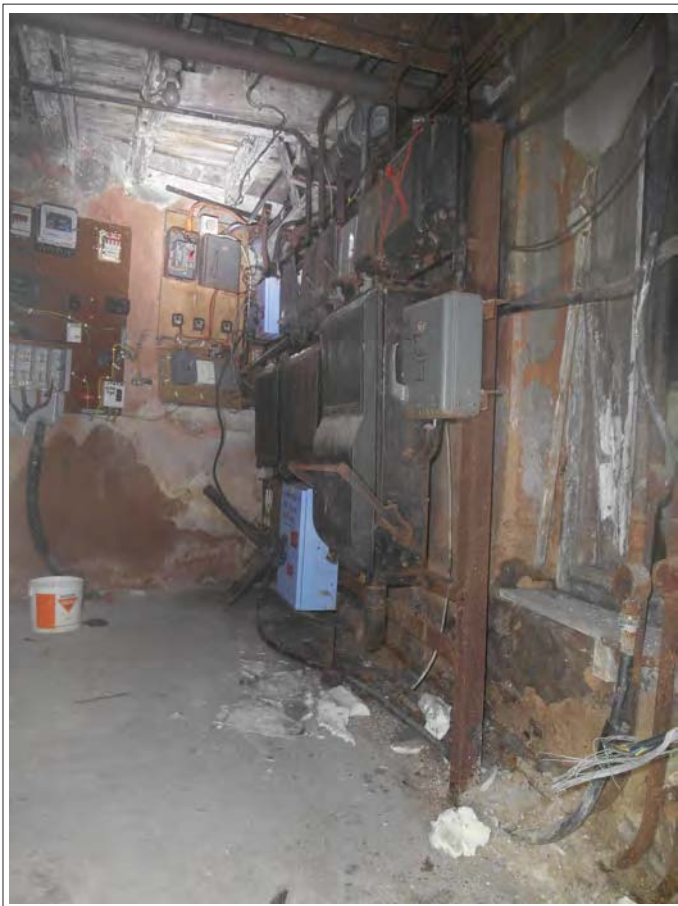
Plate 115 and 116: These images illustrate two meter rooms. While most electric appliances appear modern in date, some others can be dated to the early 20th century.

Plate 116. Meter room, looking S.

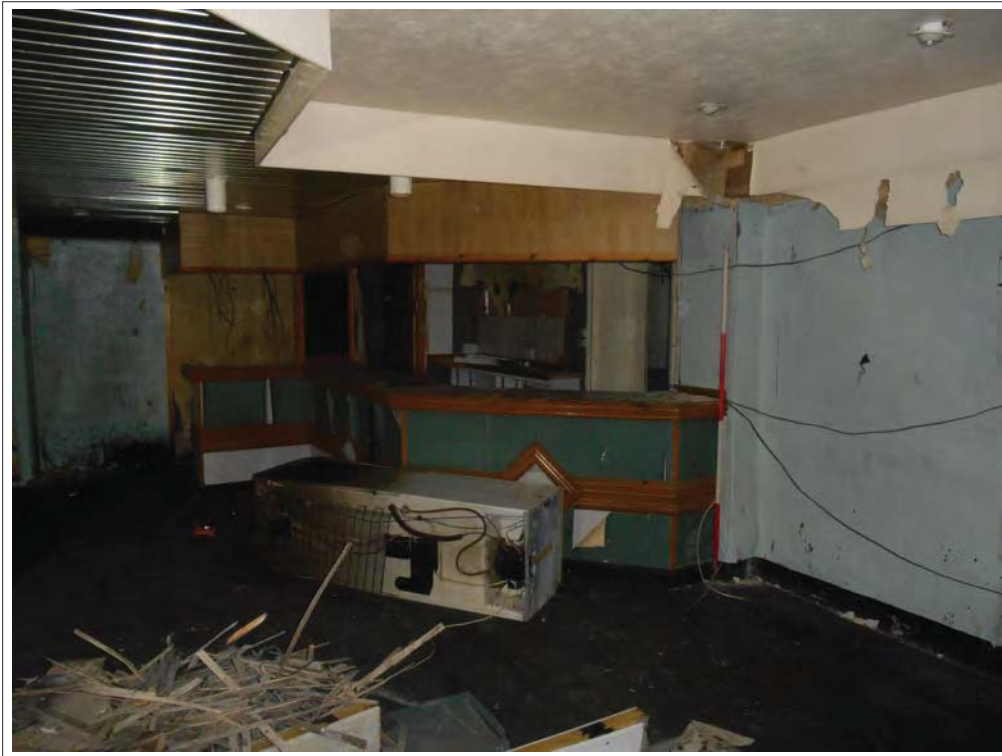
Plate 122: This plate illustrates another bar area. The walls of this area are currently covered by a light blue coat, and most of the floor is covered by a plastic black and white board which may have been used as a dance floor area.

Plate 122. Bar area, looking E.

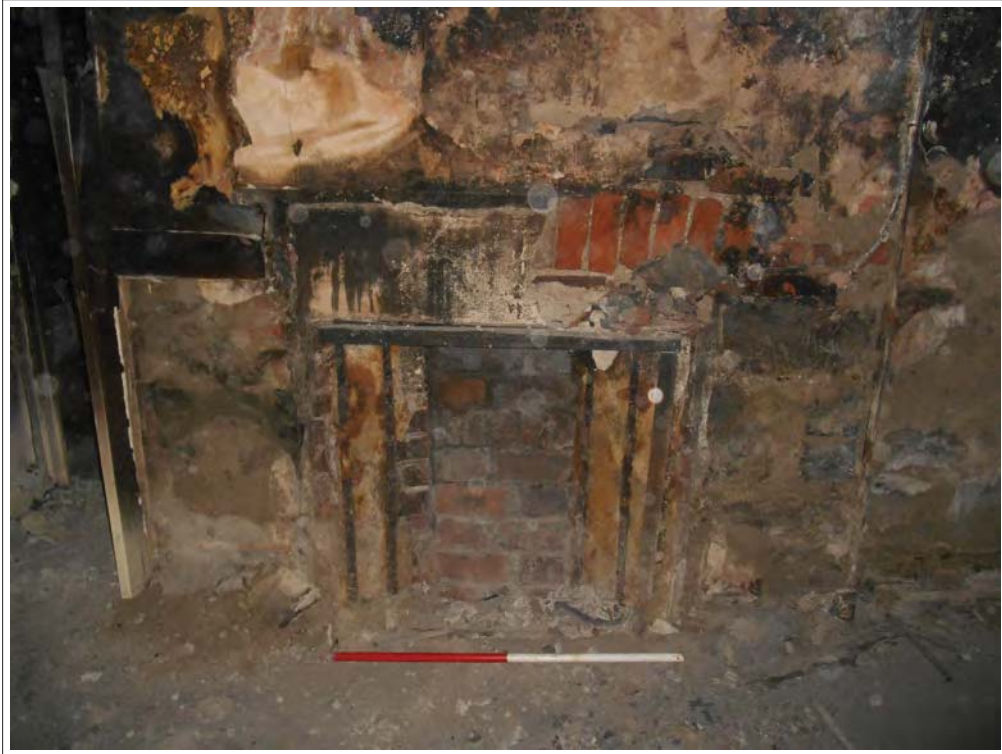
Plate 126 and 127: These images illustrate one of the surviving rooms from the basement area. An examination of this space allows noting that this room was badly damaged as a result of a fire. Despite its derelict state, it was possible to identify an original fireplace blocked off by a course of bricks and a caned three-light window currently blocked off by wooden boards.

Plate 126. Original fireplace, looking SSW.

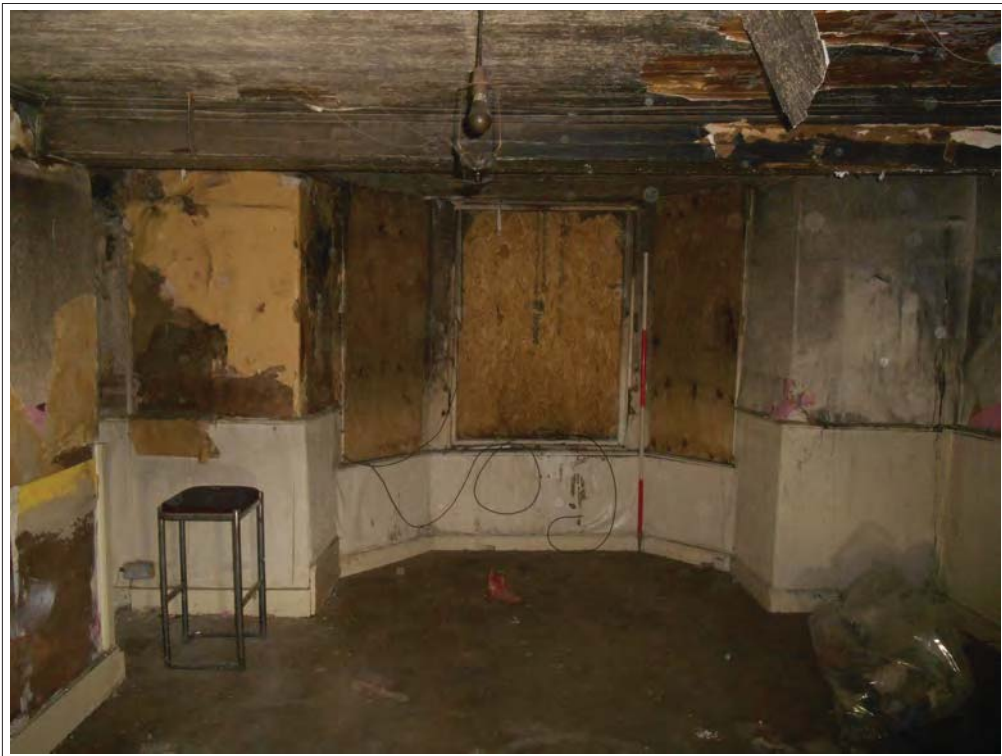
Plate 127. View of room affected by fire, looking NW.

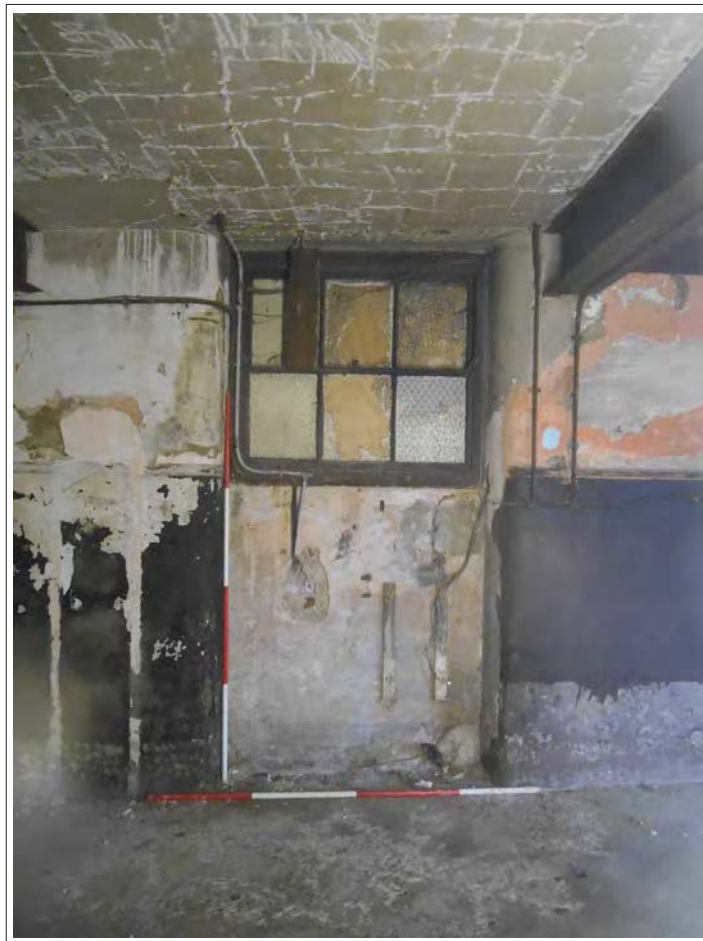
Plate 133. Remains of early door, subsequently transformed into a window which is currently blocked. Eastern facing interior wall.

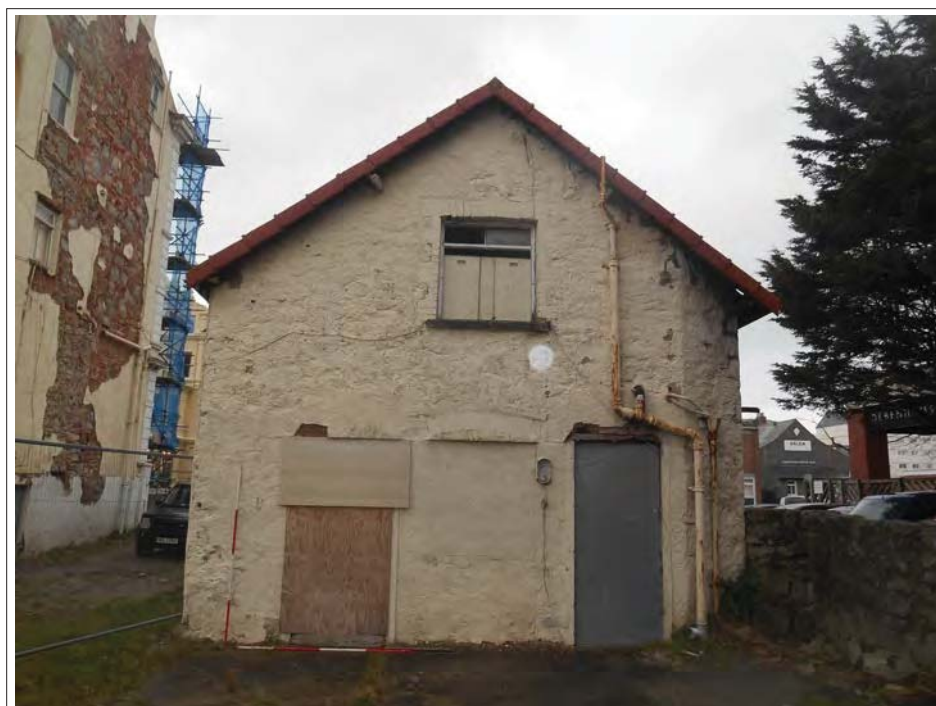
Plate 151. View of back entrance. Windows and doors are not original and demonstrate a number of alterations over time. 1960's hoods. First floor window with reveal toothed brick effect. Scales 2 x 2m

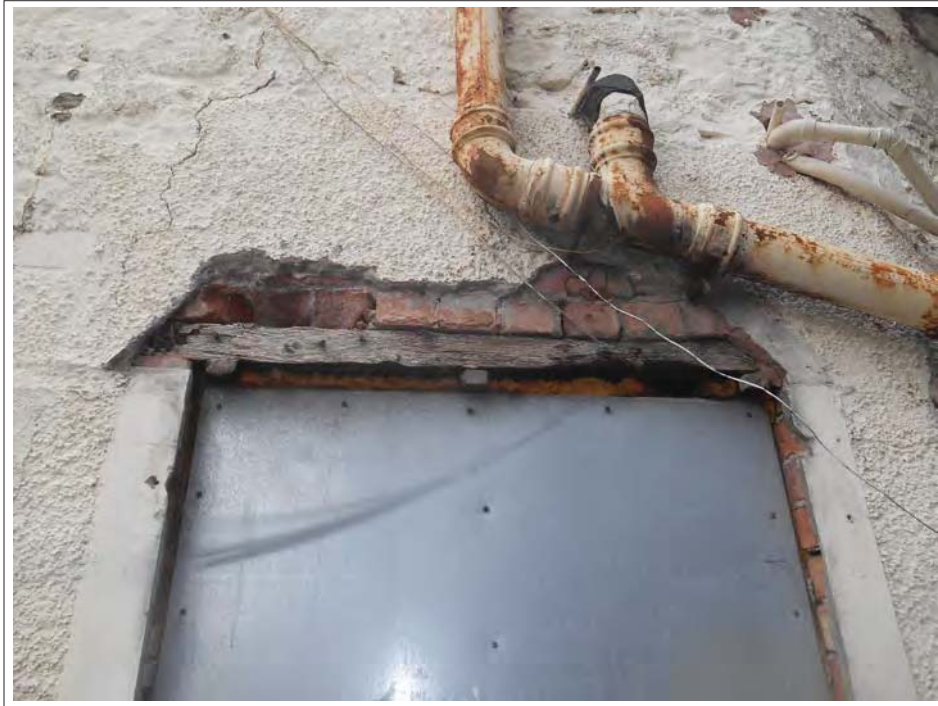
Plate 158. Detail of wooden lintel.

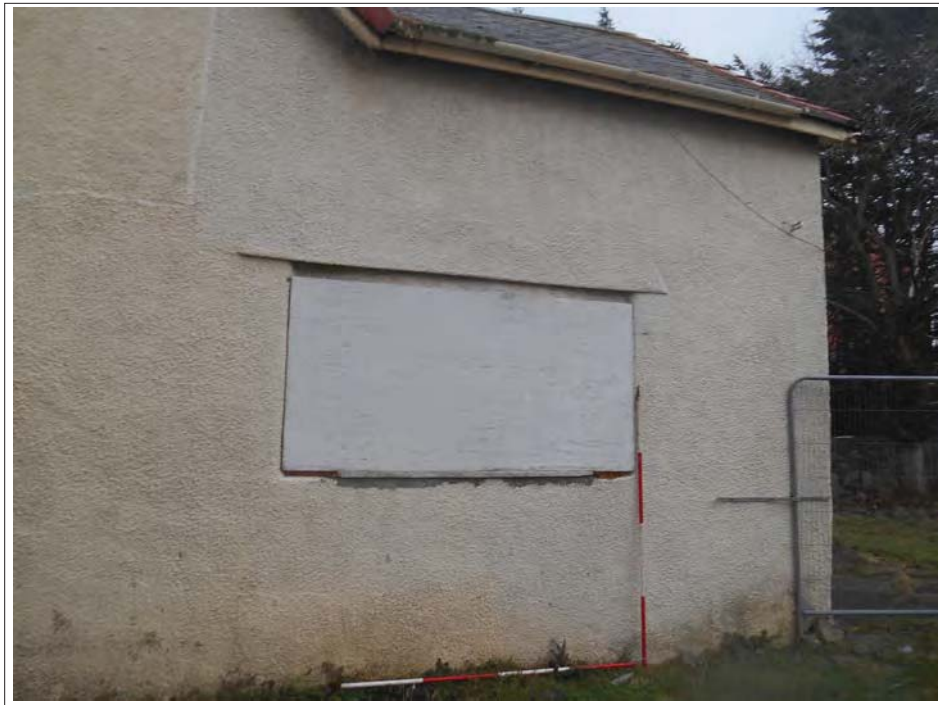
Plate 159. 1960's Window with hood. Pebble dashed wall, east facing.

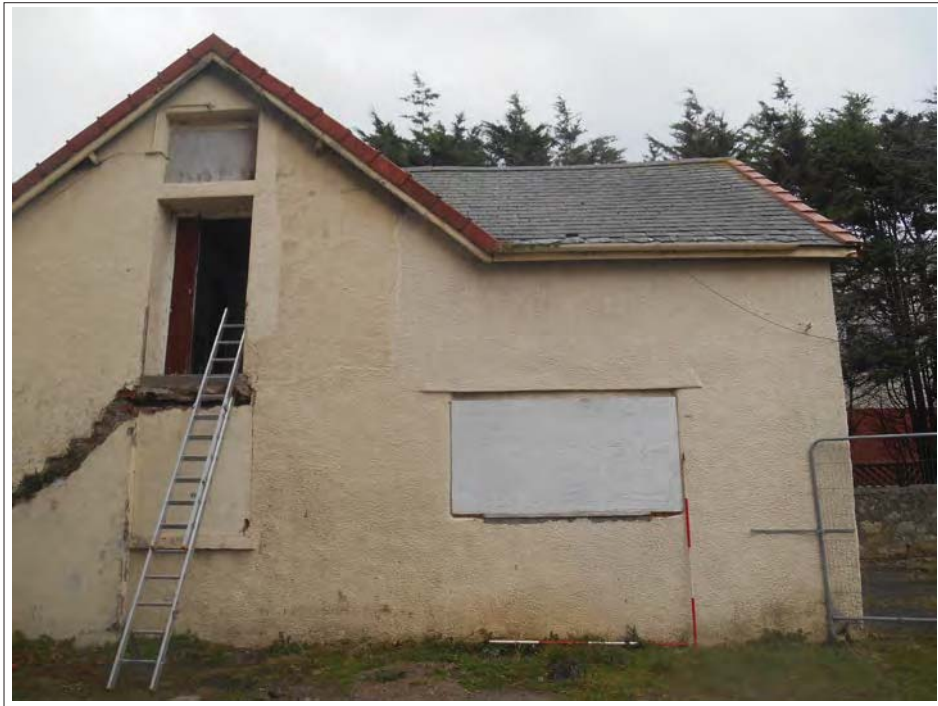
Plate 160. View of east facing wall.

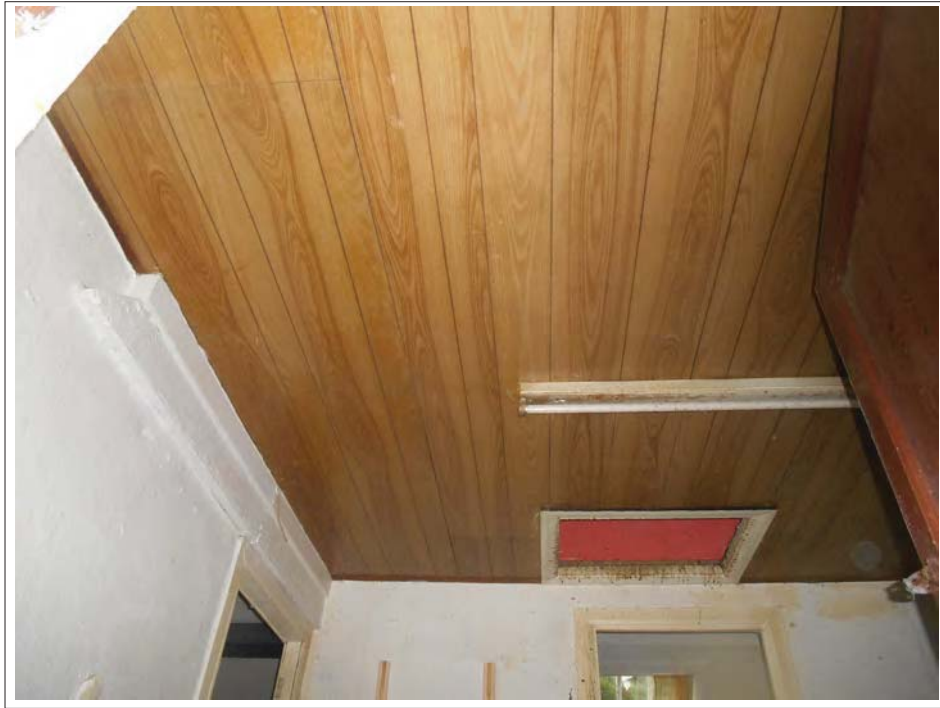
Plate 164. First floor sealing.

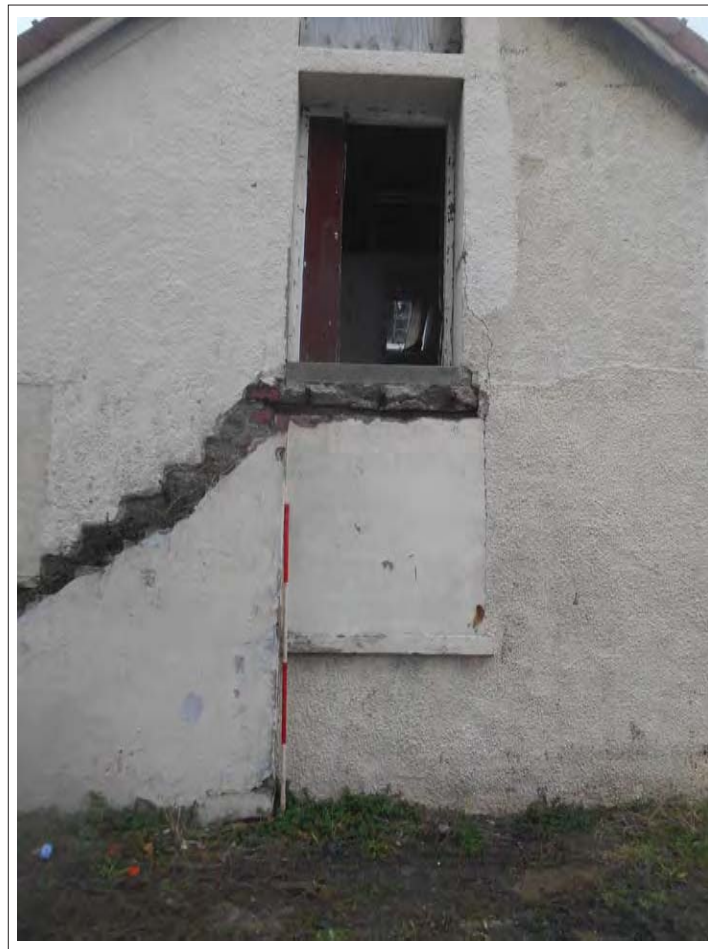
Plate 165. Detail of first floor door and exterior stair case, east facing wall.

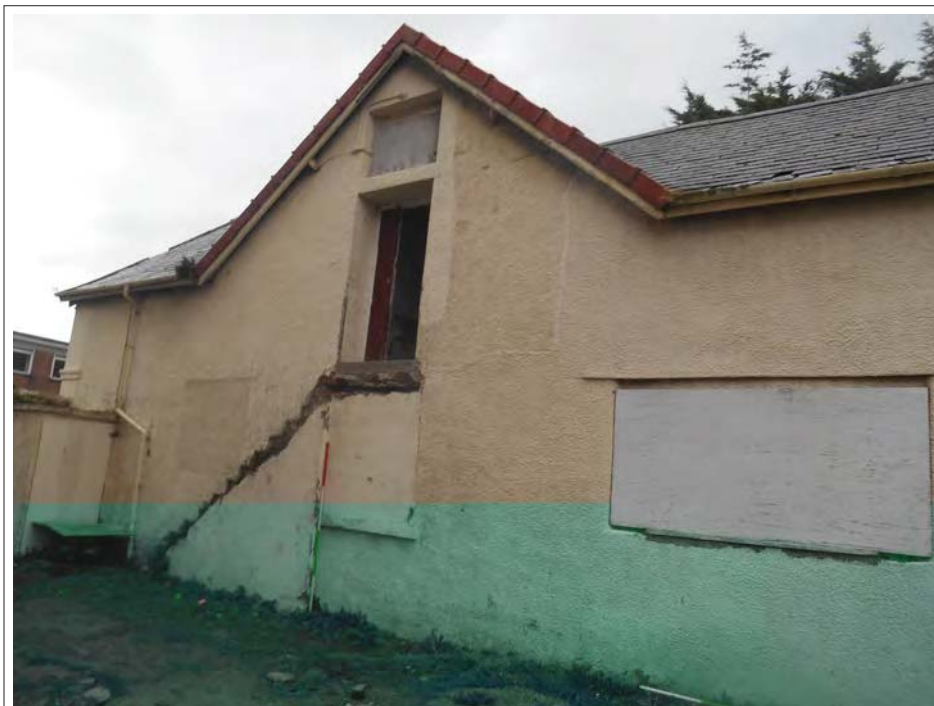
Plate 166. Detail of first floor door and exterior stair case, east facing wall.

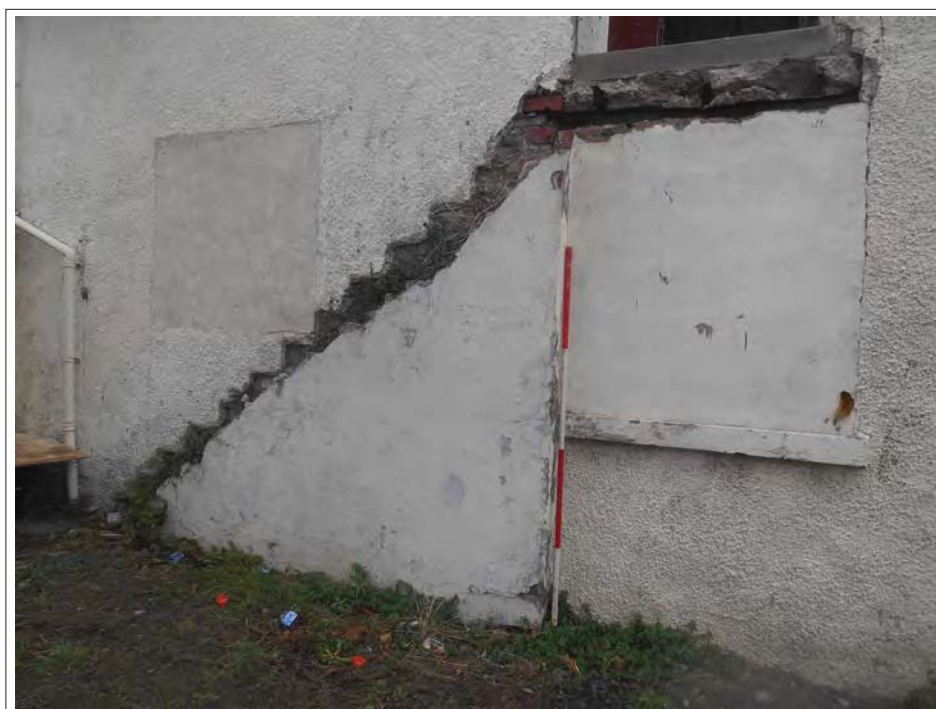
Plate 167. Detail of exterior stair case and doorway/window. Scale 2m

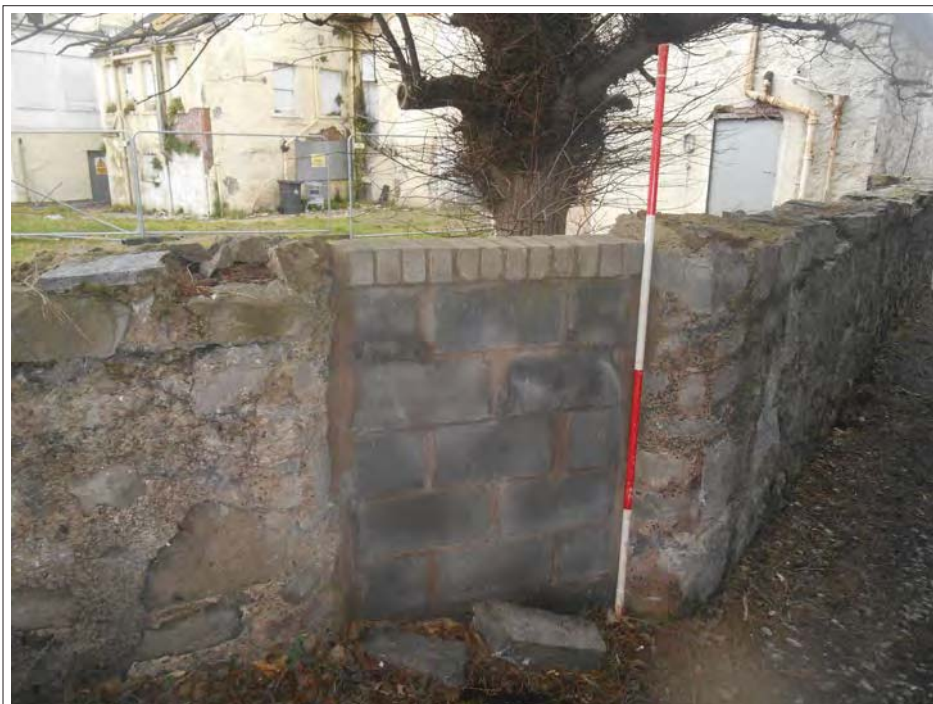
Plate 172. Modern alteration of circuit wall. Scale 2m

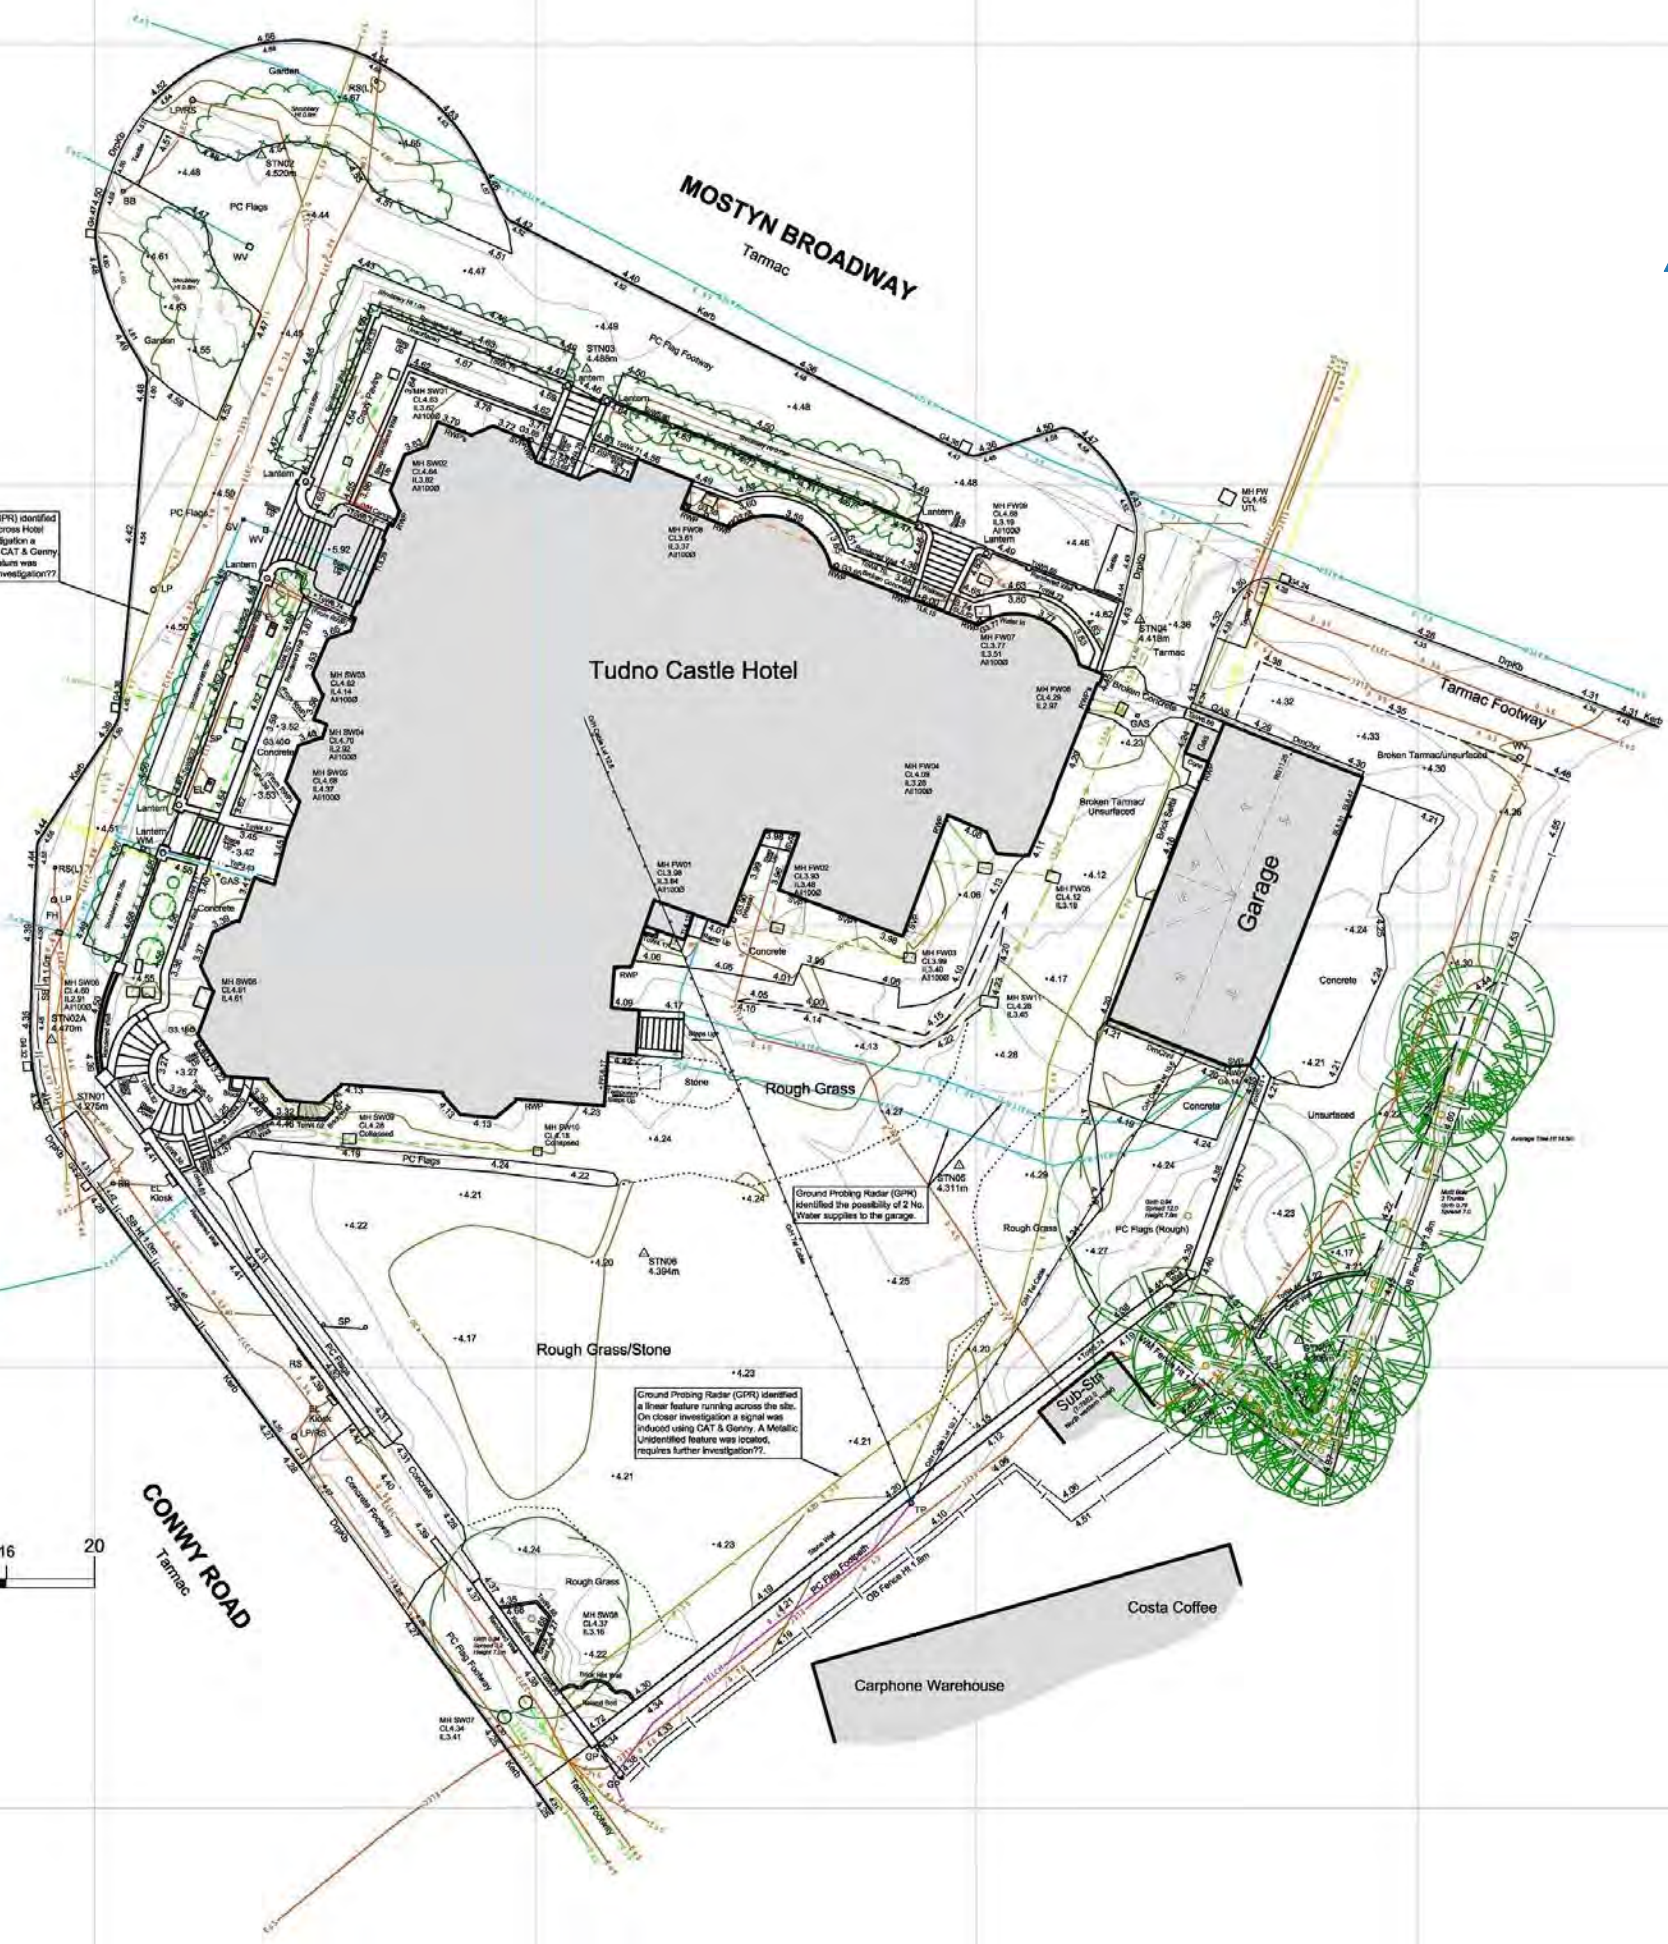
Figure 3: Plan of existing buildings on site, from developers supplied information, 1:200

Ground Probing Radar (GPR) identified a linear feature running across the site. On closer investigation a signal was induced using CAT & Genny. A Metallic Undersized feature was located, requires further investigation??
