**A.P.A.C. Ltd.**

WATCHING BRIEF

WB/AONB3/10

**Angiddy Ironworks, Tintern.**

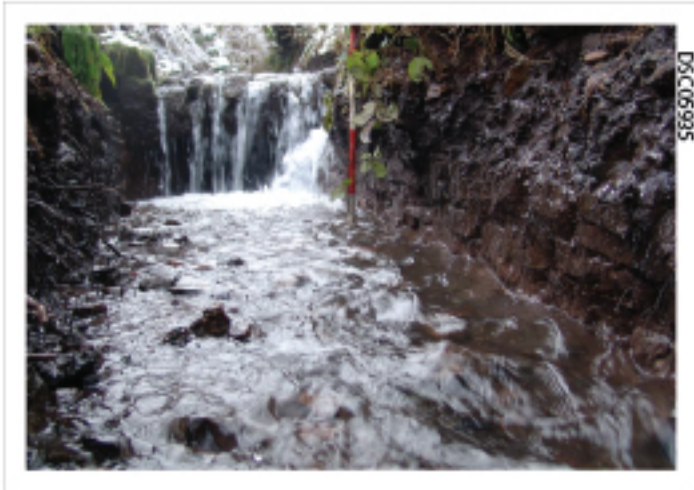
Plate 02: View of culvert resurgence after 1m de-silting (WB/ACNB2/09)

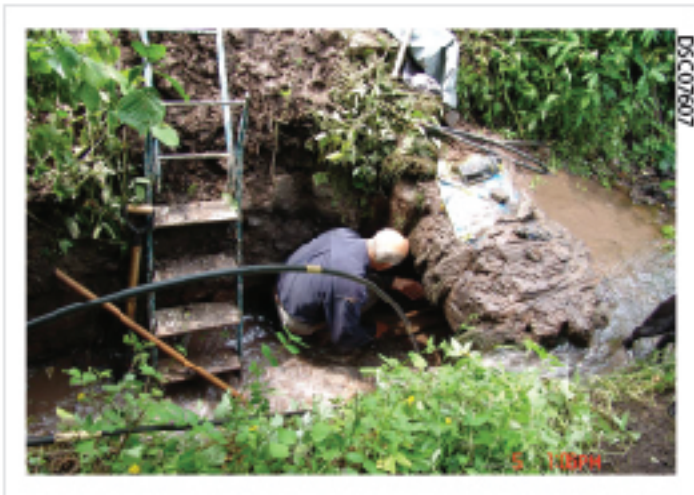
Plate 04: Rodding out the culvert after further de-silting (WB/JB/10).

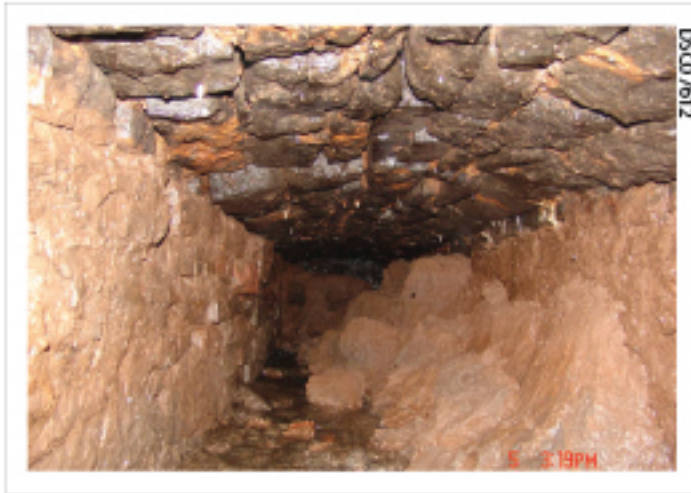
Plate 05: Culvert beside cottage showing level of silt (WB/JB/10).

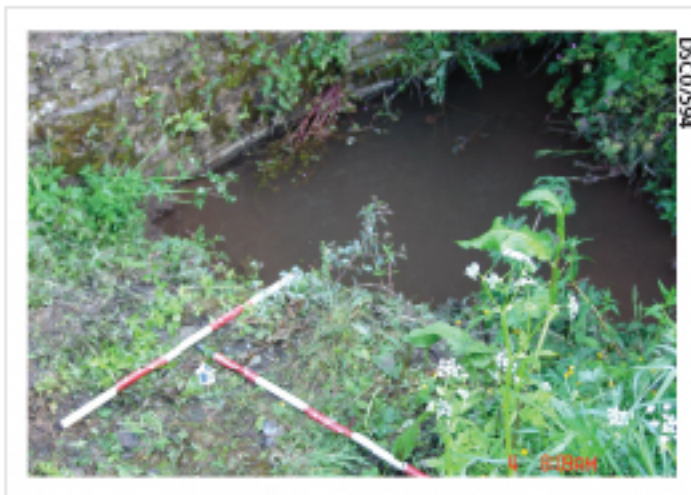
Plate 06: Culvert beside cottage showing level of water (WB/JB/10).

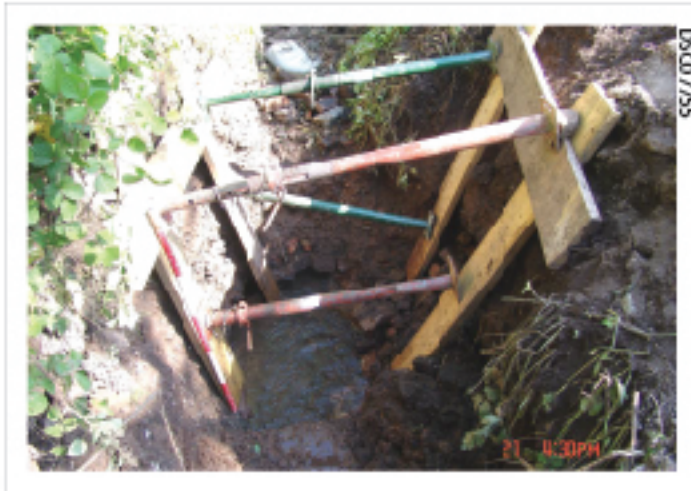
Plate 08: Culvert beside cottage, water levels reduced.

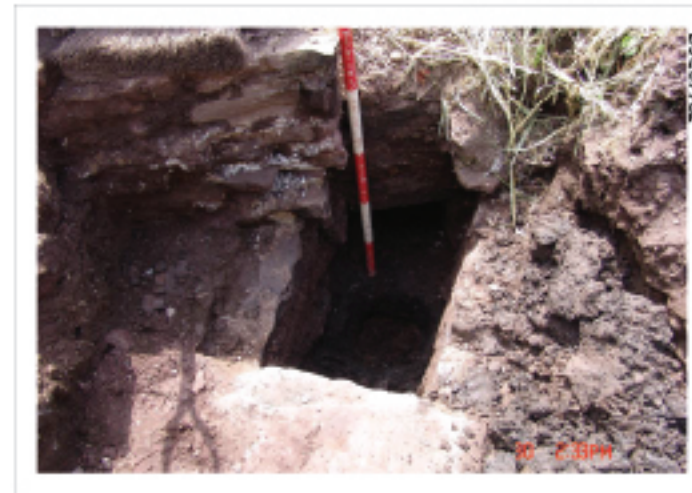
Plate 15: Upper culvert at join under 198 after clearing of silt

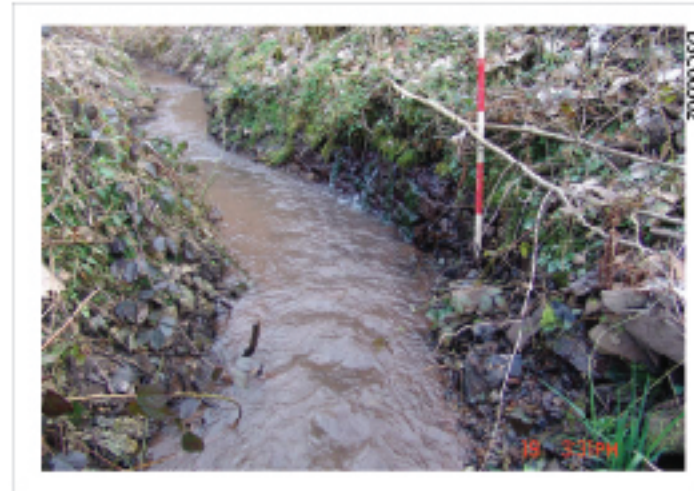
Plate 23: Curved walling of culvert, south bank and just south of stream join

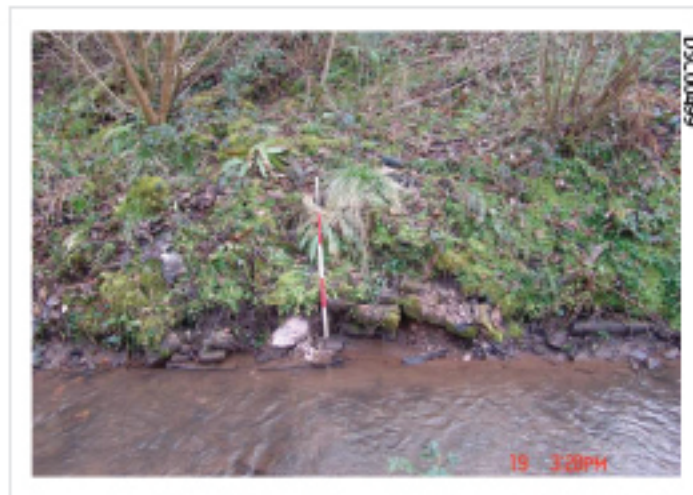
Plate 24: Culvert drystone wall with section of mortared wall above and at angle

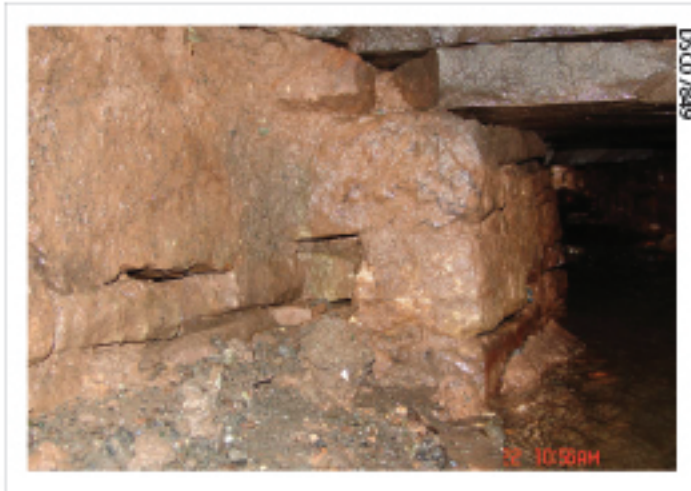
Plate 29: Close up of butt joint to south west wall of culvert, beyond the mortared arch

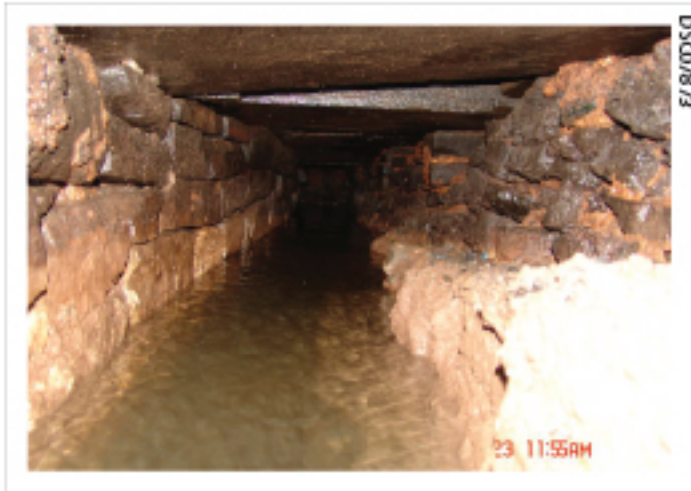
Plate 36: Beyond silt remains at the cottage outfall culvert.

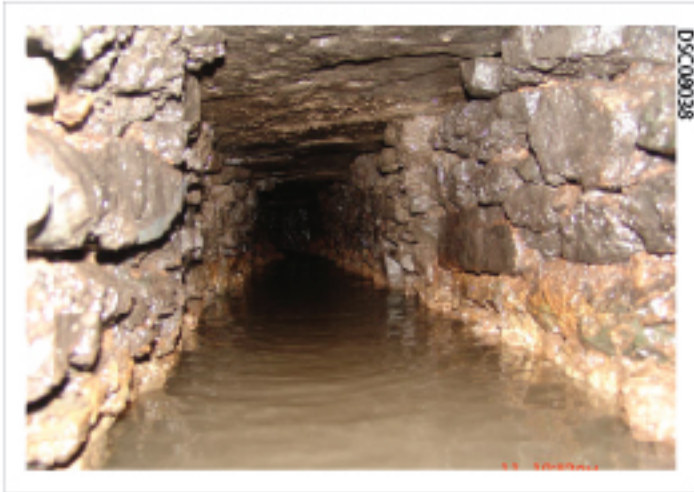
Plate 47: Test pit 1 culvert after de silting. View along culvert, towards wheelpit.

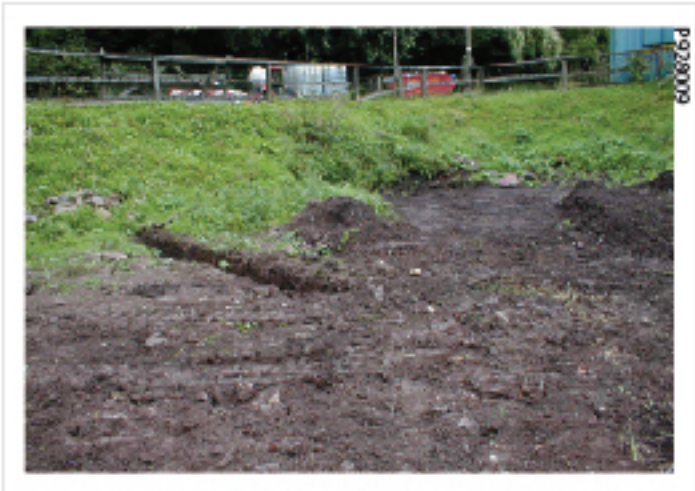
The probable position of test pit 2, assessed from photographs, Plates 48, 17, 18 & 19, is shown in the second plan, Fig 09.

Plate 48: Area K. Test trench and advised position for test trench. Stone pile.

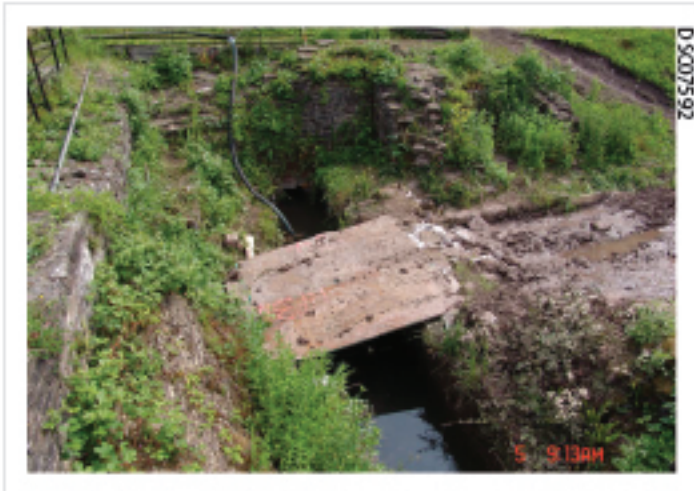
The upper surrounds of the wheel pit before the present work began was in a very bad state of repair, as has been shown in Plates 07, 22 & 49. Once clear of vegetation a comparison can be made between the excavation photographs of 1979/81, Plate 60 and 61. Such a comparison identifies areas where restructuring had been undertaken; particularly along the wheel pit edges and the construction of the barrelled buttress Plate 62.

Plate 49: Silt dump at the wheel pit

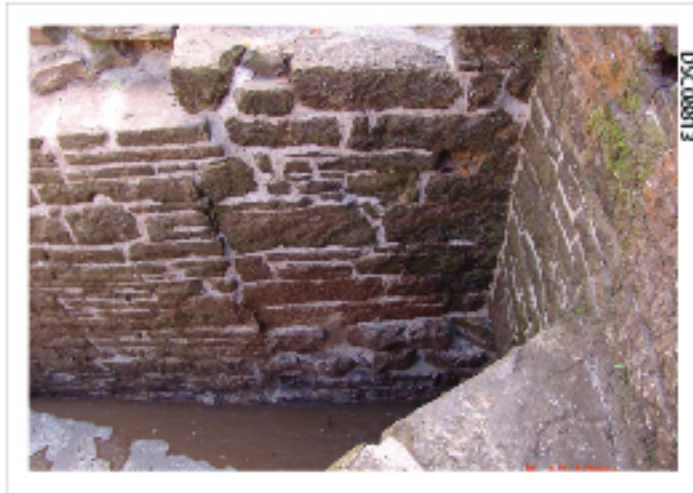
A feature of a narrow ledge; mid height, on the south west side of the wheel pit is also more apparent, now that it has been cleaned and repaired, Plates 50, 51, 53 & 54.

Plate 54: Phasing detail, wheelpit after repointing

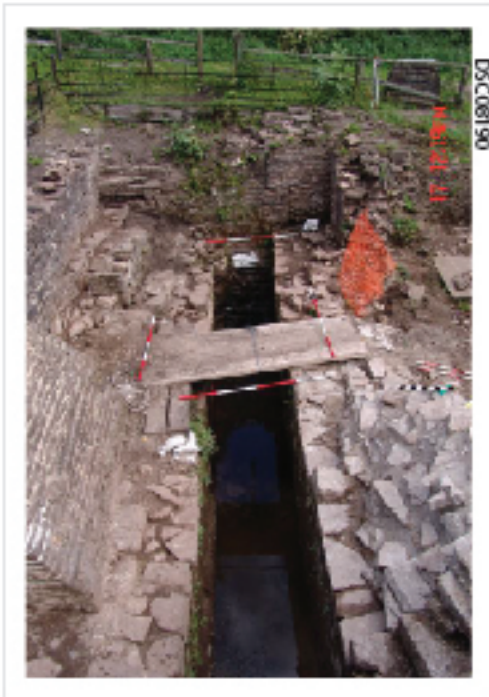
The photographic recording undertaken in September 2010 Plate 61 from which fig 11, 2, was drawn; shows feature 111 has not changed much but 112 is less well defined. One in the sequence of vertical photographs taken to record this area during clearing; shows the area of 112 as a jumble of mortared and loose stone Plate 64.

Plate 61: Wheelpit. Measured photographic recording.

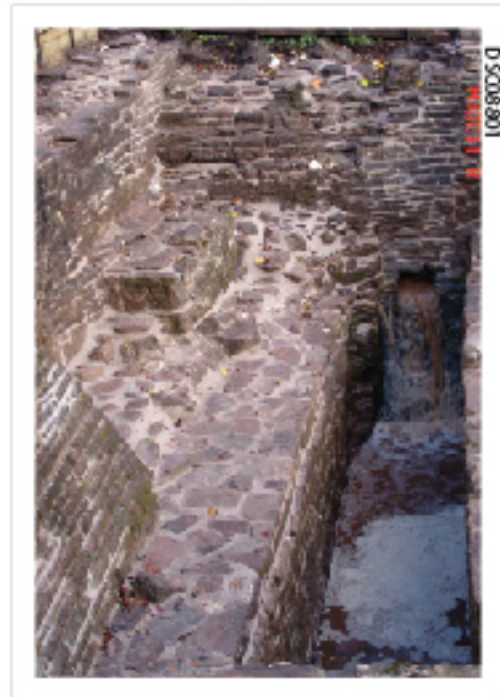
Plate 63, shows the final consolidation work and again clearly identifies changes that have taken place to the structure. Worth noting, is the re-interpretation of the some of the features to create more rounded and flatter structures. The sequencing shown in fig 11 illustrates this quite clearly.

At the end of consolidation work fig 11, 3, the area 112 has been established and constructed as a raised rectangular platform abutting wall 111. Although it is likely that the raised structure is the remains of the final support for the raised launder; the path of the launder, which is shown in fig 02, would suggest caution. In particular, the angle between 119 and 112 which would be indicative of a sharp turn in any supported launder. In addition, the large stone jutting out from the south corner of the raised base throws some doubt as to the full extent of the original structure at this point Plate 63.

Plate 63: Overview of wheelpit after consolidation

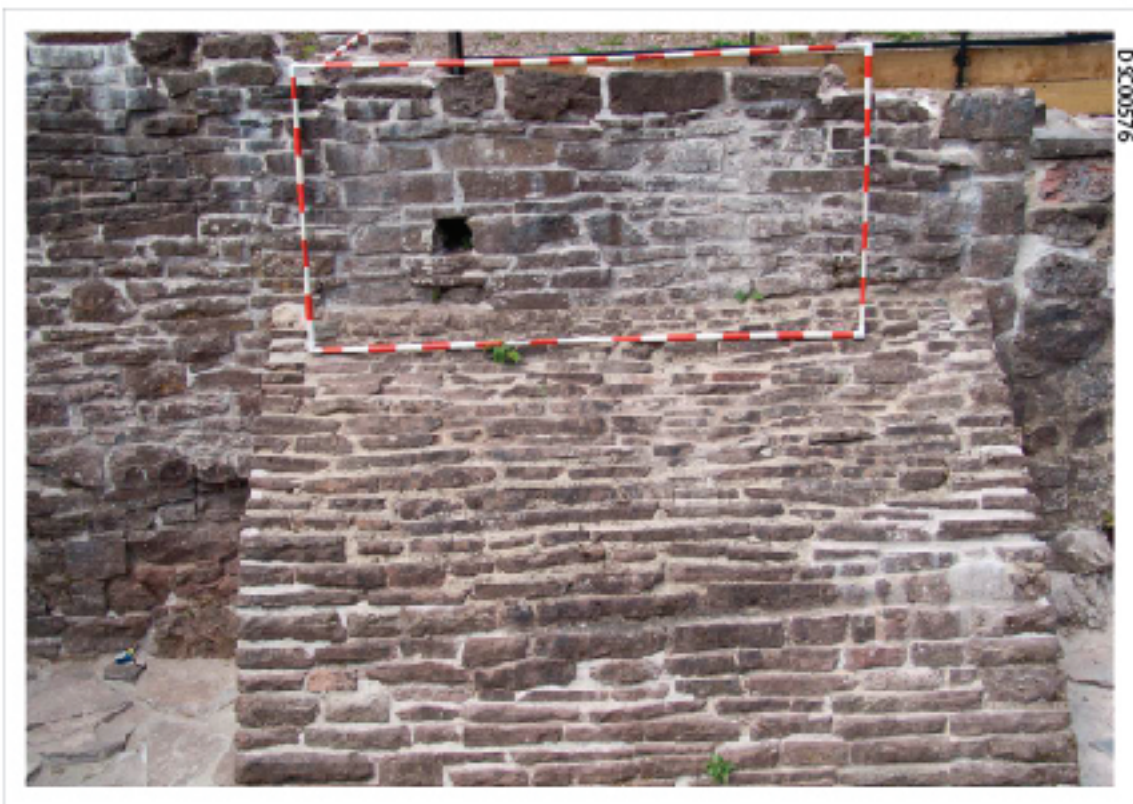
Base wall 111 is exposed for a distance of 3.7m, running from walls 210 & 115, fig 05, after which it continues a further 1.4m under 209, where it creates the undercut which prompted the 1979/81 construction of the supporting barrel buttress, Plates 65 & 66. Base wall 111 forms an 8 degree angle at its intersection with later wall 209. At the north end, it has a 0.55m width measured perpendicularly from 209 whereas at the south end, it undercuts by 0.12. It should be noted that the extent of the undercut has been obscured by the 1979/81 barrel buttress, Plates 62, 67 & 68.

Plate 62: Final elevation record, Upper wheel pit 5

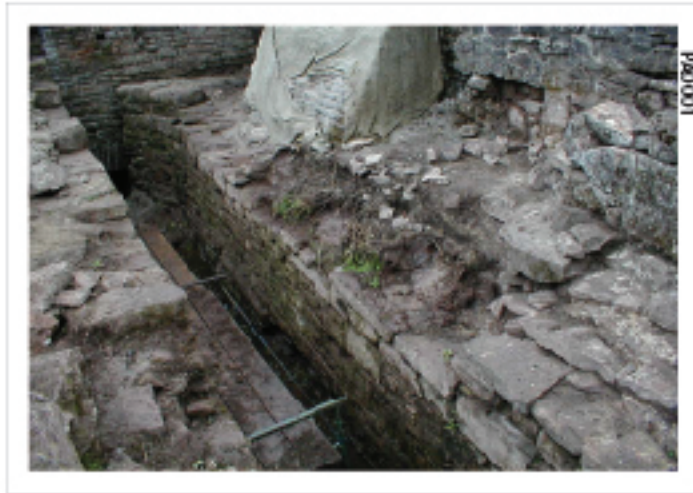
Plate 78: Wheelpit. Upperwall, clearing

The following sequence shows the work to remove the overburden prior to the discovery of the plank Plate 78. Plate 79 shows the position of the plank in relation to known surroundings; for any future investigation. Plate 80 establishes the size of the plank against a 2 inch WHS trowel. Plate 81 shows some of the grain detail including the impression left in the mortar underneath.

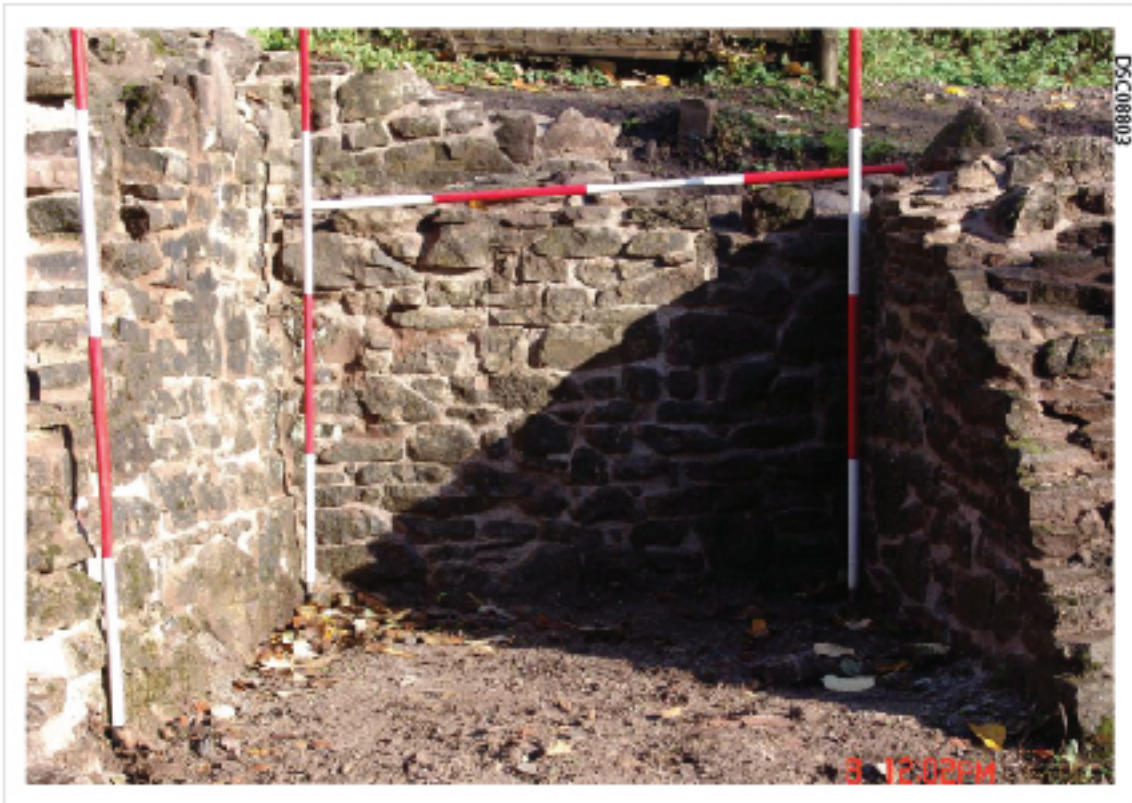
Present work on the enclosure involved the removal of the backfill and re-pointing of the walls. From the limited evidence for comparison, there would appear to have been no change to the structure of this enclosure, Plate 82.

Plate 82: Enclosure behind blowing house after consolidation
