Stabilisation Works at Ruperra Castle, Glamorganshire

Historic Buildings Record

Project #: AD042

March 2019

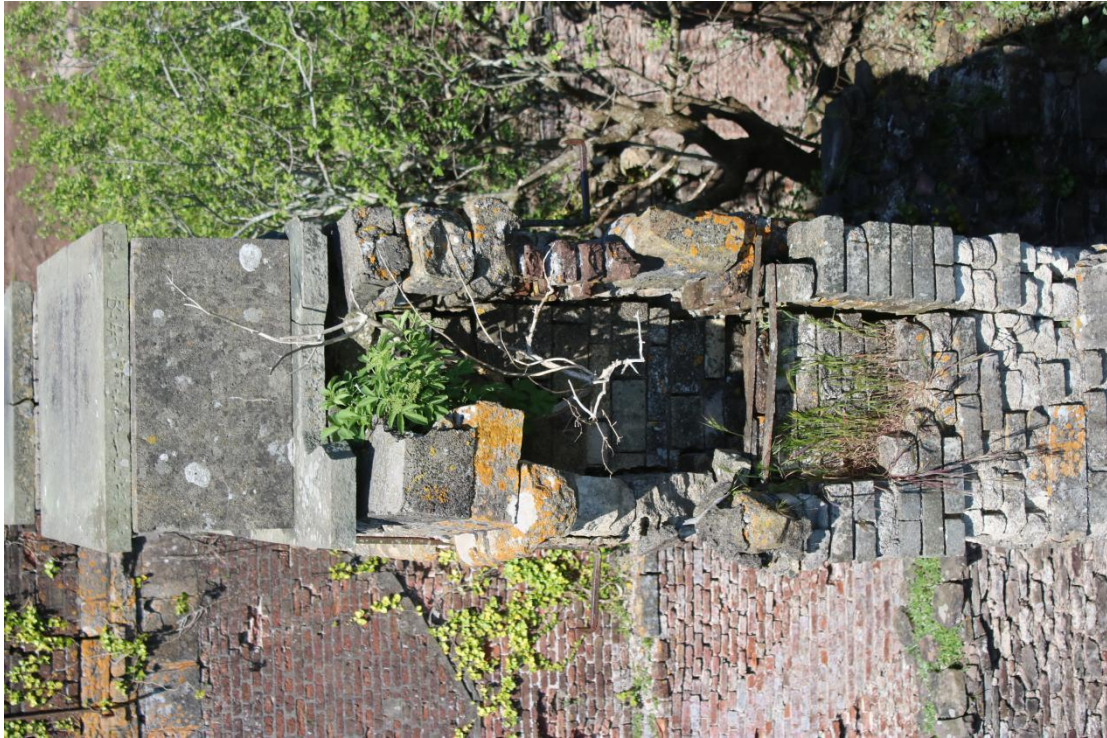
6.4.2 A 150mm crack was observed between flues 1 and 2 to the north of the chimney (**Plate 13, 039; Fig. 7, 8**), the result of which caused this element of the chimney to begin to fall away and a large bulge to appear, due to twisting, to the top of the east face (**Plate 34**). The southern flue (number 5) of the chimney had already partially collapsed (**Plate 03**).

Plate 3 - AD042_WB_003 - South chimney elevation, showing top of flue, caused by partial collapse of brickwork.

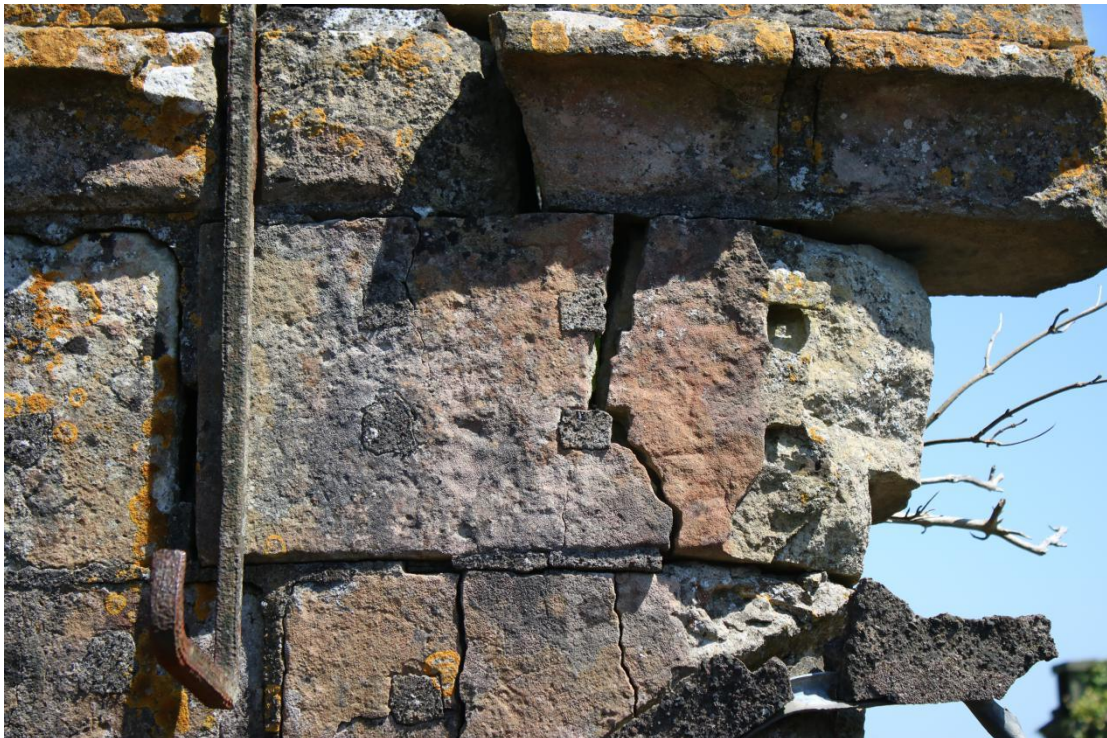
Plate 8 - AD042_WB_008 - West elevation, showing damaged sandstone ashlar.

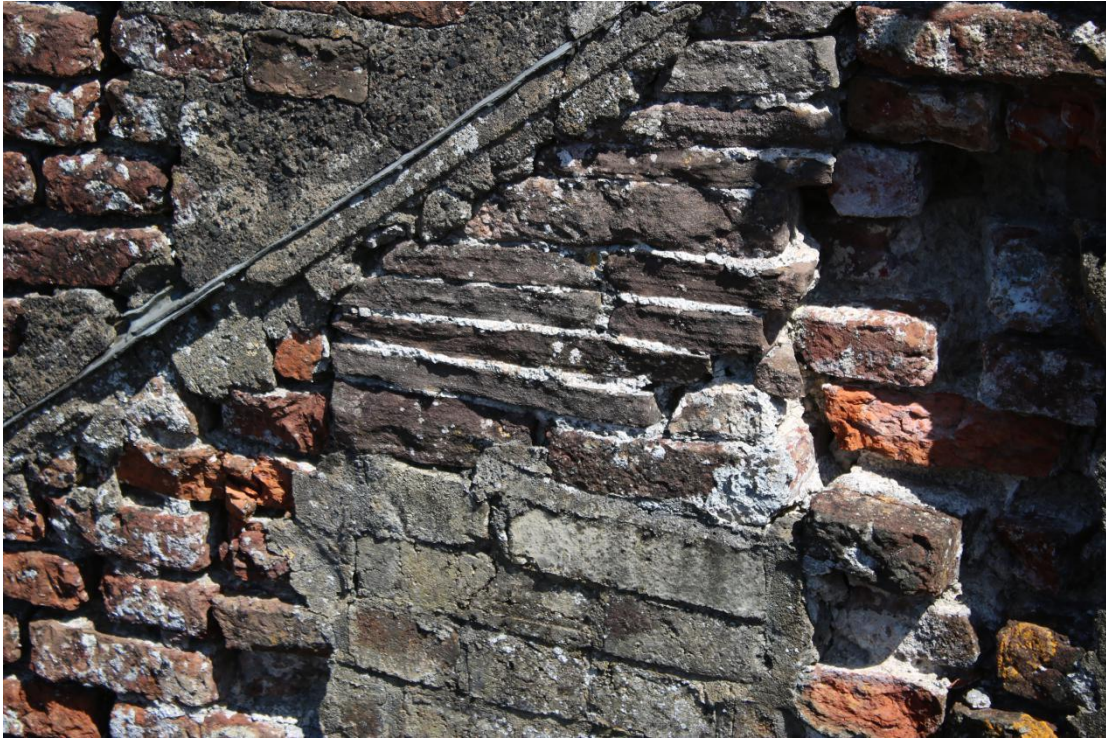
Plate 11 - AD042_WB_011 - West elevation, showing lead flashing and limestone and later brick patch-repair.

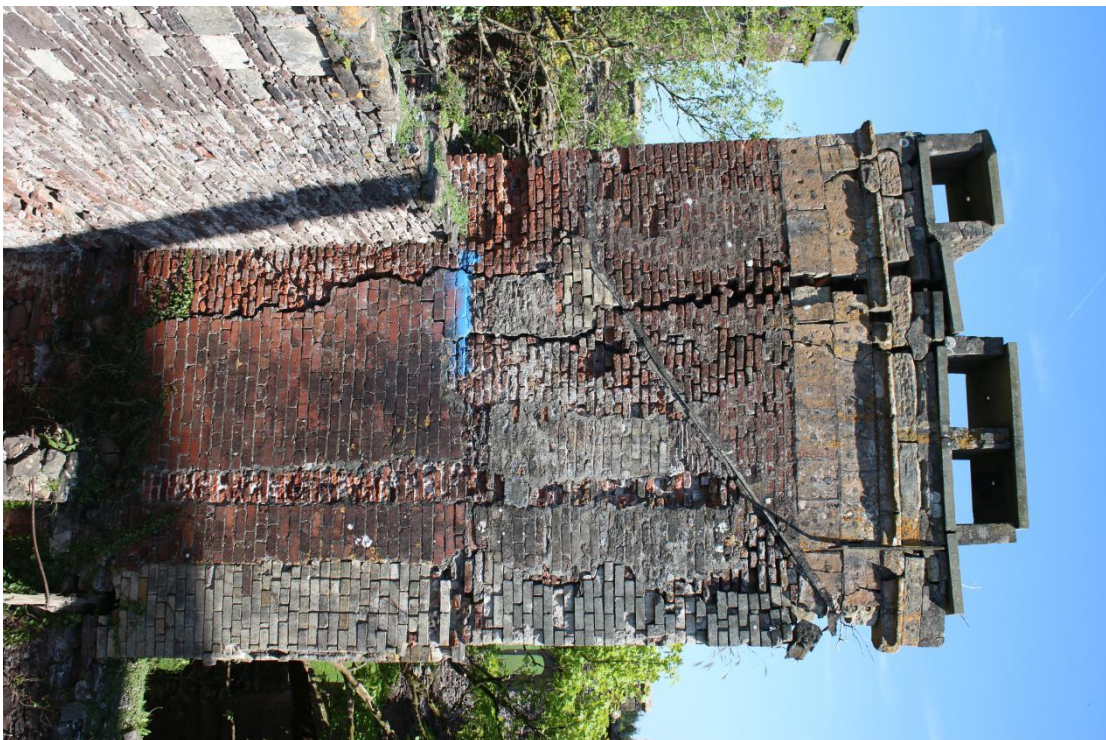
8.4.4 Grazing to the west elevation of the chimney (Plate 12) demonstrates the existence of an abutting wall and provides evidence to suggest the floor plan, at least at the second floor, was rearranged at this time.

Plate 12 - AD042_WB_012 - West elevation, showing full visible extent.

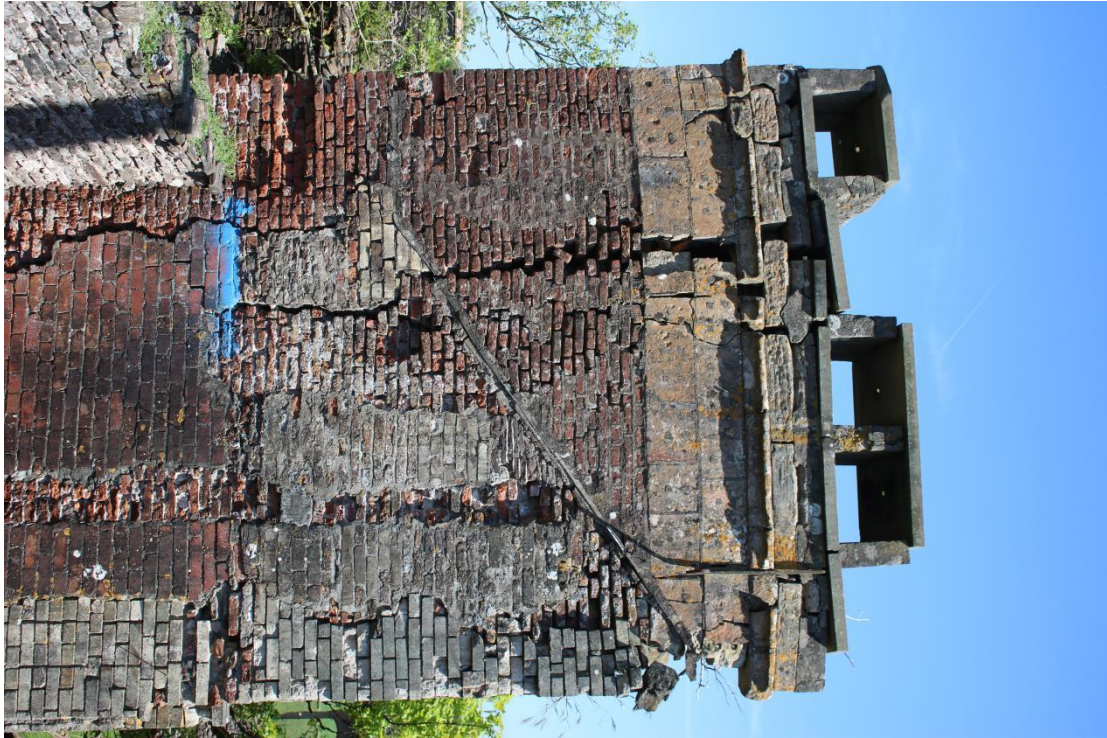
Plate 13 - AD042_WB_013 - West elevation, showing initial area to be dismantled (to blue line).

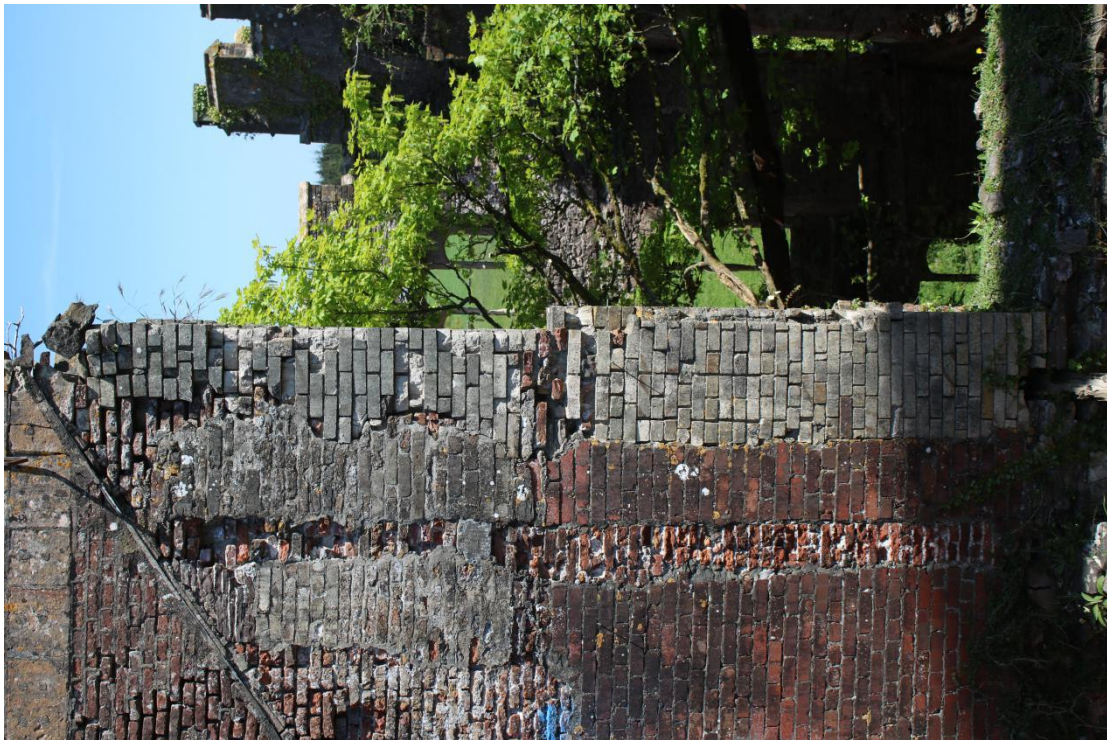
- 8.7.1 A number of other interventions to the chimney are apparent through the patchwork of brick, most notably to the south and western elevation.
- 8.7.2 The most notable intervention is the addition of the flue number 5, made apparent by the white brick used in its construction to the south end of the chimney.
- 8.7.3 The west elevation has undergone a number of interventions and repairs. Several large areas of 19th/20th century red brick fill the chimney's west elevation (**Plate 12**); although the reason for this is not completely clear, it is likely a result of the repair or reorganisation of flues. A small patch of yellow brick (**Plate 15**), to bottom of the 1783 roof pitch, is another patch repair and is possibly associated with the replacement of deteriorated brickwork. Several pieces of limestone have been used to fill small areas of deteriorated brickwork (**Plate 42**).

Plate 14 - AD042_WB_014 - West elevation, showing later inserted/added brickwork (white brick) for additional fireplace and flue; and former wall scar.

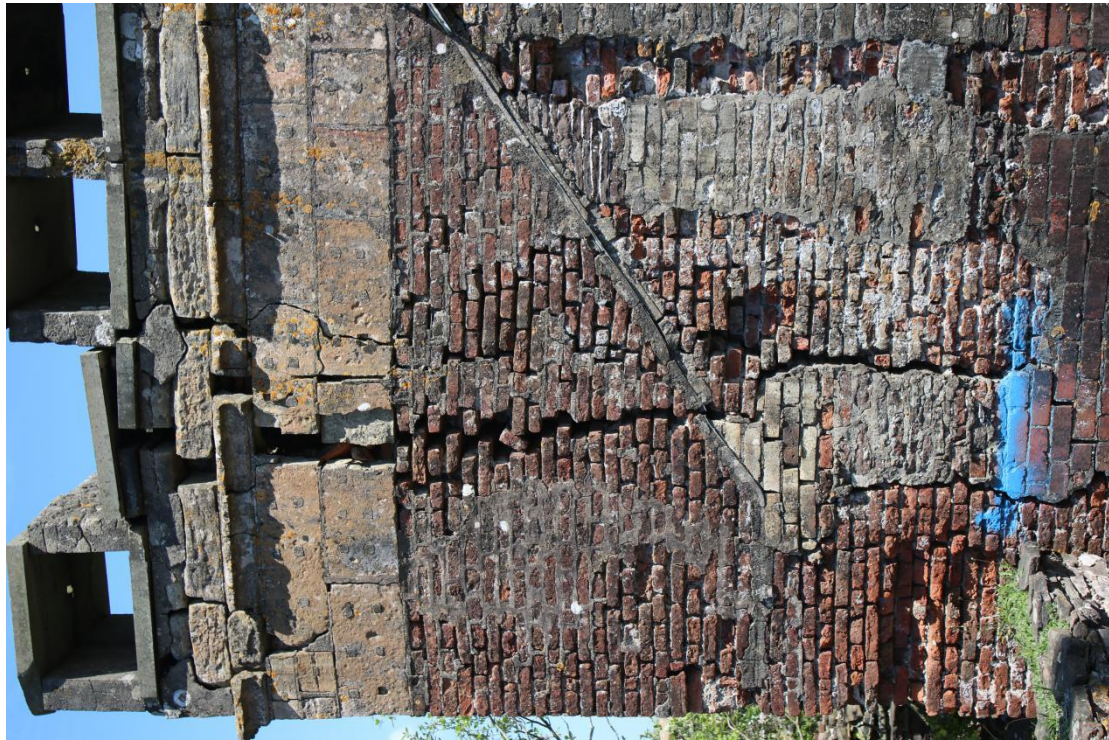
Plate 15 - AD042_WB_015 - West elevation, showing crack, caused by northern flue falling away.

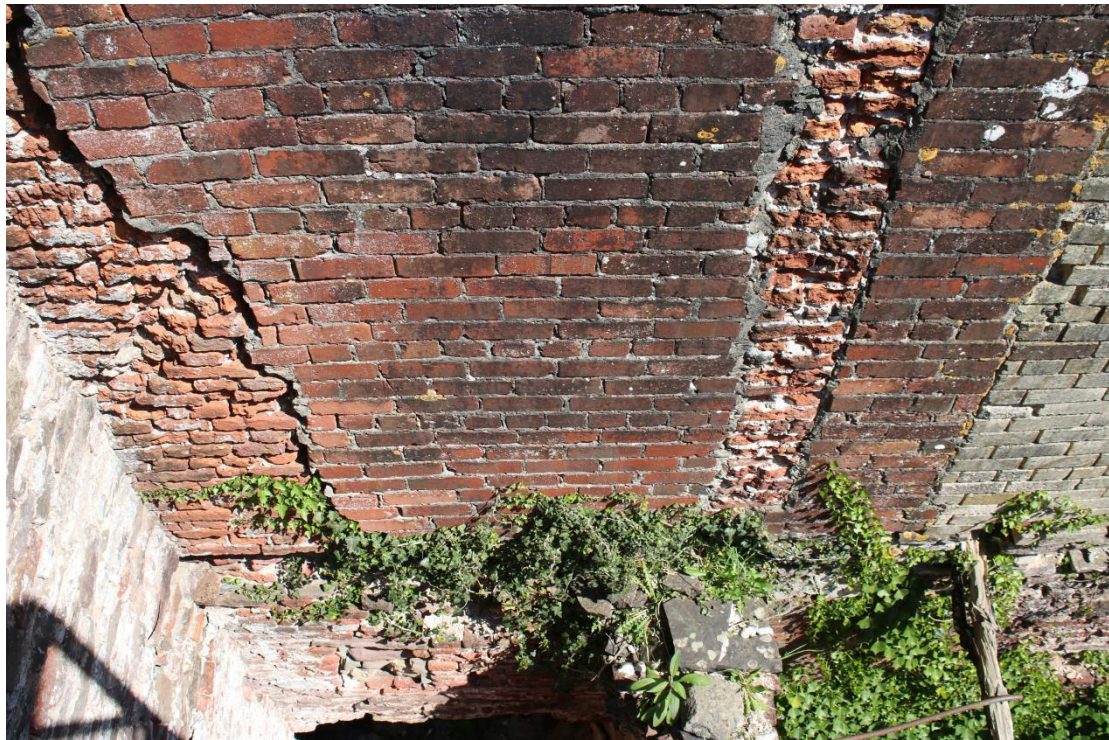
Plate 18 - AD042_WB_018 - West elevation, showing 20th century red brickwork and wall scar.

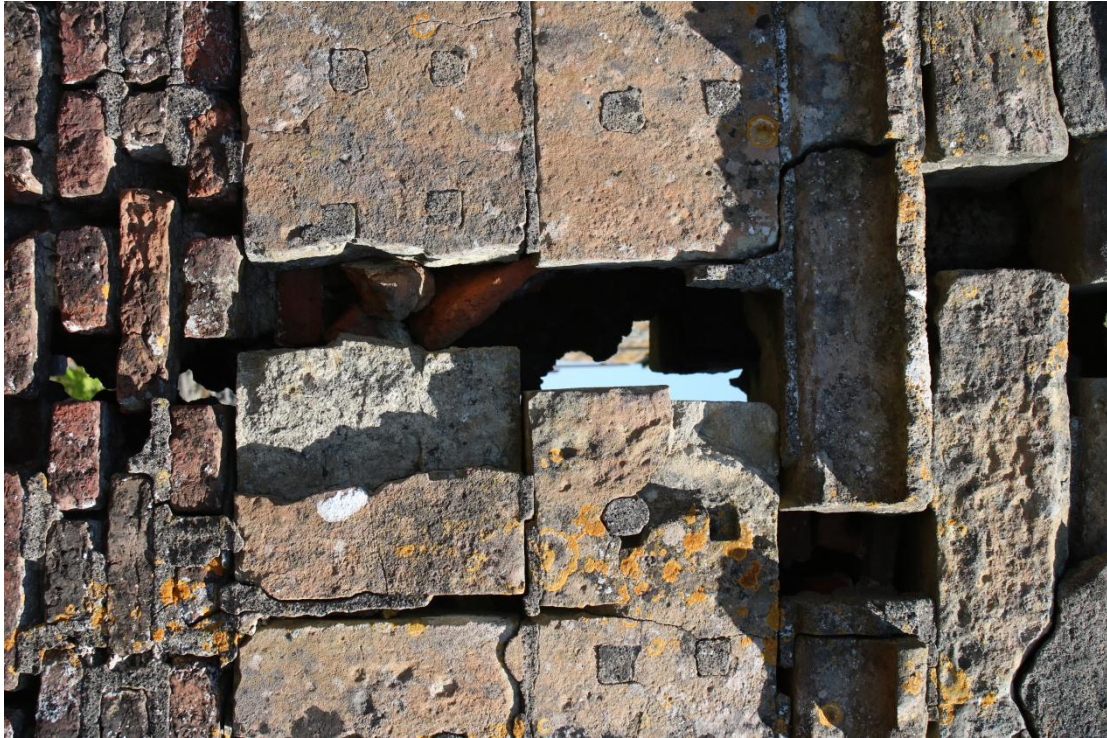
Plate 19 - AD042_WB_019 - West elevation, showing crack to sandstone ashlars opening through to east elevation.

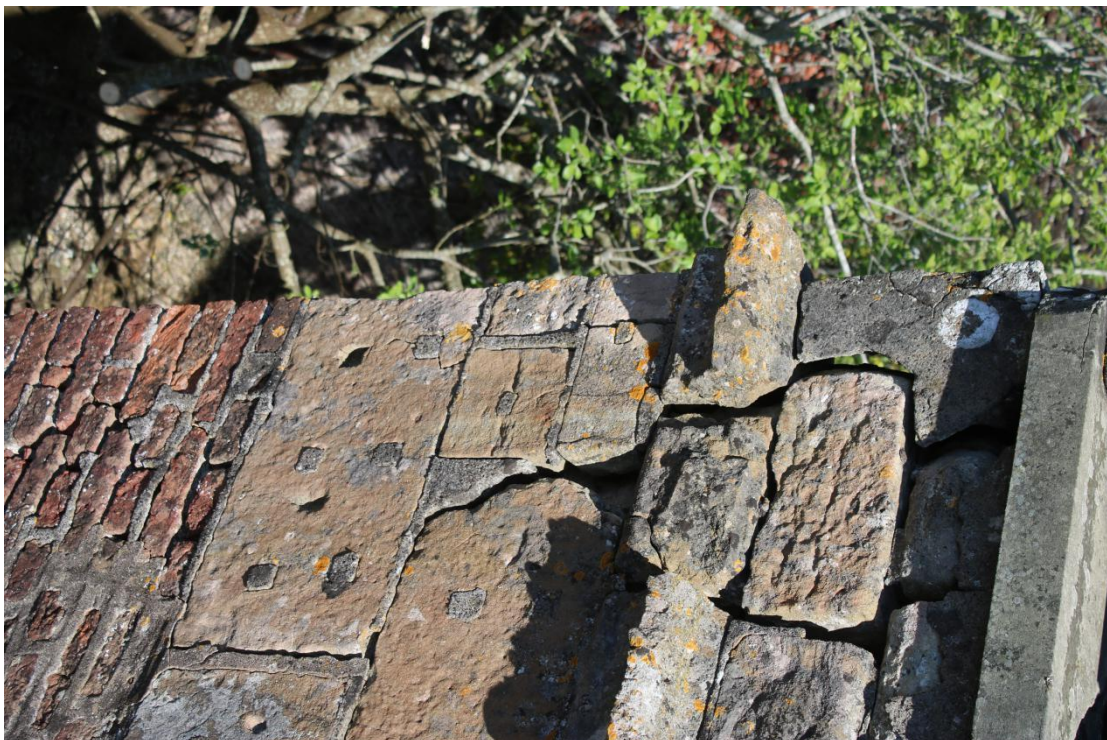
Plate 22 - AD042_WB_022 - West elevation, showing sandstone and concrete fill to north-west corner.

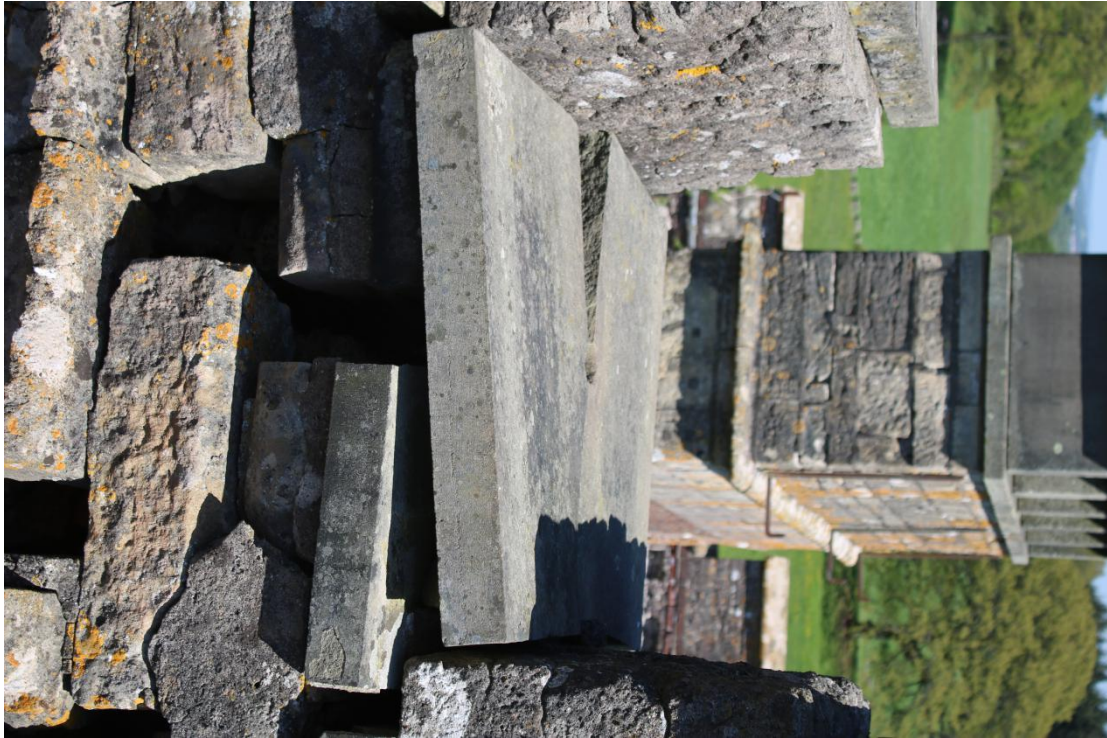
Plate 23 - AD042_WB_023 - West elevation, showing dropped capstone.

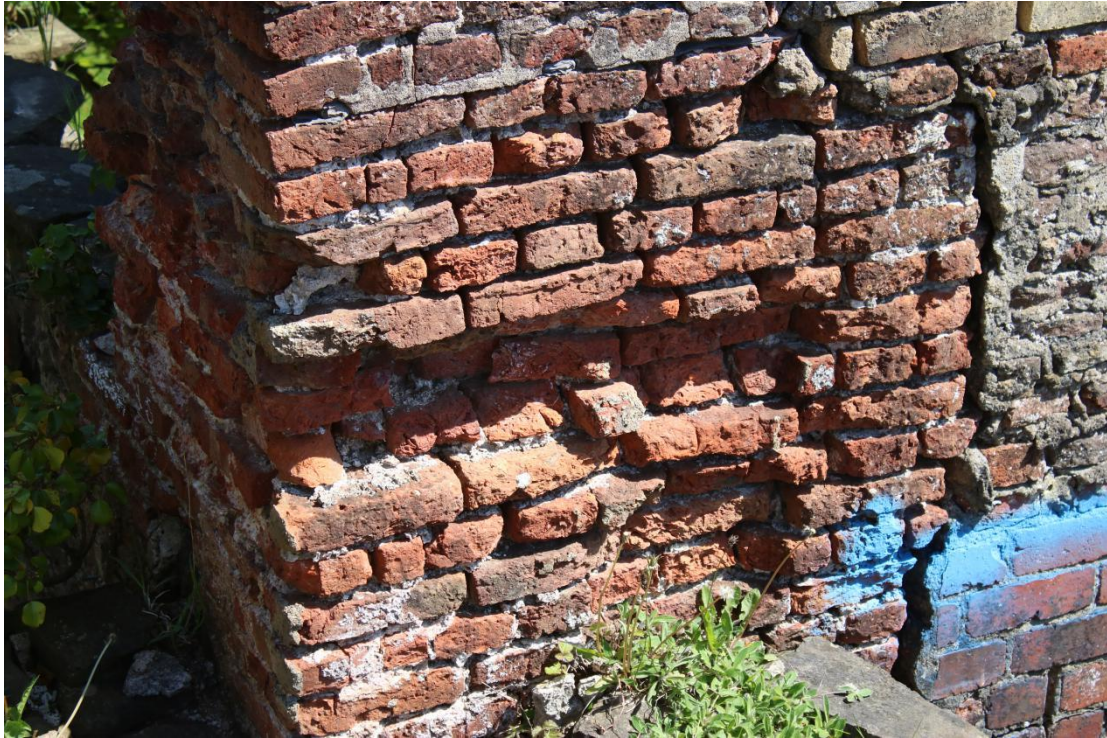
Plate 25 - AD042_WB_025 - West elevation, showing pinch spalling.

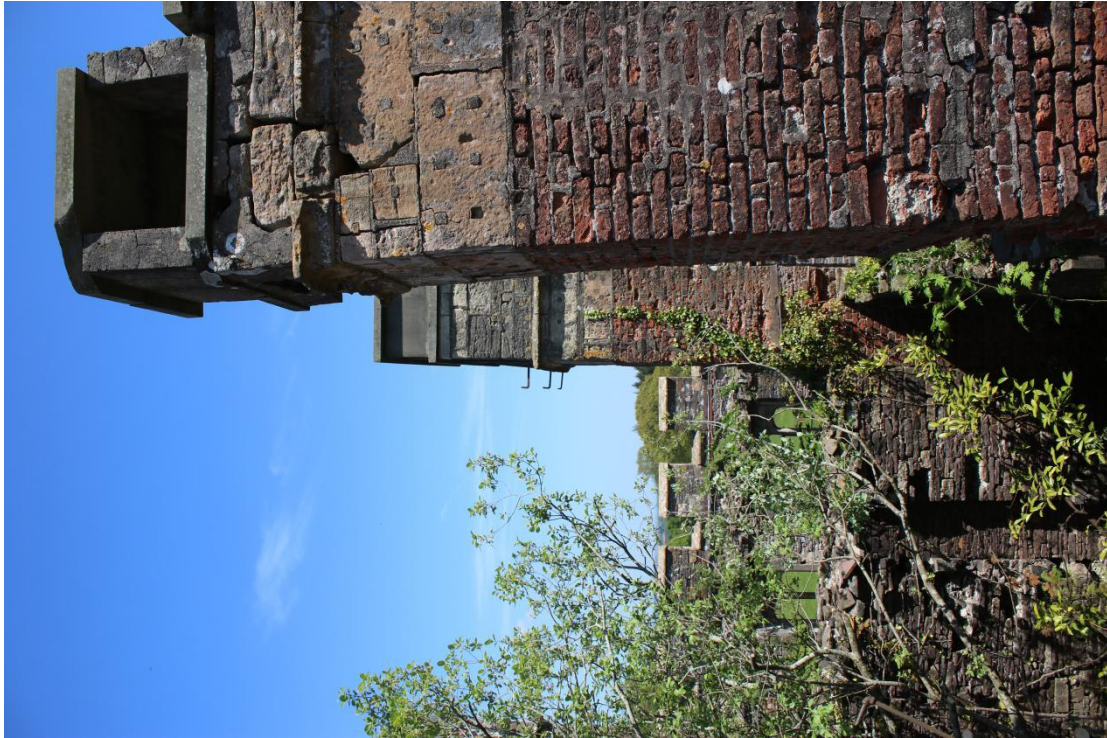
Plate 27 - AD042_WB_027 - West elevation, showing fall of the north flue from plumb.

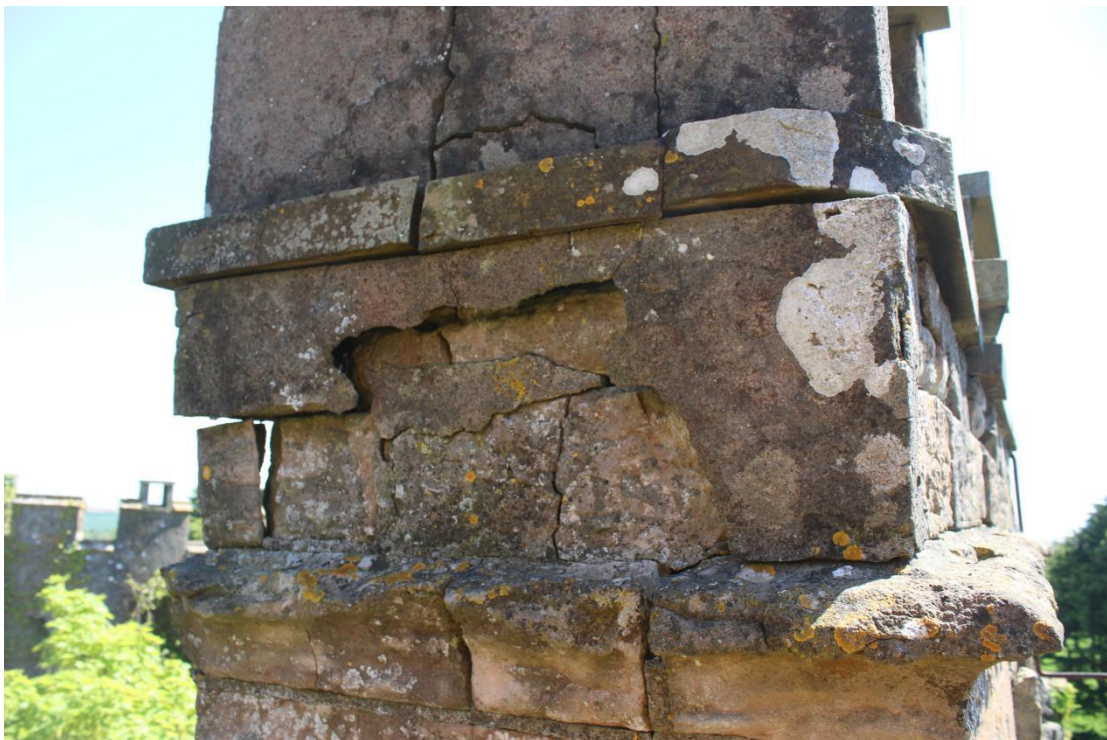
Plate 28 - AD042_WB_028 - North elevation, showing cementitious mortar fill.

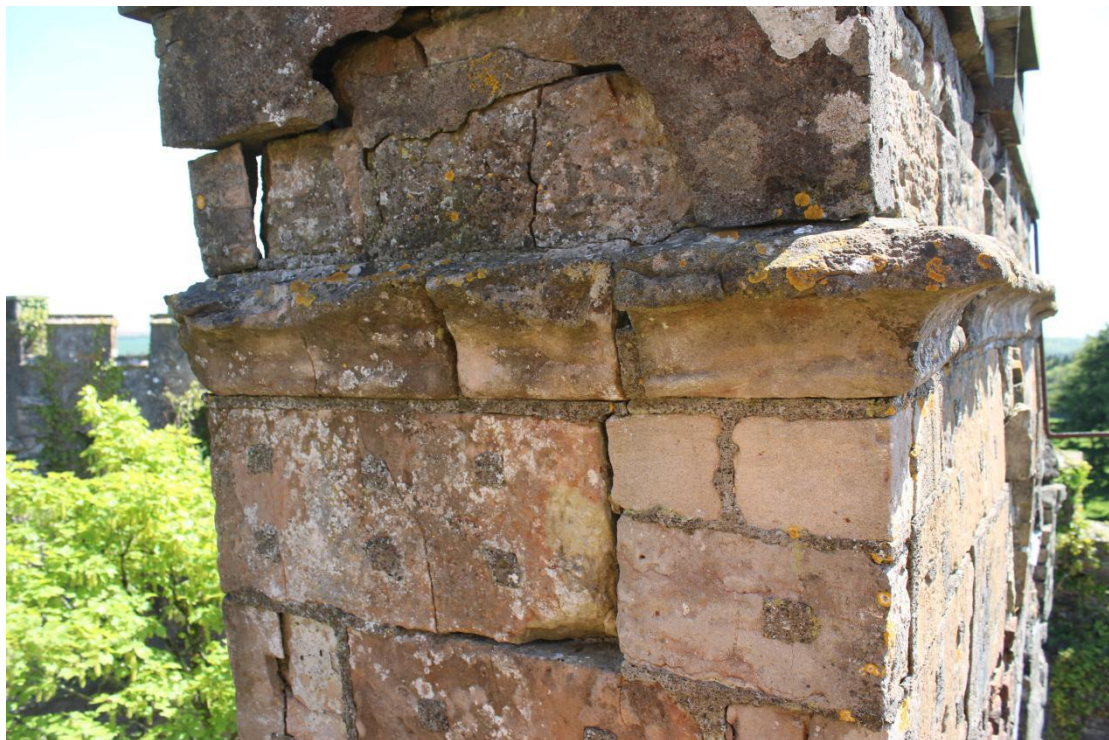
Plate 30 - AD042_WB_030 - North elevation, showing string course.

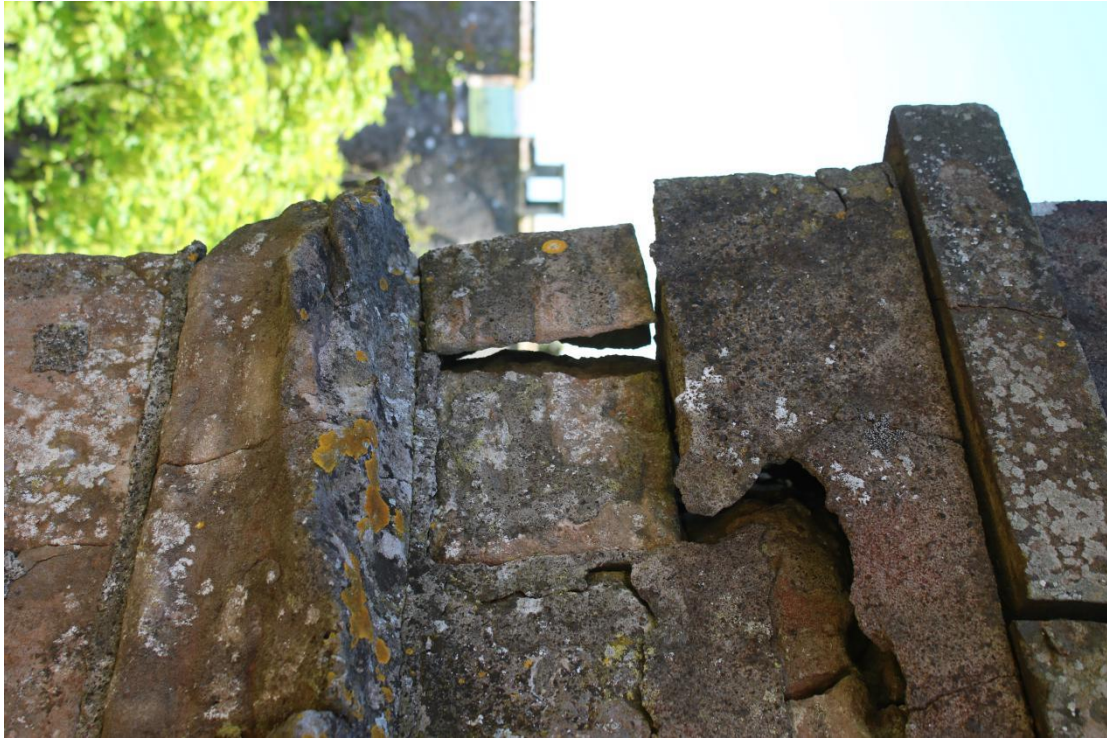
Plate 31 - AD042_WB_031 - North elevation, showing decayed sandstone ashlar with cementitious mortar above.

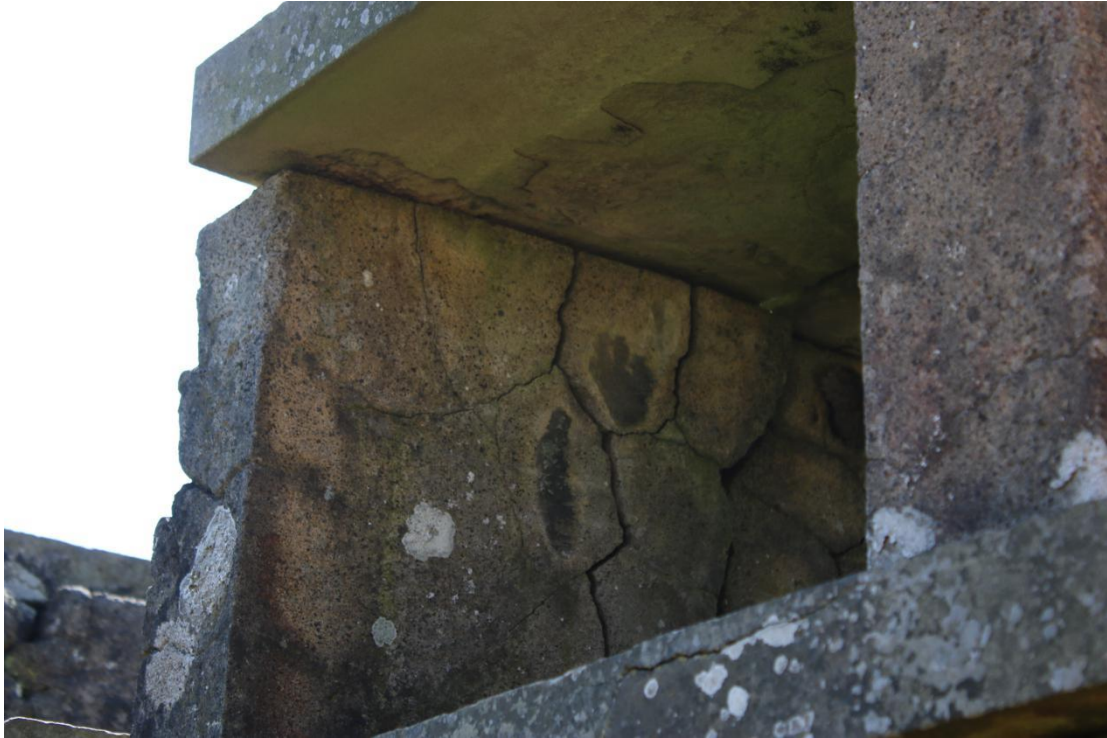
Plate 33 - AD042_WB_033 - East elevation, showing evidence of mud-casting to concrete upright.

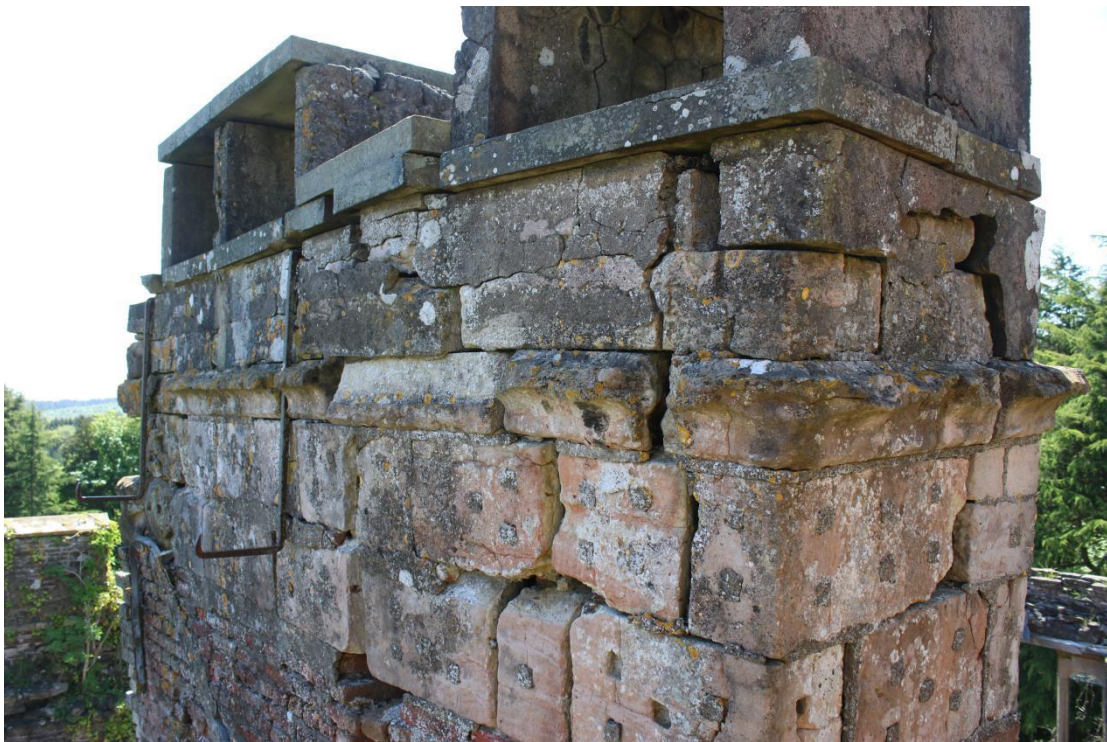
Plate 34 - AD042_WB_034 - 3/4 view of north and east elevations, showing string course.

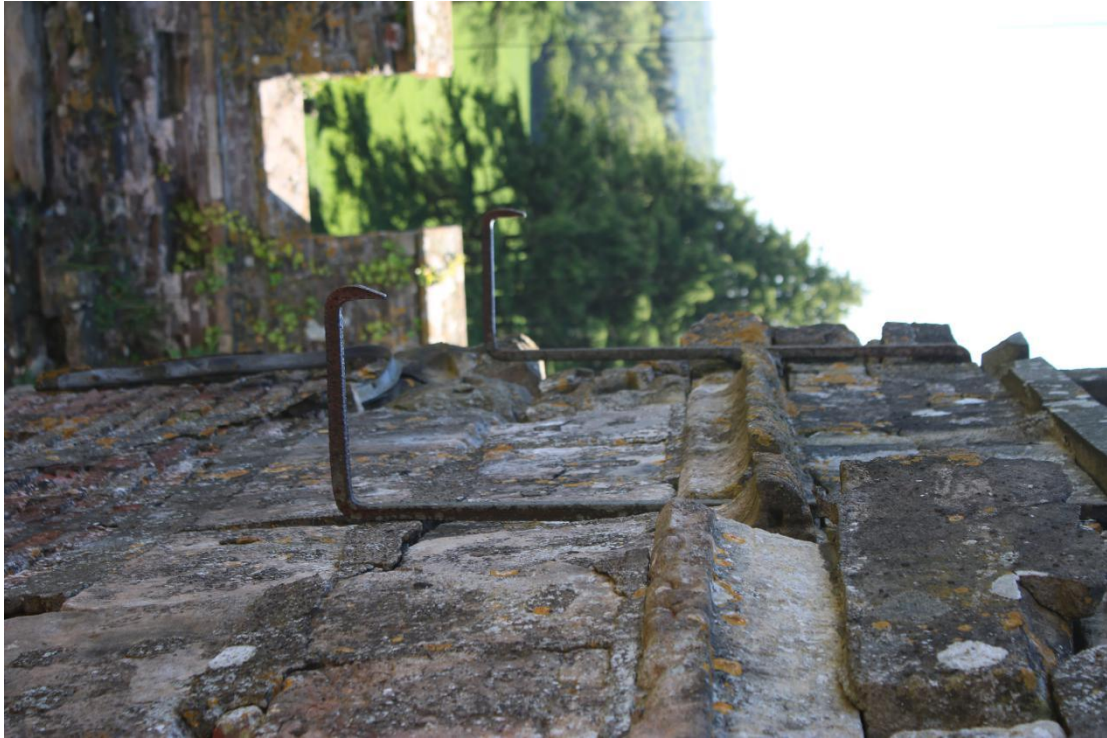
Plate 35 - AD042_WB_035 - East elevation, showing iron hook/strap.

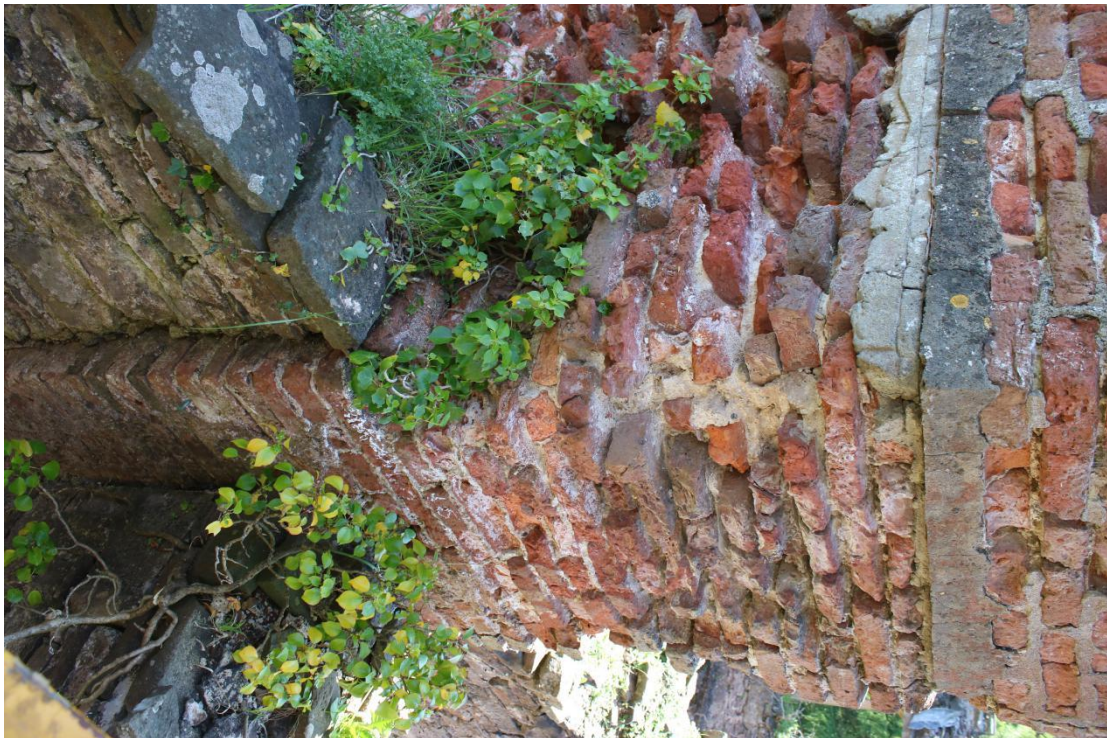
Plate 36 - AD042_WB_036 - 3/4 view of north and east elevations, showing pinch spalling and flashing line to former roof.

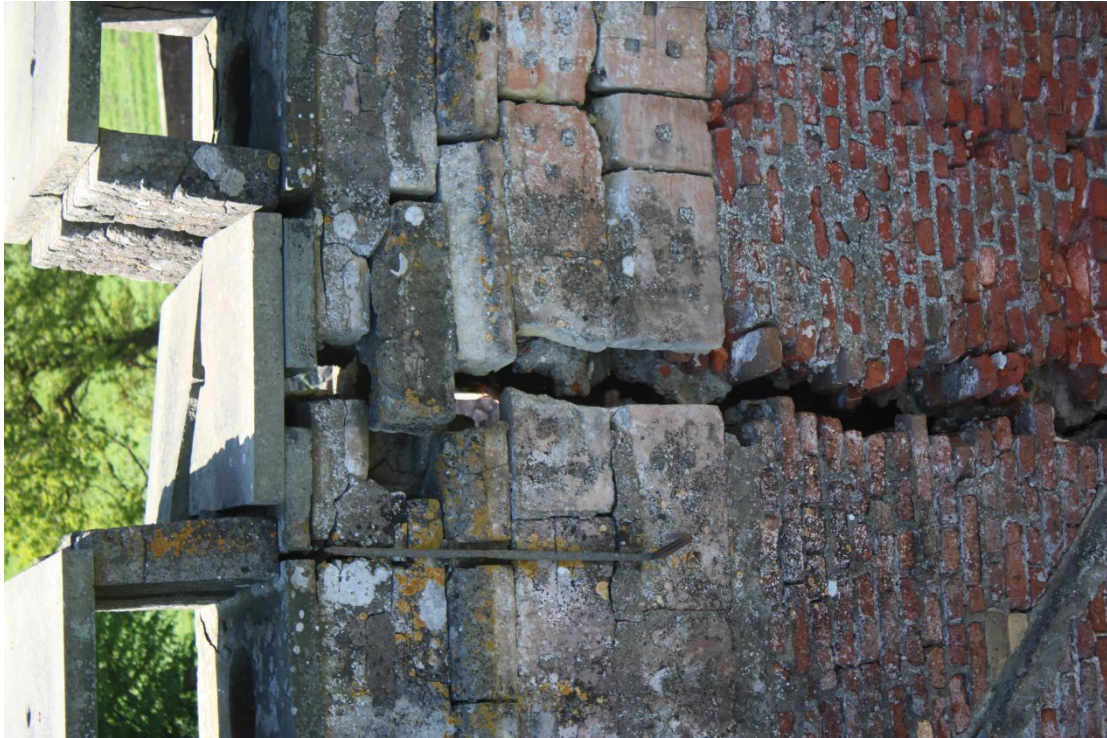
Plate 42 - AD042_WB_042 - East elevation, showing inserted flue (5; white brick).

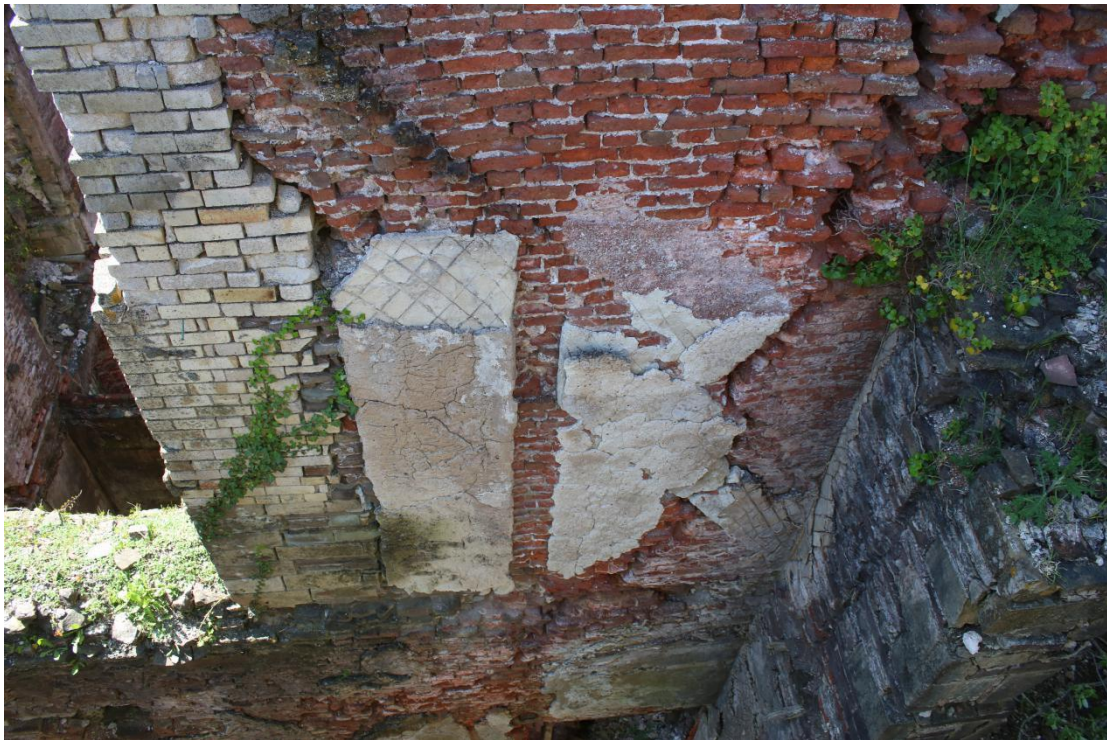
Plate 45 - AD042_WB_045 - East elevation, showing remaining evidence of 1626 roofline.

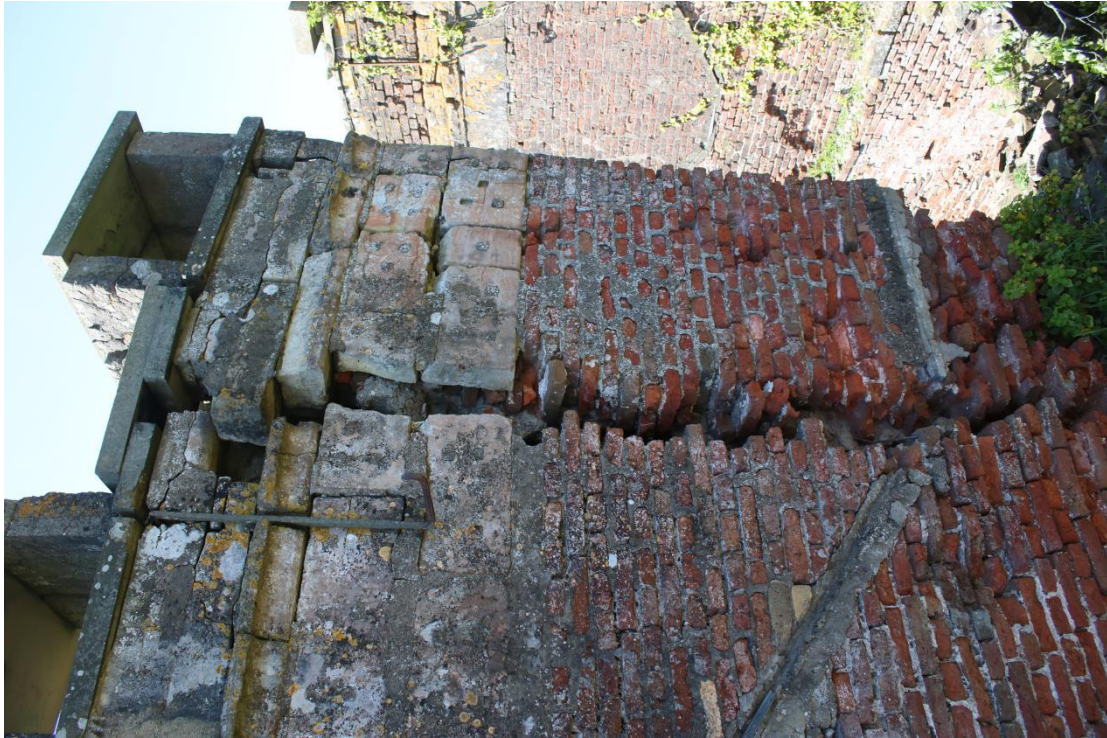
Plate 46 - AD042_WB_046 - East elevation, showing 1626 roofline and surviving lime plasterwork.

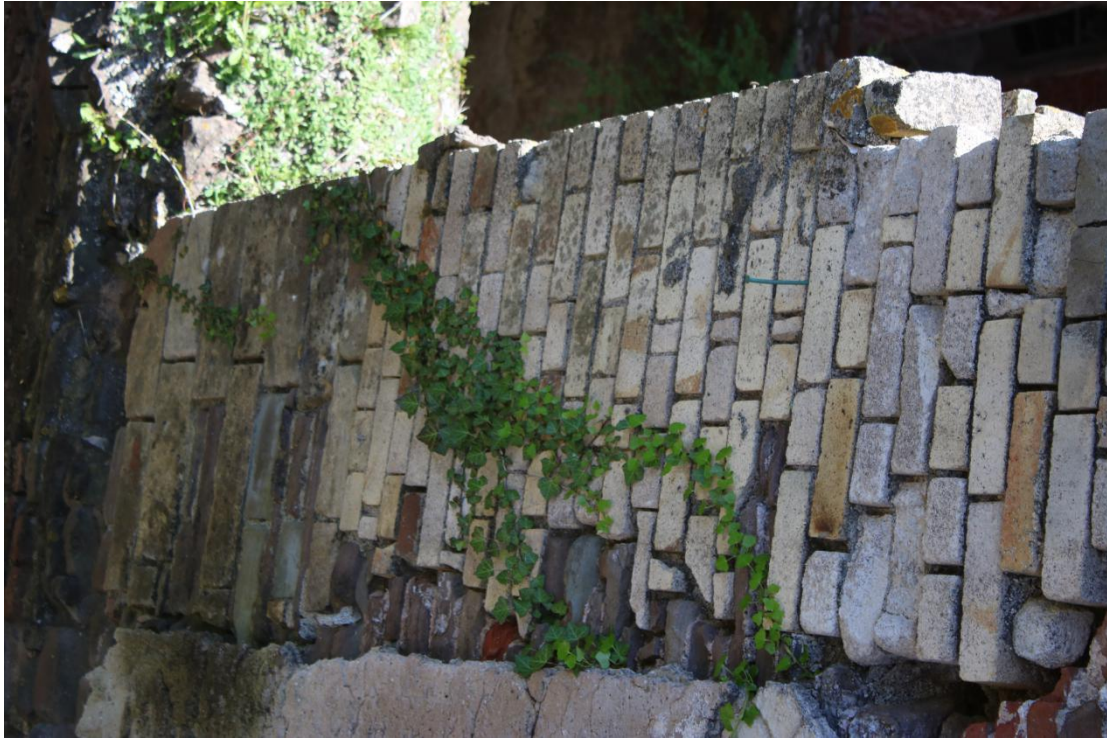
Plate 50 - AD042_WB_050 - East elevation, showing brickwork supporting upper masonry to south end of east elevation.

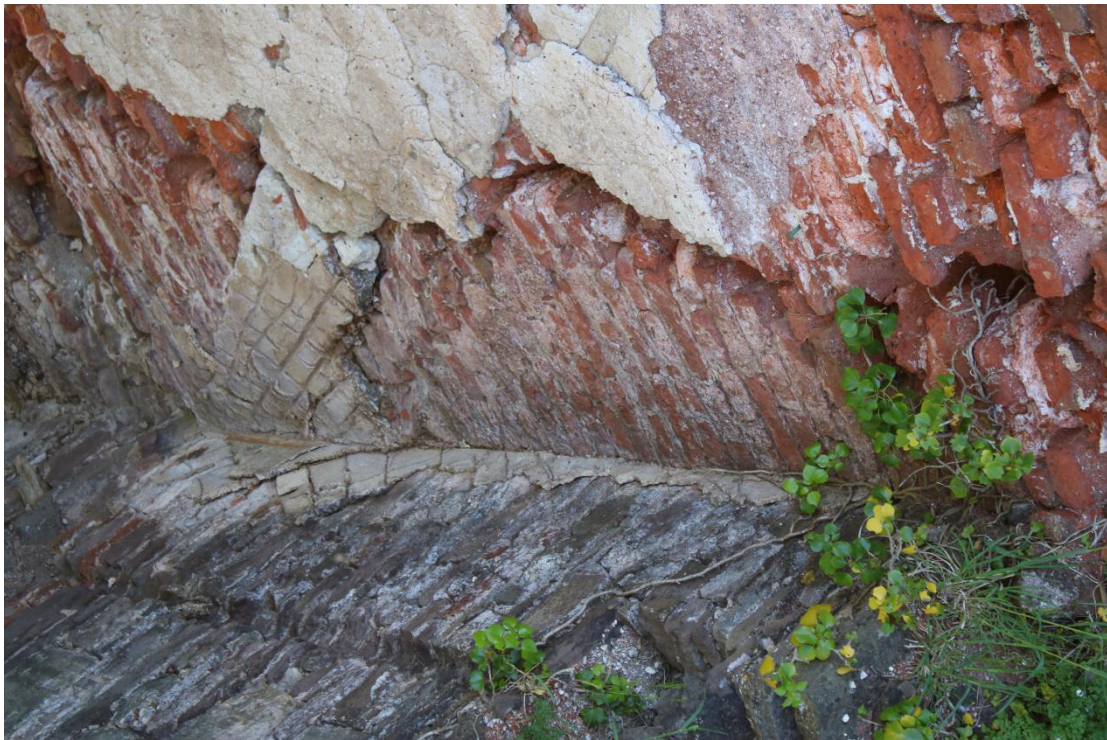
Plate 51 - AD042_WB_051 - East elevation, showing latter flue (5) addition in white brick.

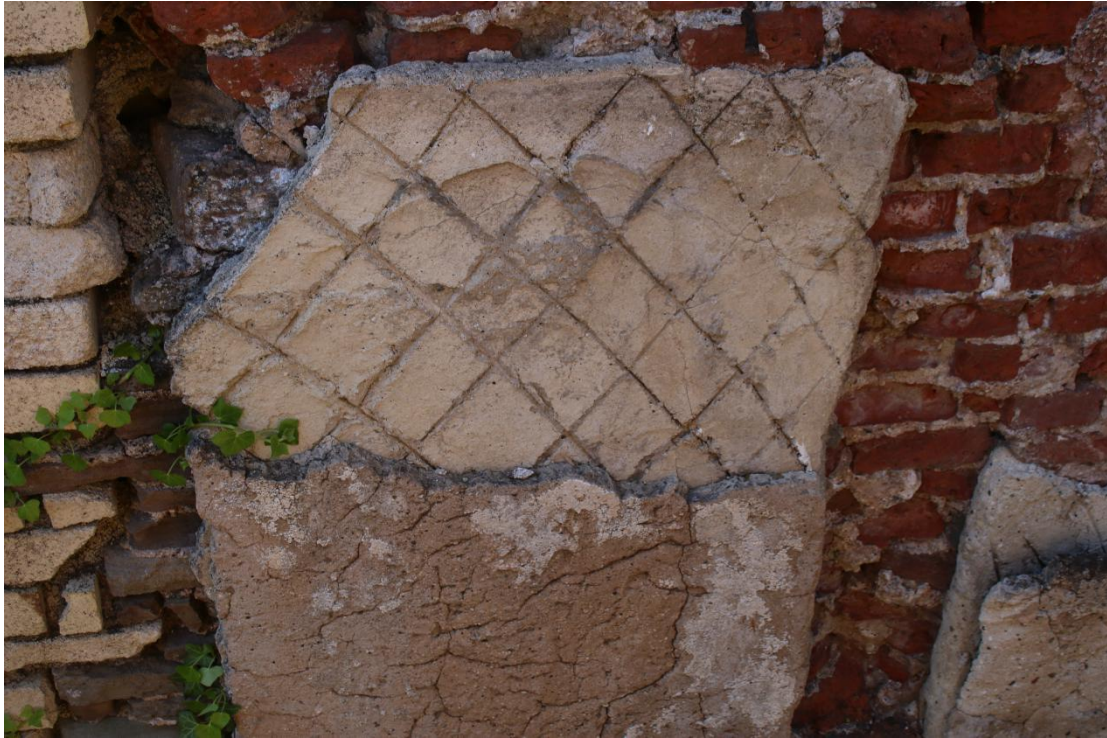
- 8.3.7 The chimney retains evidence of the 1626 roof pitch (Plate 54; Fig. 7) to the east elevation. This area of brick, made apparent by its protrusion from the face of the brickwork, runs at a pitch of 50°. A sketch of circa 1770 by an unknown artist (Fig. 3) confirms this earlier roof form and shows Ruperra as a Renaissance house of Elizabethan and Jacobean styling.

Plate 54 - AD042_WB_054 - East elevation, showing 1626 roofline.

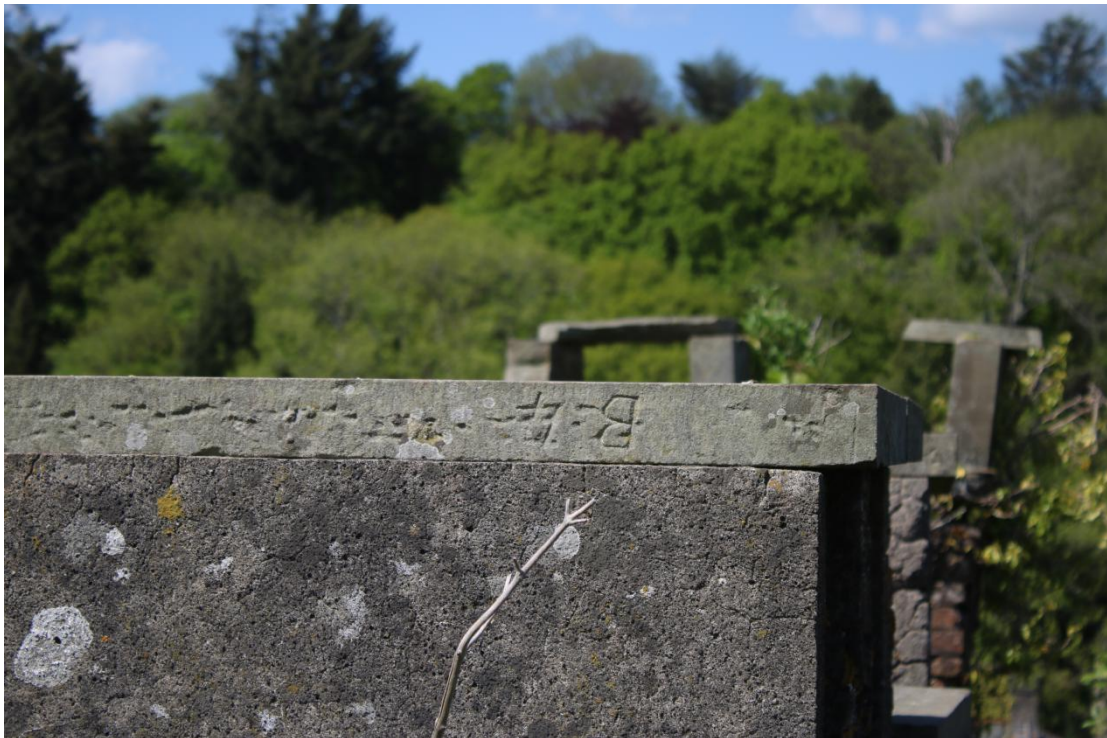
Plate 57 - AD042_WB_057 - South elevation, showing iron support to former 3rd floor fireplace.
