Stabilisation Works at Ruperra Castle, Glamorganshire

Historic Buildings Record

Project #: AD042

March 2019

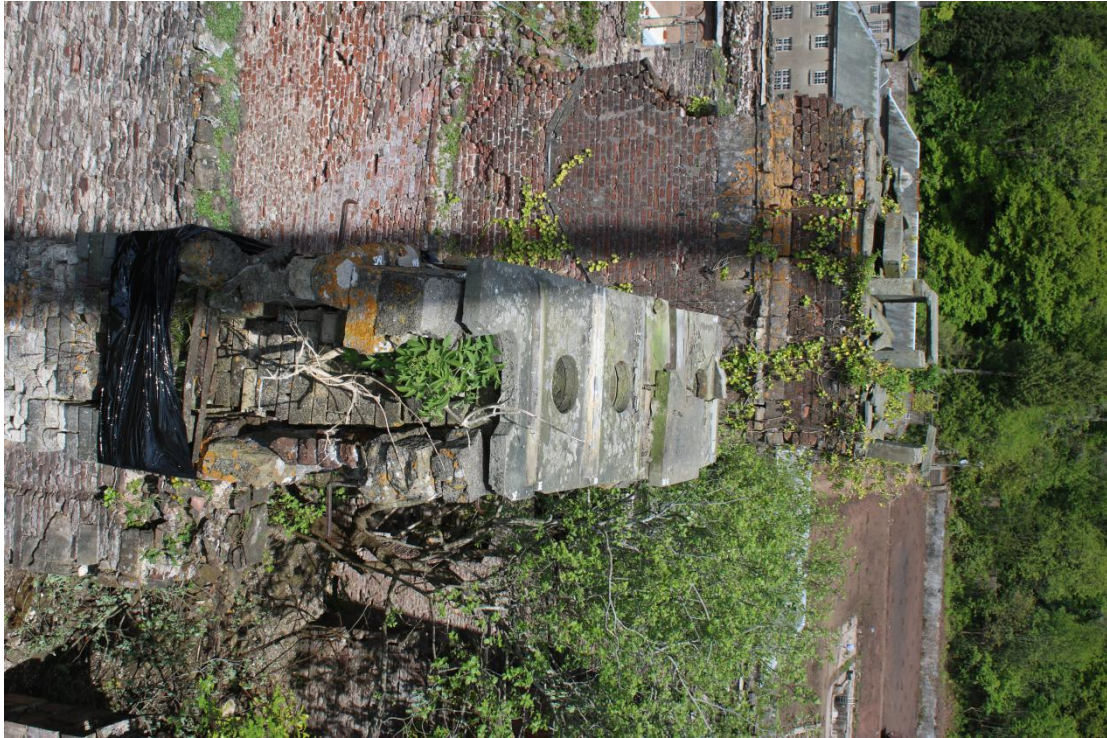
Plate 60 - AD042_WB_060 - Chimney after removal of rows 1 and 2, showing flue stones.

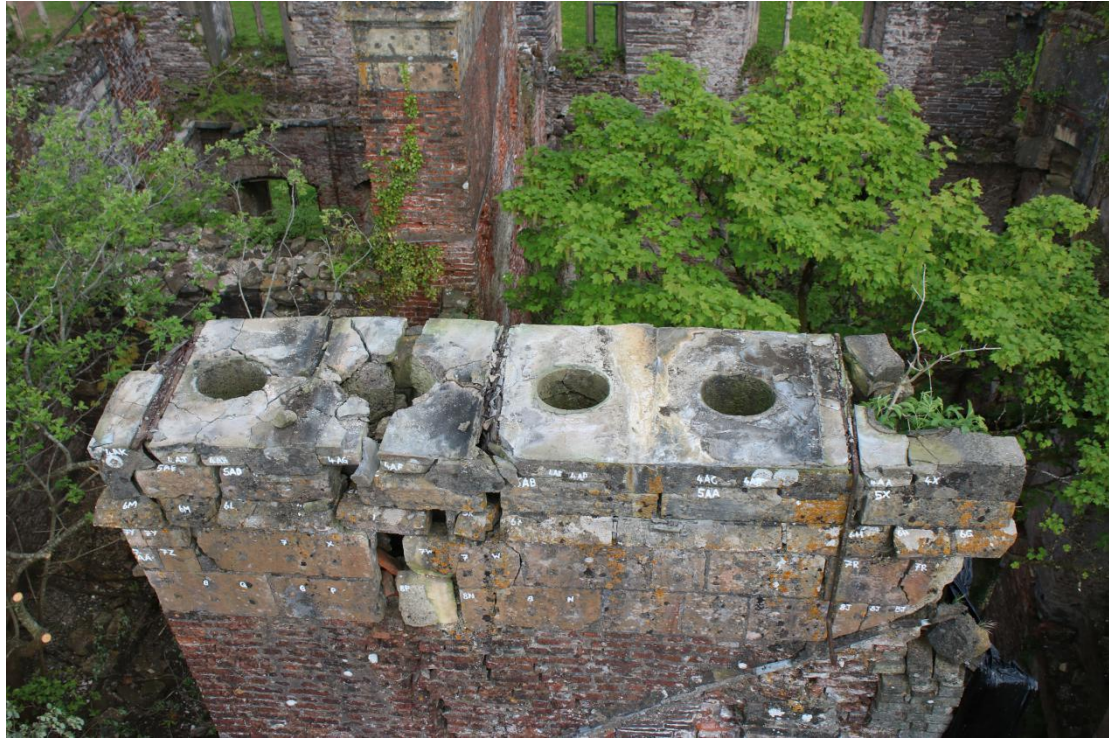
Plate 66 - AD042_WB_066 - Chimney after removal of row 3.

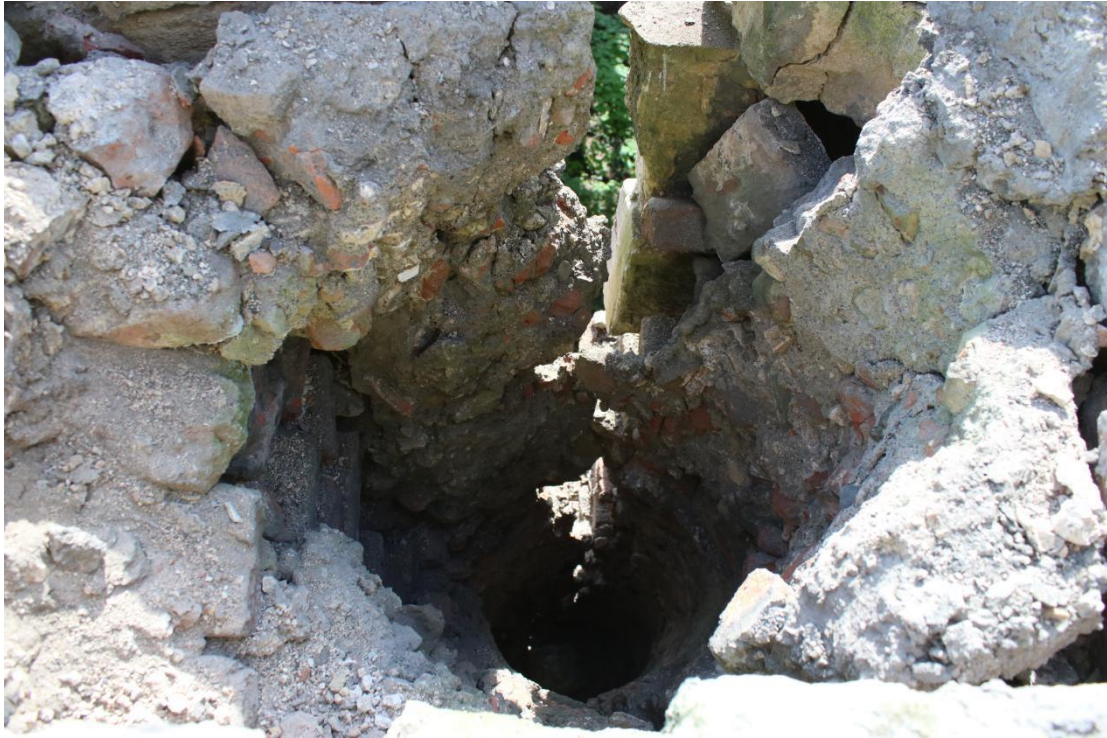
Plate 68 - AD042_WB_068 - Chimney after removal of row 4.

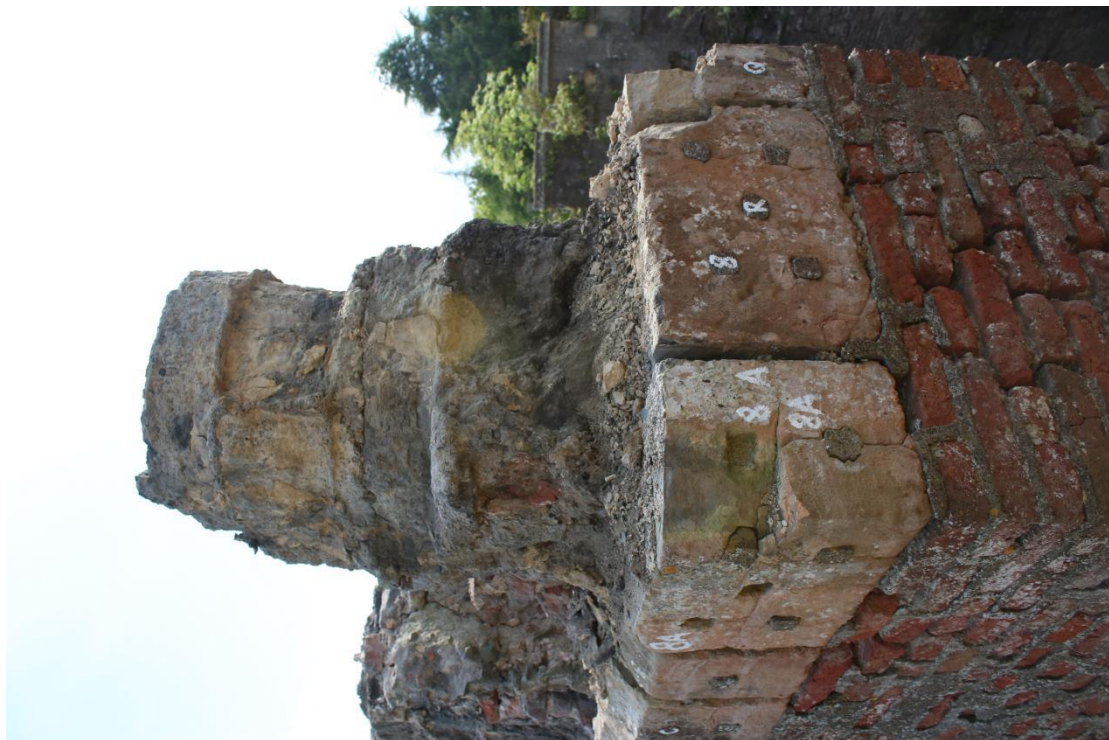
Plate 80 - AD042_WB_080 - Chimney after removal of row 7, showing north cementitious mortar lined flue 1.

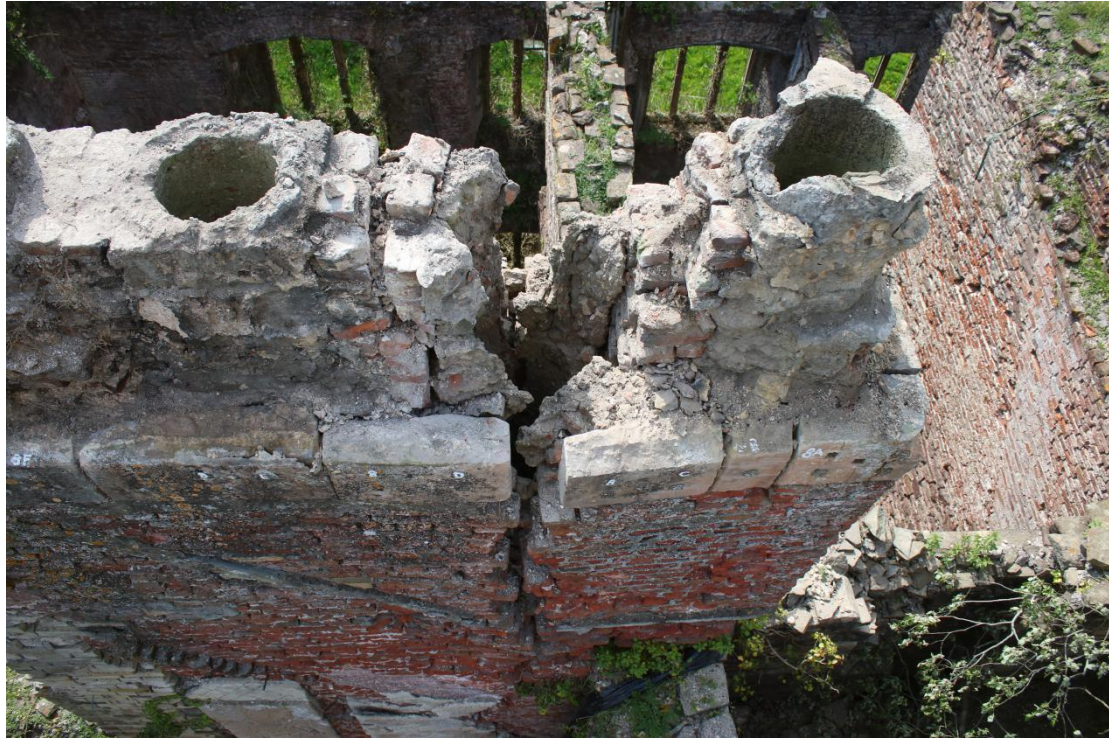
Plate 83 - AD042_WB_083 - Chimney after removal of row 7, showing flues 1, 2 and 3.

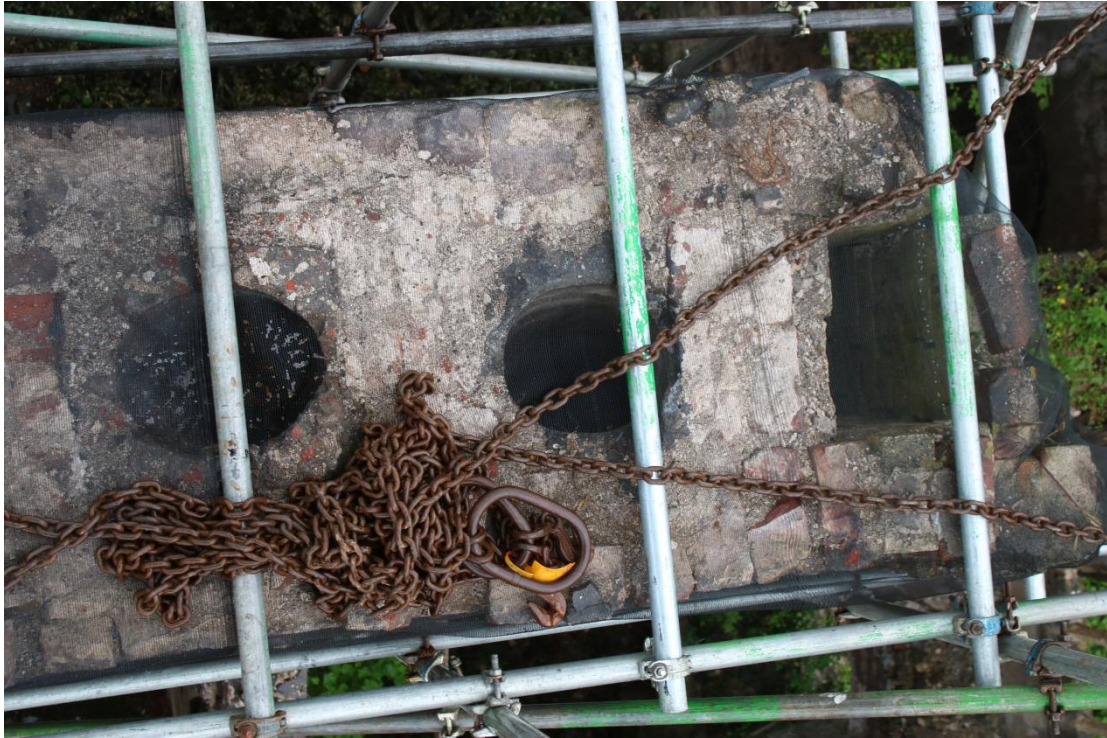
Plate 113 - AD042_WB_113 - Chimney after removal of row 8, showing flues 3 to 5.

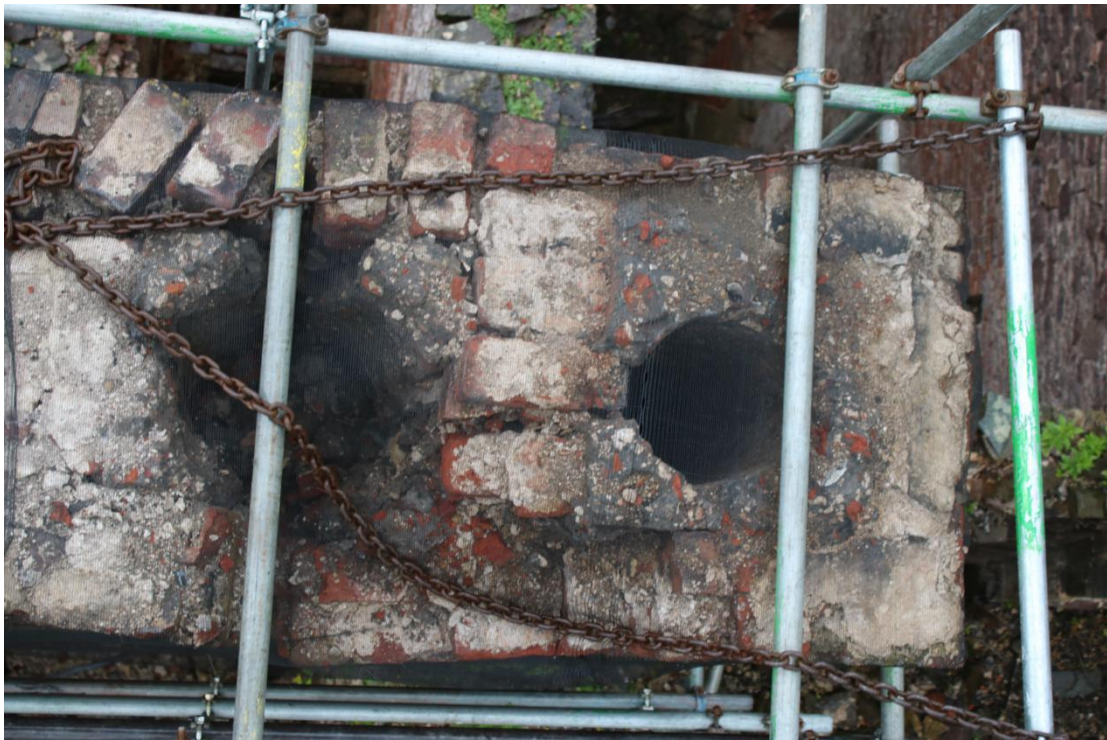
Plate 114 - AD042_WB_114 - Chimney after removal of row 8, showing flues 1 and 2.

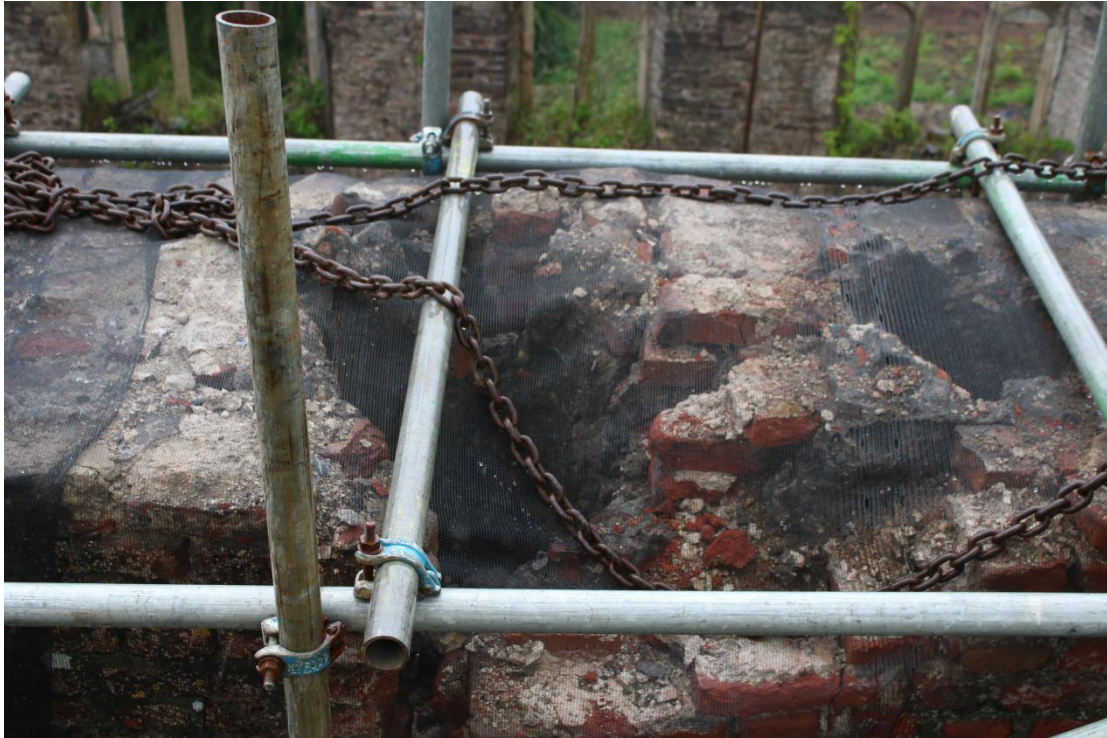
Plate 115 - AD042_WB_115 - Chimney after removal of row 8, showing flue 2 and area of lost brickwork.

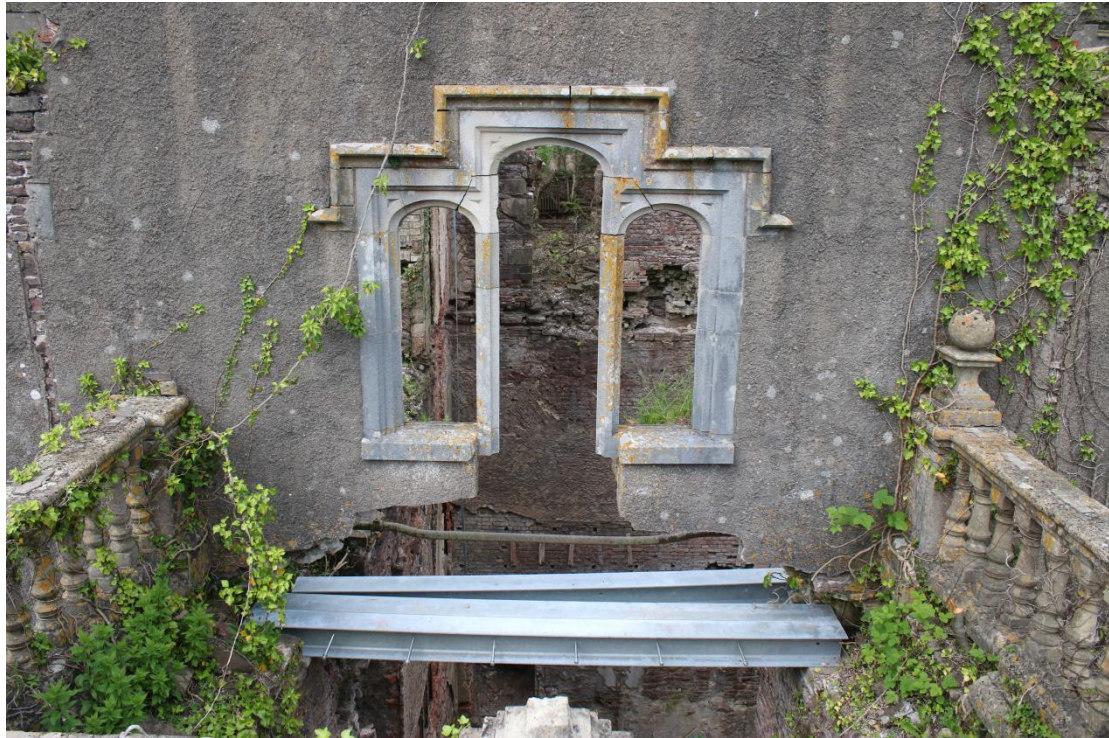
Plate 121 - AD042_WB_121 - South window exterior, showing rolled steel joists (RSJ).

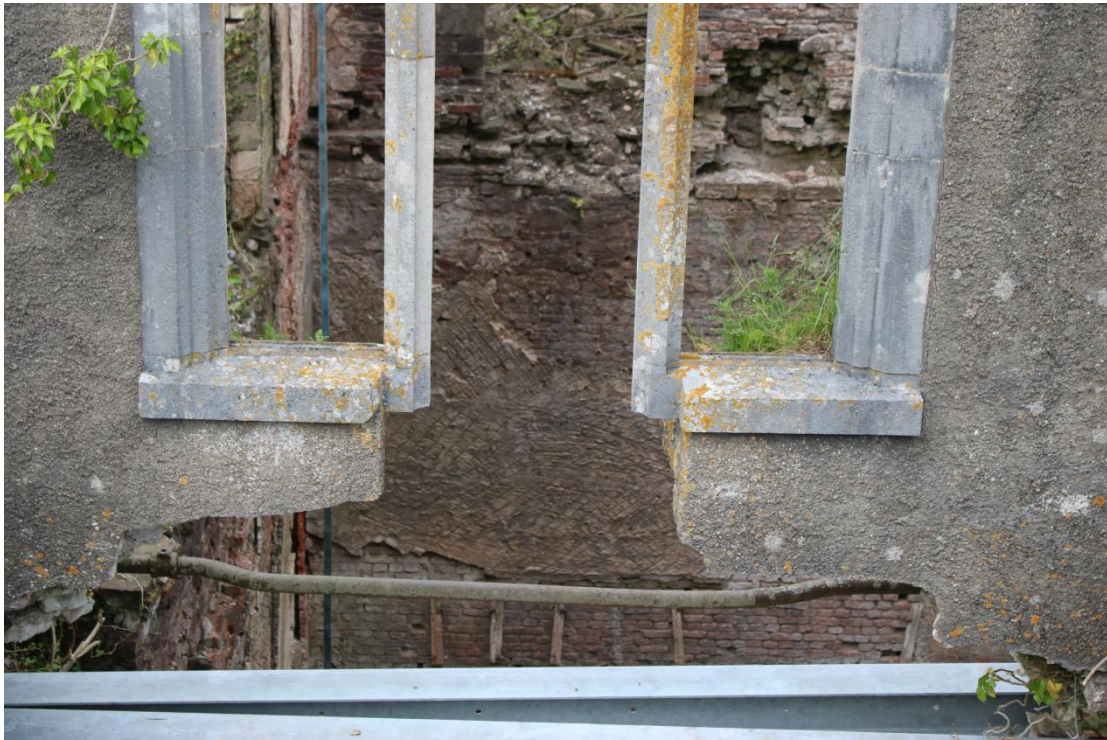
Plate 123 - AD042_WB_123 - South window exterior, showing sills and fallen masonry.

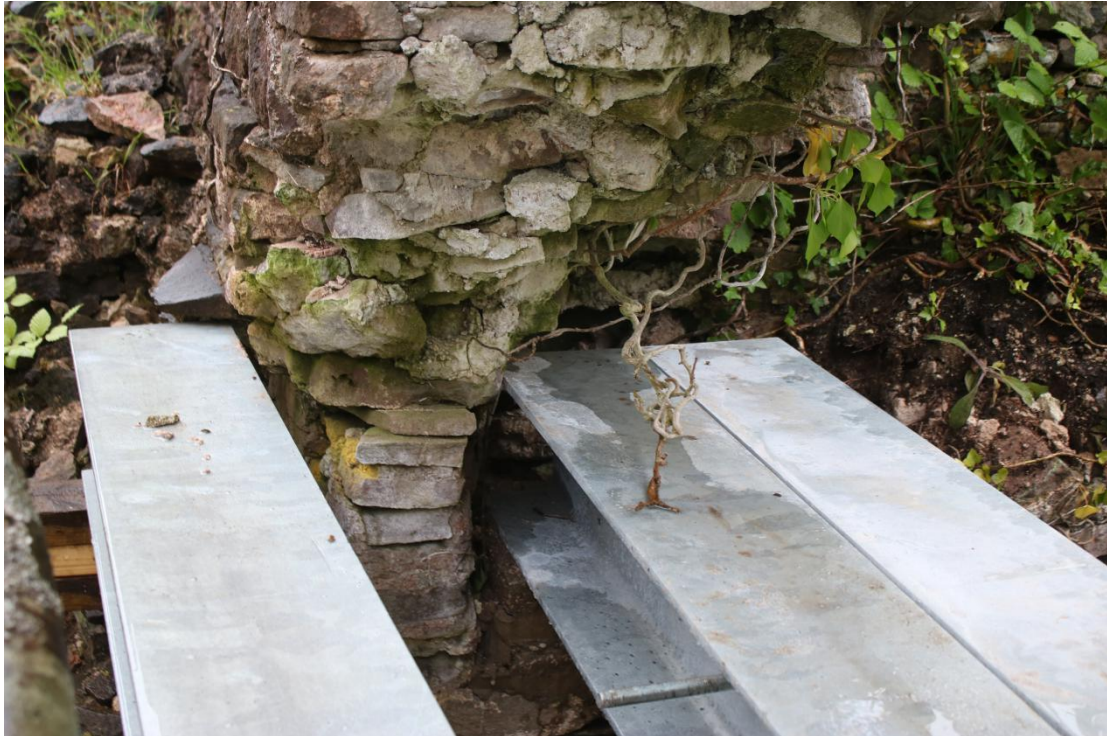
Plate 139 - AD042_WB_139 - South window, showing temporary RSJ siting and masonry to be removed.

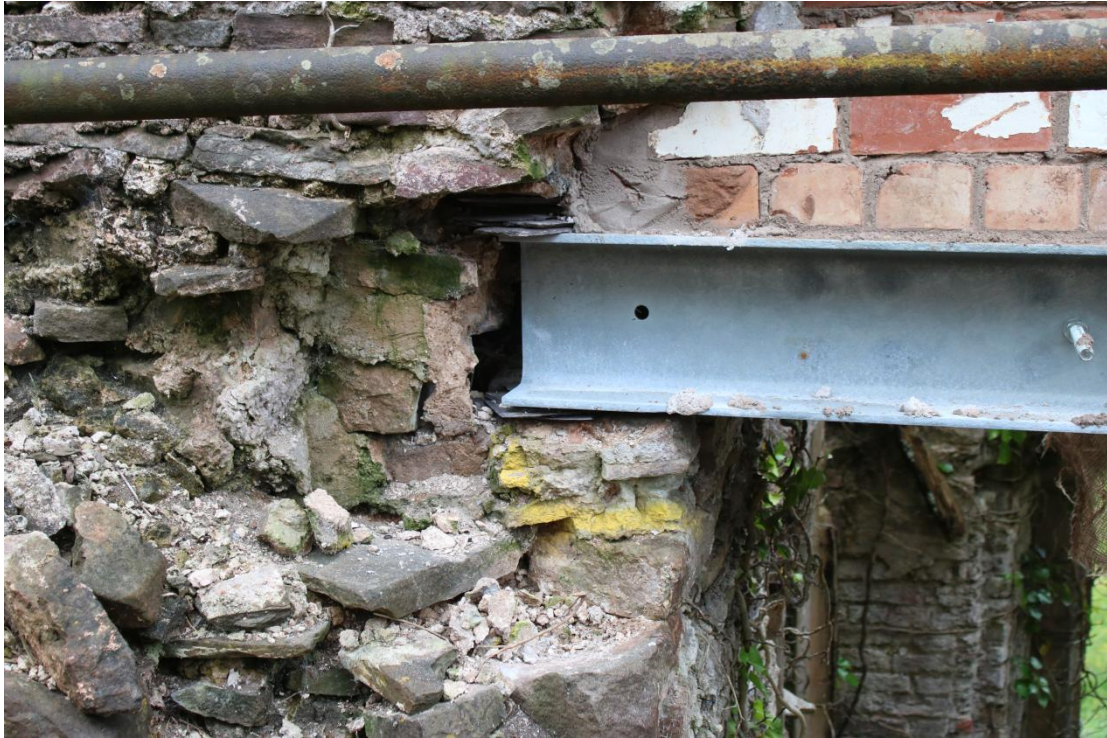
Plate 140 - AD042_WB_140 - South window, showing temporary RSJ siting and masonry to be removed.

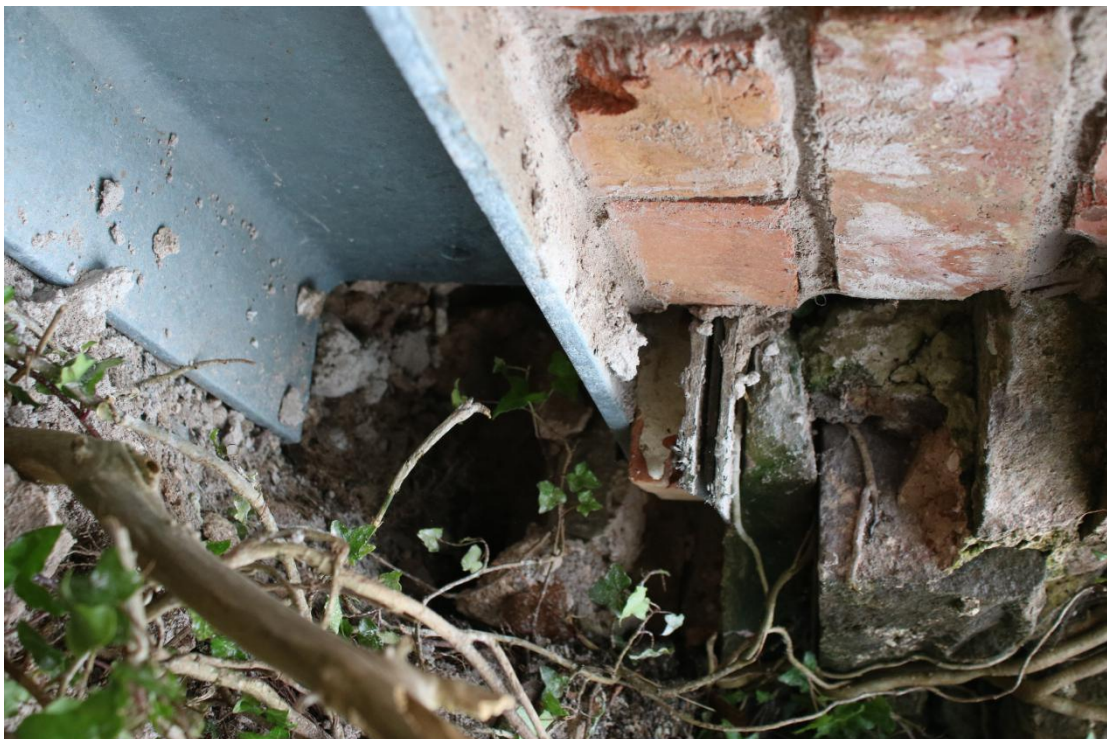
Plate 141 - AD042_WB_141 - South window, showing temporary RSJ siting and masonry to be removed.

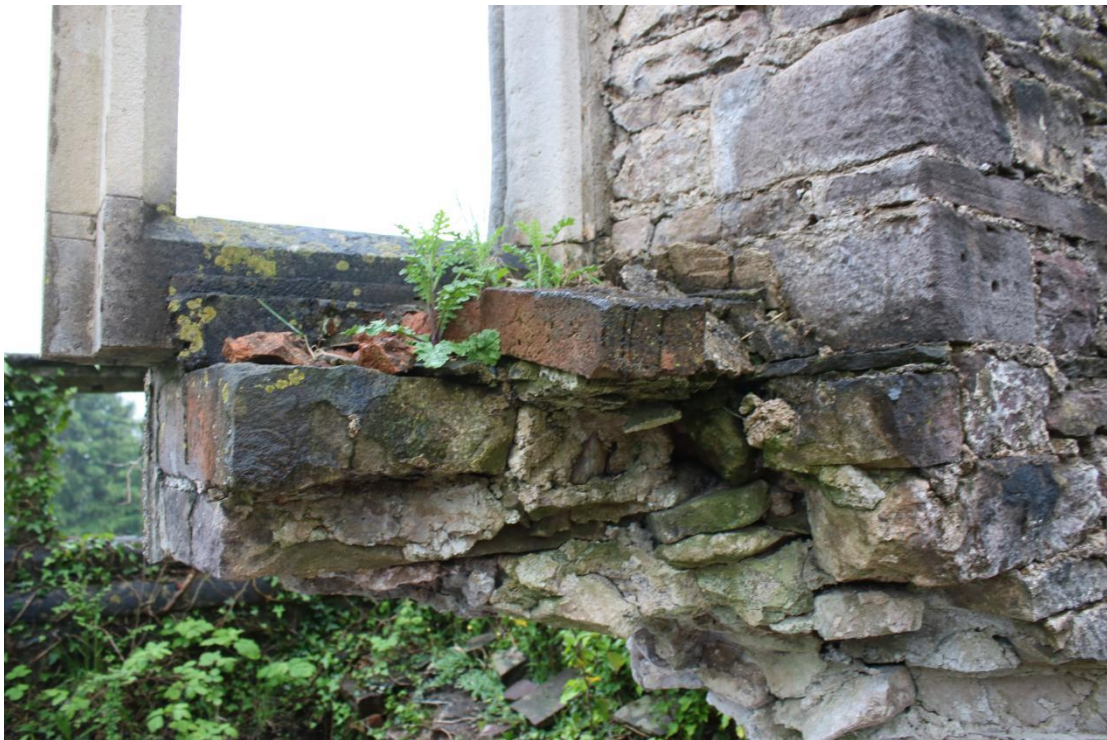
6.5.2 The masonry below the window (**Plate 125**) had fallen away at 45° after the 1942 fire had caused the loss of the original timber bressummer supporting this and, as a result, has left the sandstone window hanging precariously. The decision was taken that this should be supported with new brickwork built of rolled steel joists, bedded into the original beam sockets. The rolled steel joists were coded from north to south, with **GRD1** being the northern most, **GRD2** the middle, and **GRD3** the southern.

Plate 142 - AD042_WB_142 - South window interior, showing hanging masonry.

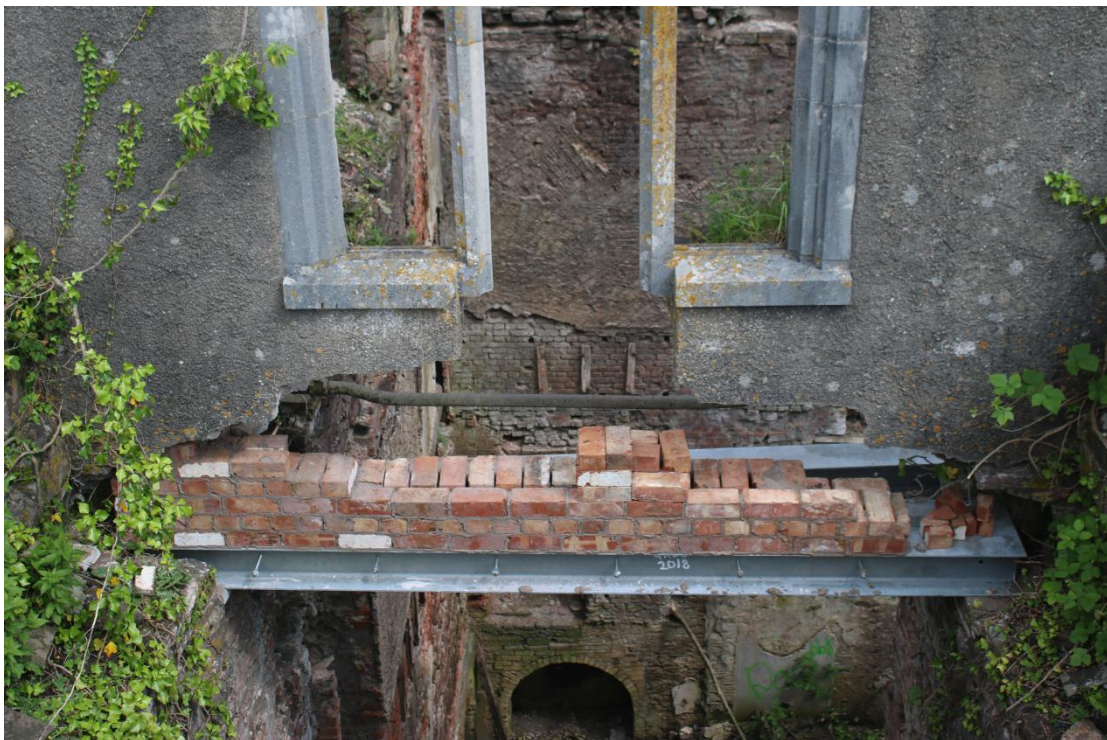
Plate 156 - AD042_WB_156 - South window, showing supporting brickwork complete to exterior.

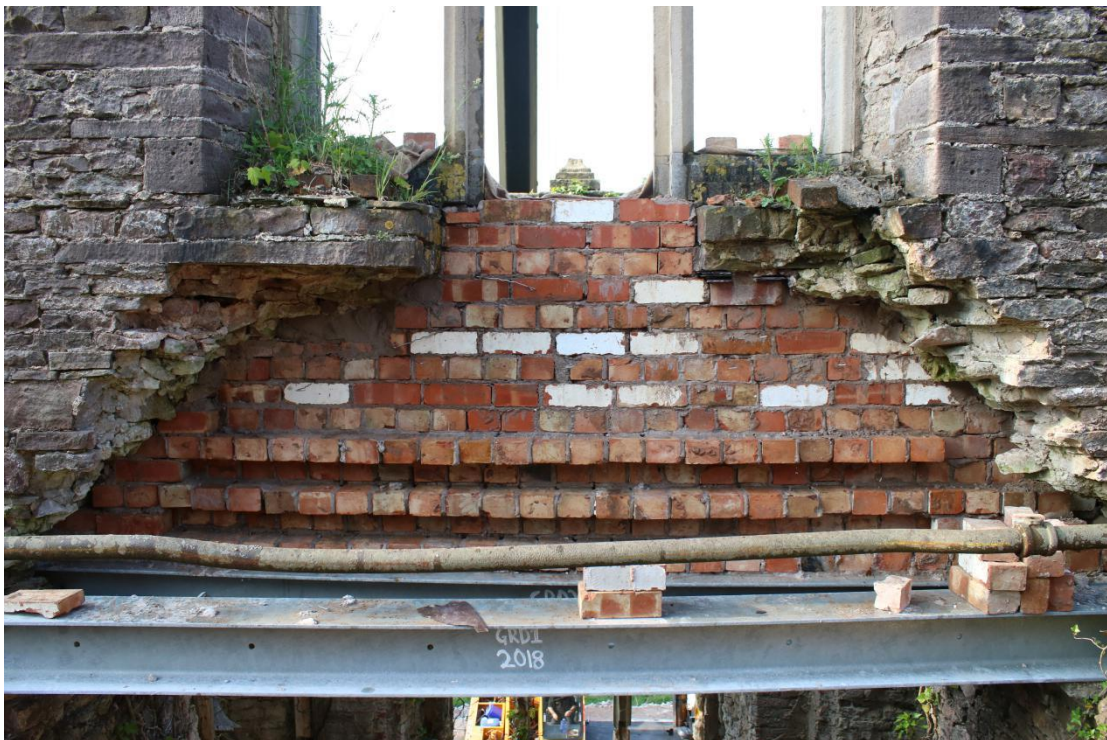
Plate 157 - AD042_WB_157 - South window, showing supporting brickwork exterior skin, inner face.

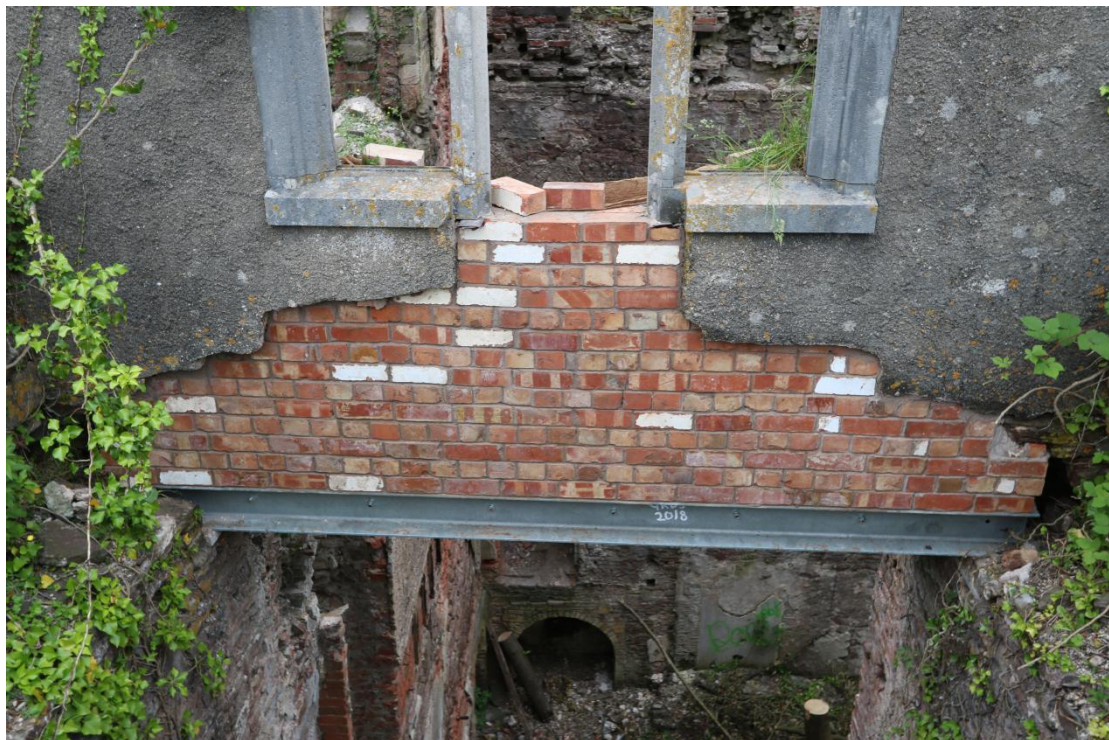
Plate 159 - AD042_WB_159 - South window, showing supporting brickwork complete to exterior.
