Former Coach House, Newport, Pembrokeshire

Archaeological Buildings Record & Watching Brief Report

Project #: AD010 25th May 2016

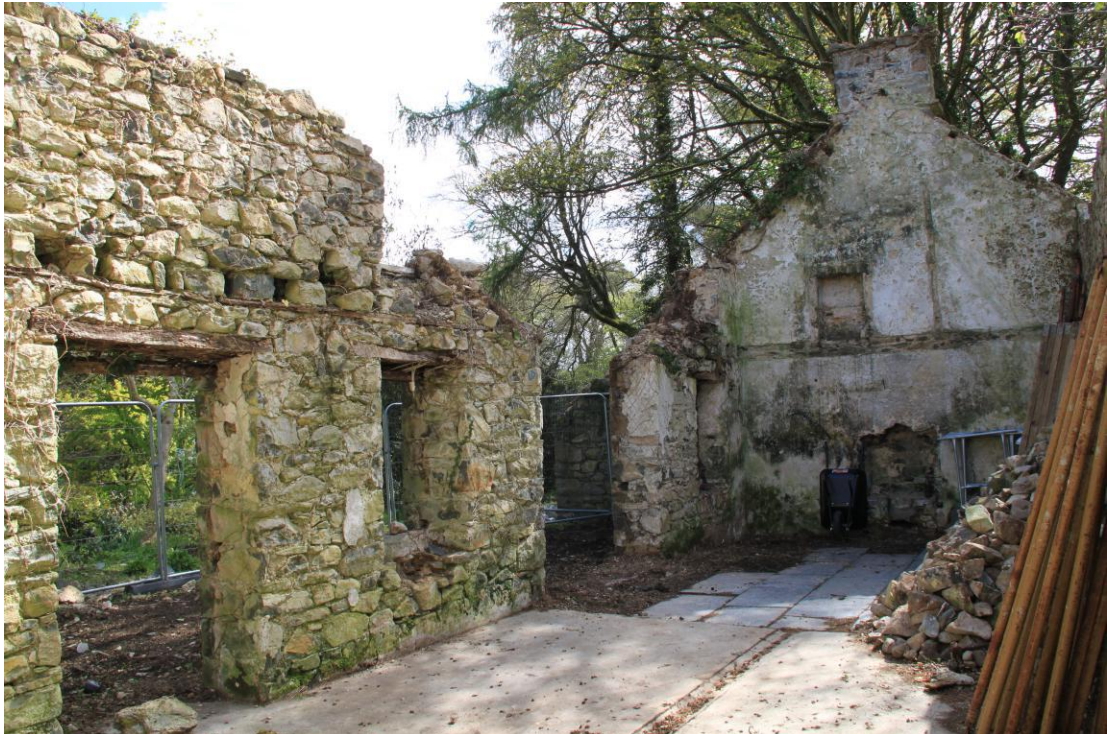
Plate 20 - AD010-BR-020 - Internal view of Former Coach House towards the east.

The internal face of the north elevation (**Plates 20, 23, 26 & 30**) has the remains of lime plaster in places, but otherwise is largely of roughly shaped and well coursed limestone blocks of varying size. Oak lintels form the heads of the three windows and door within this elevation. Joist sockets can be seen where the first floor once sat.

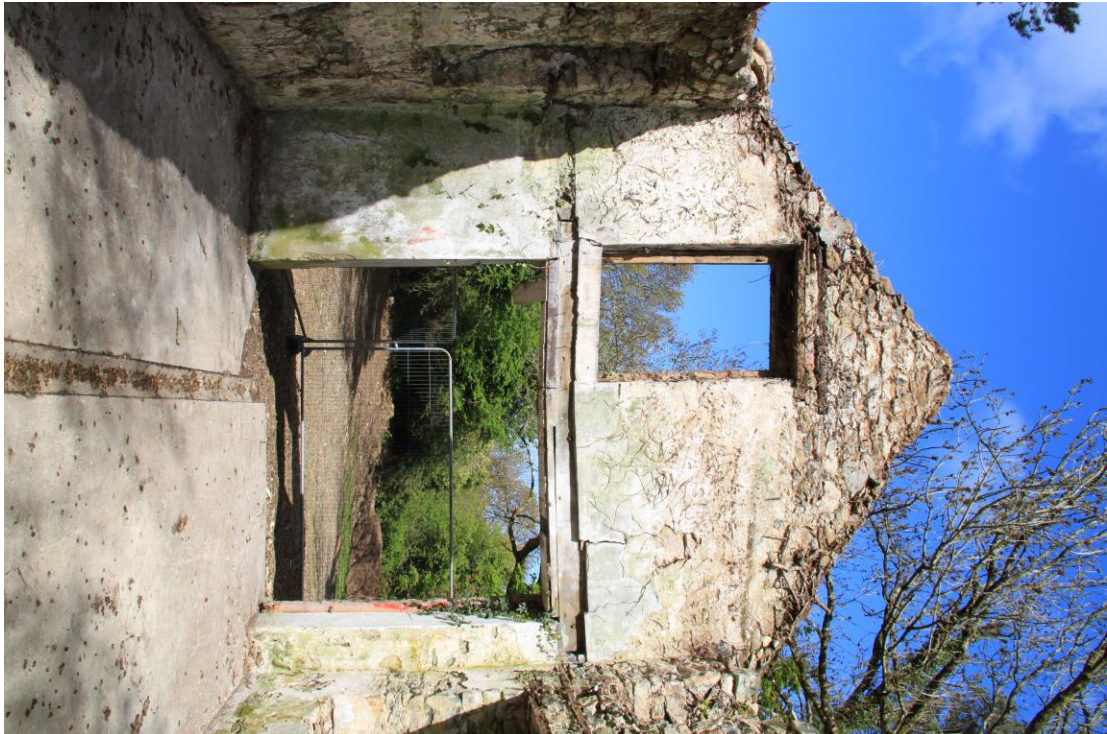
Plate 28 - AD010-BR-028 - Internal view, west wall.

The internal face of the west elevation (**Plate 28**) is, by and large, the same as the external elevation, with a single large garage door at ground level and a large window/door at first floor. The wall is covered in patched of lime and cement based plasters.

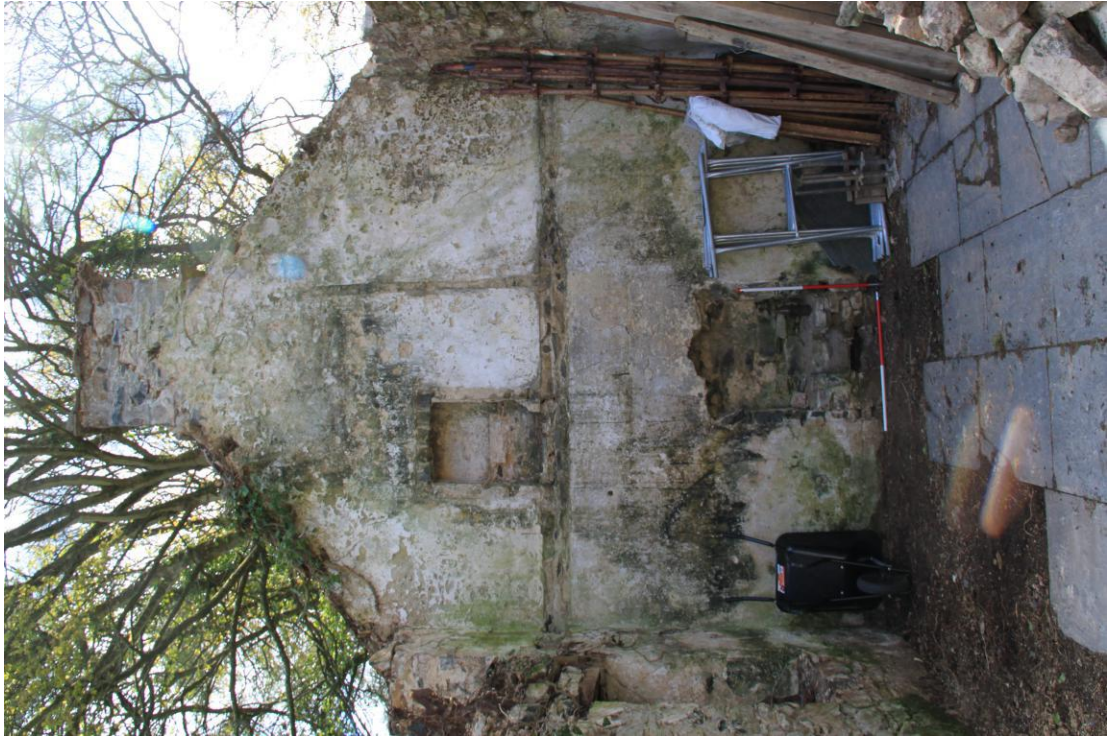
Plate 29 - AD010-BR-029 - Internal view, east wall.

At the east end, the gable of the Coach House (**Plates 24, 25 & 29**) has the remains of a small coal range at ground floor level and fire place at first floor, which rise to a stone stack. The chimney stack is of stone, and has a stone tray and the remains of its flaunching, although badly weathered. The wall is still largely covered in a lime plaster, with a break line indicating where the first floor level once was.

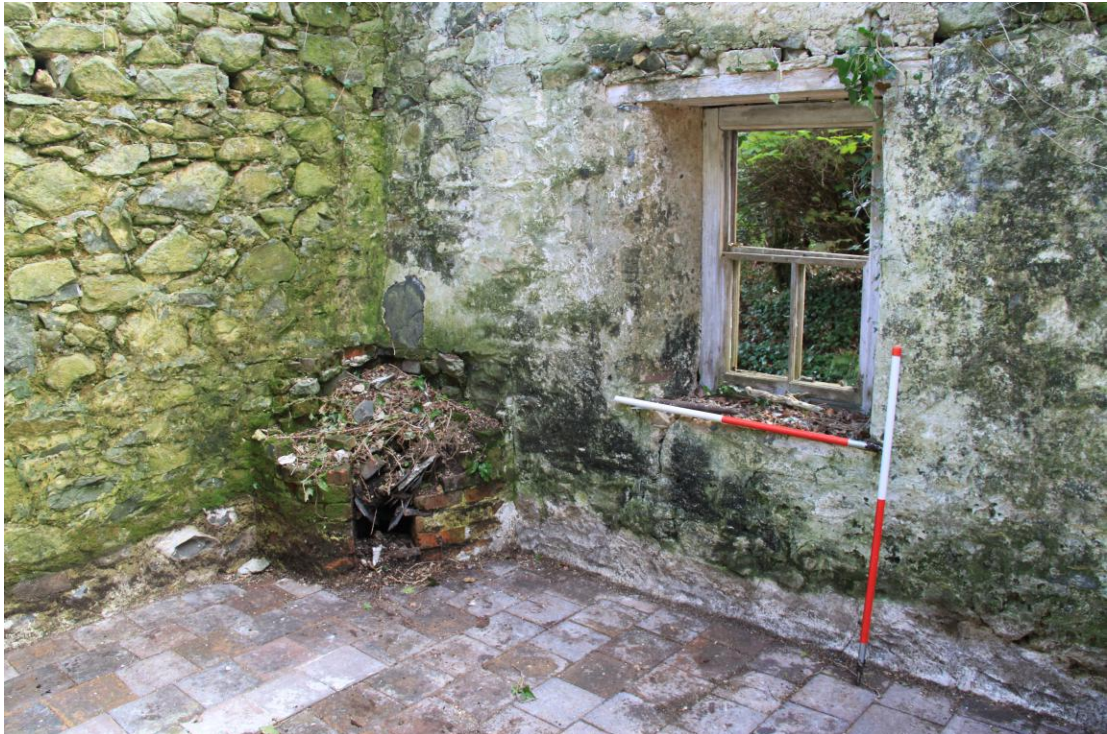
The remains of a small boiler occupies the north-east corner of the room (**Plate 38**) and red quarry tiles cover the floor (**Plate 37**). The two windows and door all have oak lintels internally (**Plates 39-40**). A four light sash window frame remains, but de-glazed and damaged in the east elevation (**Plate 47**).

Plate 40 - AD010-BR-040 - Internal view of Extension B towards the east.

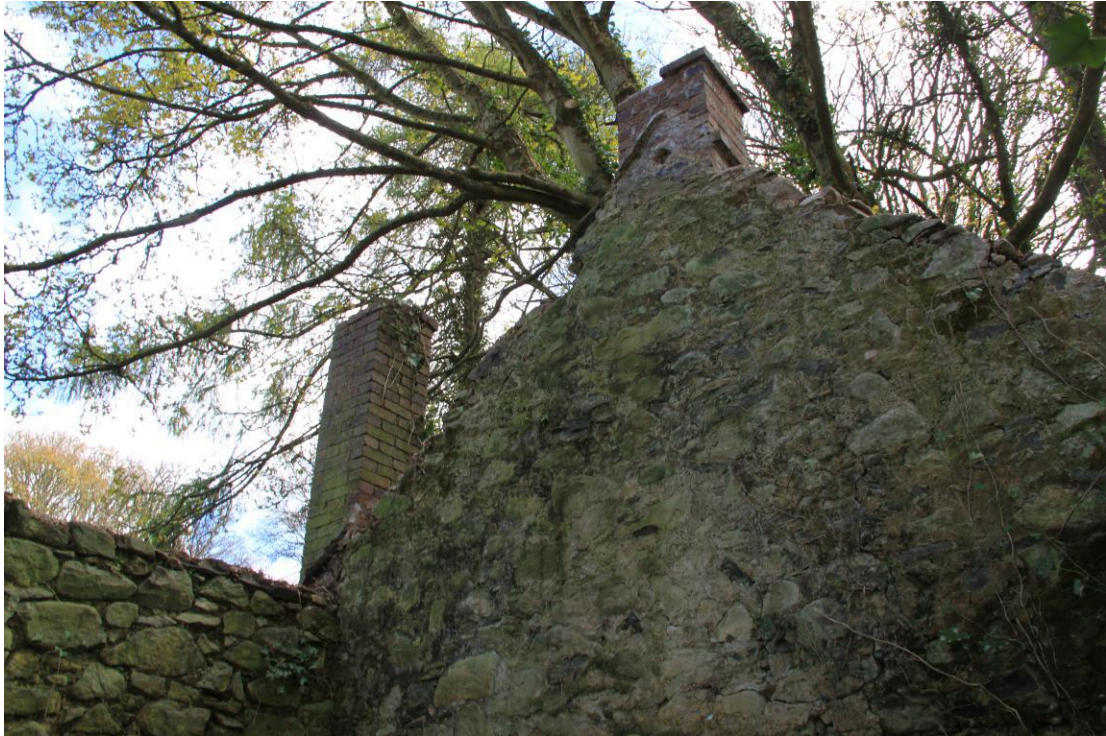
Joist sockets to the lateral walls (**Plate 42**) demonstrate the former existence of a loft. The east gable rises to a red brick stack with drip stones (**Plate 41**), at the apex a ridge purlin socket can be seen (**Plate 41**). The opposing gable shows, shared in common with the Coach House, there were four purlins, with additional weather protection above in the form of drip stones (**Plate 44**).

Plate 41 - AD010-BR-041 - Internal view of Extension B towards the east, showing chimney stacks.

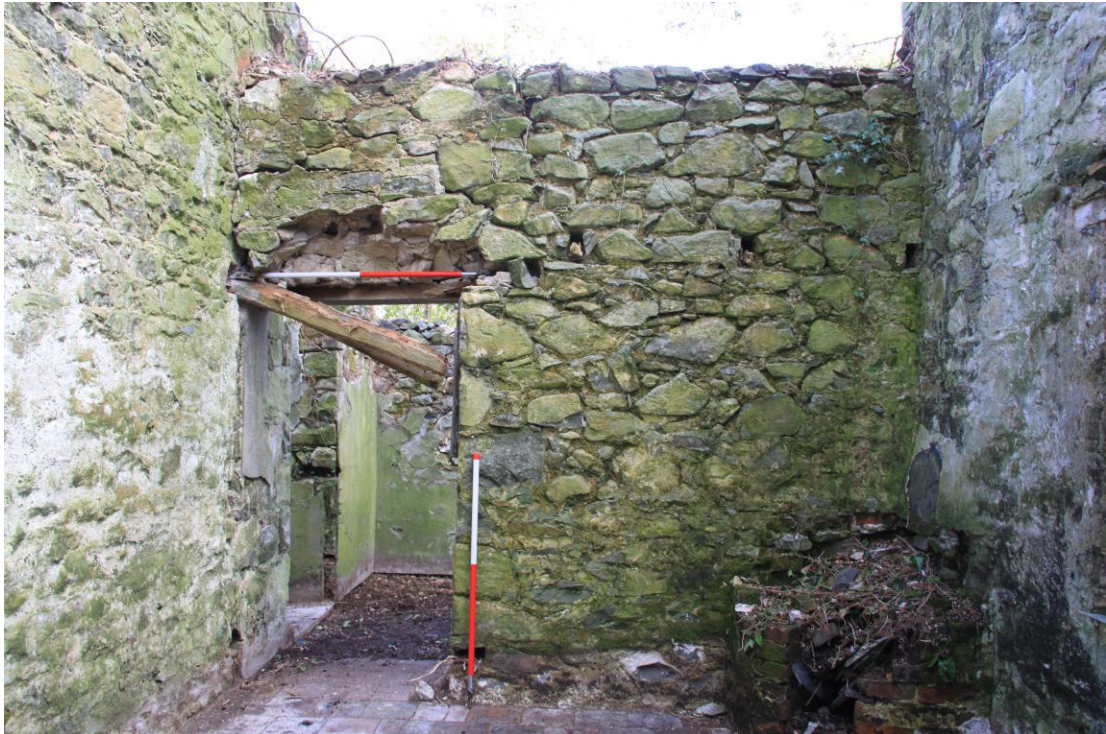
Plate 42 - AD010-BR-042 - Internal view of Extension B towards the north.

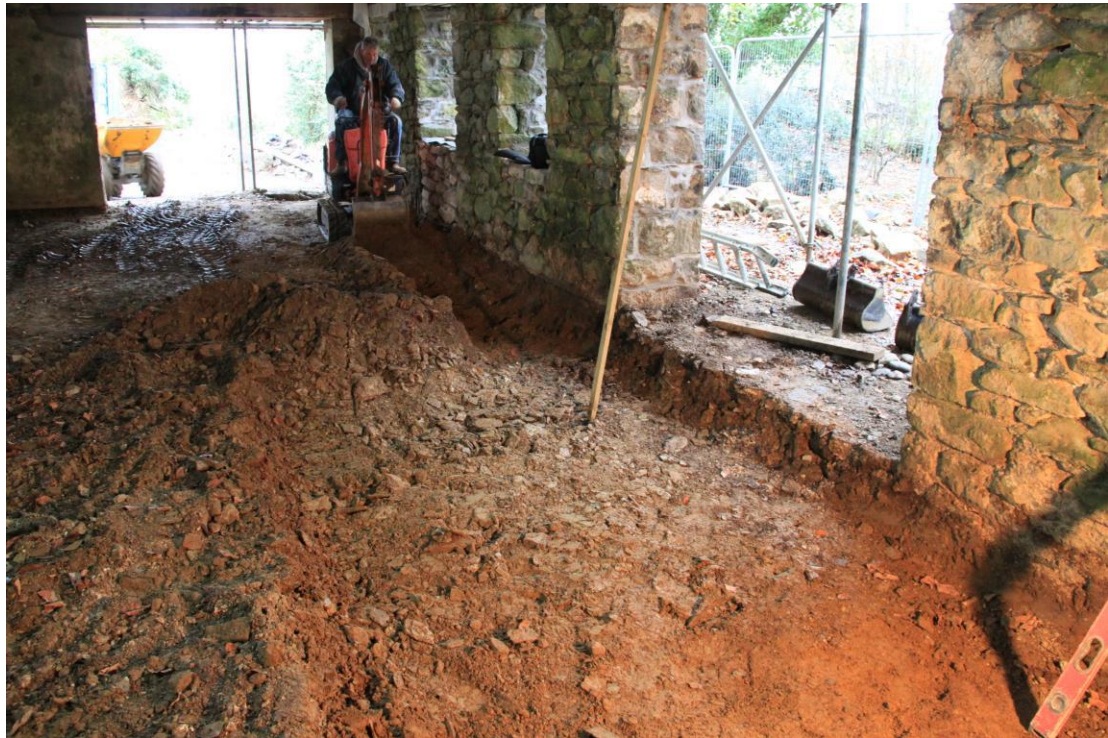
Plate 48 - AD010-D1-001 - Internal excavations for poring of concrete slab, view north-west.

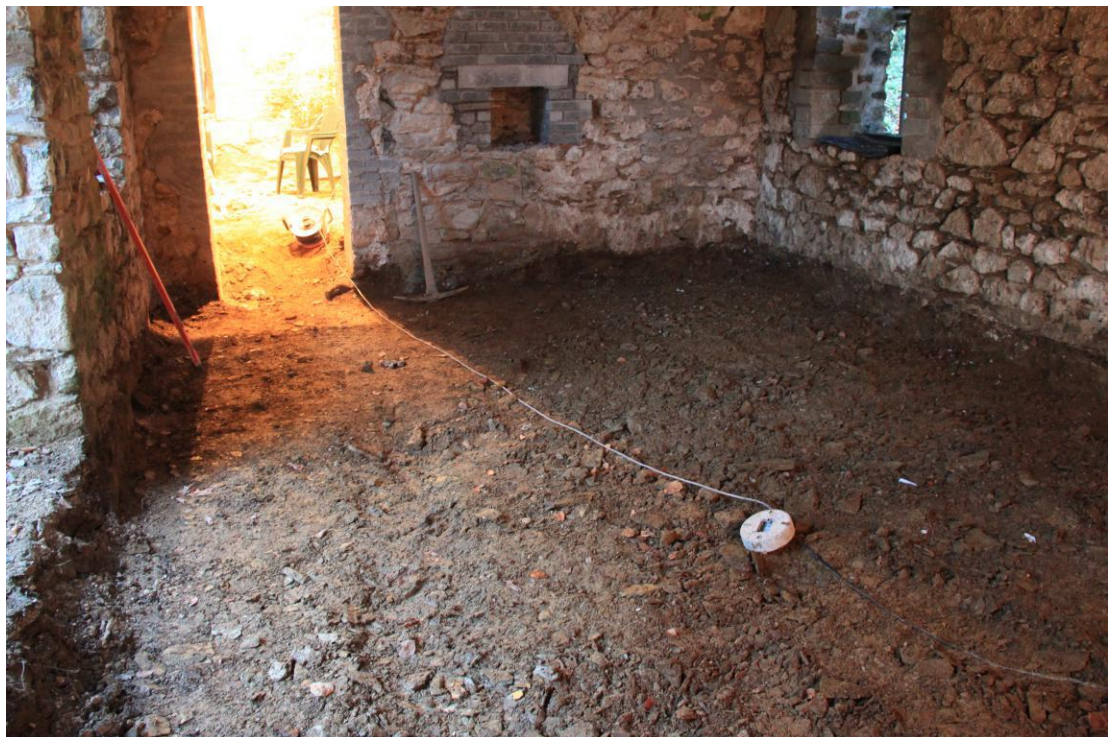
Plate 49 - AD010-D1-002 - Internal excavations for poring of concrete slab, view east.

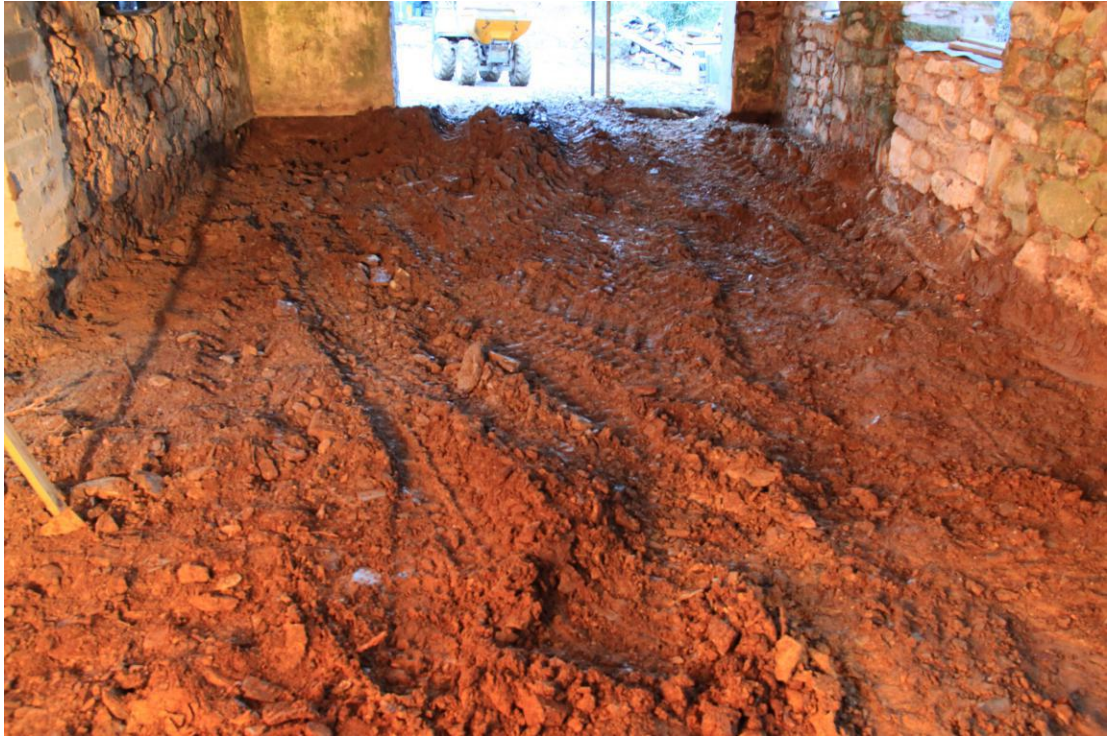
Plate 50 - AD010-D1-003 - Internal excavations for poring of concrete slab, view west.

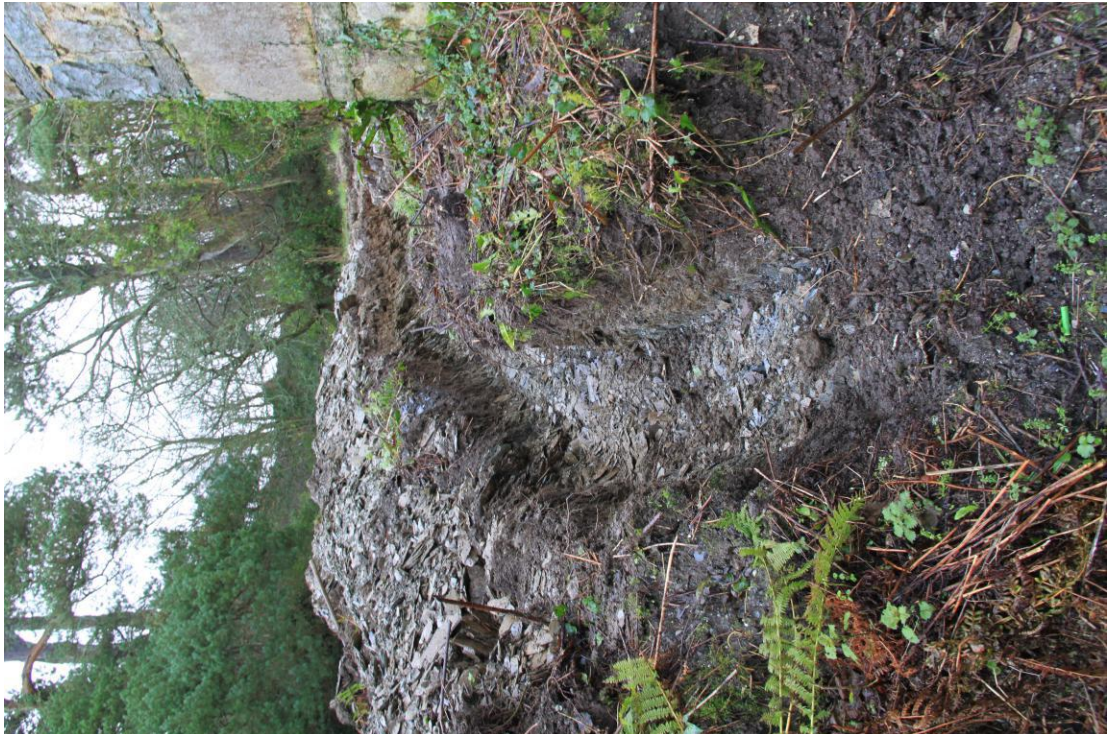
Plate 51 - AD010-D1-004 - Service trench 1 starting at Castle Mill, view south-east.

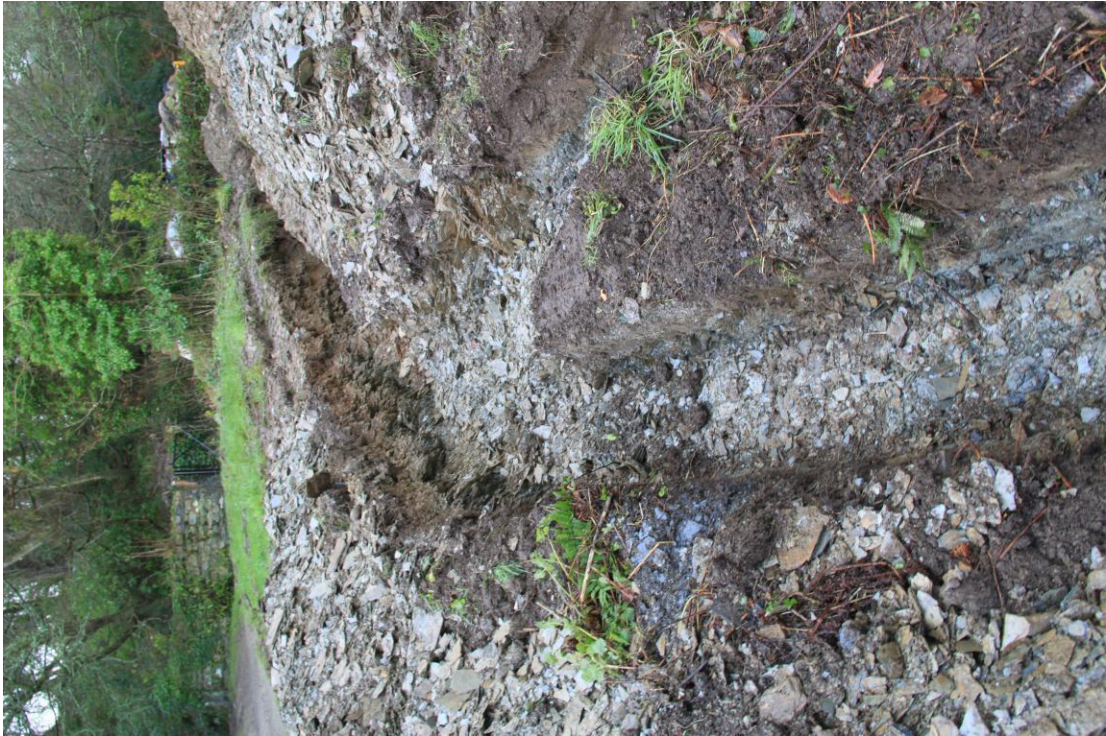
Plate 52 - AD010-D1-005 - Service trench 1 passing Castle Mill.

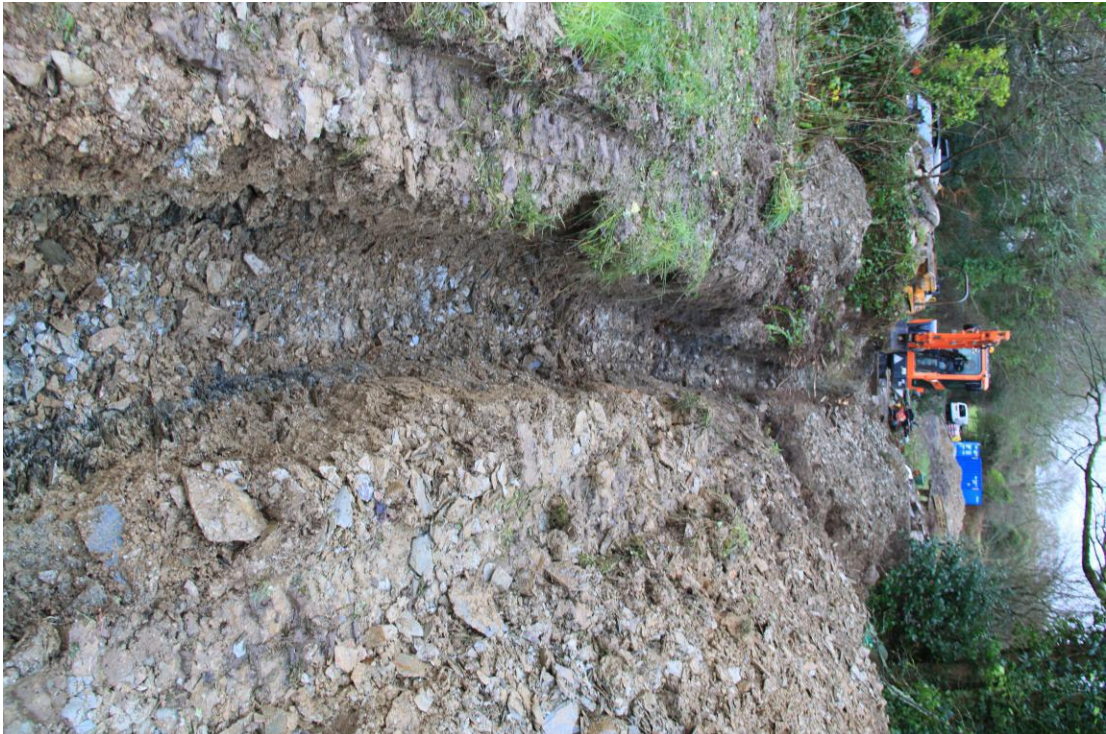
Plate 53 - AD010-D1-006 - Service trench 1 passing Castle Mill.

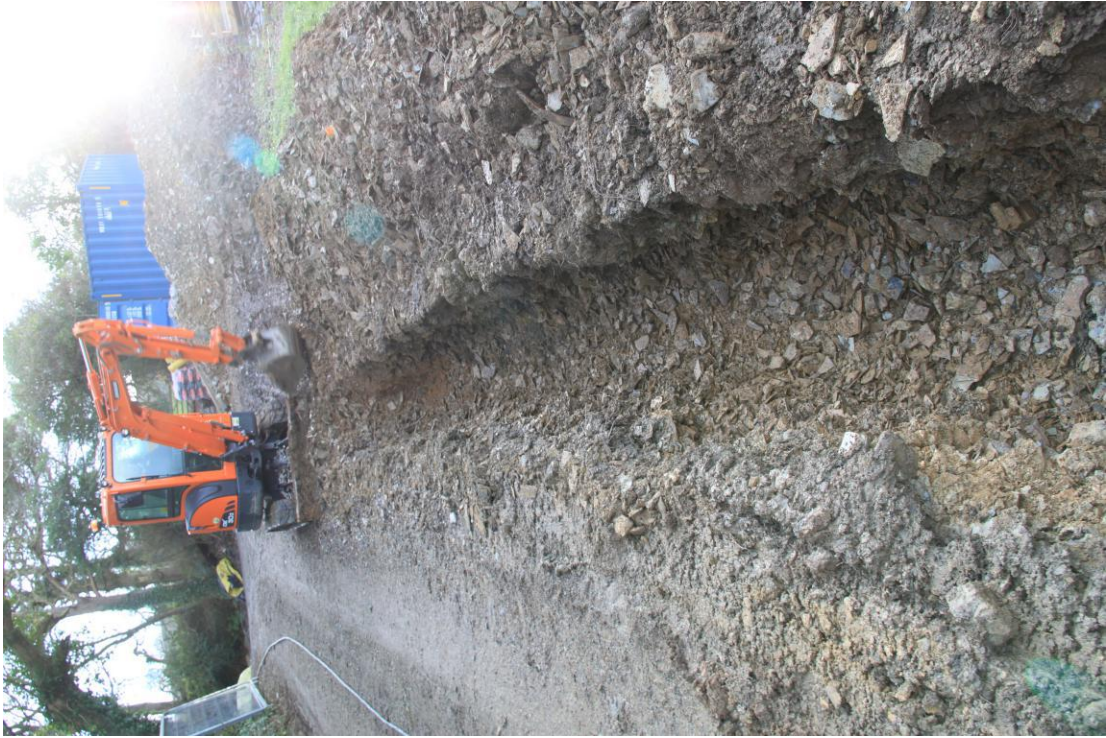
Plate 54 - AD010-D1-007 - Service trench 1 at half way along track.

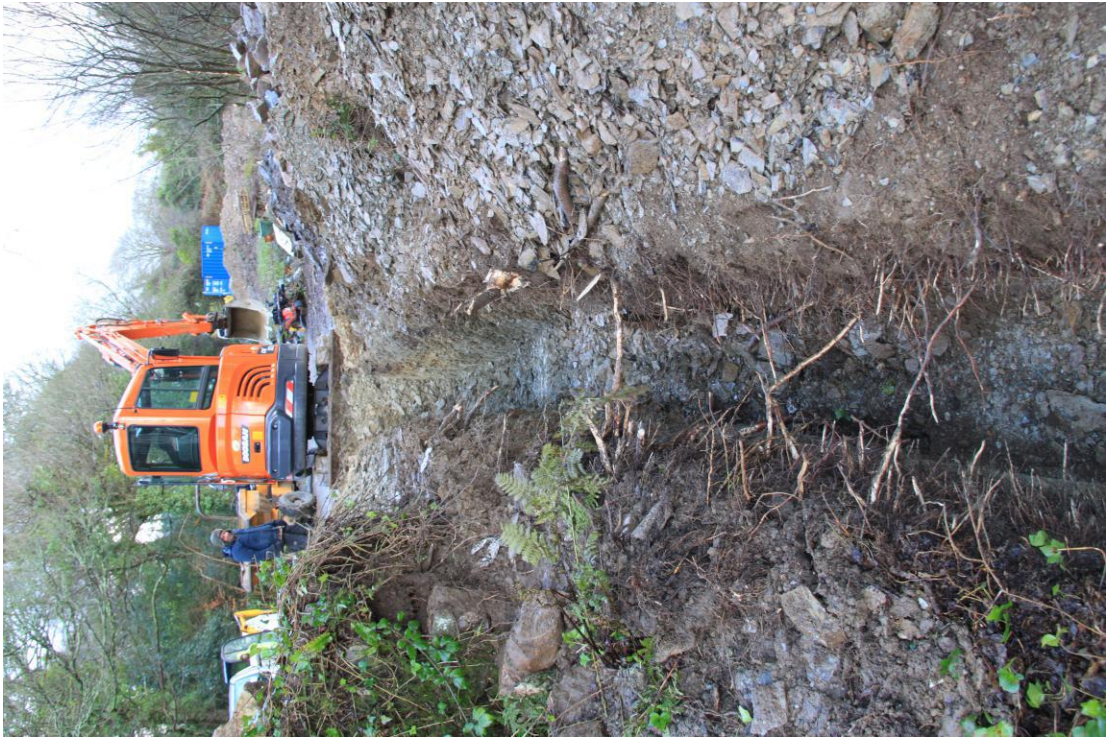
8.2.2 The former leat was originally excavated to a depth at which the parent bedrock was reached, no lining material could be identified; a grey silty deposit was identified. Subsequent disuse caused the tumble of the earth banks into the waterway.

Plate 55 - AD010-D1-008 - Service trench 1 cutting through disused leaf.

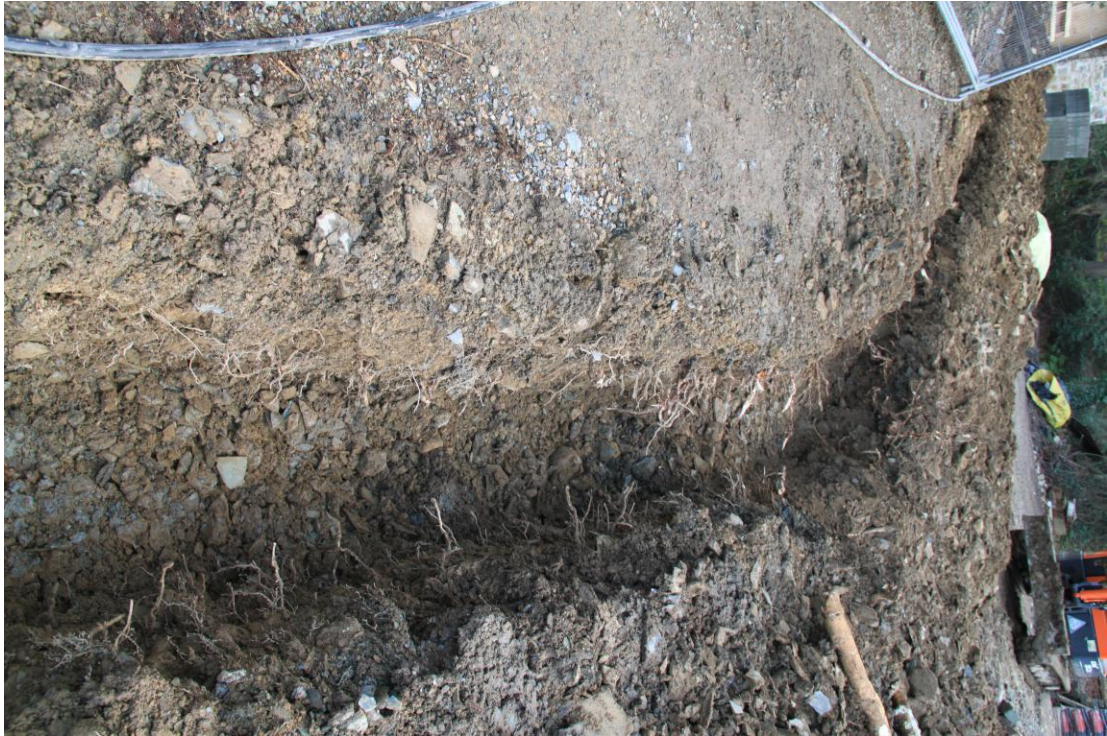
Plate 56 - AD010-D1-009 - Service trench 1 at top of bank and returning back towards the Former Coach House.

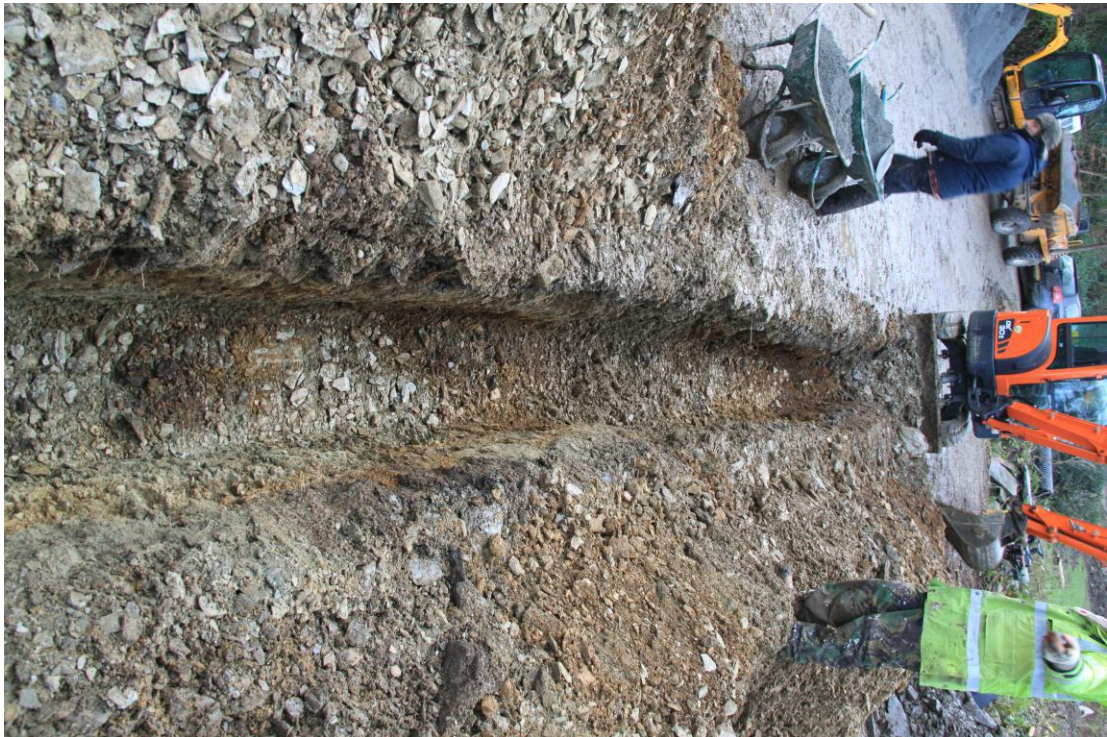
Plate 57 - AD010-D1-010 - Service trench 1 at west end of Former Coach House.

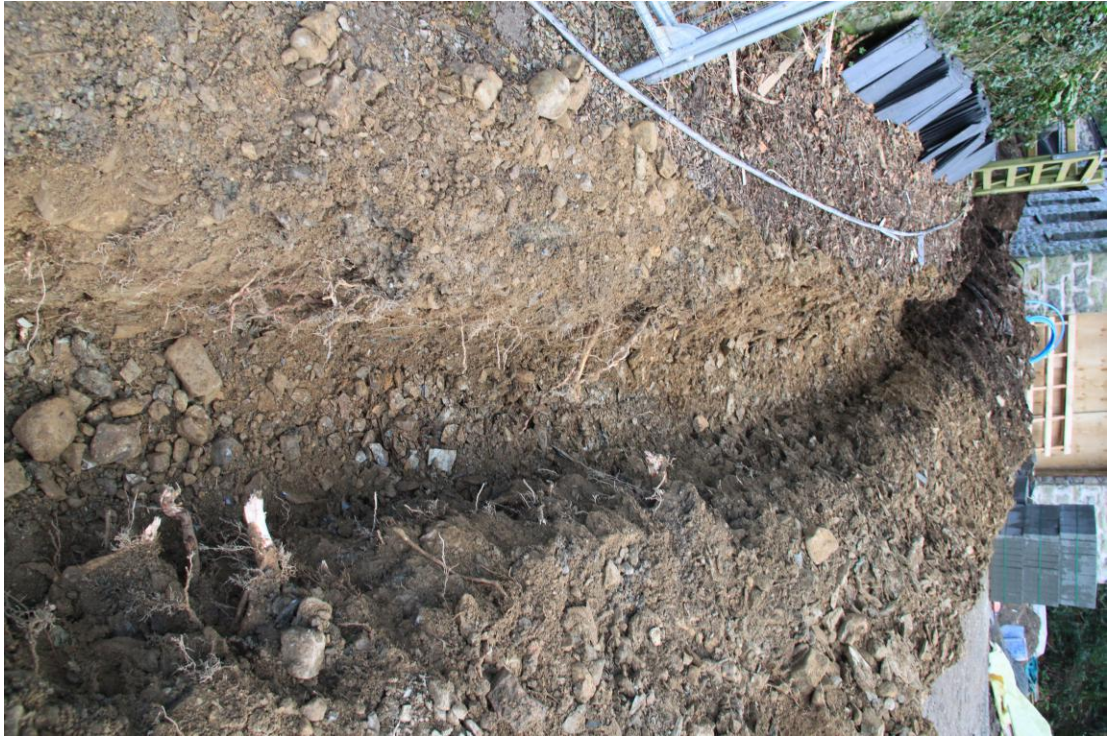
Plate 58 - AD010-D2-011 - Service trench 1 at west end of Former Coach House

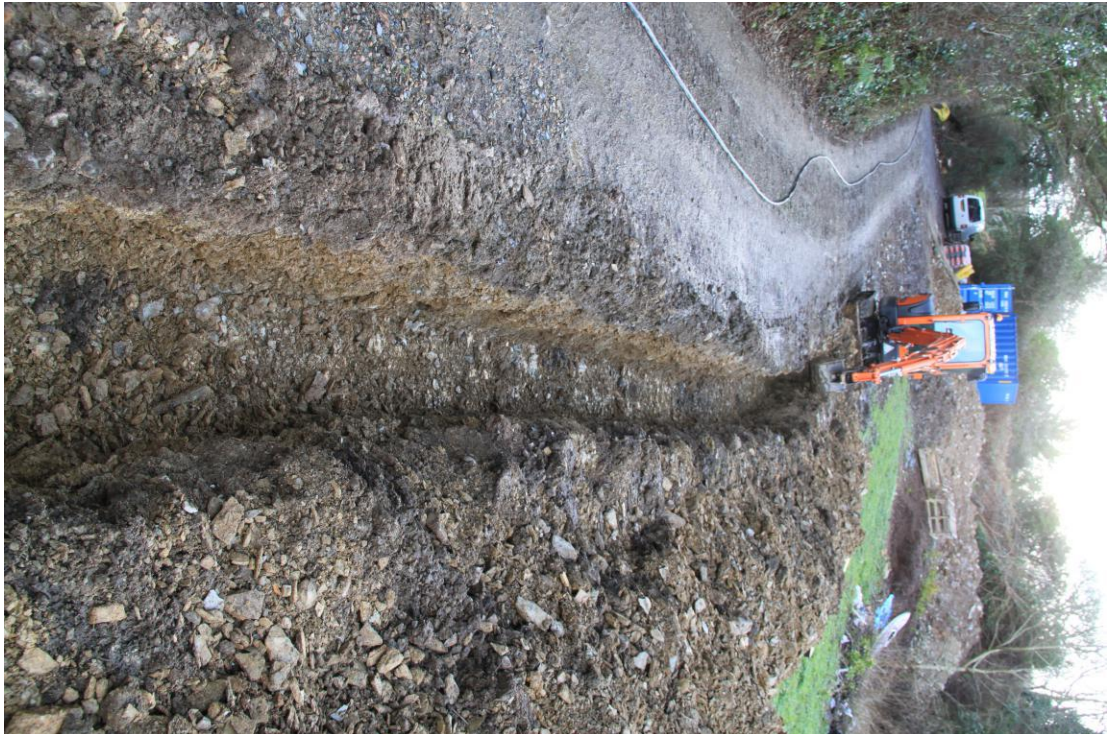
Plate 59 - AD010-D2-012 - Service trench 1 extending along track.

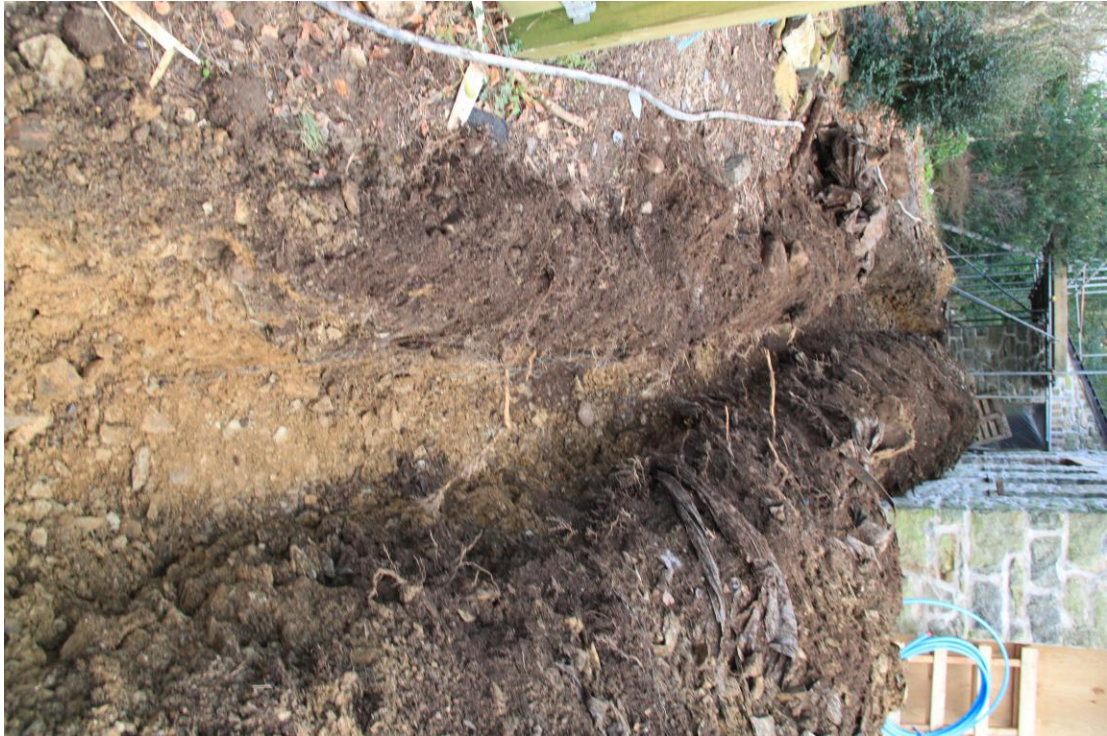
Plate 60 - AD010-D2-013 - Service trench 1 returning along front of Former Coach House.

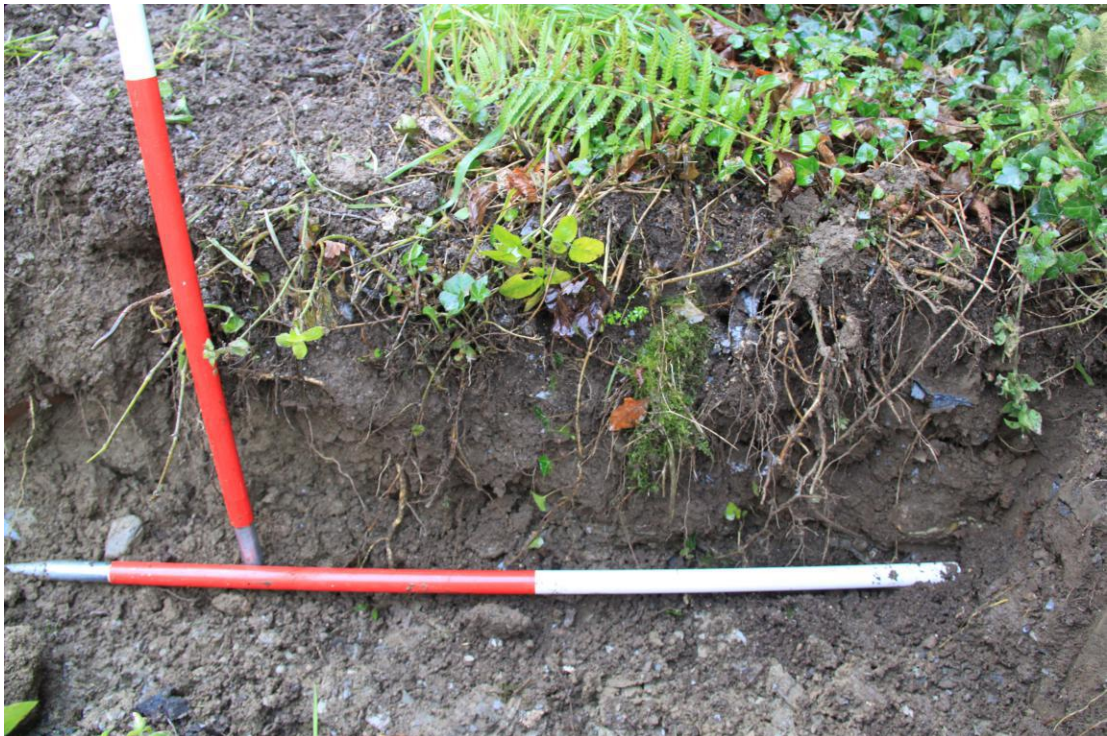
Plate 61 - AD010-D2-014 - Section of service trench 1 next to Castle Mill.

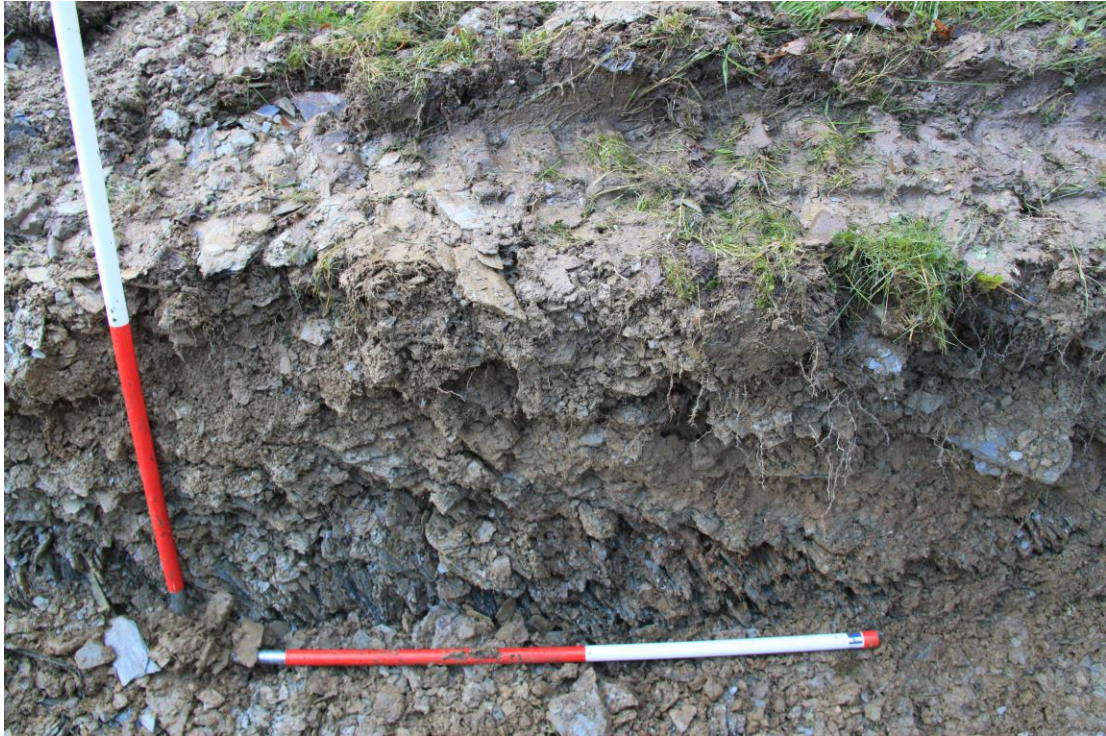
Plate 62 - AD010-D2-15 - Section of service trench 1 above Castle Mill.

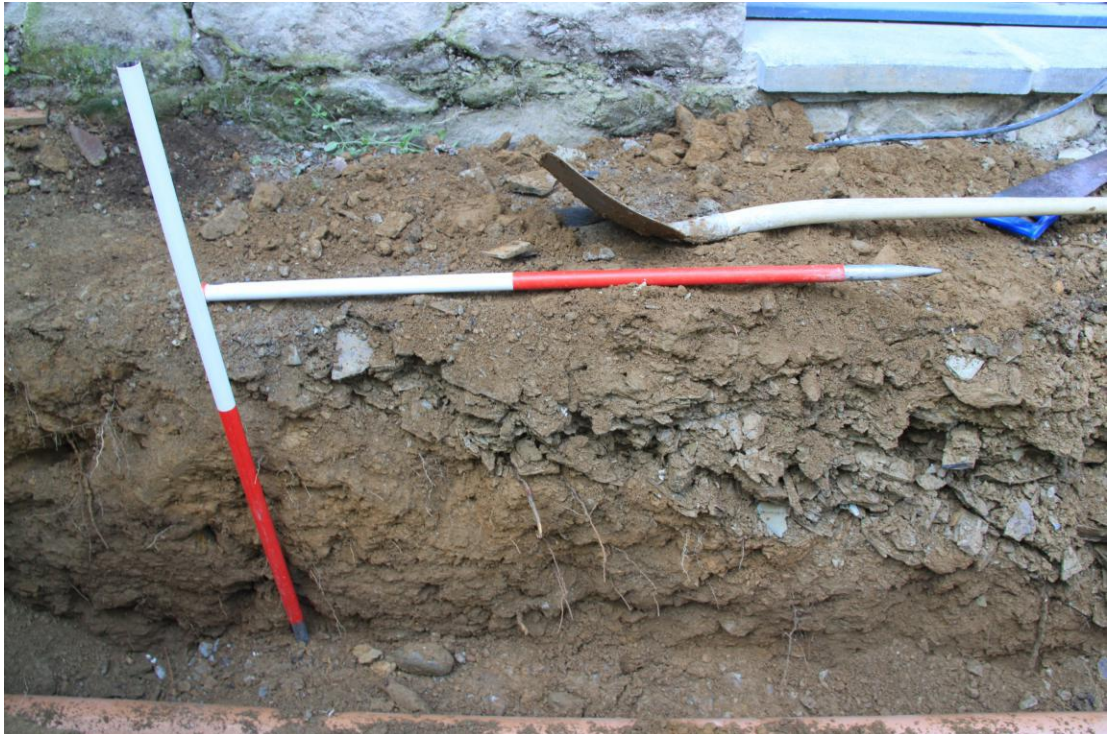
Plate 65 - AD010-D3-018 - Service trench 2 in front of the Former Coach House showing layers of levelling - shale over clayey-loam.

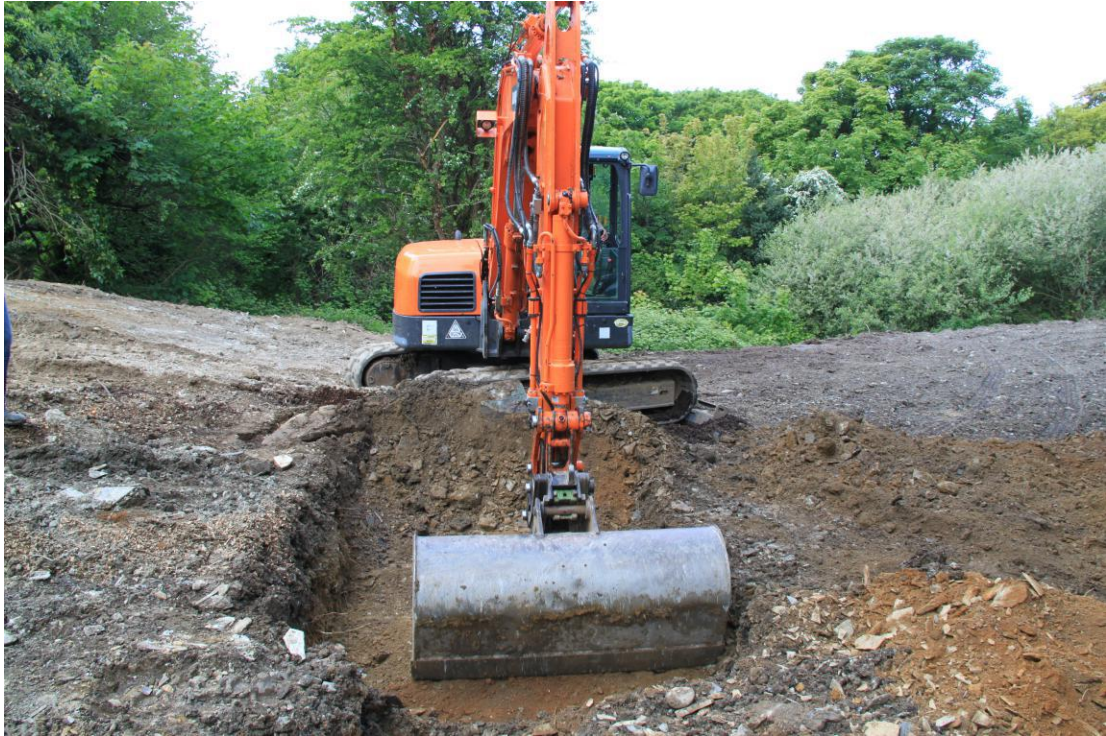
Plate 66 - AD010-D3-019 - Excavation of septic tank pit.

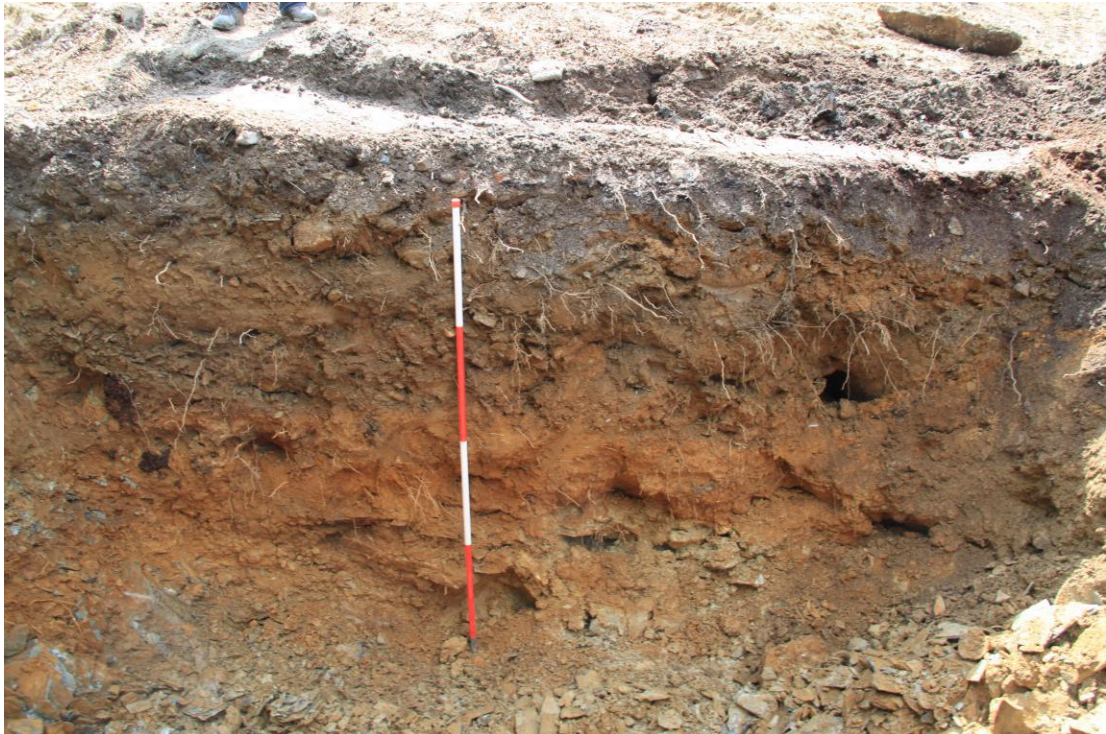
Plate 67 - AD010-D3-020 - North section of septic tank pit.

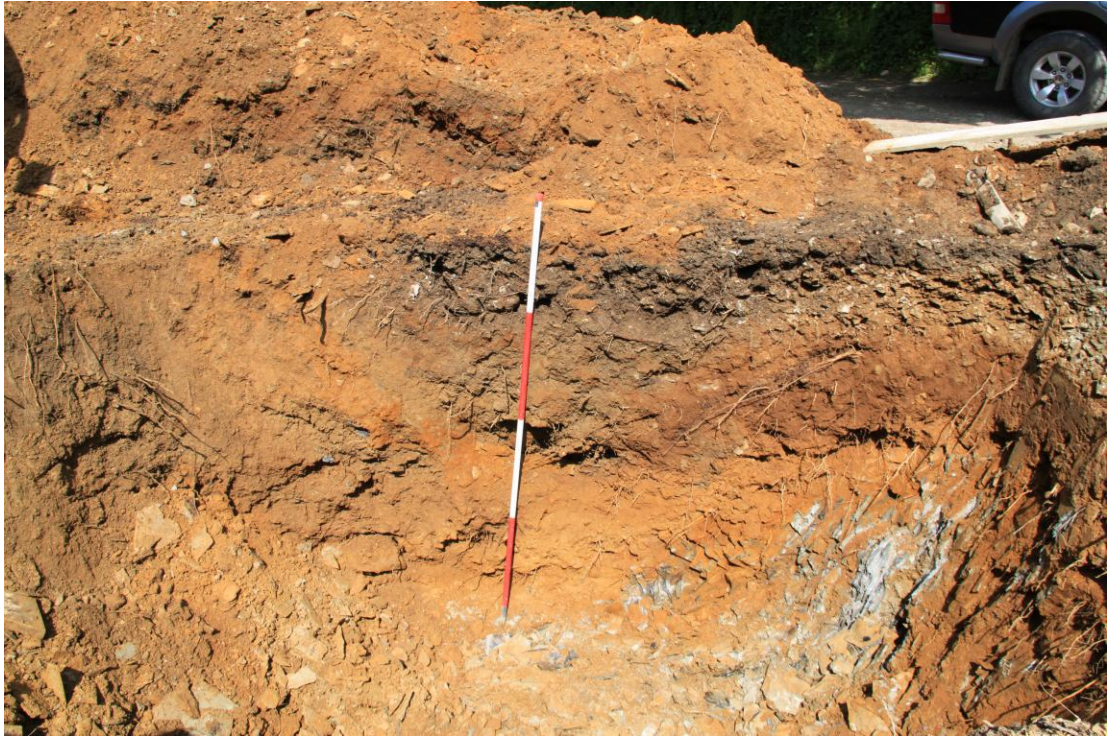
Plate 68 - AD010-D3-021 - South section of septic tank pit.

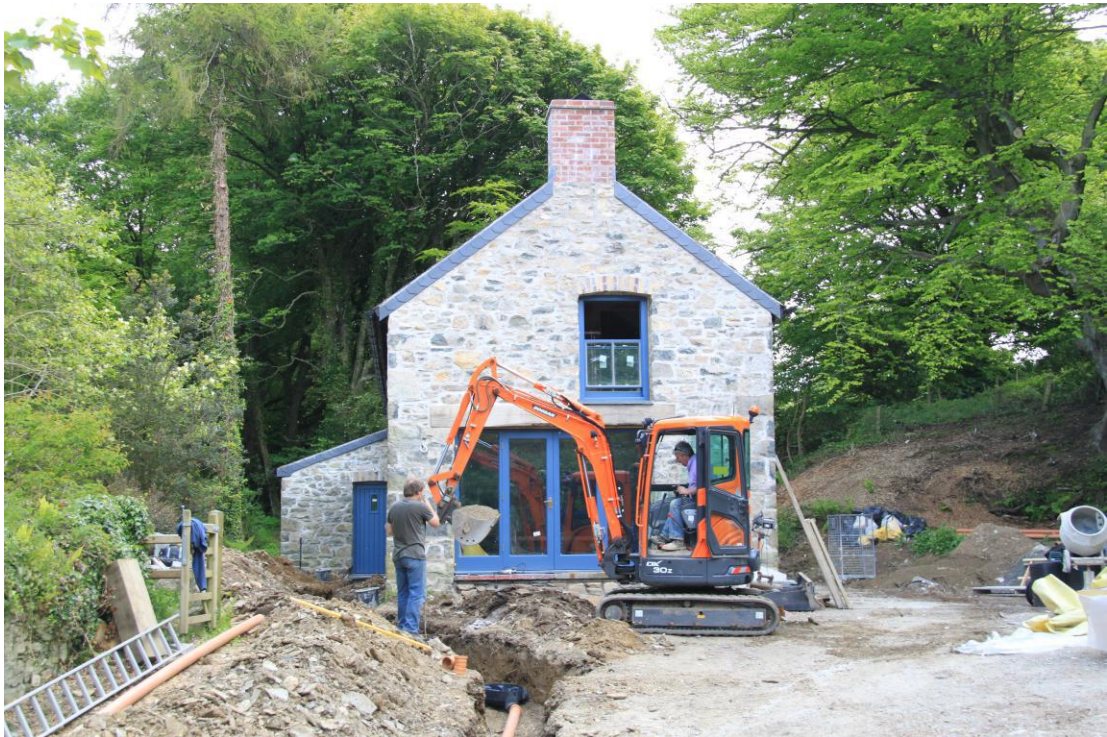
Plate 69 - AD010-D3-022 - View towards Former Coach House showing location of service trench 2.
