Airbus Building 058, Broughton

Level 3 Building Survey

Report No . 1975

May 2021

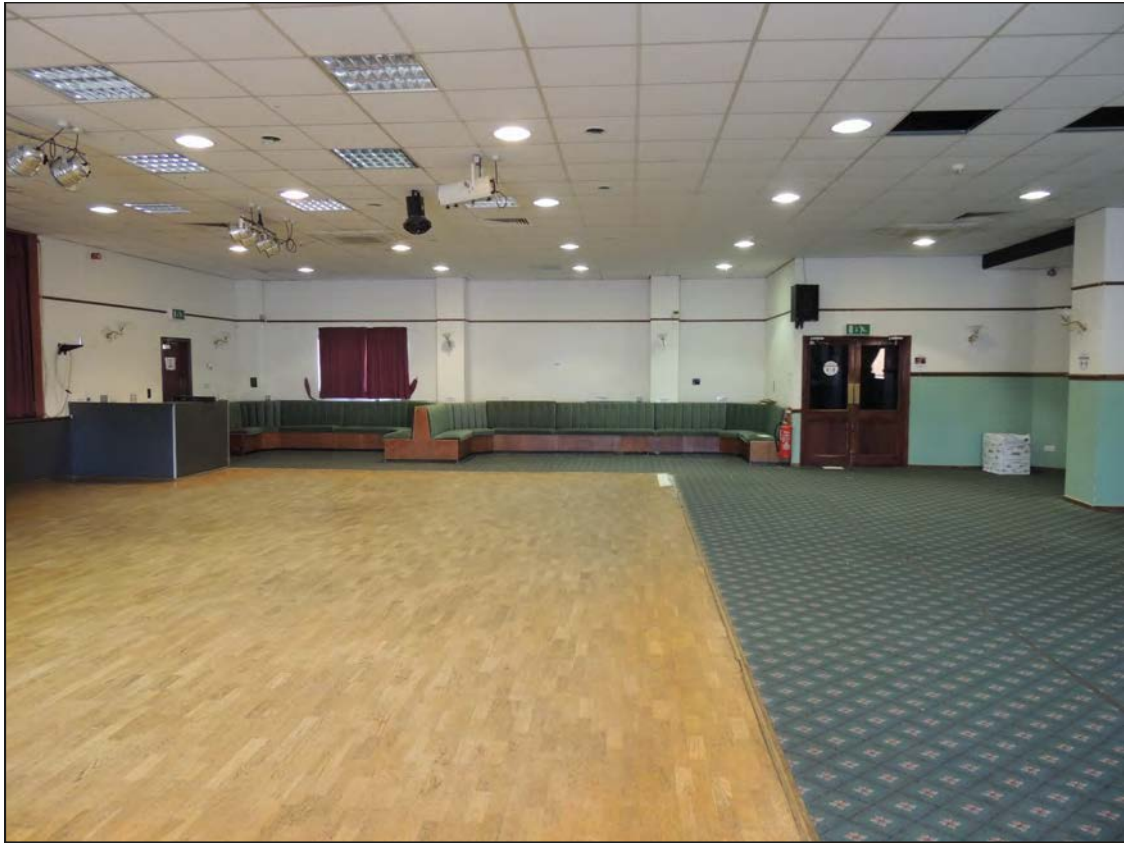
5.51. Plate 22 documents the NNE elevation. Two sets of booth seating are located here as well as a timber double door acting as a fire exit, holding to large glass panels. The image also documents the areas where the structural columns – also visible from the outside – are located, as well as a dado and picture rail running across the elevation.

Plate 22. View of the function room facing NNE

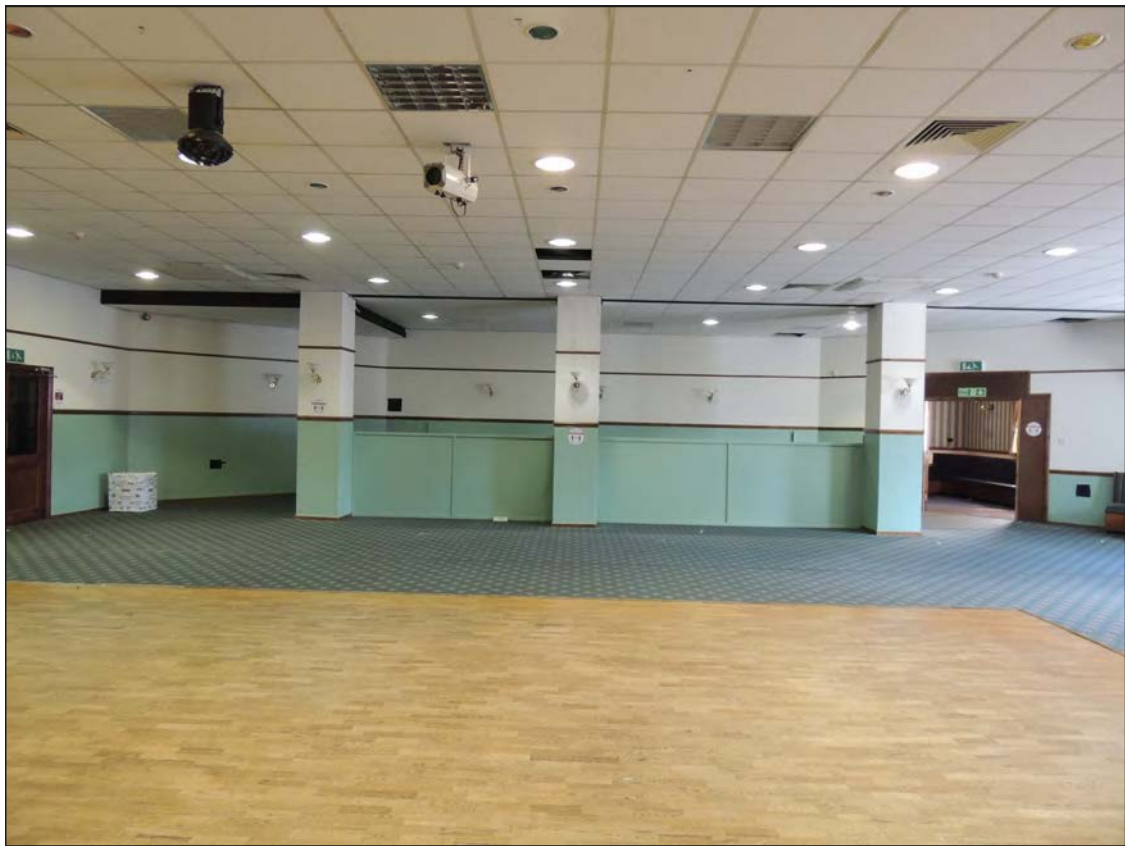
5.52. Plate 23 documents the SE end of the room. This image documents how three structural columns have been used to delimit an area behind and in front of them with wooden panels painted green which can be removed. A large timber double door leading to the bar, and acting as an emergency exit, is also documented on this photograph.

Plate 23. View towards the back of the function room looking SEE

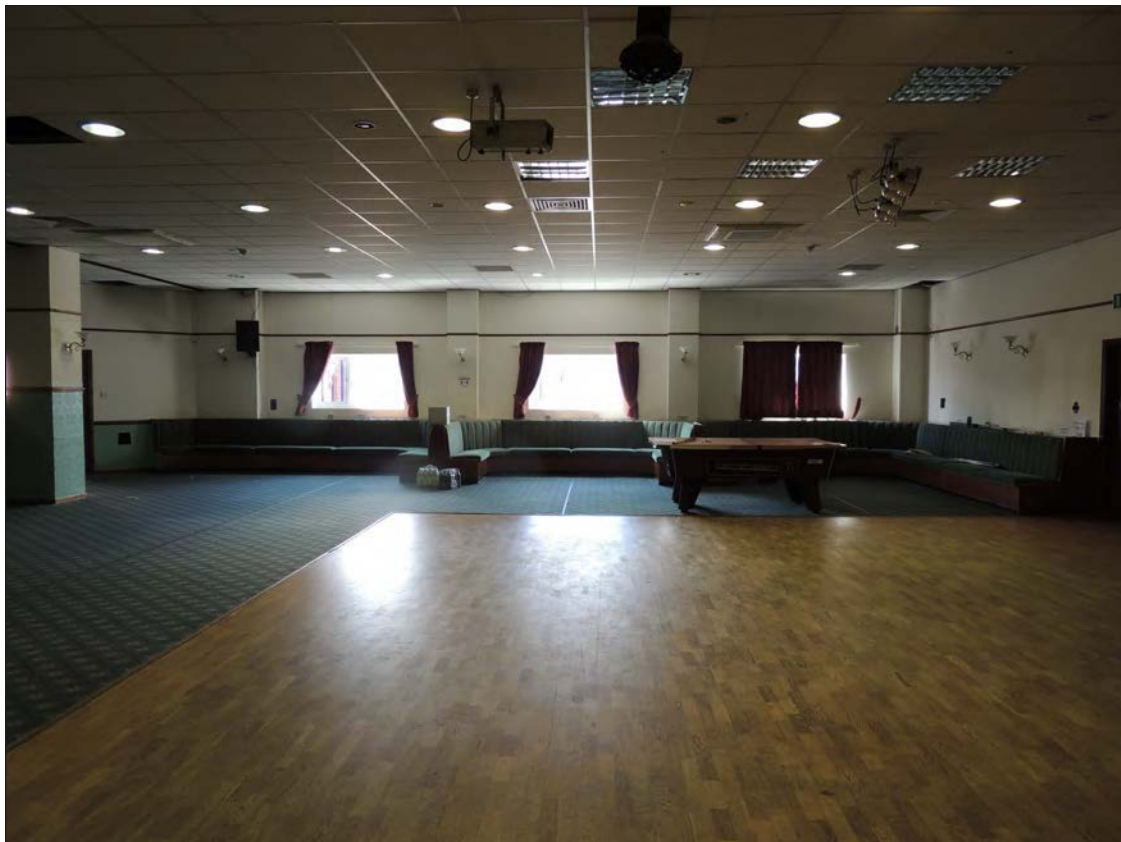
5.53. Plate 24 overlooks the SSW region of the room. Again, booth seating abuts the elevation. Three rectangular windows are located here with red velvet curtains identical to those hanging off the stage. A pool table is located in front of the seating area.

Plate 24. View towards the pool table and seating area in the function room looking SSW

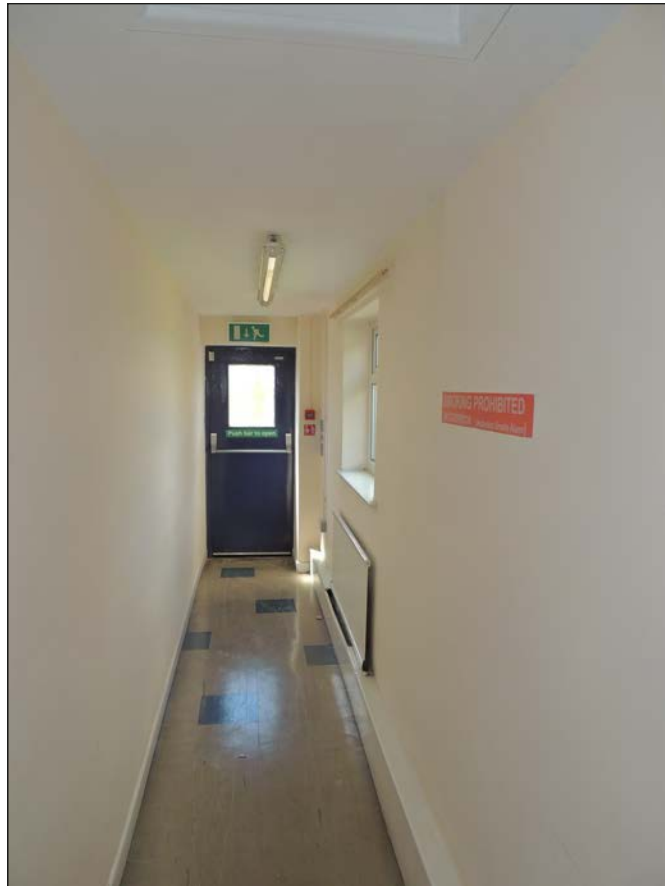
5.55. Plate 29 documents the thin corridor leading to a fire exit located adjacent to Room 3. The floor in this area is overlaid with vinyl and a UPVC window is located on the SE facing elevation.

Plate 29. View of the corridor leading to an emergency exit behind the stage looking SSW

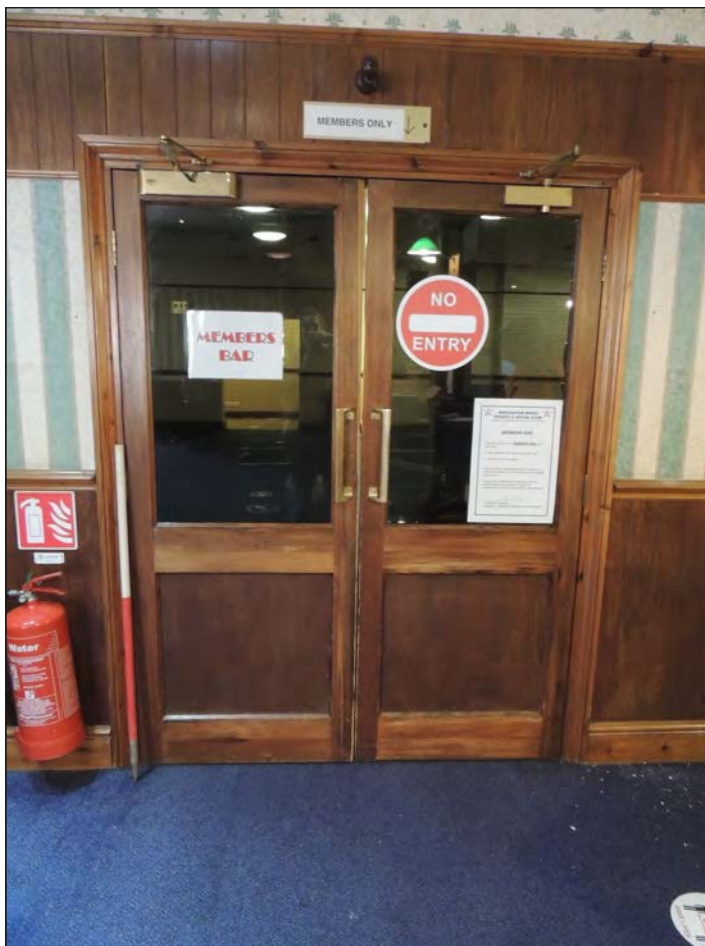
5.62. Plate 36 documents the double door that leads to the pool room. Each door is half glass half panel with a timber surround inserted into a wall currently covered

Plate 36. Wooden door and decorative wall panelling in the bar area looking NNE

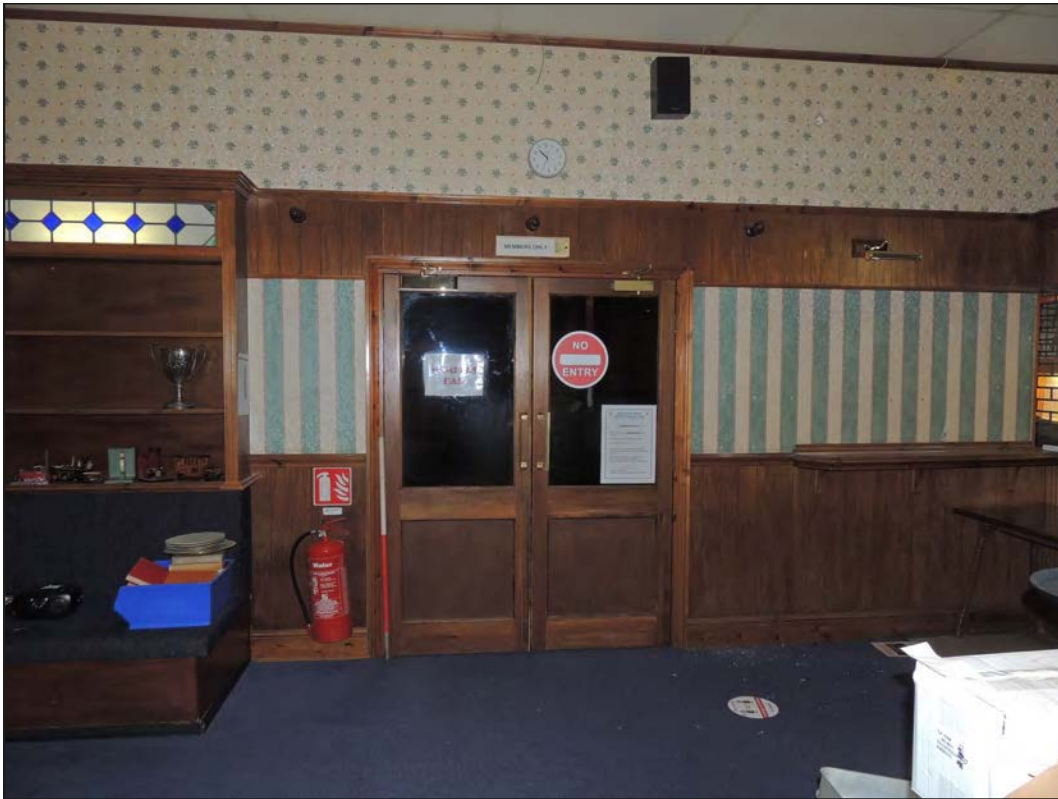
5.63. Plate 37 evidences four curtain pole wall mounts. To the NW of the wall, a small bar table projects from the wall and to the SE a booth seating adjoined to a timber shelving unit is located. The latter has a band of stained glass with geometric patterns.

Plate 37. View of NE facing wall in the bar area looking SW

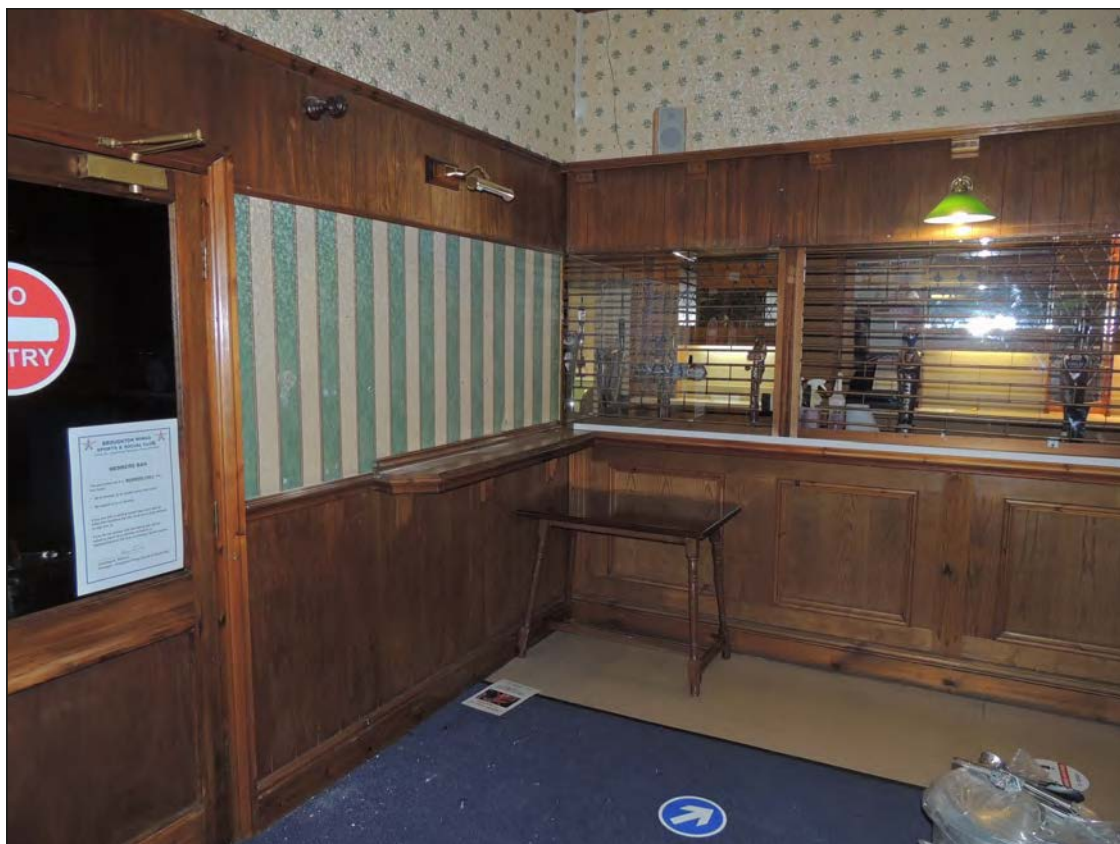
5.64. Plate 38 looks toward the bar area. The latter is defined by timber cladding with square decorative panels below and decorative brackets supporting the decorative cornice above. Plate 39 and 40 also offer views towards the bar area.

Plate 38. View of the corner of the bar area and counter top looking E

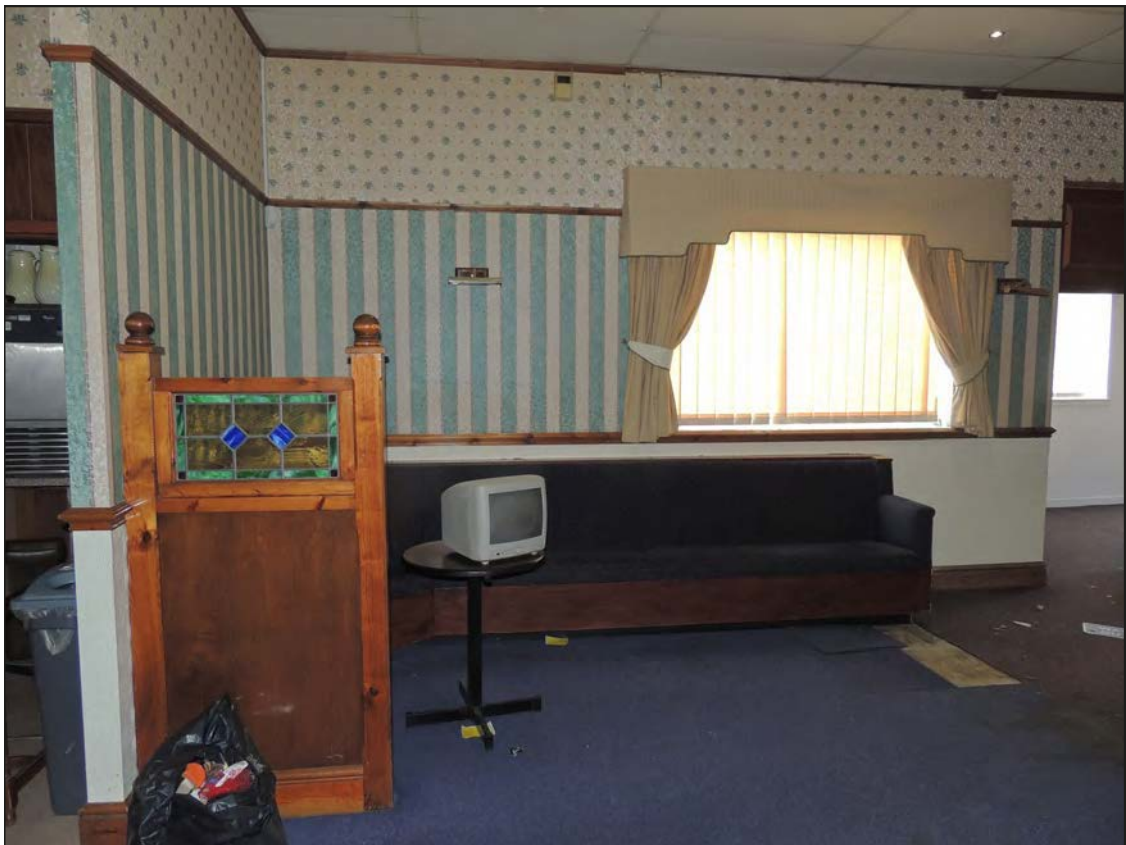
5.65. Plate 41 documents the SW facing elevation. Booth seating is located here with a dividing timber panel decorated with stained glass forming geometric patterns. A large rectangular window is located here cutting through the space created between the dado and painting railing.

Plate 41. View of seating area within the bar area looking SW

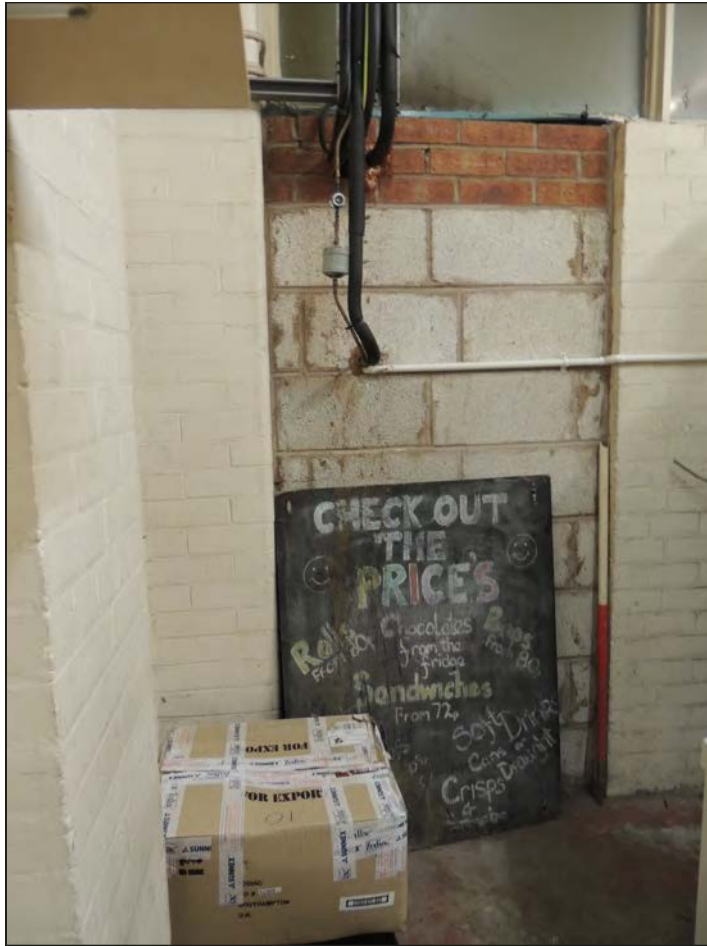
- 5.72. Plate 50 evidences a number of episodes of alteration and repair. According to the 1939 plans and elevation, this area was open and therefore, the brick (currently painted white) masonry corresponds to the moment in which the elevation was blocked off. Initially the elevation would have included a door as suggested by the image. However, the latter was blocked off with cinder blocks.

Plate 50. View of the outer wall of the upper level of the beer store looking SW

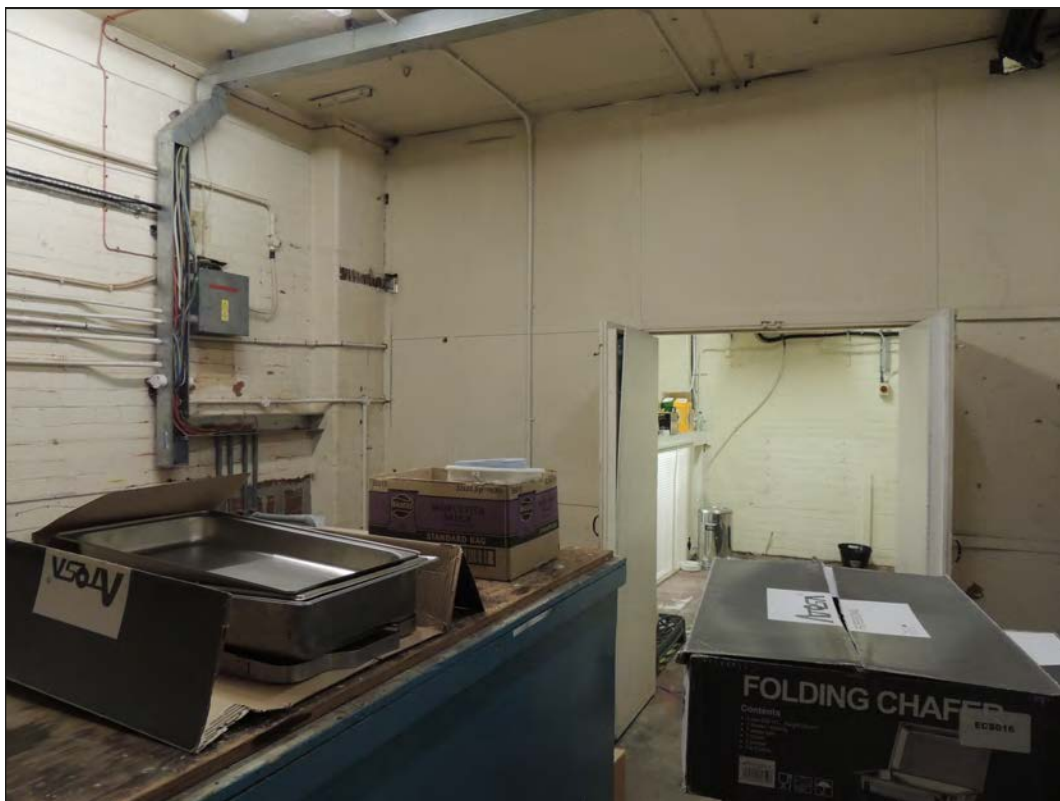
- 5.73. Plate 51 documents the storage function of the space as well as the brick walls and the division wall with a large double door overlooking the bottle store.

Plate 51. View of upper levels of the beer store leading into the bottle store through double doors, looking N

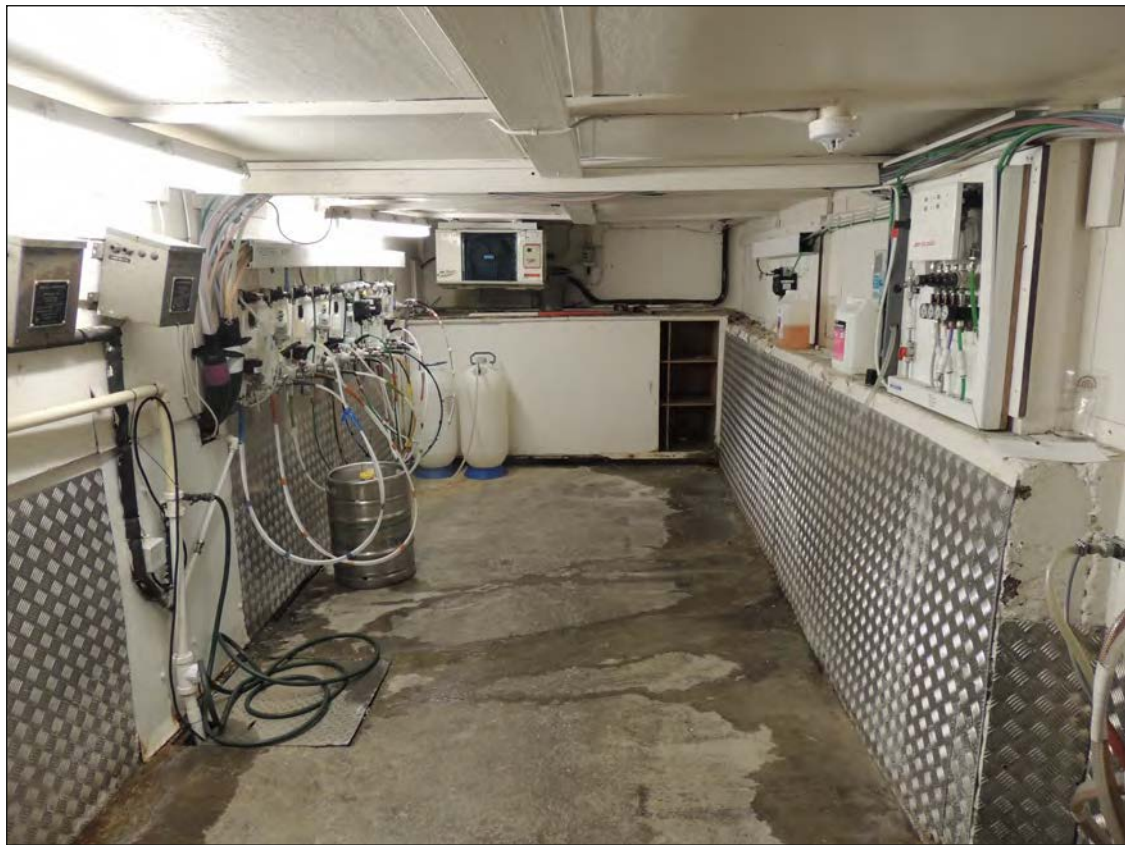
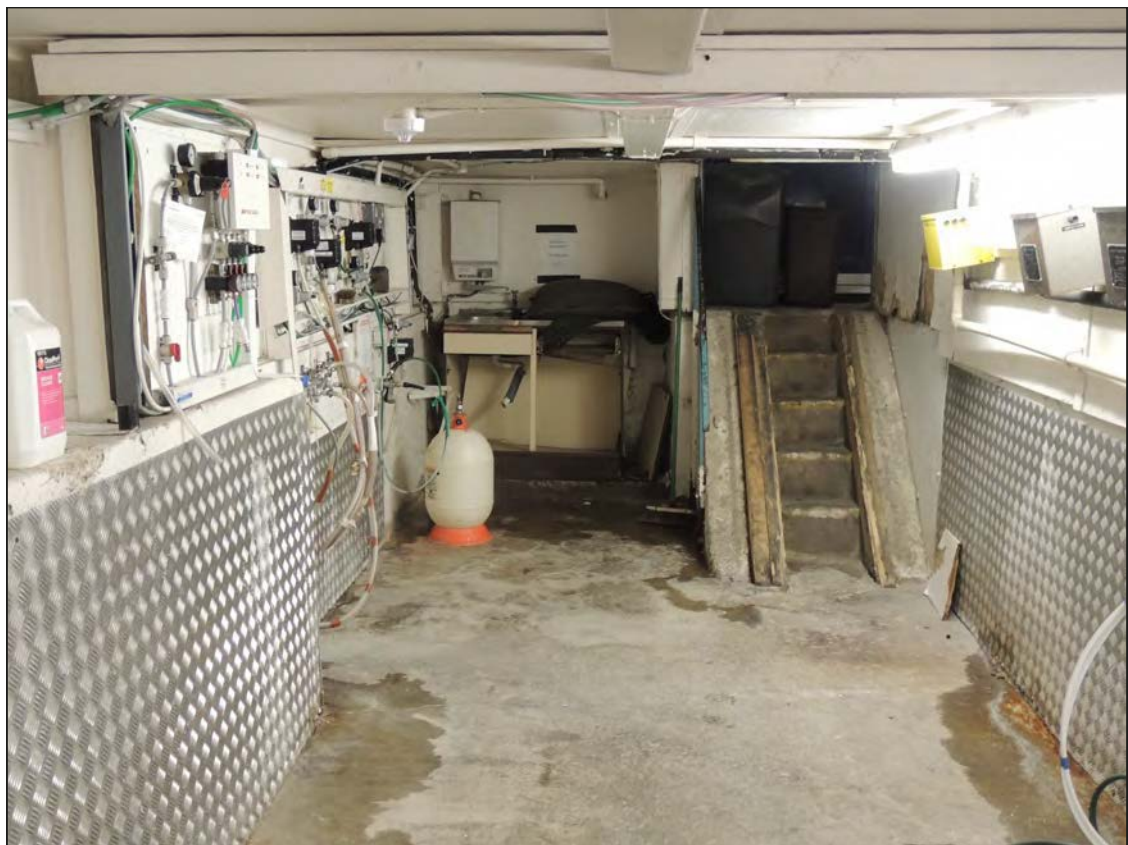
- 5.74. Plate 52 and 53 record the cellar. The latter may have taken the space of the former pit. The floor is made of concrete. A narrow stone staircase with outer string made of solid wooden beams leads to the cellar.

Plate 52. View of cellar beneath the bar looking NNE

Plate 53. View of the cellar beneath the bar looking SSW

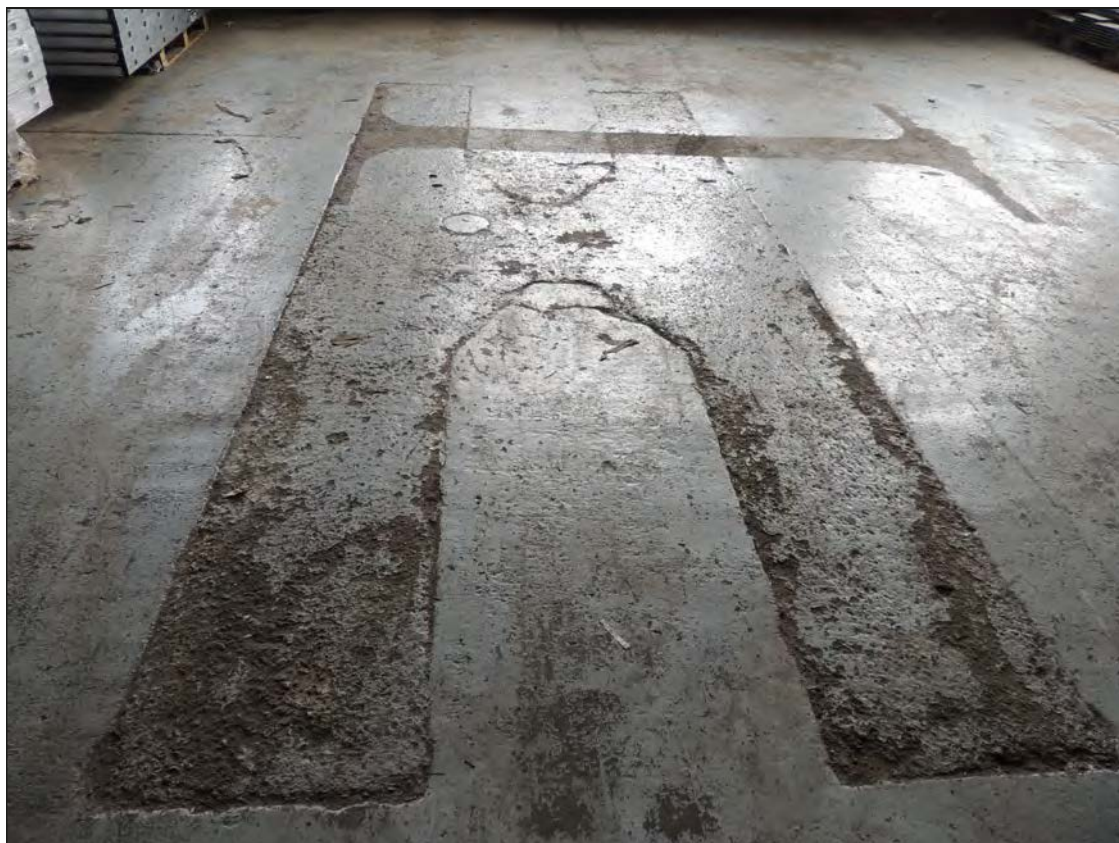
- 5.103. Plates 95, 96, 135 and 102 offer views toward the NW facing elevation and its surroundings. The images highlight the storage function that this area has at present. However, the 1948 plans for this area (Figure 9) document the presence of a wash area, two pits and a car lift. Current plans highlight the presence of two vehicle lifts. The imprint of the latter can still be observed (see Plate 96).

Plate 96. View of the floor ramp used to service vehicles, looking SE

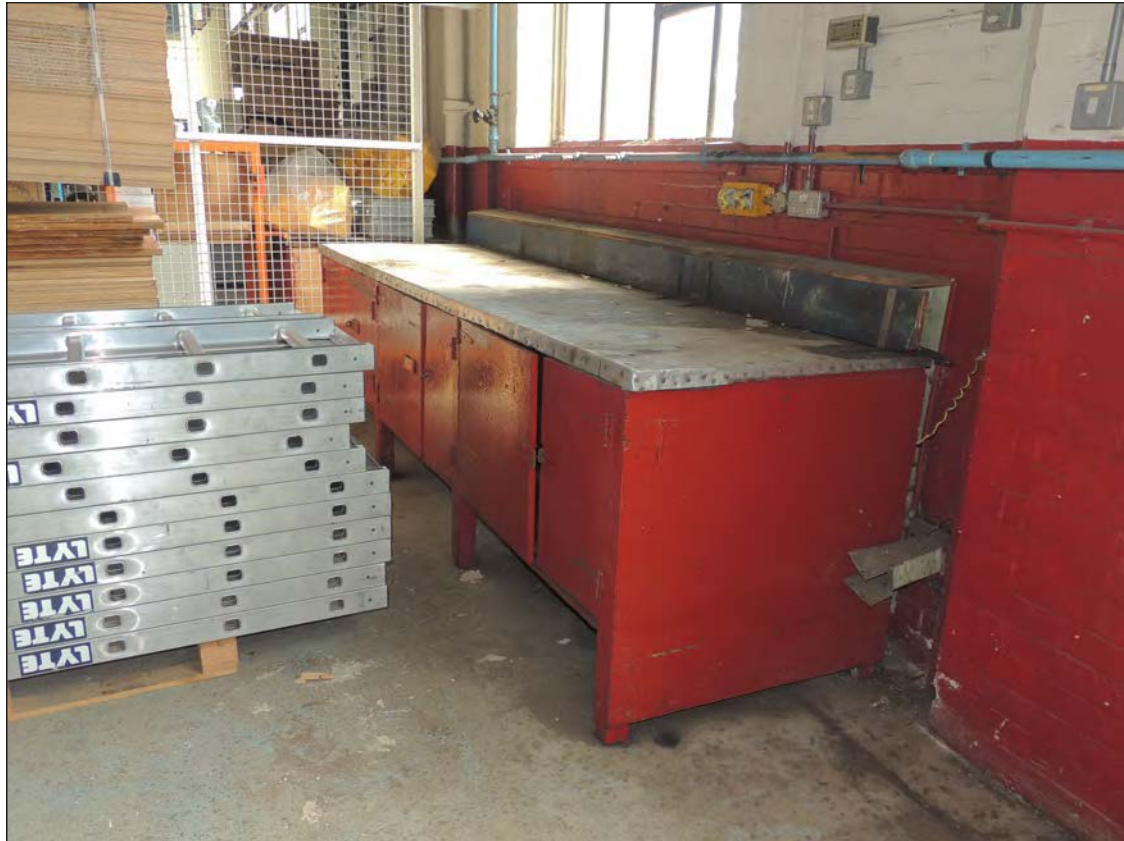
- 5.106. Plates 93 and 94 document the central area of the garage. The latter is sufficiently wide to allow motorised vehicles to enter the space. An infilled pit is located at the NE end of this space. Furthermore, plate 98 documents a workstation which may have been contemporary with the construction of this space.

Plate 98. View of a workstation that may be original to the building, looking NEE

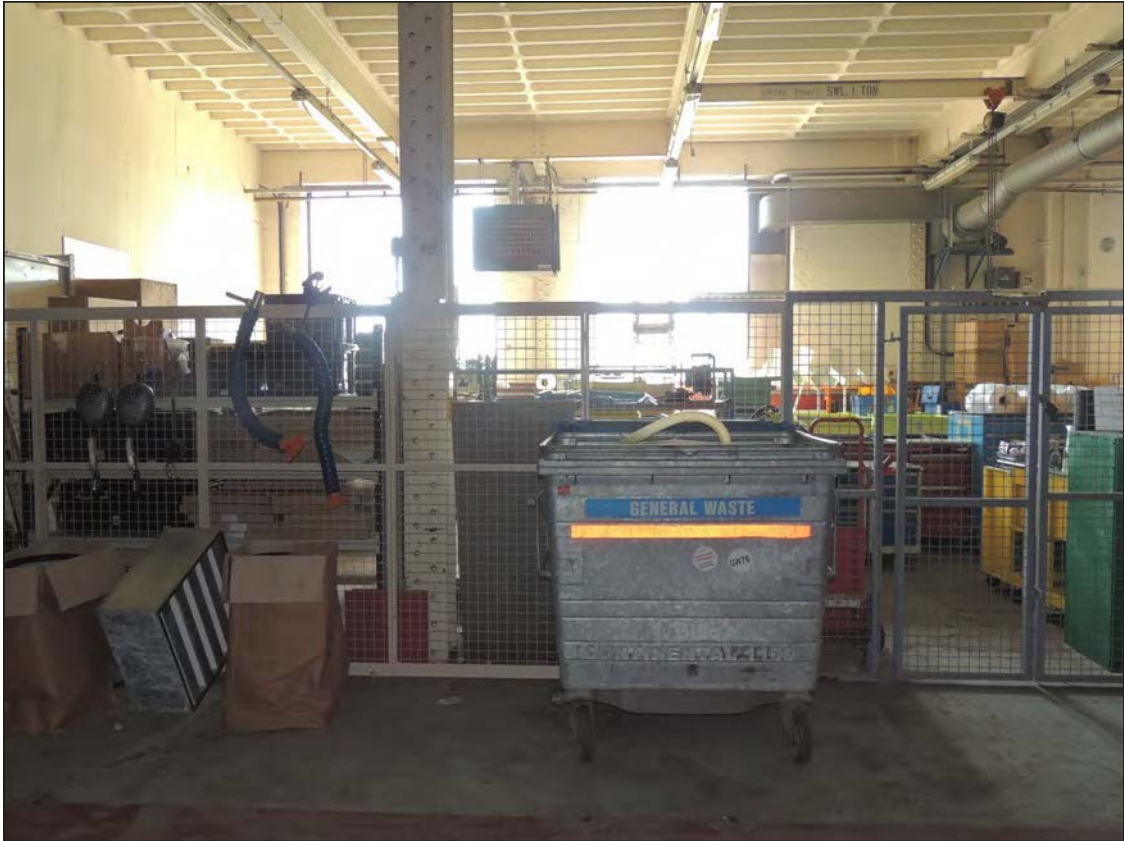
Plate 102. View of the garage looking SE

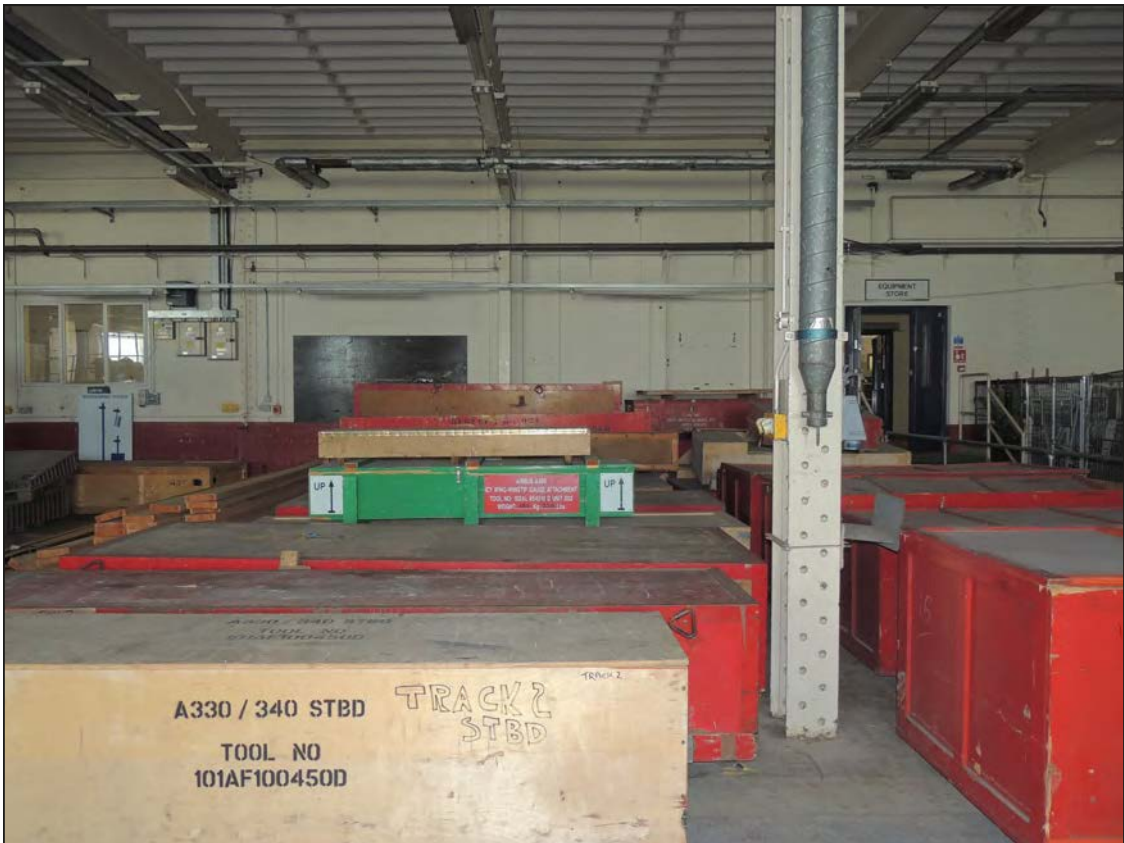
- 5.105. Plate 103 documents the SE facing elevation. This elevation has a series of openings leading to Room 25. The northernmost door exceeds 2m in width and is defined by a double door with two glass panels. A rectangular three-light window is also documented on this photograph, also providing views to Room 25.

Plate 103. View of the garage looking NW

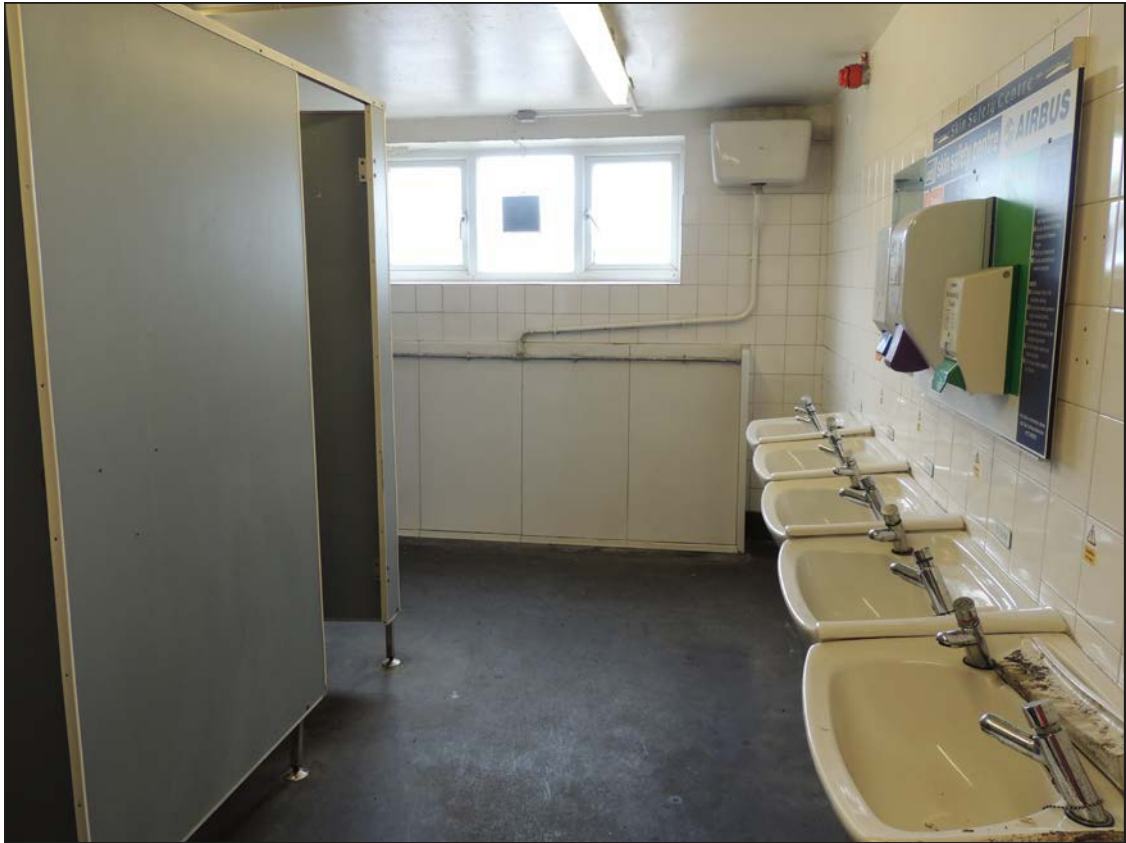
- 5.107. This space is around 47m² and it is divided into four main areas: the mechanics toilet, the staff toilet, the office and the visitor toilet. The 1948 plans for this space note that the area would have been used as female drivers' restroom, and male drivers restroom.
- 5.108. All this space and its subdivisions are defined by brick walls with Flemish bond. A metal staircase leads to the entrance characterised as a 1m in width single door made of timber painted blue holding six glass panels. A four light window is located immediately south of the entrance.
- 5.109. Plate 109 documents the character of the interior and demonstrates the use of concrete floors for this space. The toilet block (Plate 110) has been modernised, and it is located at the former's mechanic toilet.

Plate 110. View of the mechanics toilets in the garage looking SW.

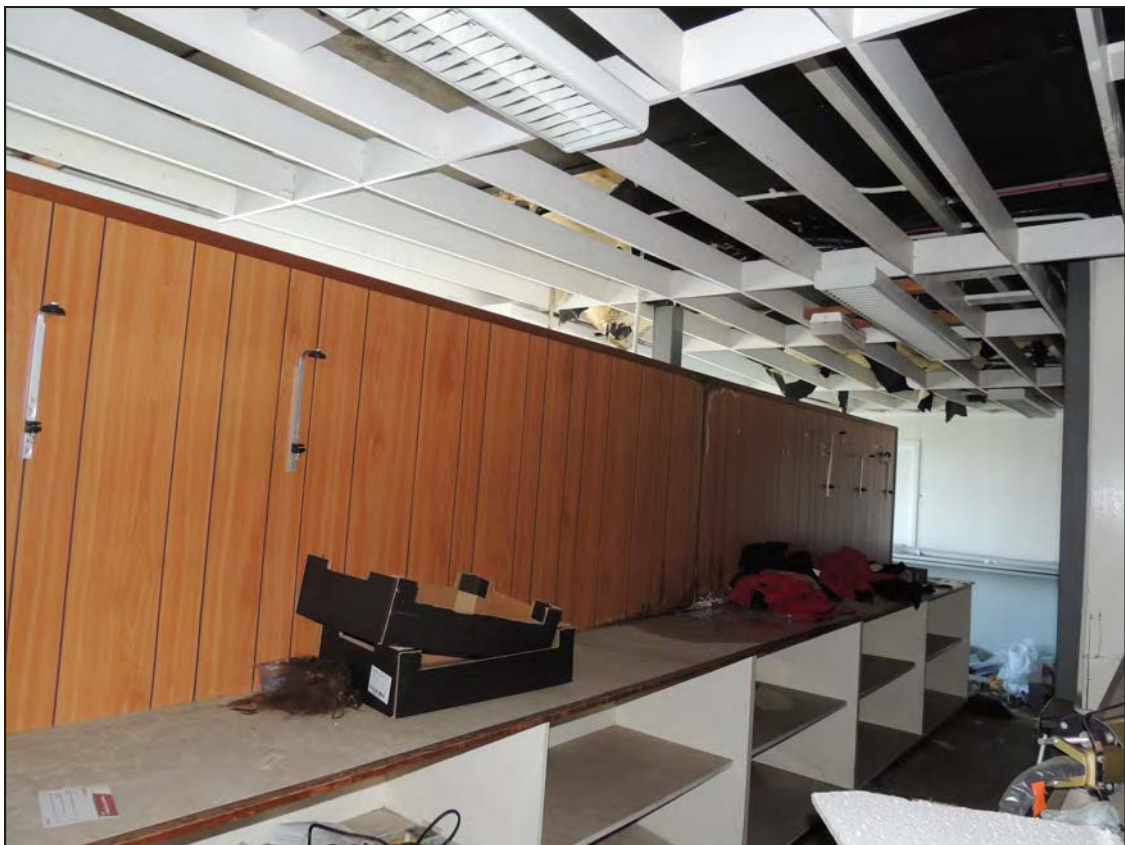
Room 30 (Plate 120)

Plate 120. View of bar to the SE end of the sports hall, looking NE

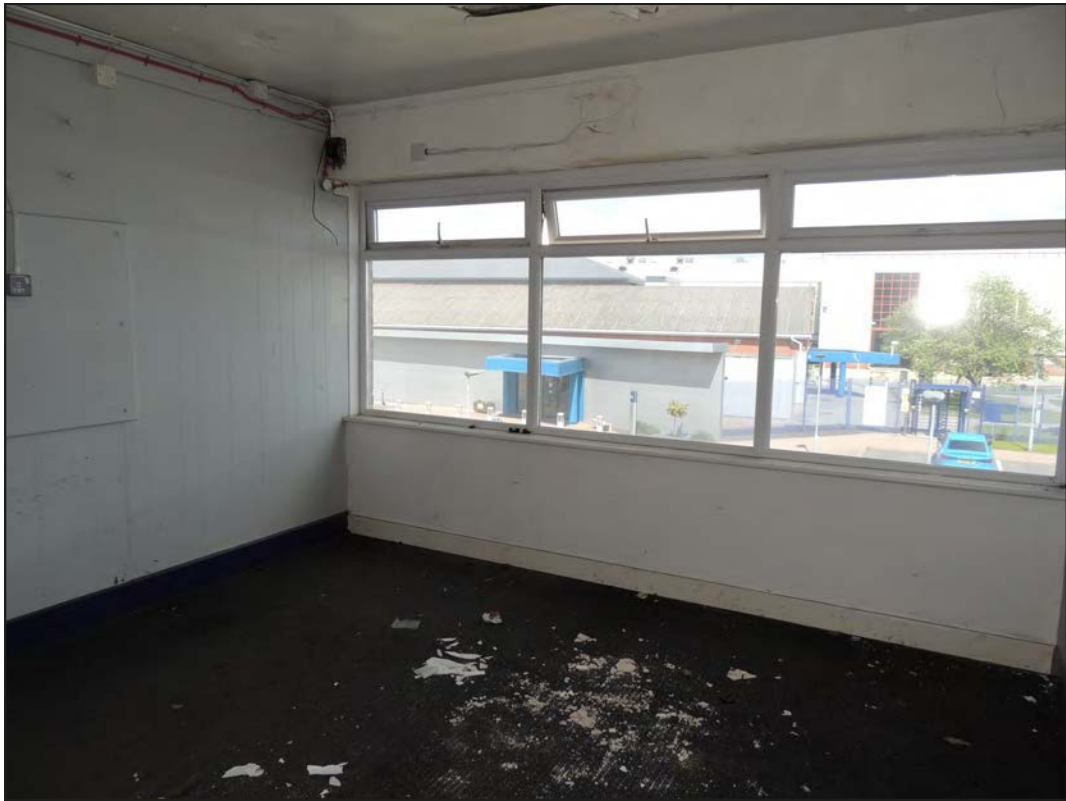
Room 31 (Plate 121)

Plate 121. View of a upper bar storeroom looking NE

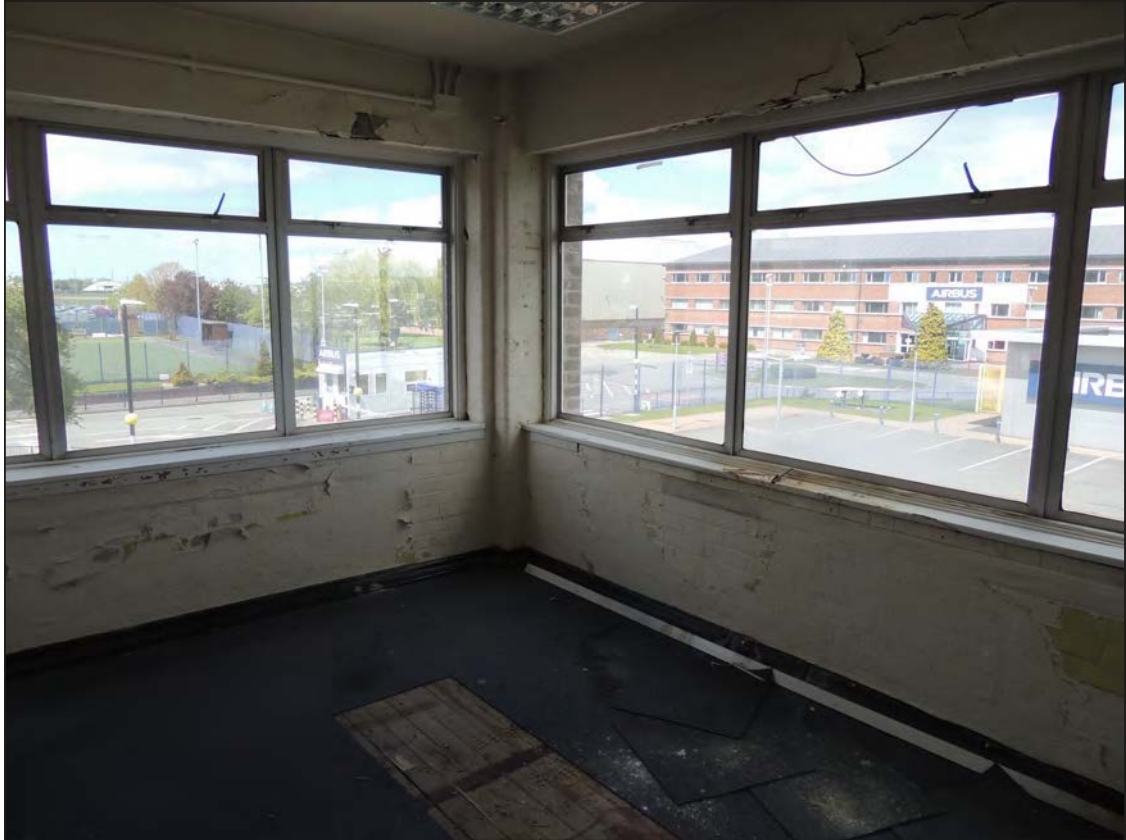
Room 35 (Plate 130)

Plate 130. View of small room off the sports hall looking N

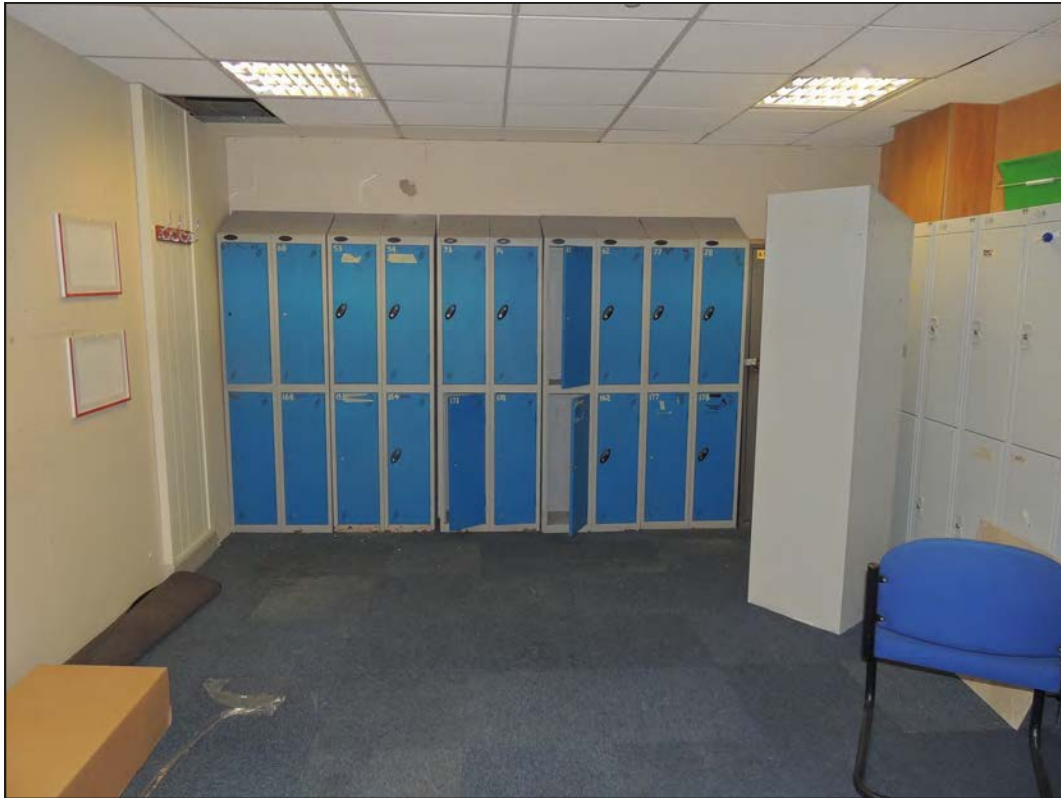
Room 36 (Plate 131)

Plate 131. View of the female locker room looking SW

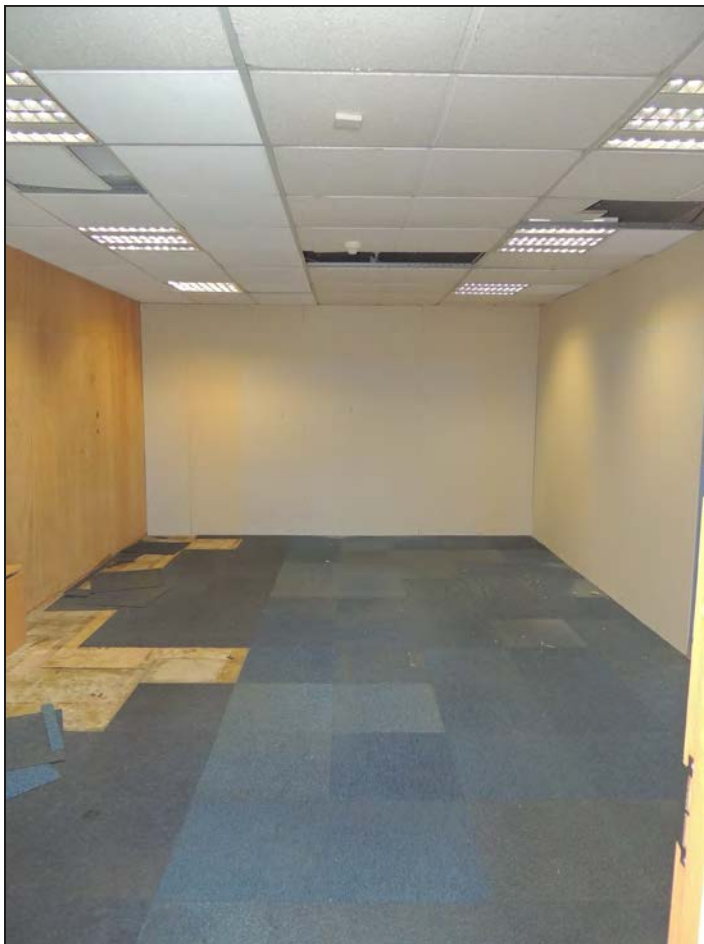
Room 37 (Plate 134)

Plate 134. View of male locker room looking NE

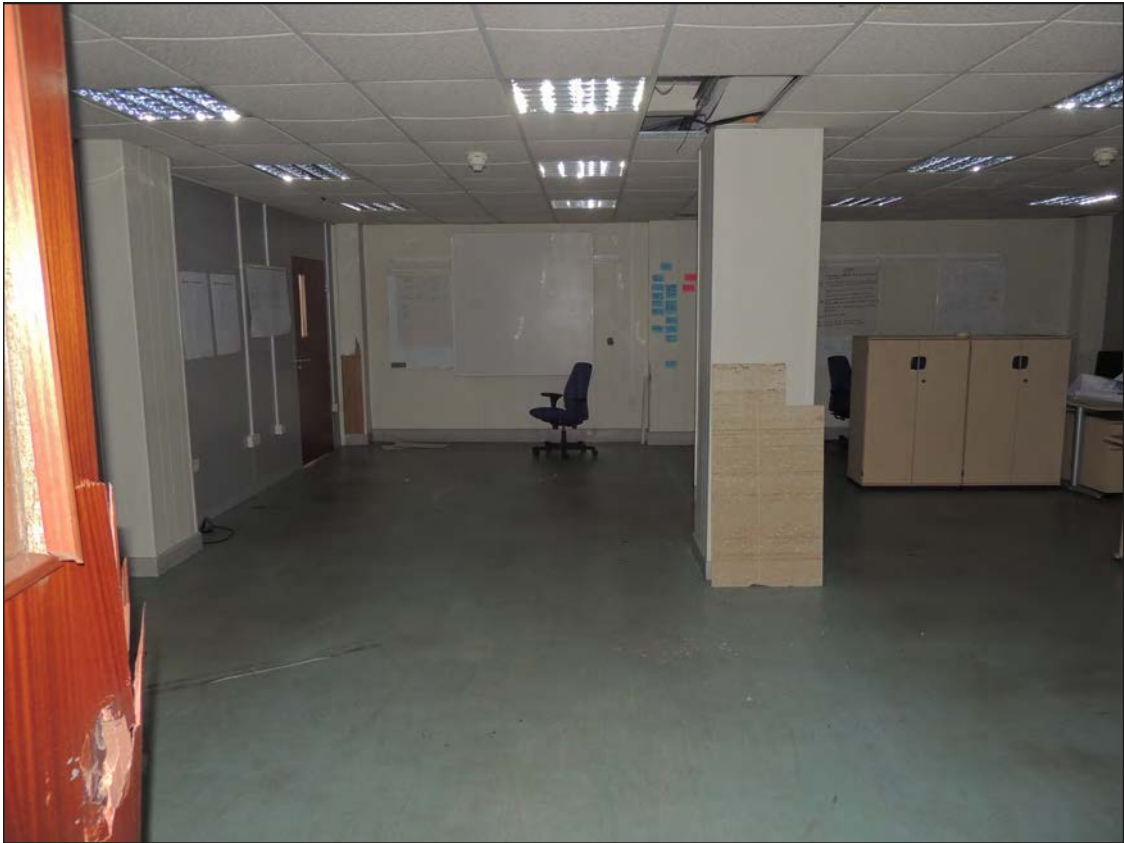
Plate 135. View of offices looking SSE
