Llanwnwr Farm, Goodwick Pembrokeshire

Archaeological Watching Brief

Report No. 1312

December 2014

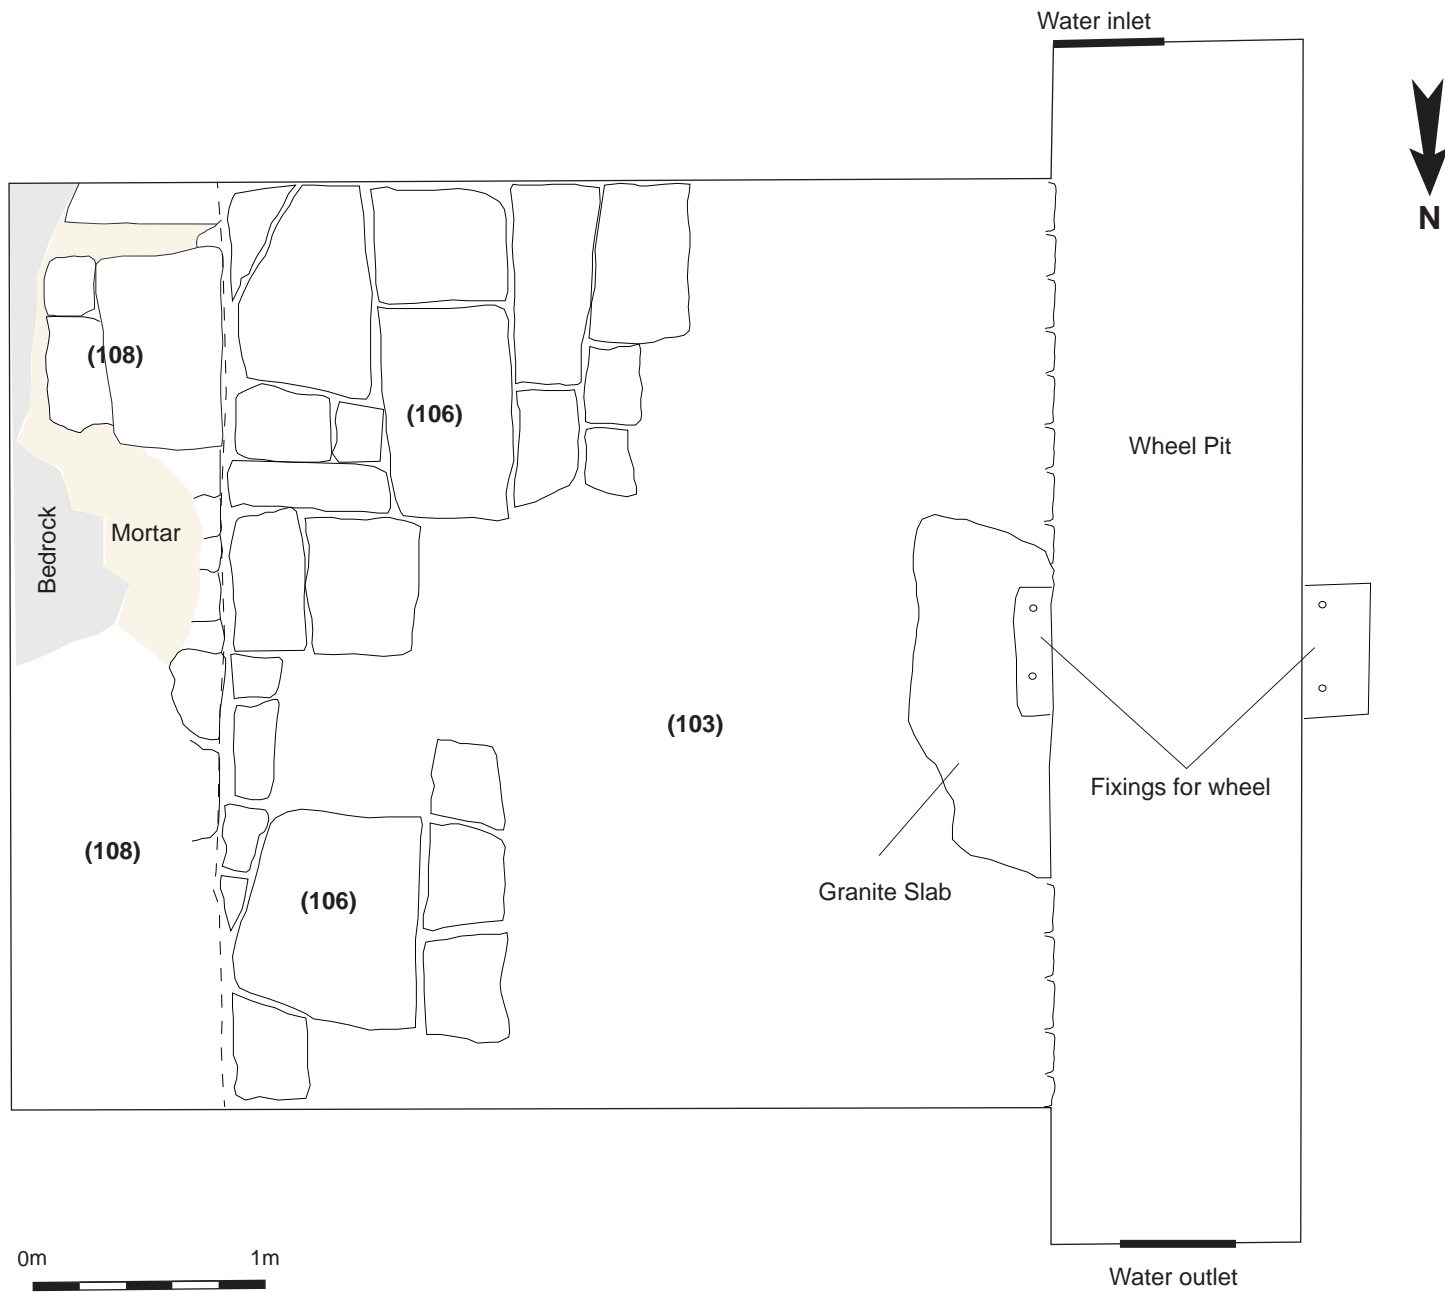
Fig. 9
Plan of interior of structure

The soil and rubble deposit (102) overlay the original floor of the building, which comprised loose laid stone slabs (106) (figs. 6 and 9). The floor slabs had been laid partly onto the natural geology (103) and partly onto a patchy deposit of dark brown silty clay (112). The floor slabs had been disturbed prior to the infilling of the building with rubble, with much of the western section lifted. Several slabs were also lifted during the removal of the rubble fill. Along the eastern wall of the structure a flight of stone steps (108), leading from the door on the eastern side of the building to the sunken floor, survived in a fragmented state. The stone steps (108) were built on top of the bedrock, which had been excavated out to form the sunken building, and built using stone rubble bonded with a pale off white lime mortar (figs. 6 and 9).

The wheel pit (105) was located on the western side of the building, orientated north/south (figs. 7, 8 and 9). It measured 1m wide by 2m deep (from the floor of the building) and was filled with loose rubble (101). A number of twentieth century artefacts were identified within the rubble in the wheel pit, predominantly broken metal tools and unidentified lumps of rusty iron. Sherds of twentieth century pottery and two leather boots (both left feet) were also identified. Due to the modern nature of the finds none were retained for analysis. The wheel pit was dug into the bedrock and had a thin layer of patchy silty clay covering the base (no context number assigned). Metal fixings, to hold the wheel in place, were built into a recess in the western wall of the structure and a granite slab containing holes for fixings was located on the eastern side of the pit. The inlet, to feed the wheel from the sluice pond, was located in the south-western corner of the building, approximately 4m above the base of the wheel pit (fig. 8 and 9). This would have fed the wheel at its mid-point, making it a breast shot wheel system. The water outlet was located in the north-western corner, at the base of the wheel pit, and fed the water into a channel which took it northwards away from the building (fig. 8 and 9).
