Blaenavon Forgotten Landscapes Project

Conservation Management Plan

Report No. 1046

Date: **March 2012**

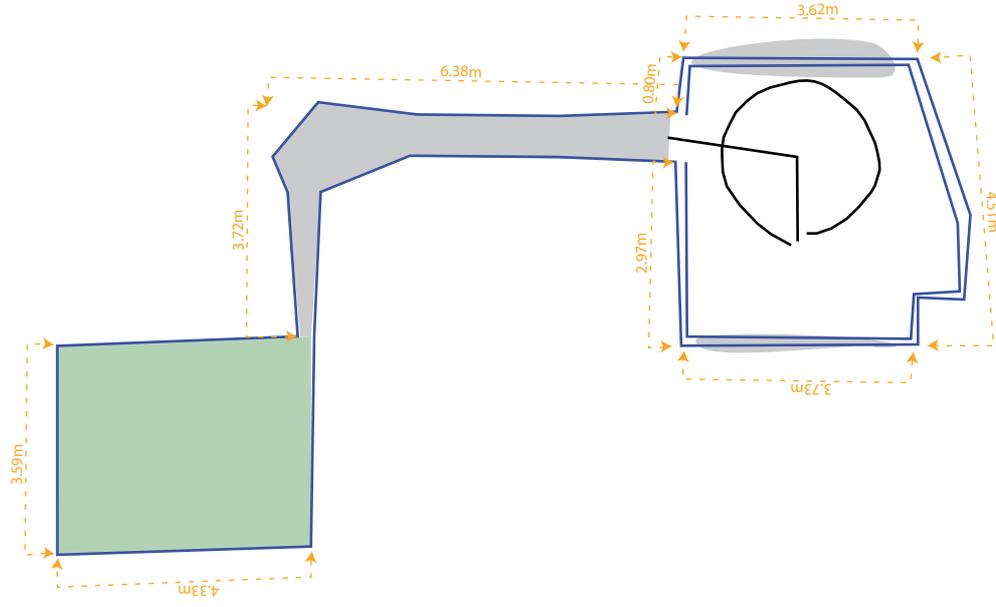
Fig. 18
Survey of the
Tramway Incline
Brake and
Brakesman's
House

The site comprises two separate elements connected by a gully. The remains of the main brake apparatus are located within a sunken structure measuring approximately 4.5m by 3.6m and up to 1.3m deep (fig. 18, 19 and 20). The structure is faced by stone walls mortared with lime, into which twelve corroded iron girders have been built. Two girders are positioned in each corner, with a single girder positioned in the middle of each side. Further iron framework is positioned on the base of the structure, on top of which are the remains of the brake mechanism. On the southern side of the brake mechanism is an iron rod, extending eastwards towards the remains of the brakeman's house. This rod runs for 4m, and is contained within a linear gully lined with stone walls mortared in lime. The gully is 0.5m wide and 0.4m deep, although it would originally have been approximately 1m deep. The gully turns 90° west 6m from the eastern edge of the sunken structure, and joins a second stone built structure. This stone-built structure measures 4.33m north/south by 3.59m east/west. Up to three courses of intact walling are visible, with the majority of the building masked by rubble and vegetation (fig. 21).

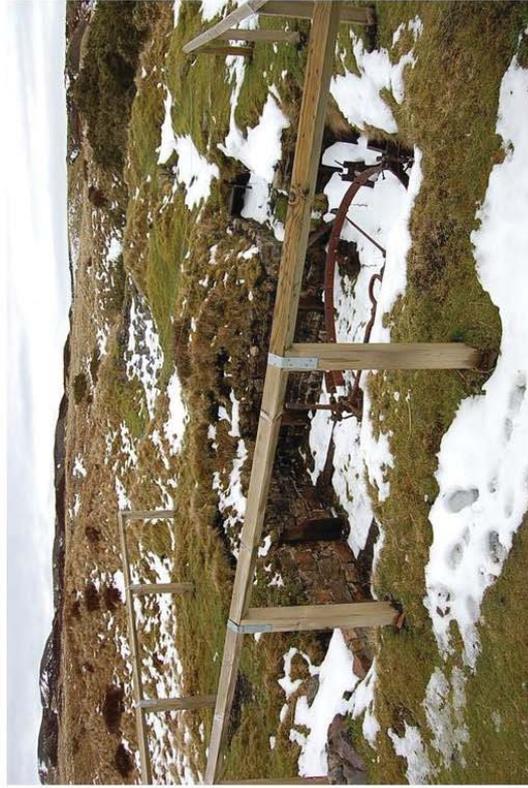
Plate 7: Hill's Pit brake wheel site. General view over the remains of the metal, brake wheel and its partially buried, enclosing buildings. The habitats here are dominated by NVC U1 grassland, with *Ulex europaeus* scrub (background right). Off-site, but still visible in this view, is the browner NVC U6 grassland of the surrounding moorland.
