DALE AIRFIELD  
PEMBROKESHIRE  
Building Photographic Survey  
2005-6

RHIF YR ADRODDIAD / REPORT NO. 2006/53  
RHIF Y PROSIECT / PROJECT RECORD NO. 55592

*A rapid photographic survey was made of most of the building exteriors and runways at Dale Airfield. A few of the buildings are in a poor and dangerous condition, although most are in a fair condition. The interior of the ablution blocks and a few other buildings are recorded in more detail.*

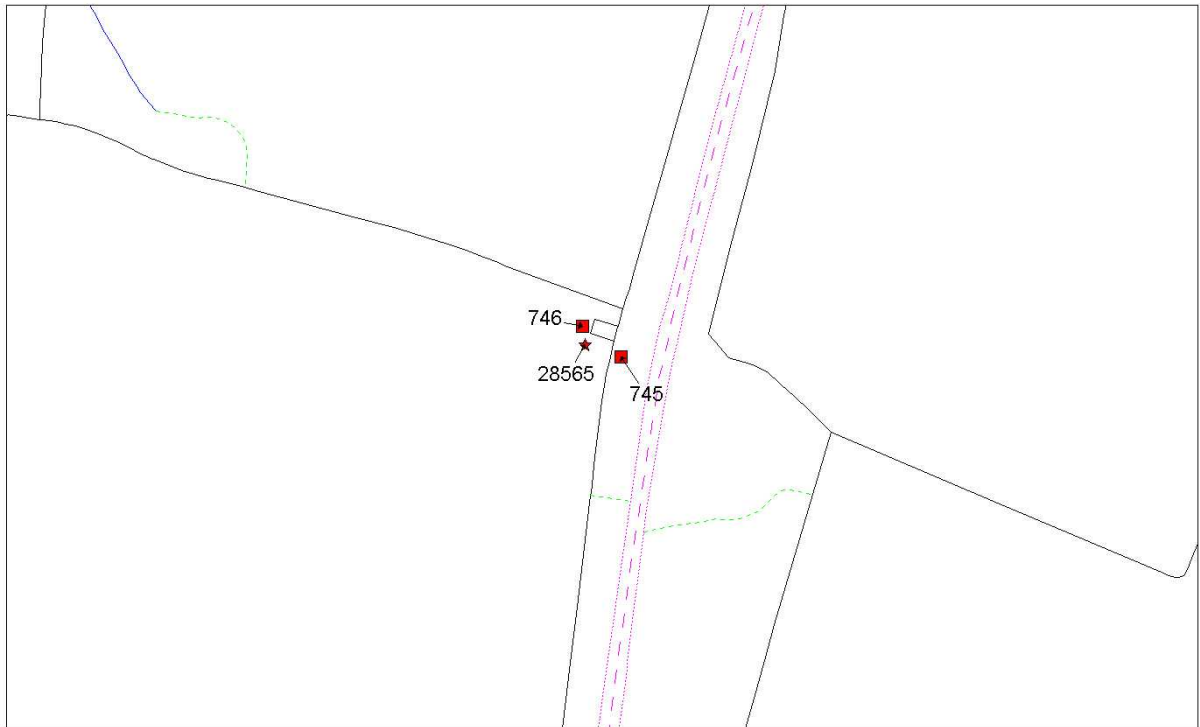
Figure 4: Stars = PRN. Squares = Photo

28565, Military Building. (Fig 4, Photo 1). c1944, Derelict, semi-sunken, 'temporary brick' construction, small rectangular two bay, pitched gable corrugated asbestos roof.. Not present on RAF Dale site plan 1364/44. *Gable roof has gone.*

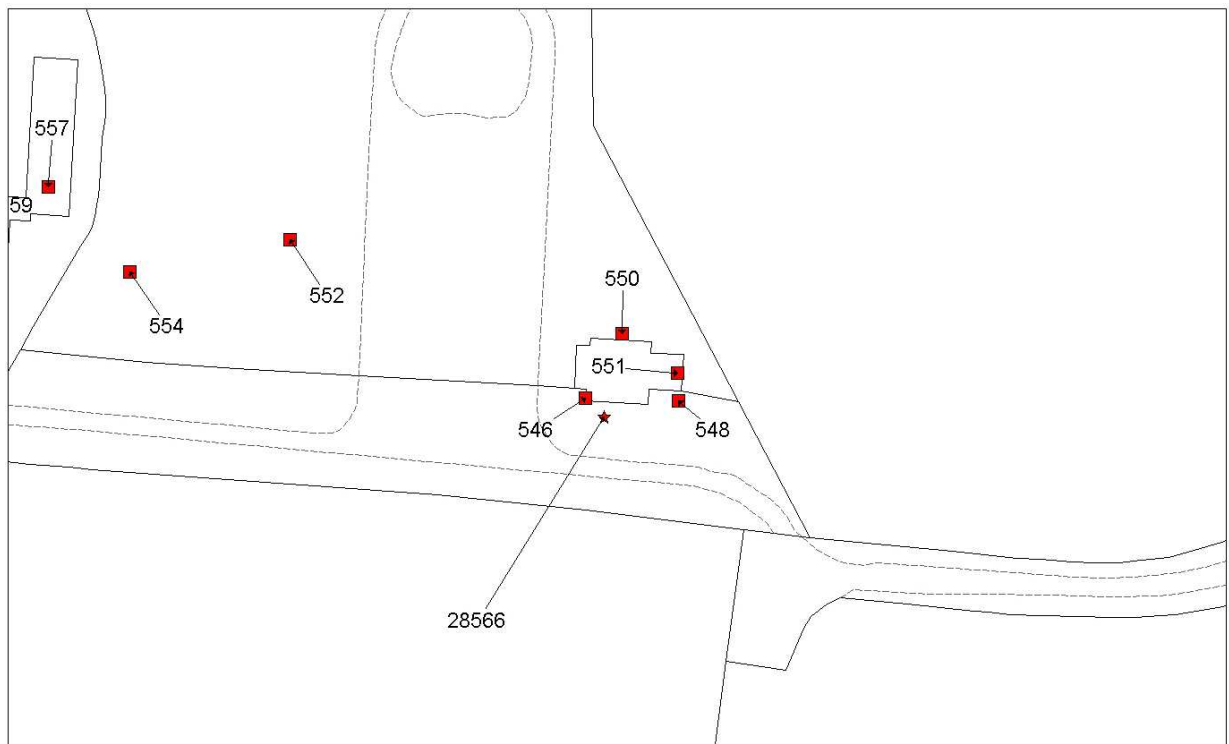
Figure 5: Stars = PRN. Squares = Photo

28566, Chapel (Fig 5, Photo 2). c1944, Chapel, now derelict. Single storey, type 'standard 24' pre-cast concrete frames, corrugated asbestos pitched gable roof. Two bay chancel with hollow brick walls, four bay nave, roof extended beyond wall posts to form aisles resting on brick walls. *Remains of altar base and pulpit?. Porch at west end has no roof.*

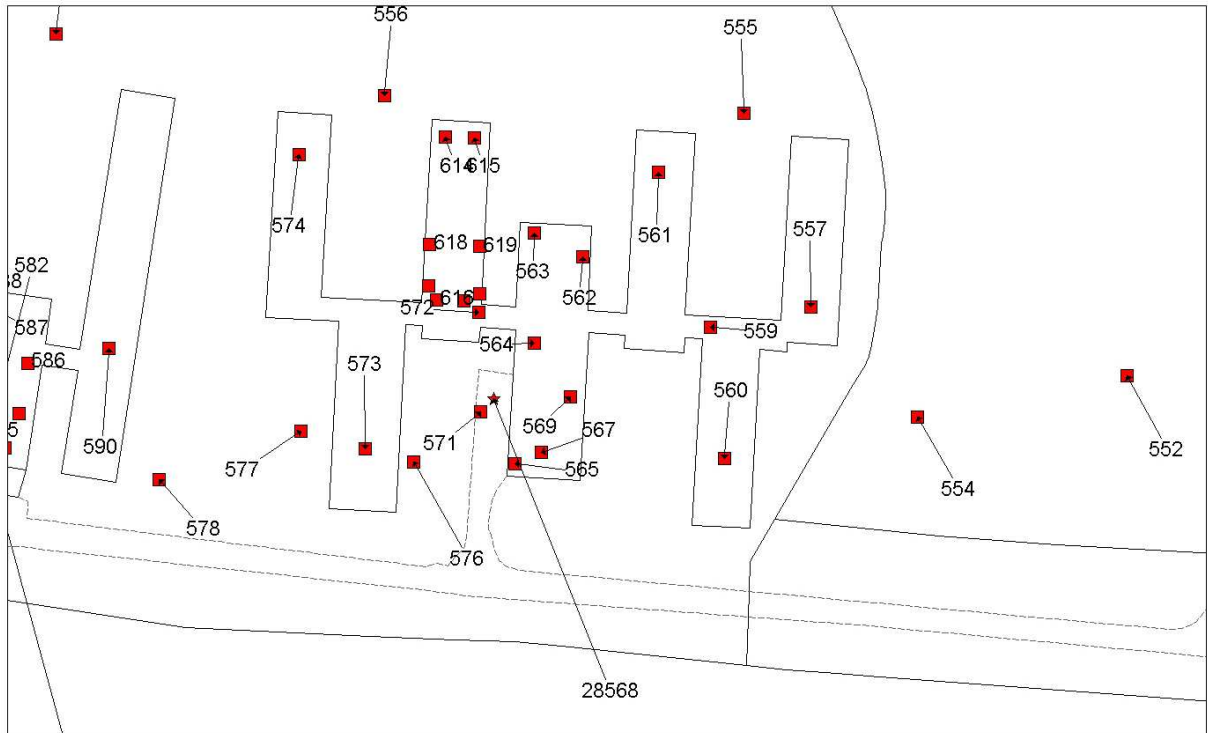
Figure 6: Stars = PRN. Squares = Photo

28568, Quarters. (Fig 6, Photo 3). c1944, Quarters, present use low grade agricultural. Six single storey, 'standard 24 huts linked by two corridors, three either side of a central ablutions block. Concrete common rafters, bolted to concrete posts, pitched gable corrugated asbestos roof. *Roofs nearly all complete. Block northwest of ablution block contains aircraft cartoons (Fig 7, Photos 4-9) on walls at towards southern end. Access to boiler room blocked by debris.*

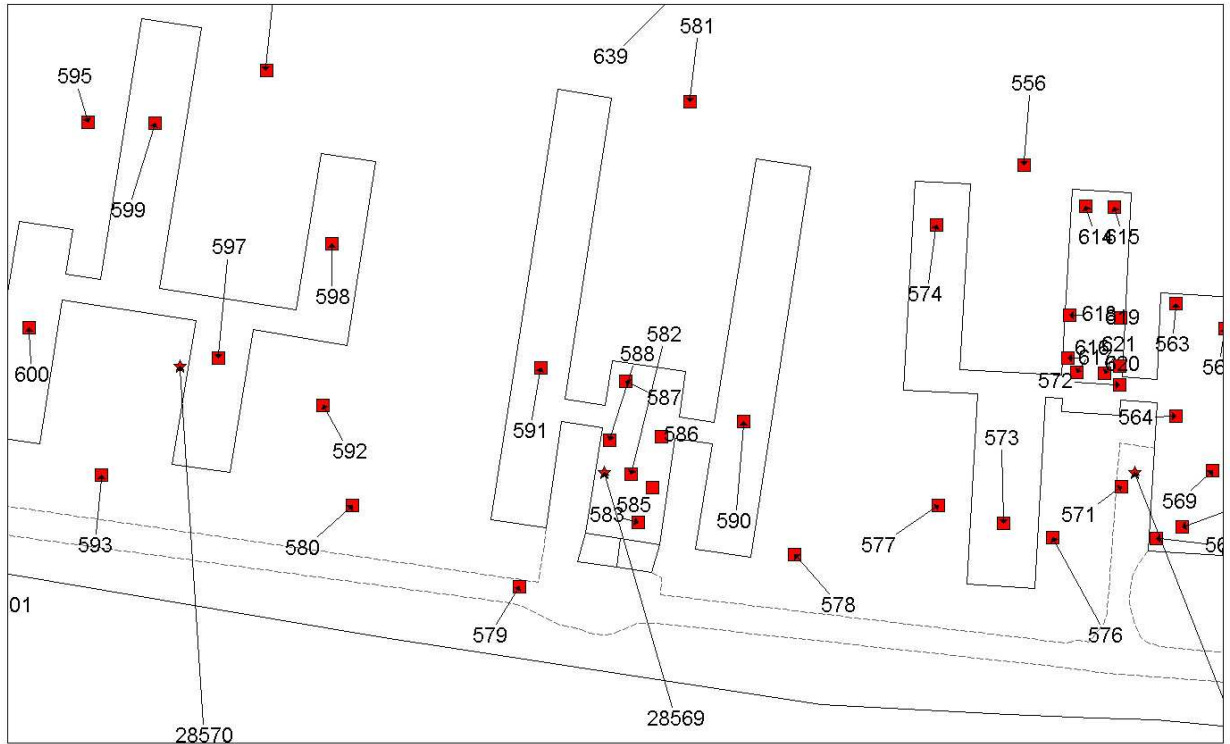
Figure 8: Stars = PRN. Squares = Photo

28569, Quarters. (Fig 8, Photo 10). c1944, Quarters, present use low grade agricultural. Two single storey, 'standard 24 huts linked by two corridors, to a central rectangular plan, 'temporary brick' construction, flat concrete roofed ablutions block with a combined water tower and chimney. *Modern opening on south end of west building. No access to west block.*

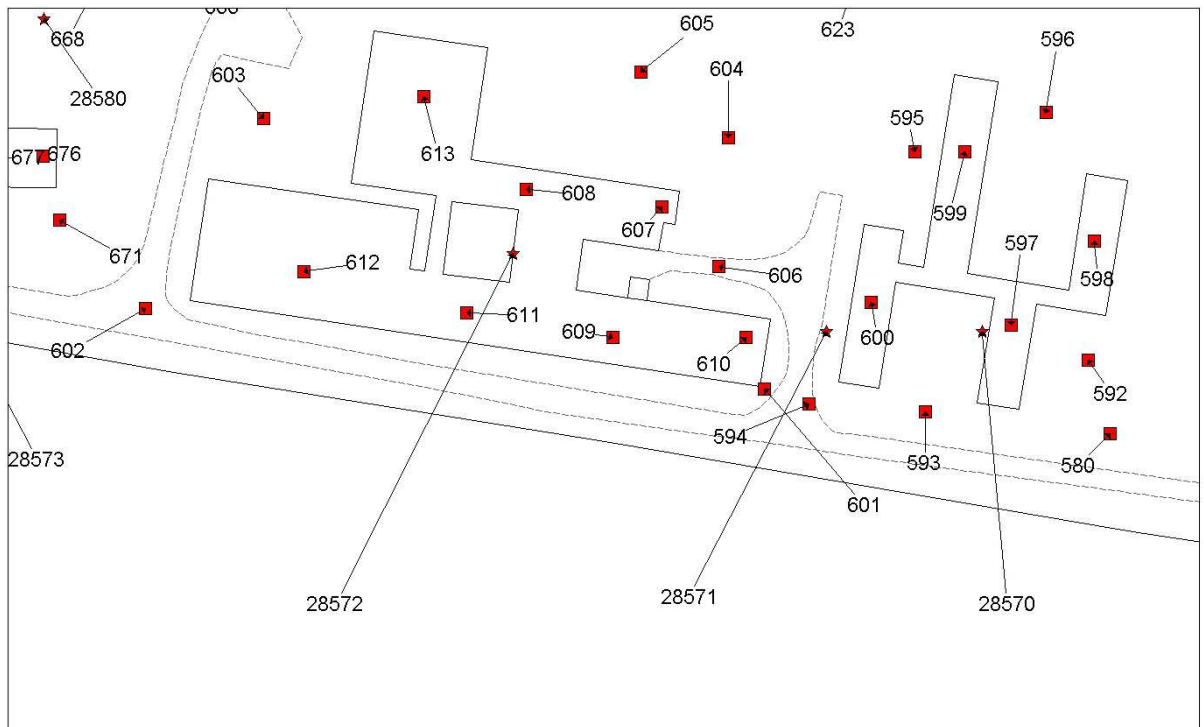
Figure 9: Stars = PRN. Squares = Photo

28571, Ablution block. (Fig 9, Photo 12). 1941-47, Sergeant's, Showers, Ablutions and Latrines, now derelict. Single storey, 'temporary brick' construction, /1/2--1/2--5--1/2--1/2--1/2 bay rectangular plan, combined water tower and chimney set at north east corner. Pitched gable corrugated asbestos. *Both gable roofs mainly intact. Shower roof nearly all gone.*

28572, Mess. (Fig 9, Photo 13). 1941-47, Sergeant's, Mess, present use low grade agricultural. Single storey, 'temporary brick' construction, pitched gable corrugated asbestos roof. Three ranges. The main range is 14 bays long with a 5 bay return range (Dinning Hall and Kitchen). *Gable roofs mostly intact. Some interior divisions. Part of roof fallen in west of water tower, only NE part of roof very bad or gone.*

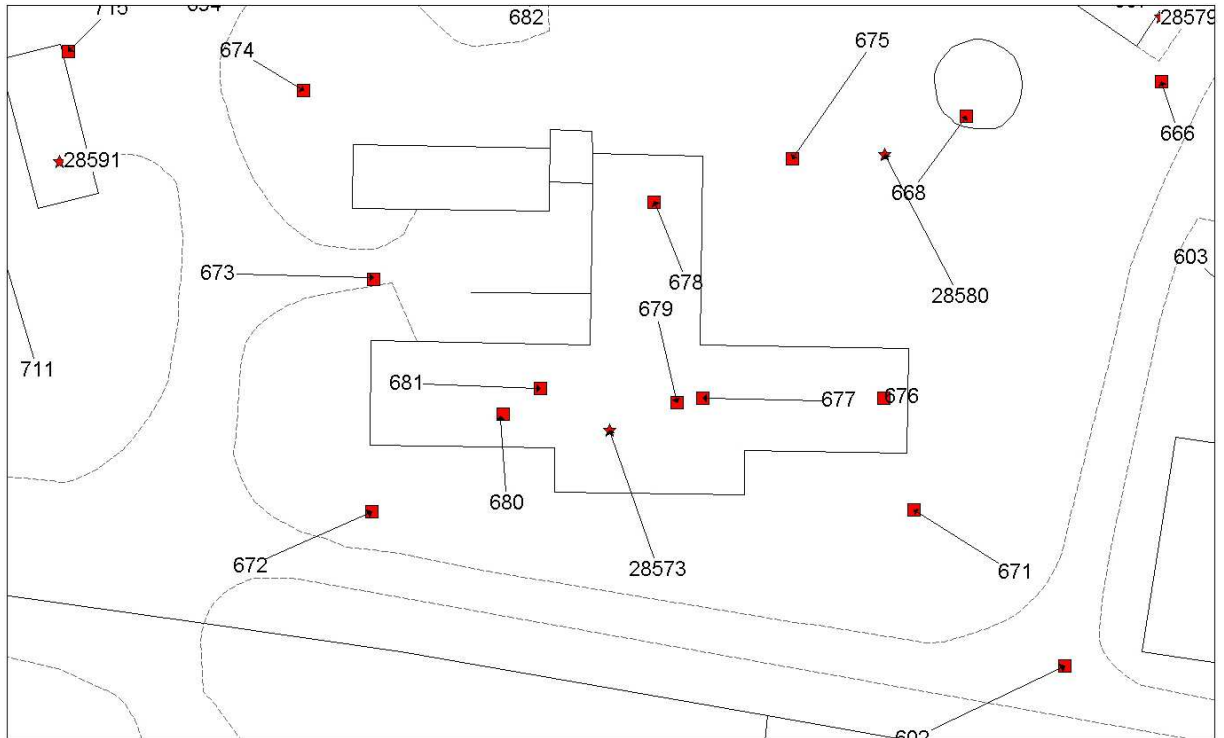
Figure 10: Stars = PRN. Squares = Photo

28573, Institute. (Fig 10, Photo 14) 1941-47, NAAFI Institute, present use low grade agricultural. Single storey, 'temporary brick' construction, pitched gable corrugated asbestos roof. 'T' plan with parallel return range to main range off west wall of the rear range. *Nearly all gable roofed and mostly intact except small part of NR block and western end of south extension. Contains fore places. North block has modern entrance. No access to adjacent block on northwest side used for car and boat storage. Some windows blocked and doors in this later block and some of the main block.*

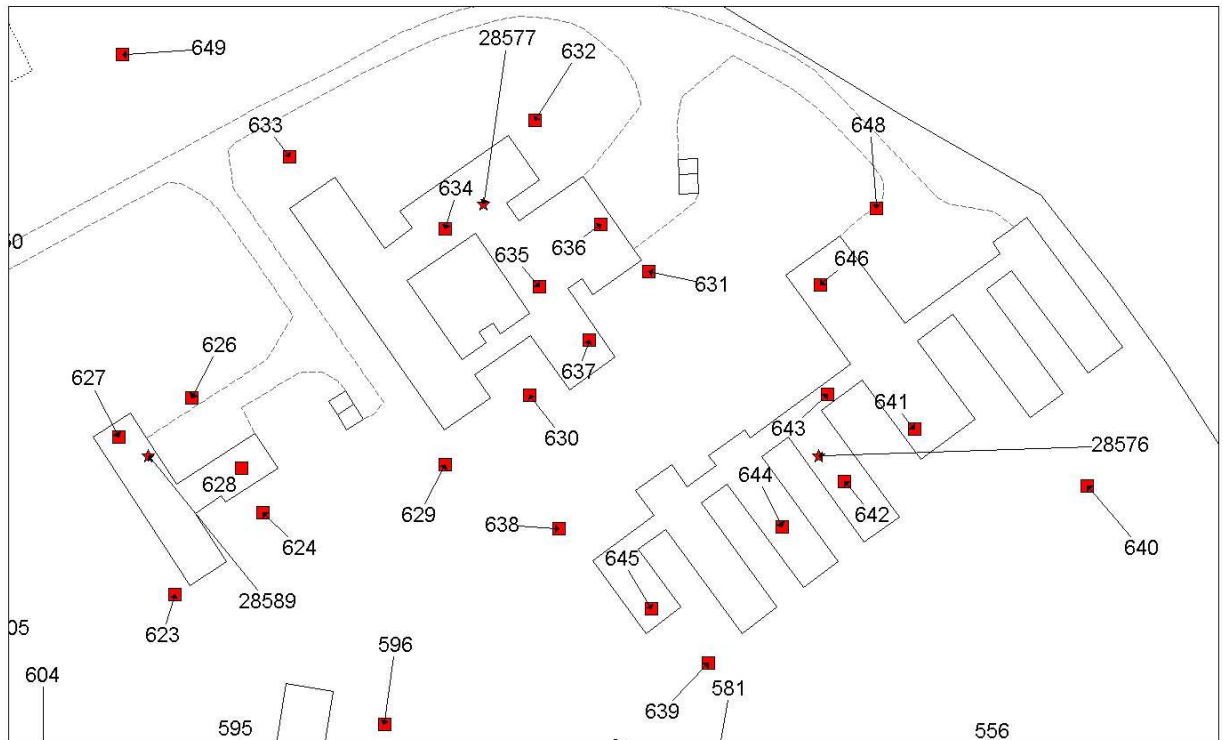
Figure 11: Stars = PRN. Squares = Photo

28576, Quarters. (Fig 11, Photo 15). 1944-47, Quarters, present use low grade agricultural, six single storey,, type 'standard 24' huts. Arranged one 6 bay, two 11 bay and one 9 bay to the south west of a large single storey, rectangular plan, flat roof, rendered brick ablutions block. *East block intact and used for storage. East but one block full of potato boxes no access. Ablution block divisions plus some fittings remain.*

28577, Mess. (Fig 11, Photos 16 and 17). 1944-47, Dining Hall/Mess, now derelict. One 6 bay, one 9 bay and one 17 bay, type 'standard 24' huts adjoining a central, six bay kitchen block. Kitchen block, tall pitched gable corrugated asbestos roof on steel trusses and purlins, ridge ventilator. *Western part of gable roof all intact except north bay which has been removed. No internal access, used for storing boat and car. NE block gable roof ¾ intact. Middle east section roof collapsed. SE block contains fireplace.*

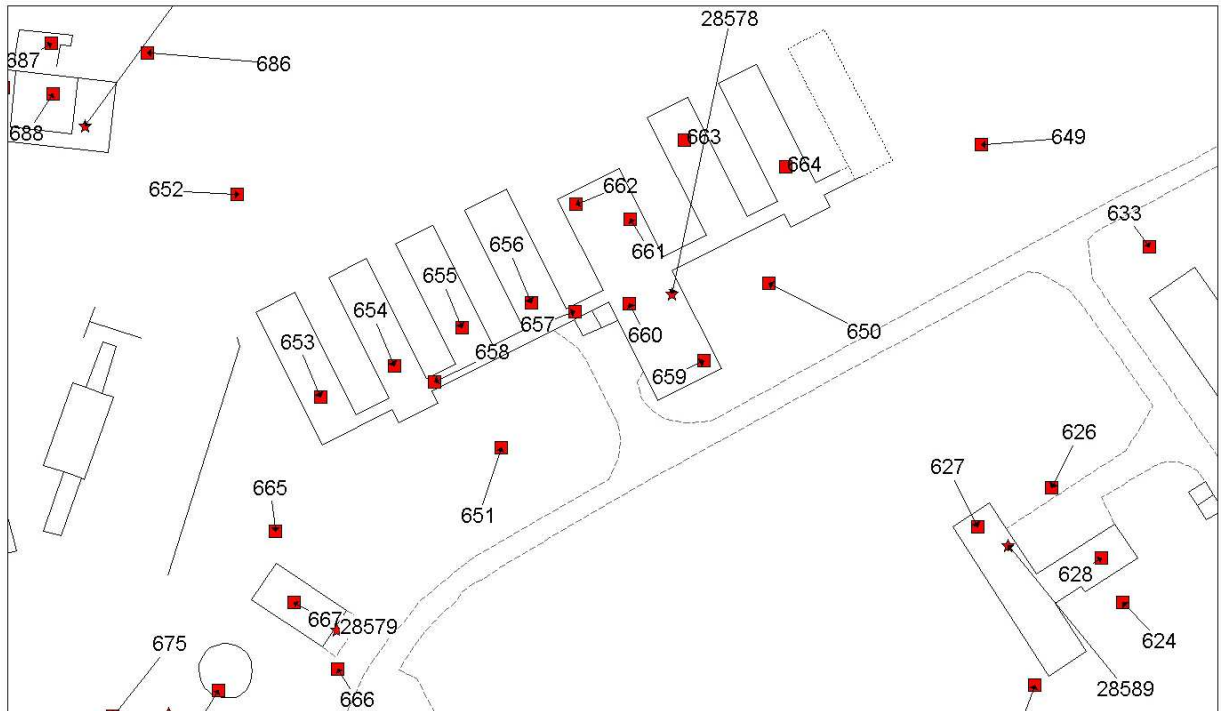
Figure 12: Stars = PRN. Squares = Photo

28579, Military Building (Fig 12, Photo 19). 1944-47, present use low grade agricultural. Single 6 bay type 'standard 24' hut. Concrete rafters bolted to concrete wall posts, large hollow clay brick nogging. *Pitched gable corrugated asbestos roof. Porched doorway in northwest wall. Roof completely gone. Building no longer used.*

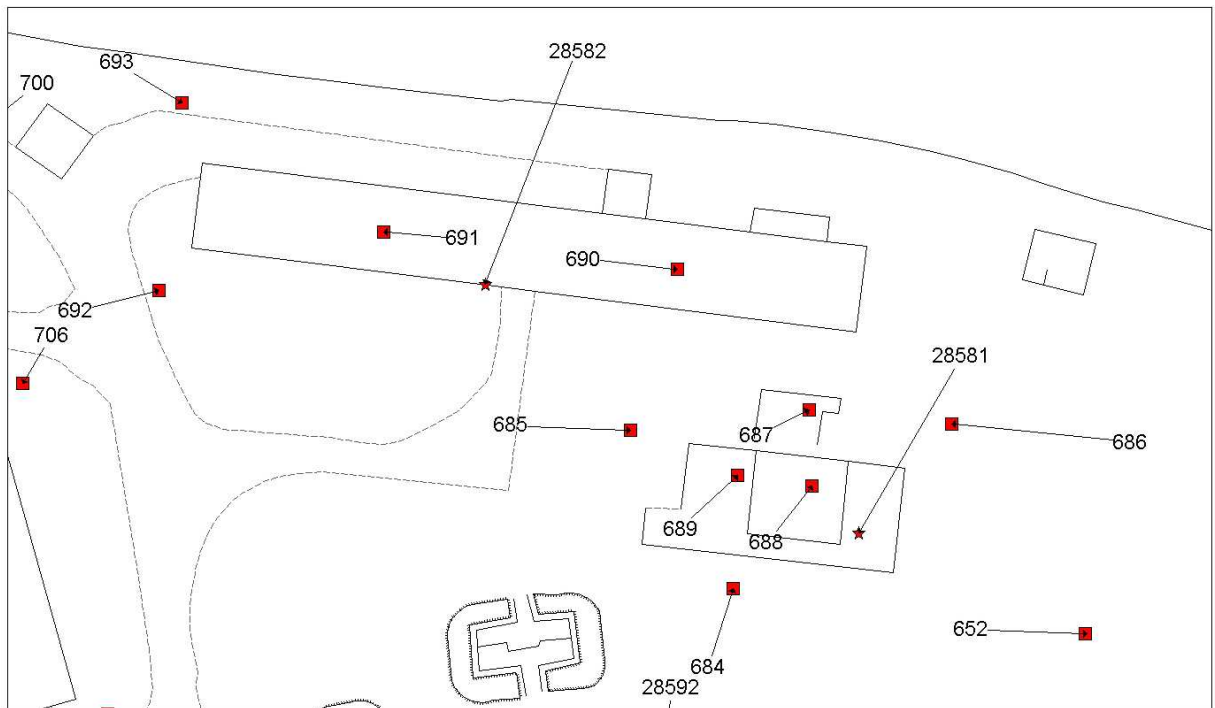
Figure 13: Stars = PRN. Squares = Photo

28581, Generator House. (Fig 13, Photo 21). 1941-47, Standby Set House, present use low grade agricultural. One and a half storey, brick built, flat concrete roof engine room, protected by a tall rectangular blast wall enclosure. Entrance to enclosure in north west wall, doorway to engine room in south side. *Remain of fuel tank in adjacent surround on north side. All brickwork and roof in good condition. No remains of machinery but some concrete engine beds*

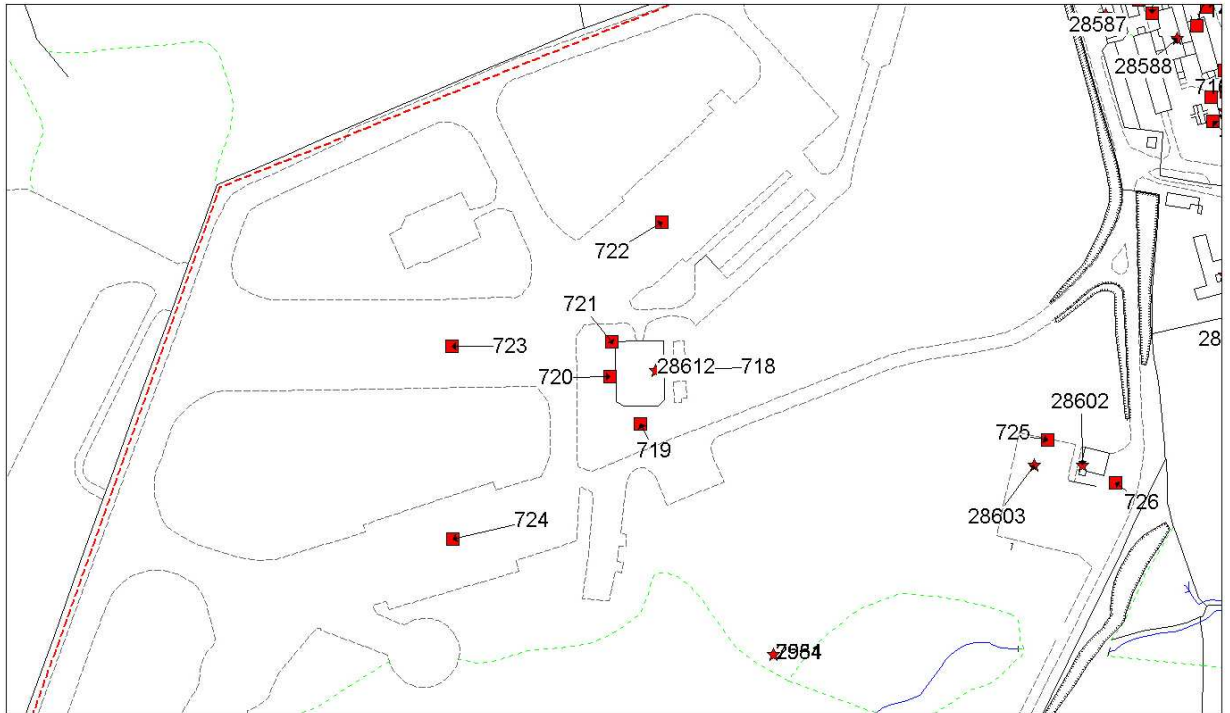
Figure 16: Stars = PRN. Squares = Photo

Taxiing areas adjacent to workshop 28602, (Fig 16, Photo 34) are in fair condition, with some surface weather degradation and slowly becoming overgrown with grass (Photo 34).

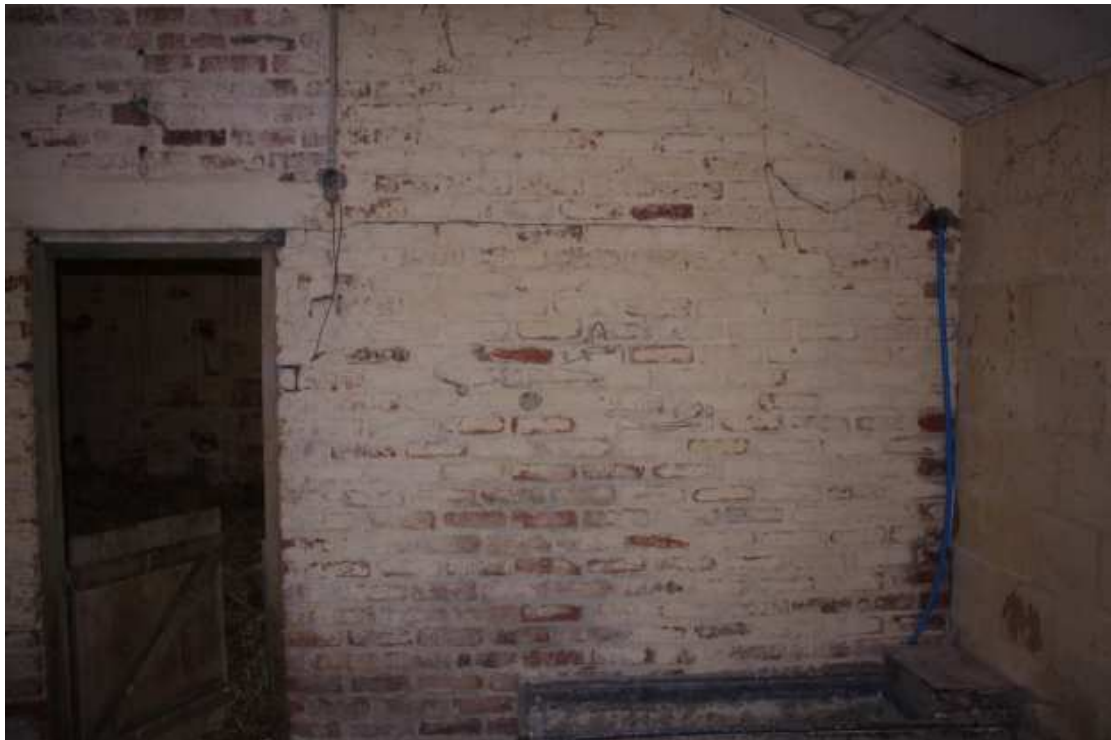
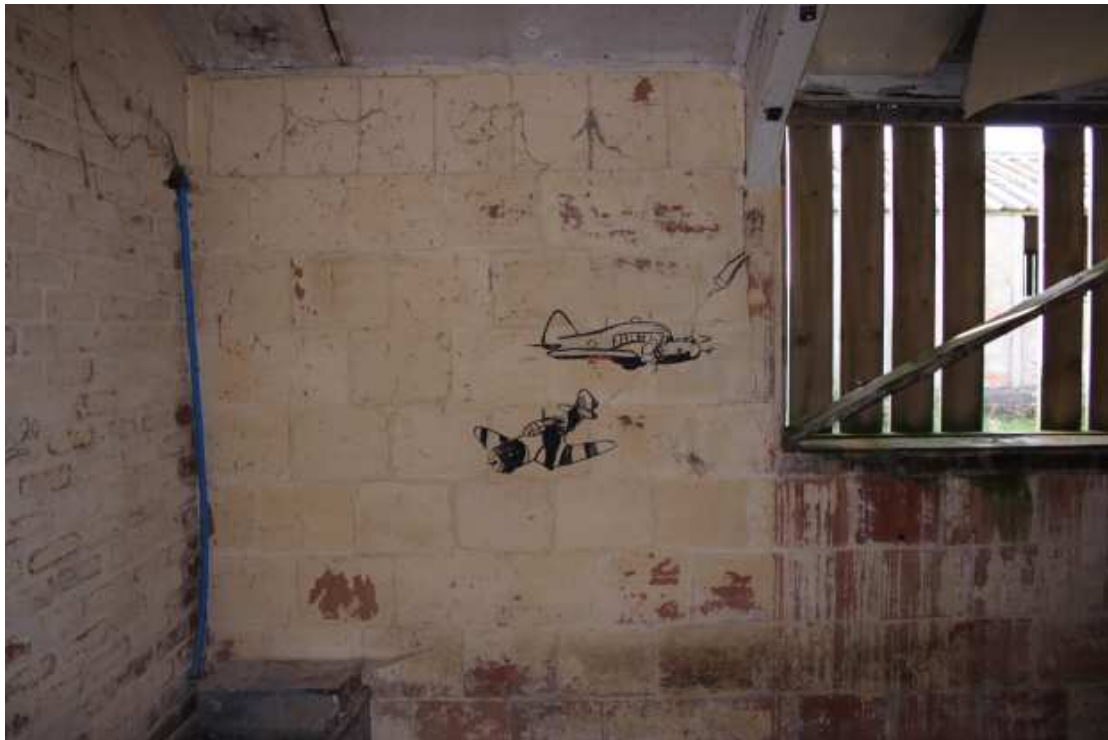
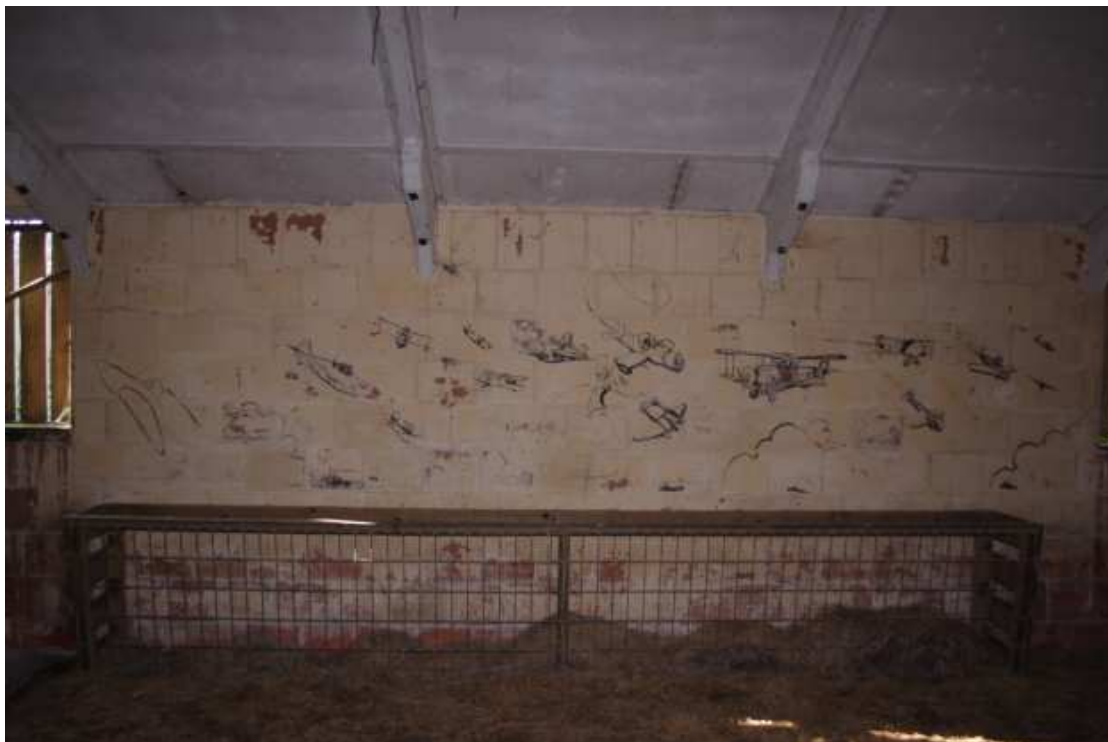
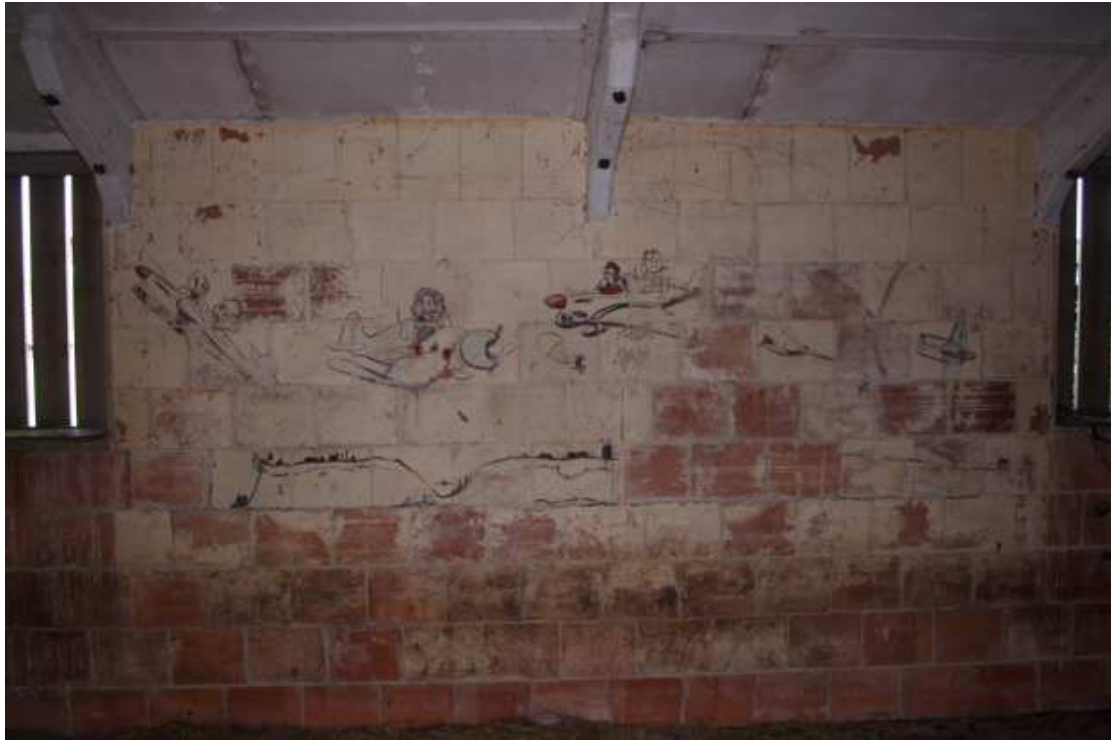
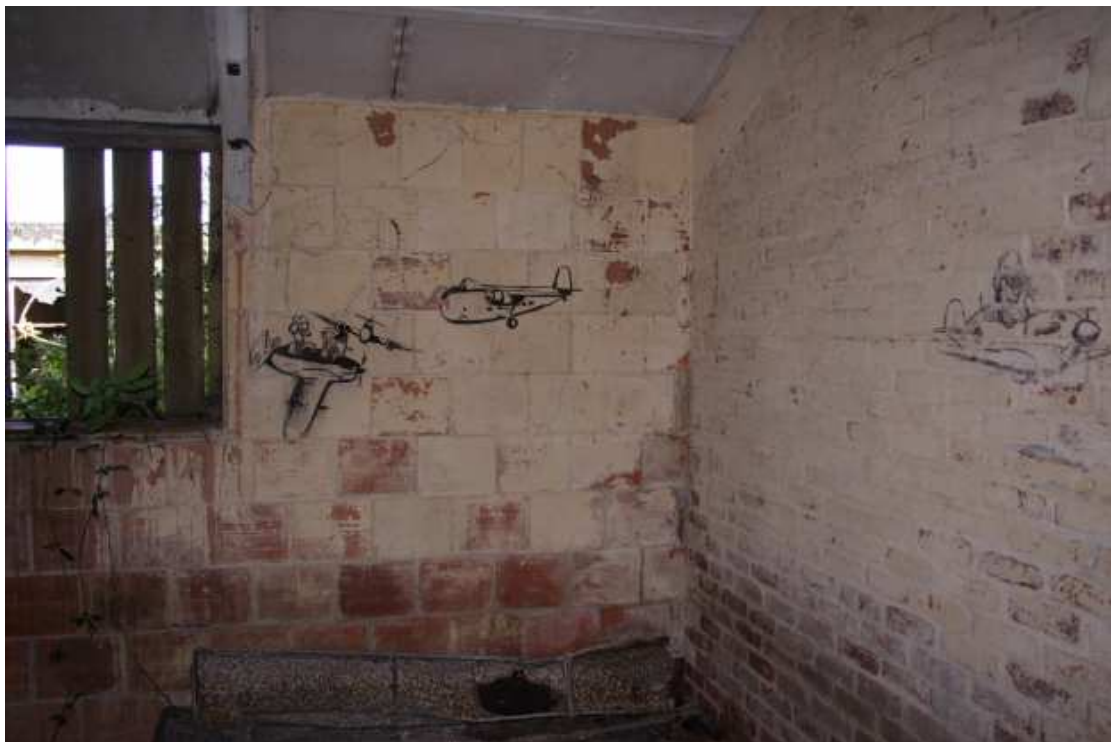
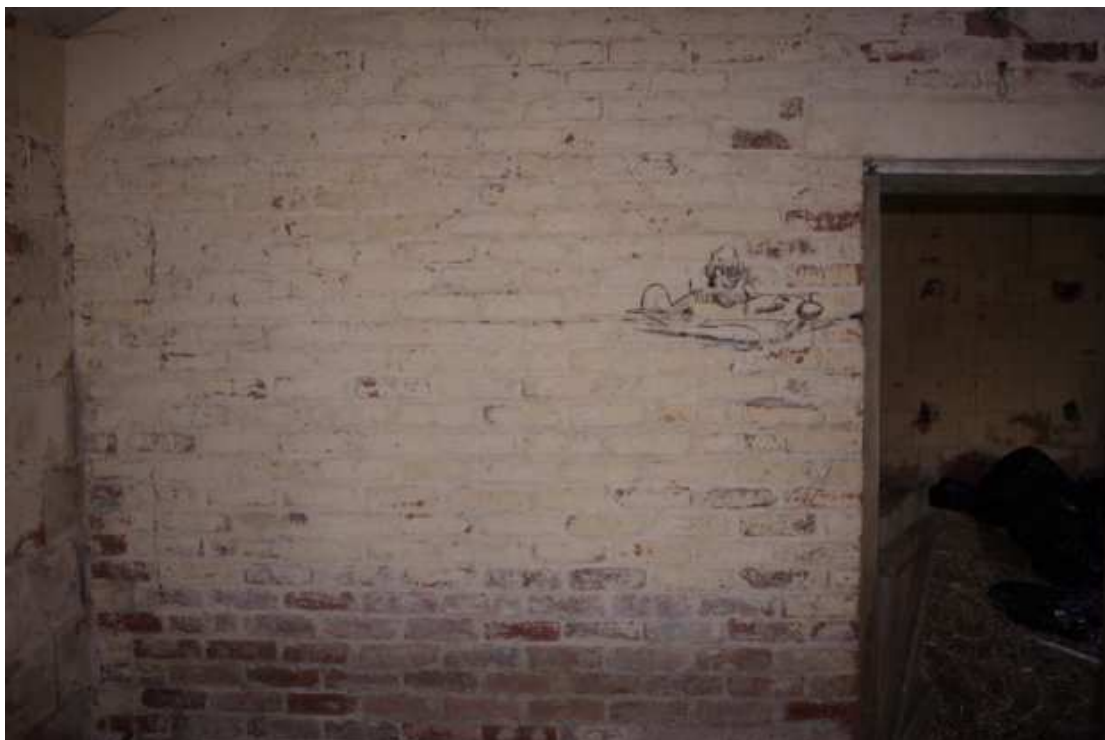
Photo 4 (616). Detail of cartoons. View S

Photo 5 (617) Detail of cartoons. View W

Photo 6 (618) Detail of cartoons. View W

Photo 7 (619). Detail of cartoons. View E

Photo 8 (620). Detail of cartoons. View E

Photo 9 (621). Detail of cartoons. View S
