Llanerch

Cynwyd, Denbighshire, LL21 ONB

Architectural Record 2017

For Discovering Old Welsh Houses Group

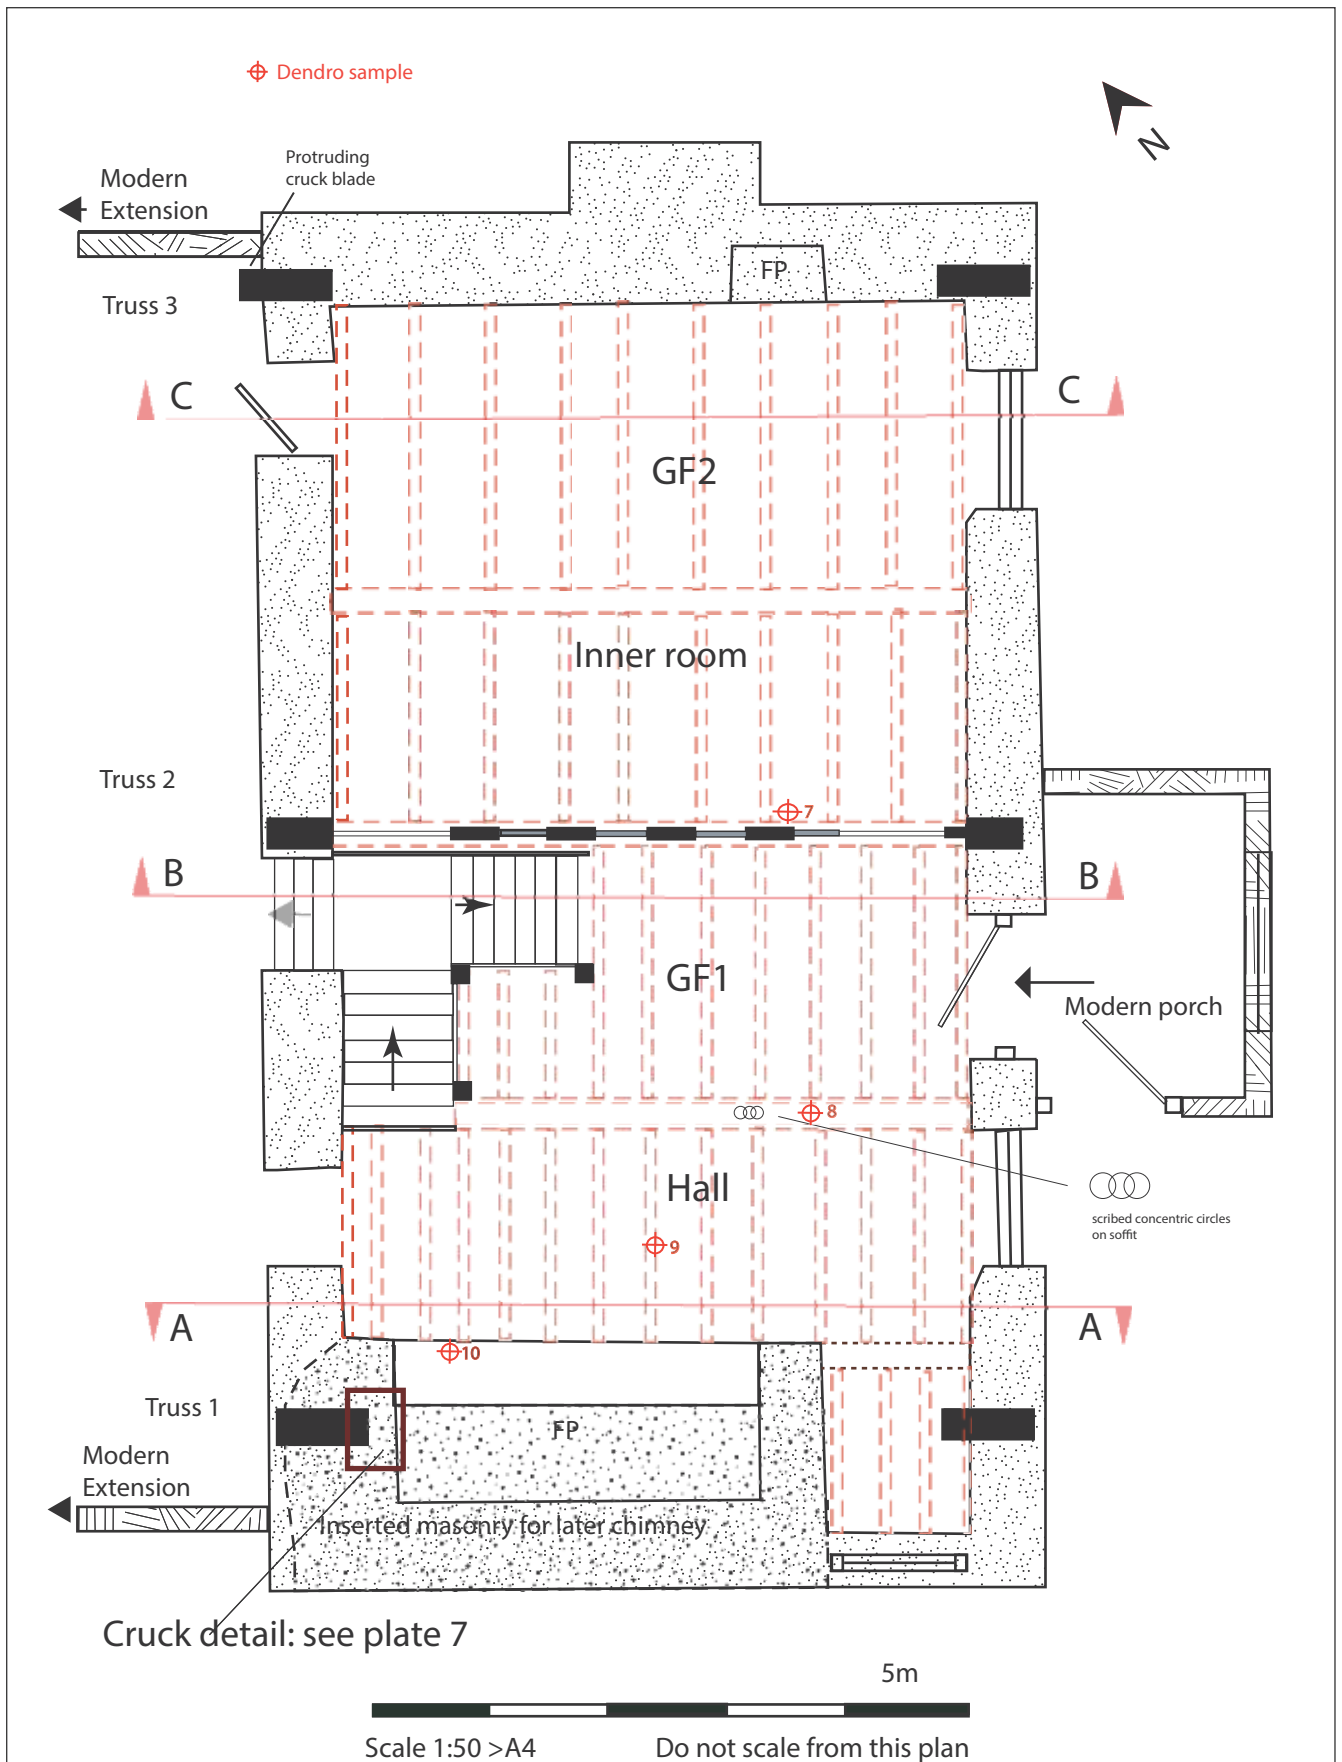
Figure 25: Ground Floor Plan
 Llanerch, Cynwyd, Denbighshire,
 formerly Merioneth, LL21 ONB

- 4.2.1 The ground floor is now accessed through a centrally placed door within a modern porch and enters into what was once the original hall. (fig 25 **GF1**) A standard feature of a late medieval hall house, whether open or ceiled, would have been a cross passage with opposing doorways but the evidence here is not obvious. This may be that early timber framed walls were replaced and perhaps the plan was altered. To the left is a large inserted fireplace with heavy bressumer or mantel beam. To the left of the fireplace is an opening now lit by a window. On the southern elevation wall the base of the L cruck protrudes from the wall and upwards through the ceiling. (figs 6,8) A mortise shows the location of a low tie beam now removed. From below this mortise runs a mortised groove which seems to have accommodated a screen or partition. The corresponding joint on the R cruck blade, now located within the fireplace, reveals the same detail but retains a fragment of the tie beam within the mortise. (fig 7) This clearly shows that the tie beam was also mortised, along with the cruck blade and the conclusion is that a partition of some form extended below the truss at tie beam or ground floor level. It confirms the insertion of the fireplace as the masonry of the chimney encloses the cruck truss that stands here and ties and collars have been removed to facilitate its construction.

4.2.2 The room to the right, (fig 25 **GF2**) originally an inner room (or formerly rooms?), also has a transverse beam of cruder workmanship supporting two sets of ten joists that are also of poorer workmanship and without embellishment. These joists have been re-set or even re-located into the tie beam above the screen with former joist holes blanked off (with modern timber). A mortise hole in the screen head beam is suggestive of a dividing partition in this room. The wall on the northern elevation is plain with an exit to rear extension at R. Wall outside this door, part of gable, displays part of the foot of cruck blade exposed as part of masonry. (fig 15) Wall to right, the gable end, is plain but to right a rail to carry the joists is planted onto cruck truss tie plates beam part of which is exposed in corner of room. (fig 14) Jointed and pegged. A small fireplace is placed to right side of wall. The return wall is without detail save for a window with modern casement.

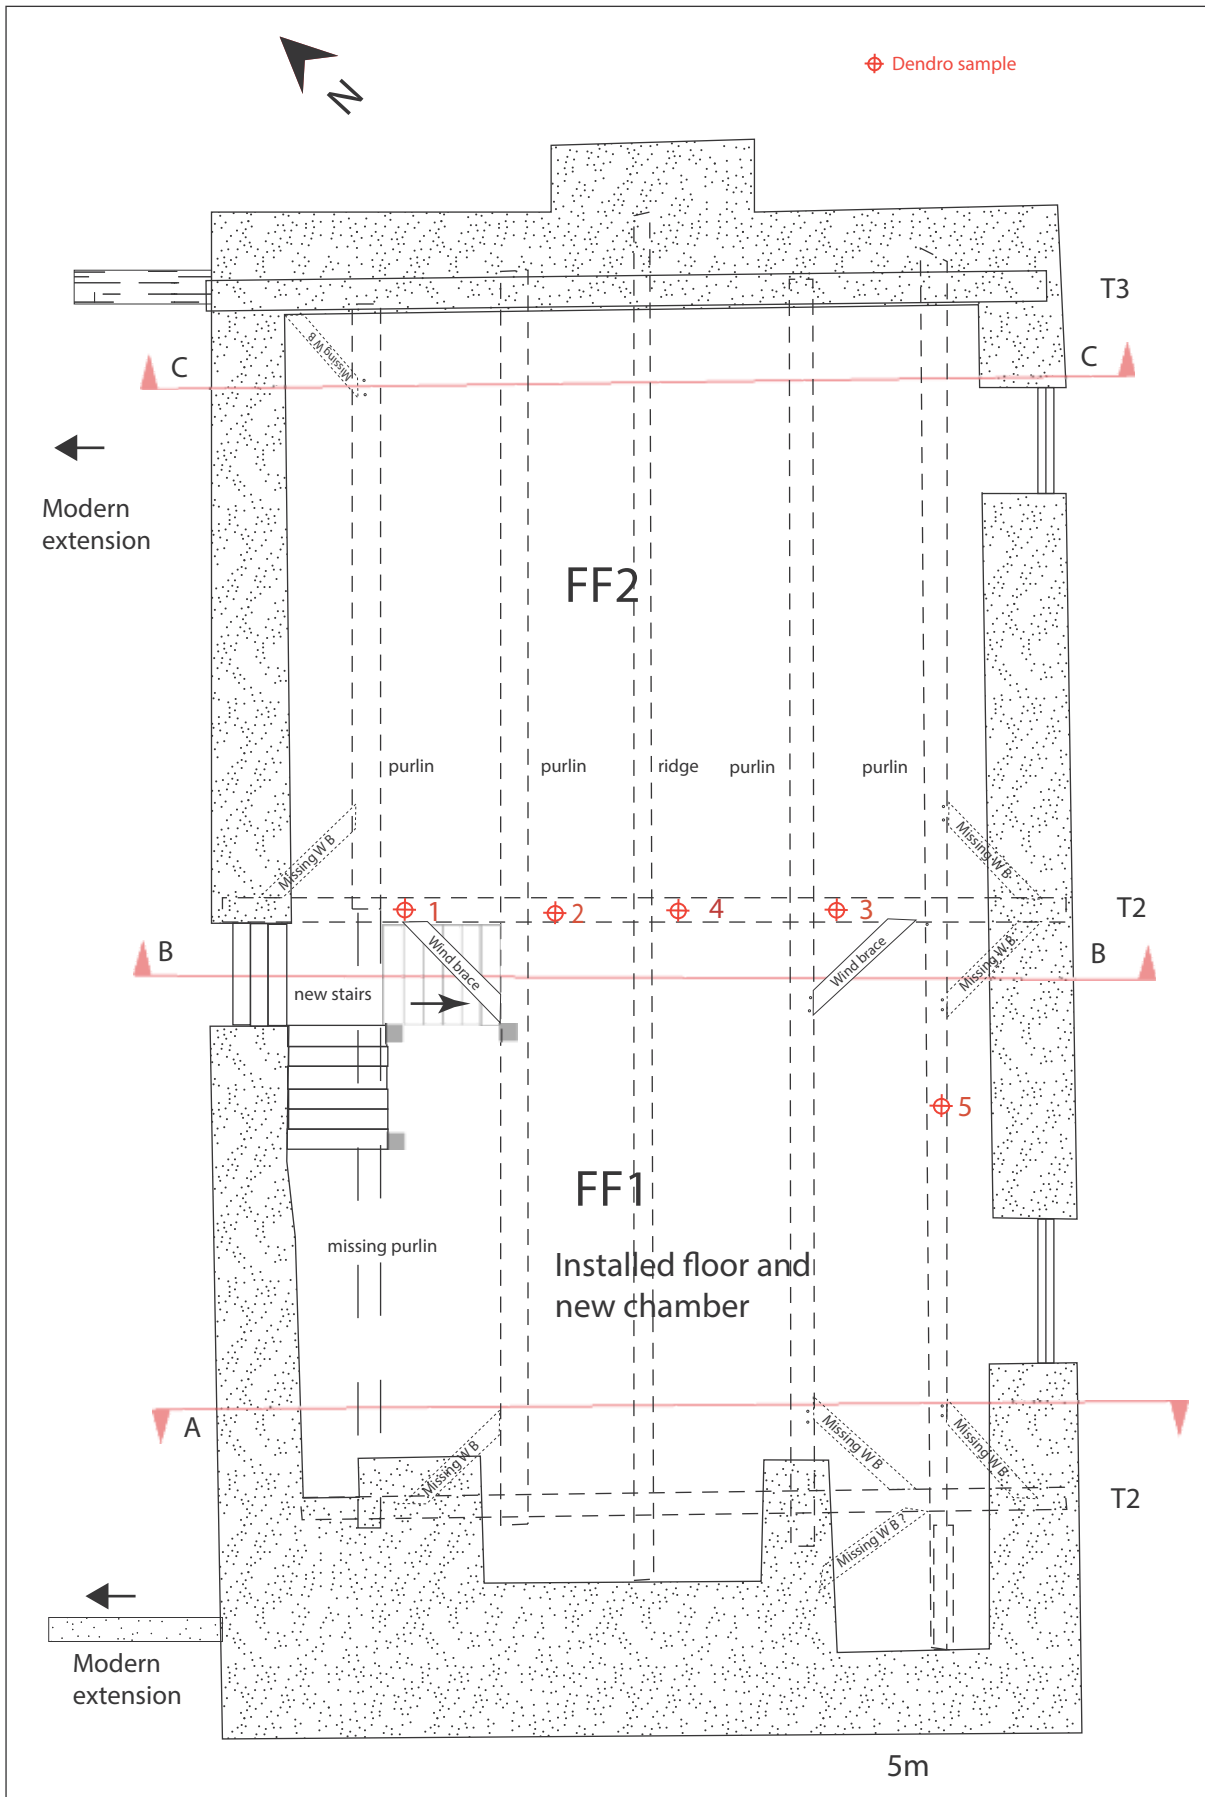
Figure 26: First Floor Plan
Llanerch, Cynwyd, Denbighshire,
formerly Merioneth., LL21 ONB

- 4.3.2 The second bay (fig 26 **FF2**) sees a room of comparable size to FF1. The room is now entered through the central door which was a later insertion to access the new floor perhaps. Not all purlins are original. Those to left have mortises for windbraces which are missing. Purlins to right S have been replaced. A splendid cruck truss is displayed at the opposite gable wall. (fig 29 section) It is framed with two central studs to collar, level with lower purlins. Horizontal rails to studs. Two diagonal struts or braces from collar to principal rafters. A plain block, pegged to the tops of the crucks completes the truss assembly. (fig 23) Peg holes cannot be discerned between the two vertical studs between collar and tie beam on the inner side, suggesting the possibility of a window or door. The ridge piece is of 100mm square section carried diagonally on the apex of the trusses through the building.

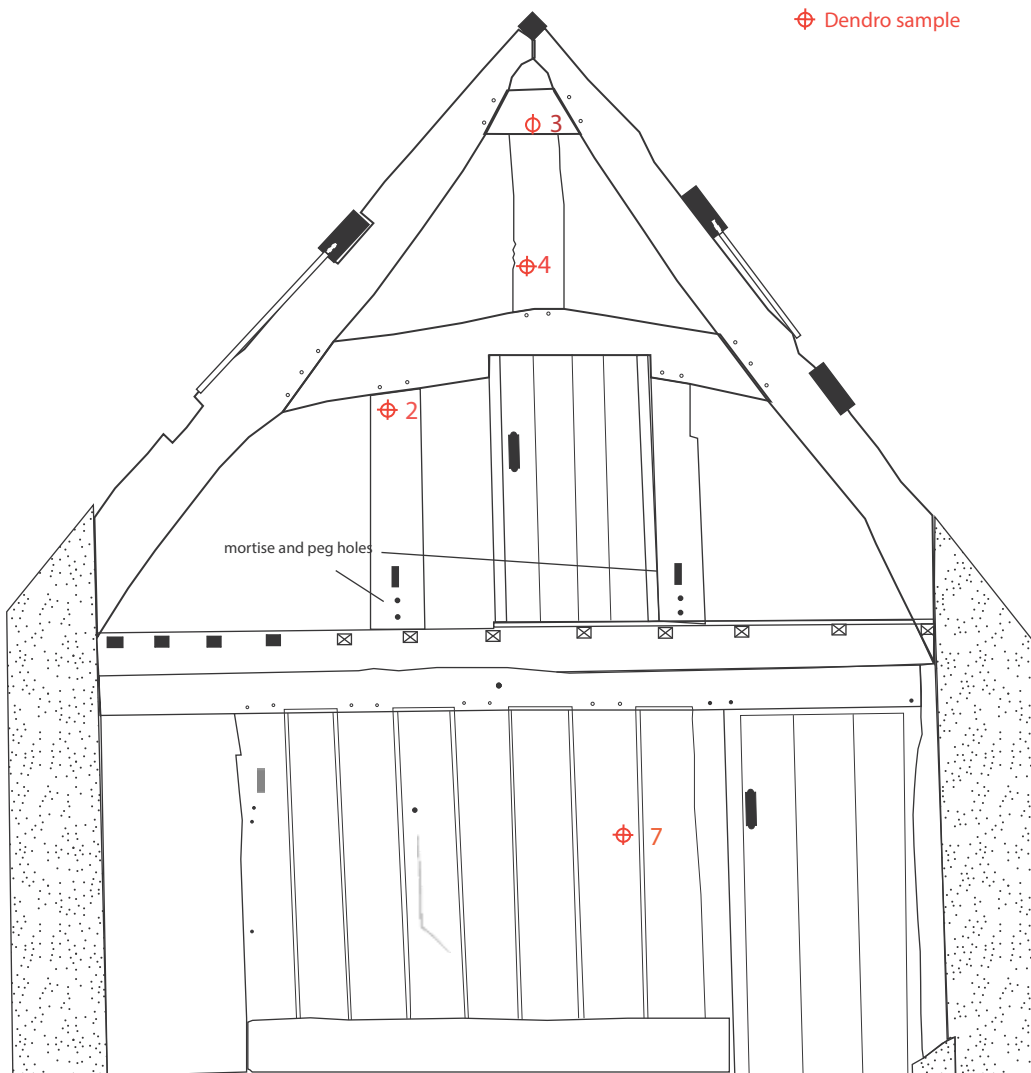
Figure 27: Section BB Truss 2.
Llanerch, Cynwyd, Denbighshire,
formerly Merioneth., LL21 ONB

Looking back the reverse face of Truss 2 is seen. (fig 24 and 27 section)
