CPAT Report No. 1532

St Michael's Church, Caerwys, Flintshire

Archaeological Watching Brief

An archaeological watching brief was carried out during the installation of a new septic tank at St Michaels Church, Caerwys. The work involved examining the excavation of both the large pit in which the tank was placed and an associated drain on the north side of the church.

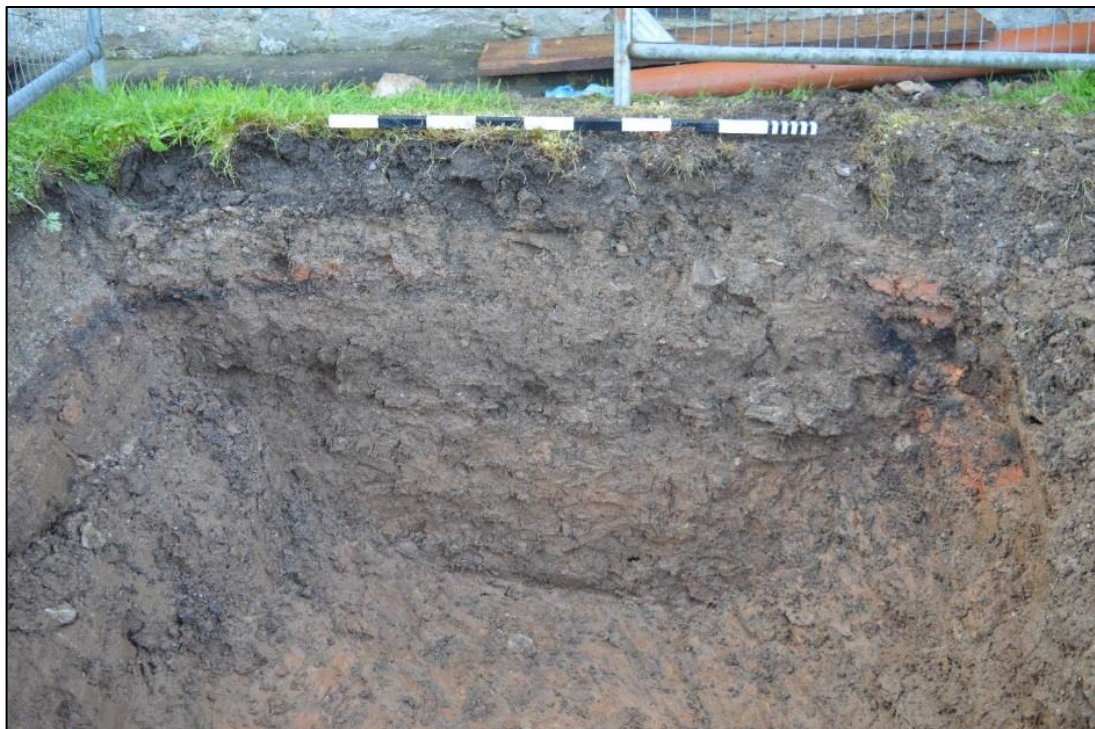
- 4.1. The watching brief was carried out over the course of two days; on day one, a large pit intended to house the septic tank was excavated down to the natural substrate, to a depth of approximately 1.1m. The excavated pit was sub-rectangular and measured 2.3m by 2.0m. It was located between the northern wall of the church, and a tarmac pathway connecting the north-east Lychgate to a doorway into the Nave.
- 4.2. Following the cleaning of the sides of the pit, the general stratigraphic sequence of the southern section, indicated an upper topsoil (101), above a demolition deposit (102), containing fragments of mortar and burning, which overlay a brown, silty clay sub-soil (103), from which occasional small fragments of human bone were recovered. The natural subsoil comprised a firm, stony, sandy clay (Fig. 2).

Fig. 2: The soil profile in the pit. Photo CPAT 4414-0006

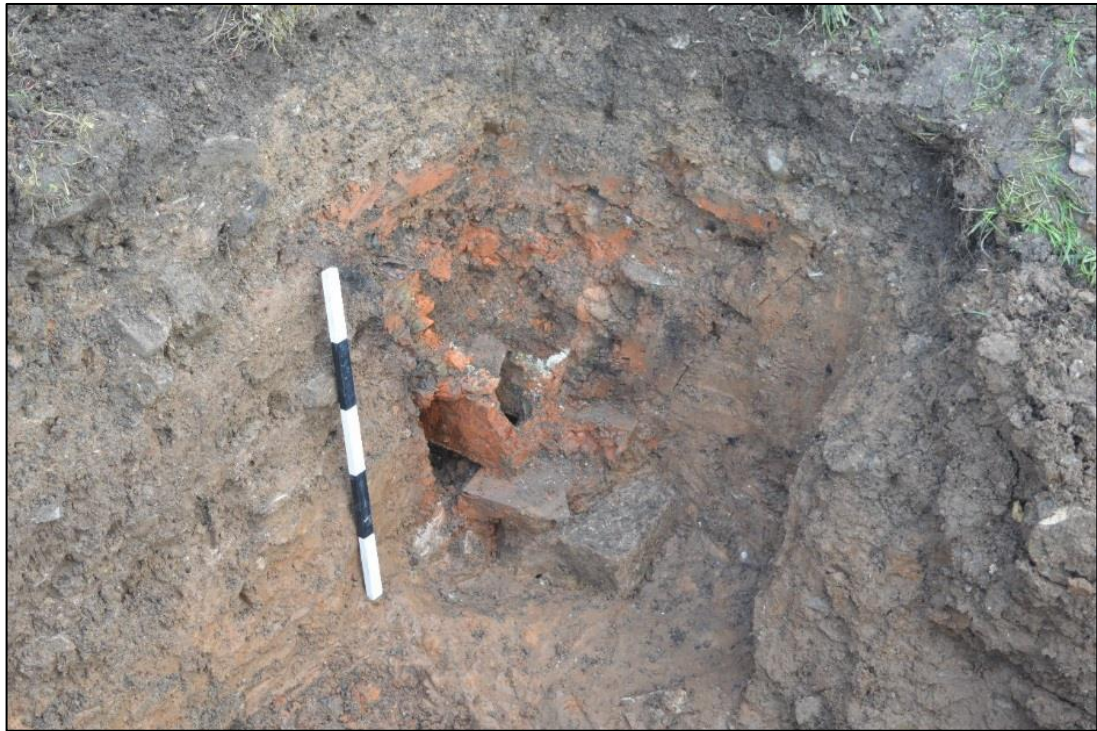
- 4.3. Structural remains (Fig. 3) were revealed in the south-west corner of the pit. Initial assessment of these remains suggested a cone shaped brick structure, which

measured 0.7m wide at the top, tapering down to 0.3m wide at the base. The overall height of the structure was approximately 0.55m, and it was stratigraphically directly beneath the topsoil (101). The top of the feature was capped by a broken band of clay (109), measuring 0.06m thick. Approximately 0.10m below the clay band was what appeared to be a free standing arrangement of heat affected bricks, forming what seemed to be a small chamber (107).

Fig. 3: The small chamber. Photo CPAT 4414-0018

- 4.4. The small chamber was 0.4m high by 0.3m wide, and appeared to be standing on a stone base or plinth, comprised of two limestone slabs (106), which measured 0.10m thick by 0.4m and 0.4m. Between the bricks of the chamber and the sloping outer edges of the feature, was a deposit of firm sandy clay, with evidence of burning particularly noticeable in the eastern edge.
- 4.5. Upon partial removal of the bricks of the chamber, four adjoining bricks were identified, arranged in a way suggestive of a possible vaulted roof, above what appeared to be a substantial void (Fig. 4). As far as could be investigated, the void extended in a southerly direction towards the northern wall of the church, for a distance of at least 0.5m metres, but its true extent could not be determined. The bricks imply an 18th- or 19th-century date for the structure.

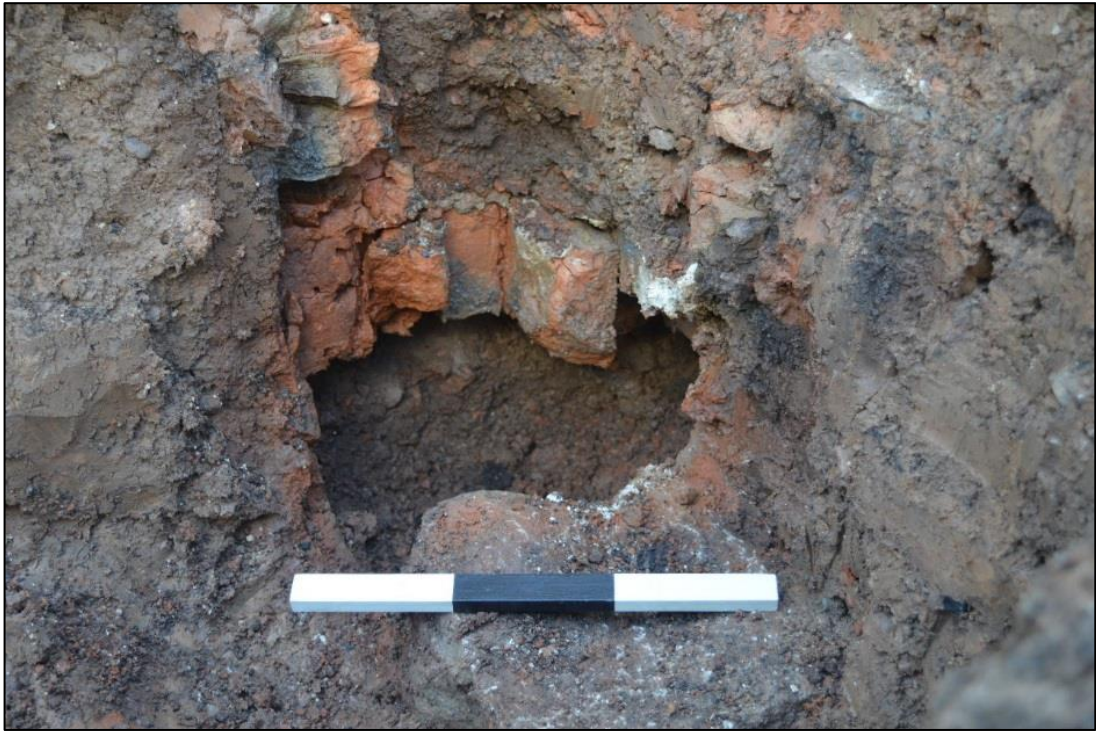
Fig 4: The possible vaulted ceiling above the void mentioned above. Photo CPAT 4414-0020

- 5.2. The other possibility was that the structure represented the remains of a small external crypt. The main evidence for this was the arched brick vaulting seen behind the small internal chamber, which was akin to a stone-built external crypt found by CPAT on the north side of Abergele church (Grant 2006). If it was such a structure, then given the nature of the materials of its construction, it would likely date to the 18th or 19th centuries. More extensive excavations, outwith the scope of this watching brief, would be needed to verify this possibility.

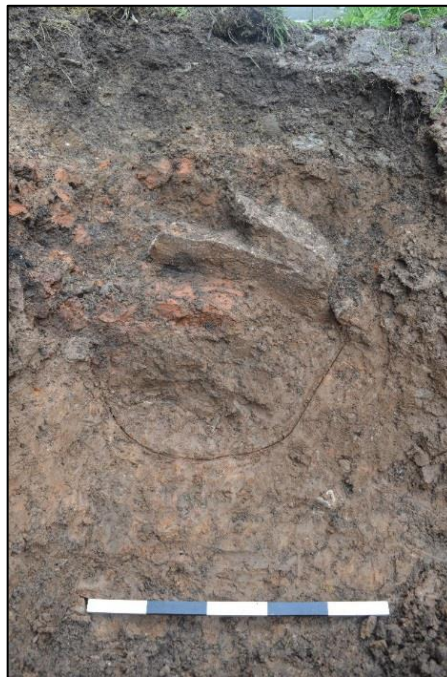
- 4.6. Visible in the western section of the pit, and directly below the bricks and limestone slabs of the chamber, was what appeared to be a feature cut into the natural subsoil (108). It measured 0.28m wide by 0.2m deep, and displayed a U-shaped profile (see Fig. 4). It was filled by a brown, friable, silty clay deposit, and contained two small fragments of human bone which were recovered from the base of the exposed fill.

Fig. 5: The U-shaped cut feature. Photo CPAT 4414-0011

- 5.4. Although a fragment of human bone was recovered from the fill of the exposed section of an earlier U-shaped feature (108), this could well have been residual, as other fragments were found in the lower fill generally. The section that was exposed would suggest an east/west orientation, supporting the possibility that this was a grave cut, though the possibility that this was some form of foundation trench or gully for the overlying brick structure cannot be ruled out.
