ARCHAEOLOGICAL WATCHING BRIEF

WB3/TRE/10

Bedwelty House, Tredegar

PREPARED BY DR N PHILLIPS
14TH OCTOBER 2010

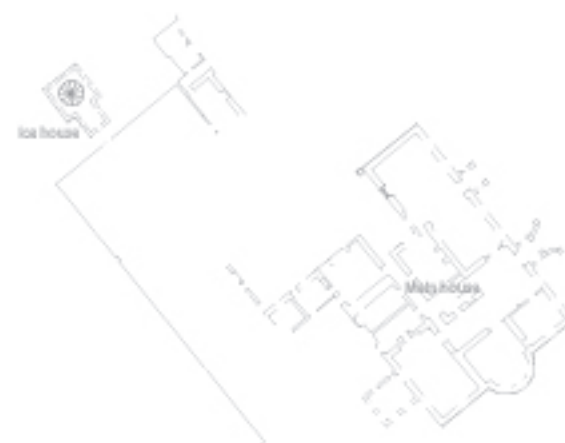
Figure 02: Position of site to main house

Structure

Length: 14.11m

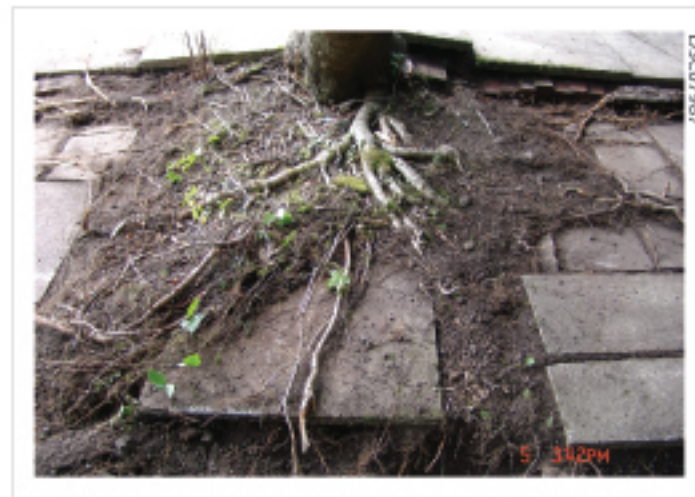
Plate 03: Mid and upper terraces.

Clearance by machine proved to be fairly limited due to the nature of the structure and the intensity of root presence; in particular, a central tree and root system, Plate 03 and another tree close to the northern end plate 04.

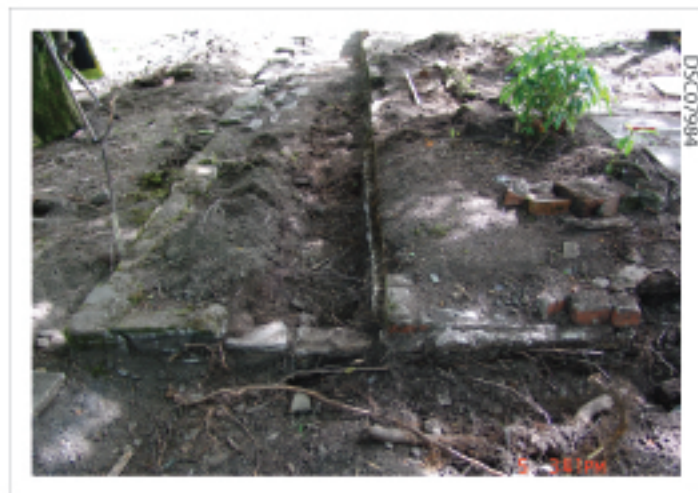
Plate 04: North edge of mid and lower terrace

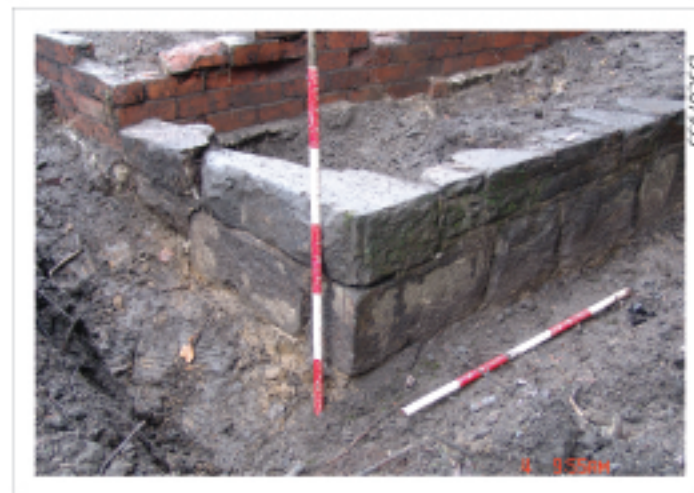
Plate 05: External wall at lower terrace SE corner showing dressed stone

Unlike the other two terraces above, the lower terrace was contained within a surround of cement bonded masonry which included both rough finished and dressed stone, figs 03 & 04, Plates 05 & 22.

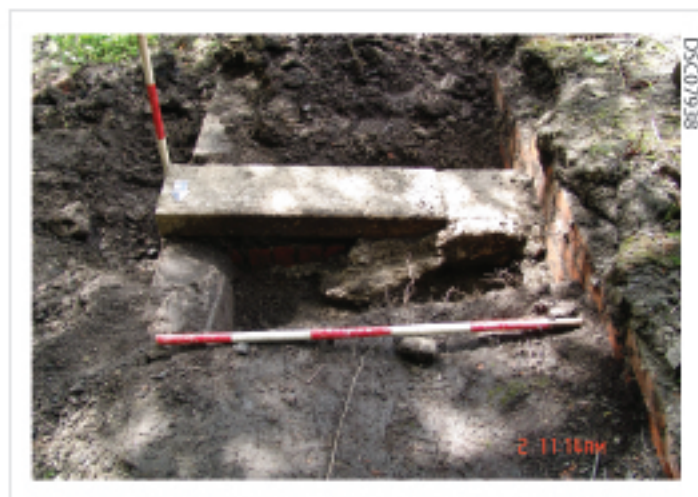
Plate 06: Exposed cross wall

The north/south ground slope was again dealt with by the inclusion of a step but this time made up of pre-cast concrete blocks, figs 03 & 04, Plates 06 & 16 on a base of cement and end laid bricks.

Test pit 1, figs 03 & 04, Plates 06, & 17, examined both north and south faces of the brick wall under the concrete step. The test pit reached a depth of 0.11m for a distance of 0.5m around the structure before interfacing with the clay layer. The test pit also proved the existence of a cement foundation to the walls but also provided no finds.

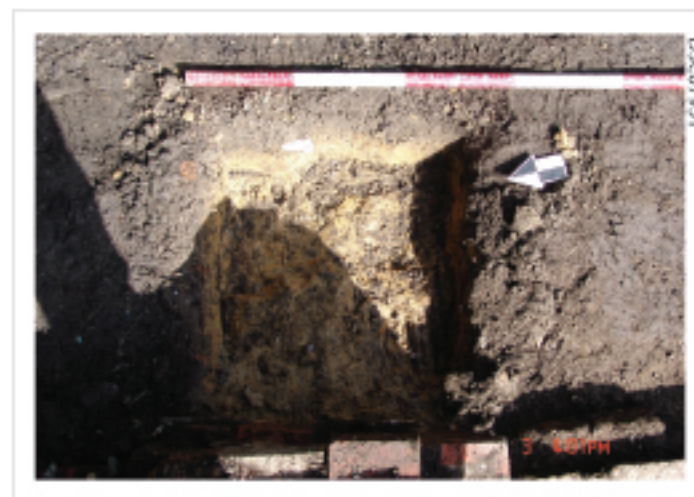
Plate 07: Exploratory trench in mid terrace abutting upper terrace and step

Two test pits: TP2 and TP3, were excavated in the mid terrace, figs 03 & 04, Plates 07, 10 & 11.

TP2, Plates 07 & 10, against the east wall of the upper terrace was approximately 0.5m by 0.5m and reached a depth of 0.08m beneath the present floor level. It produced no finds but did reveal natural clay at a depth of 0.4m beneath the present surface and a thin 0.3 layer of cement in the foundation of the upper terrace wall.

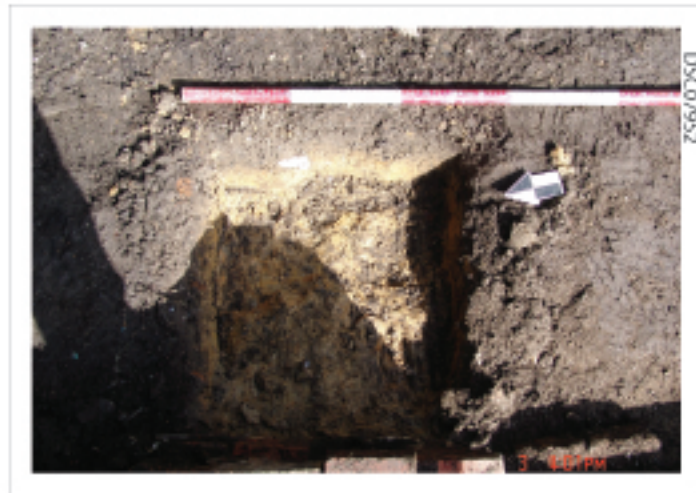
Plate 08: Exploratory trench in lower terrace at south east corner

Test pit 4, figs 03 & 04, Plates 08, & 09, examined the internal fill behind the southern corner of the lower terrace. The test pit examined the entire width of the trench for the distance of 1m. The depth of this trench reached 0.8m before encountering the clay layer and also produced no finds. The test pit did show however, that the masonry wall had no cement foundation and had been laid directly on the clay.

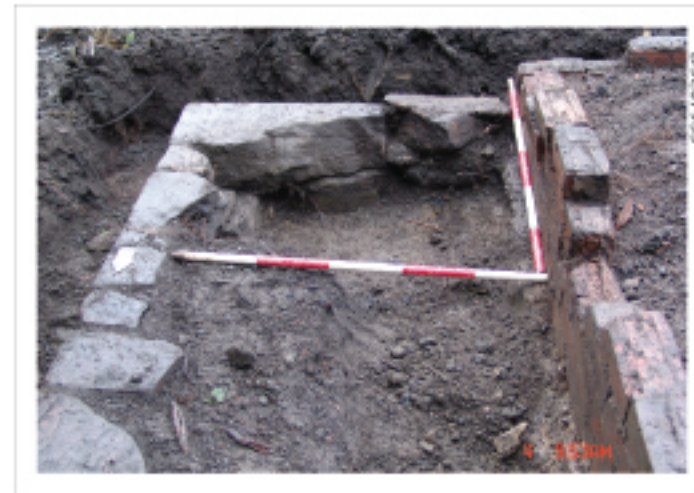
Plate 09: Exploratory trench in lower terrace at south east corner

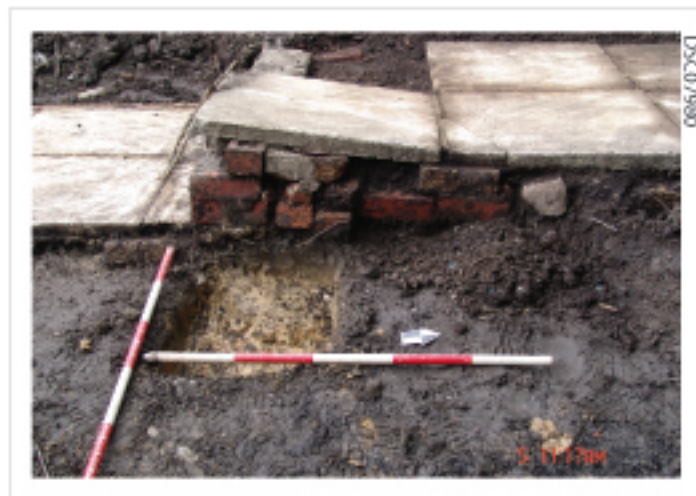
Plate 10: Exploratory trench TP2

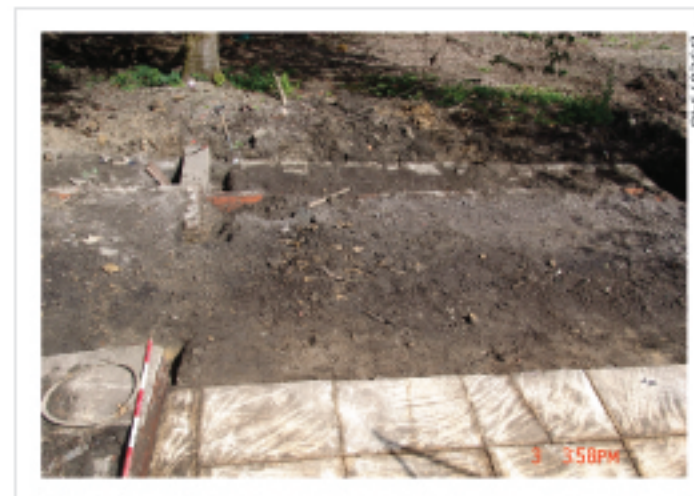
Plate 11: Upper terrace, mid point with step to the north mid & lower terraces shown

TP3, figs 03 & 04, Plate 11, a 0.5m wide excavation against the west wall of the mid terrace and around the double skin brick course, (see above). This test pit; reaching a depth of 0.9m beneath the present surface, also produced no finds. The test pit stopped short of the clay layer but proved the existence of cement foundation to the double skin brick course.

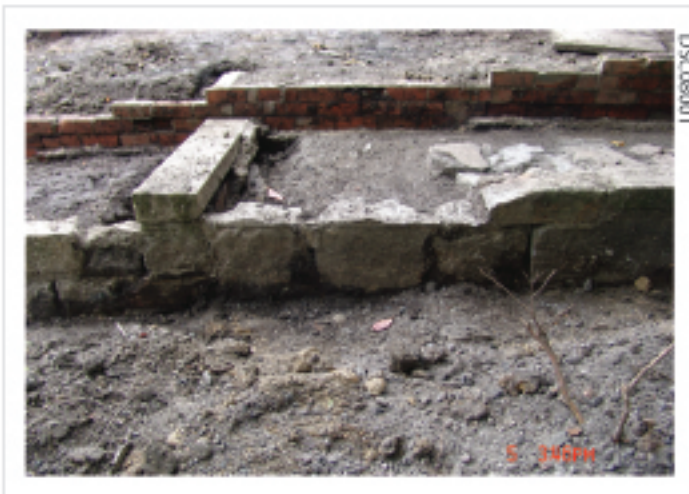
Plate 16: Lower terrace, wall face

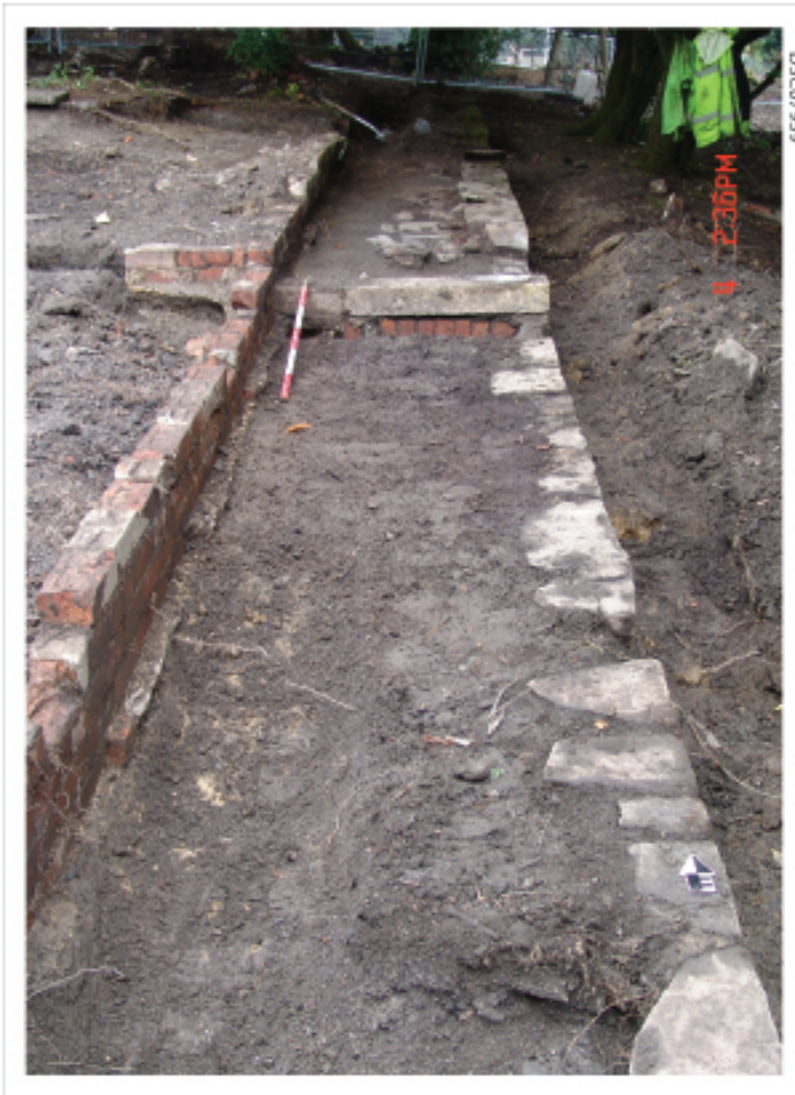
Plate 17: Overview along lower terrace after clearing

The southern end also had a partial fill of rough masonry, Plate 17.

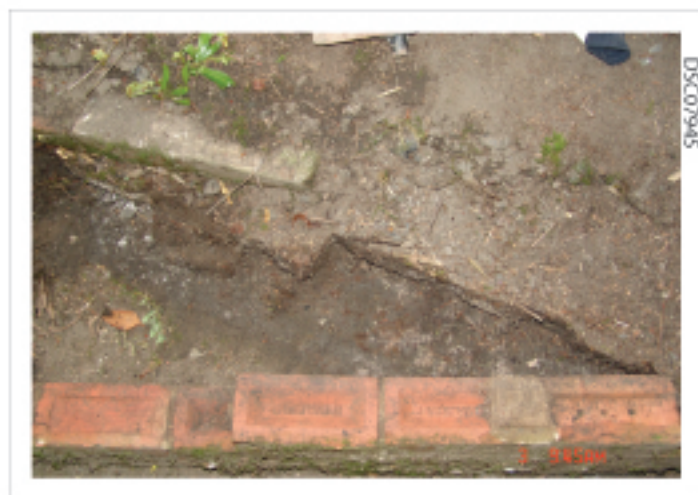
Plate 18: North edge of mid terrace showing brick construction "EBBW VALE" frogs

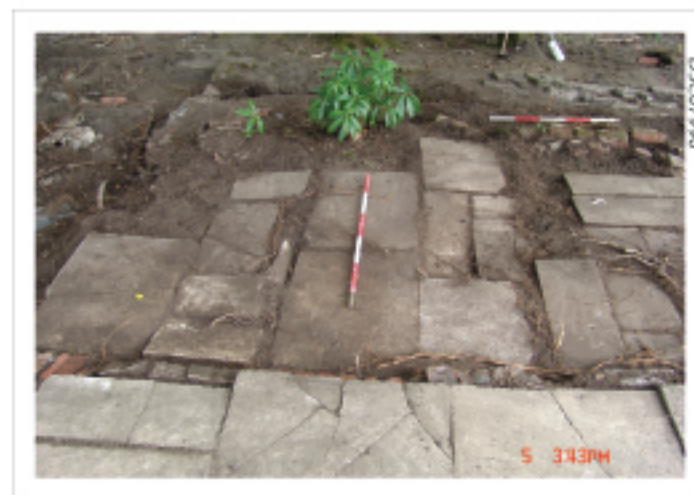
Plate 19: Lower, mid and upper terraces.

That said; the randomness of the layout with mismatched slab sizes can never have produced a very even or aesthetically pleasing floor, figs 03 & 04, Plates 19 & 20.

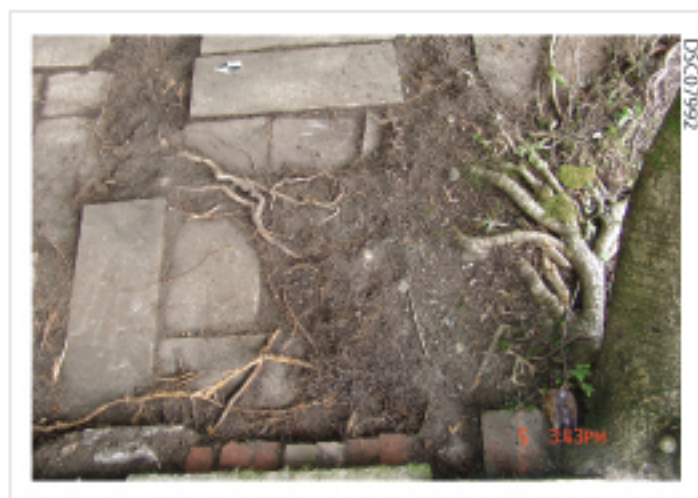
Plate 20: Mid terrace showing tree root damage

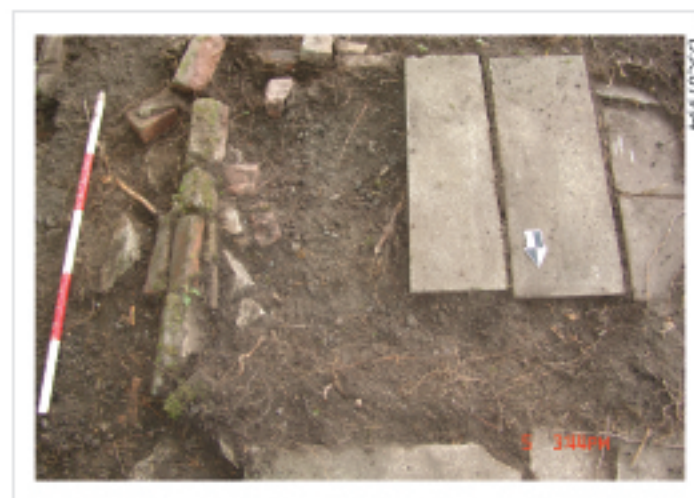
Plate 21: Mid terrace & brick structure cleared

At the southern and eastern ends of the slab covered area, was a tumbled row of cemented bricks, some two courses high, which formed a right-angled corner, fig 04, Plate 21. A change in direction and shape of the slabs close to this wall suggests some distinct difference to other areas within the site.

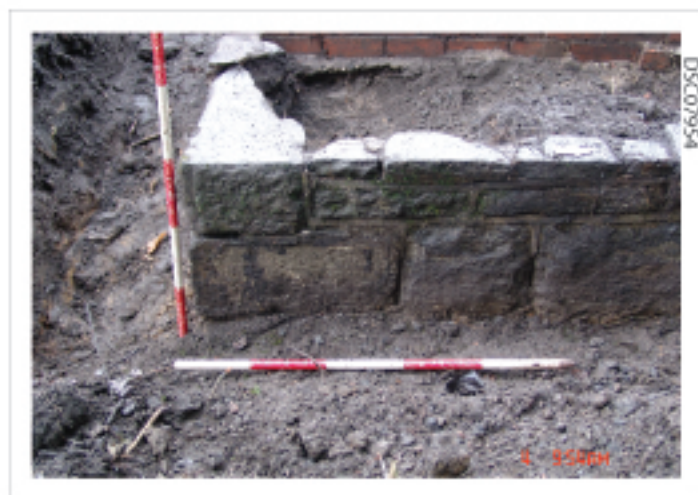
Plate 22: External wall at lower terrace SE corner showing dressed stone

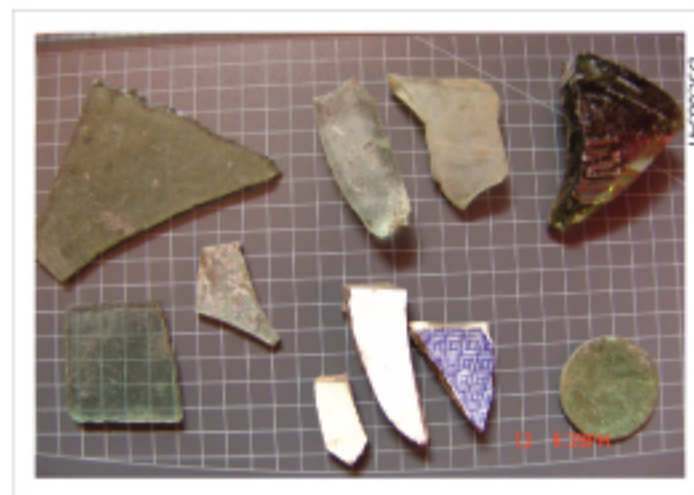
Plate 23: Small finds

Of those finds removed during trowelling were three shards of green tinged, 2mm, window glass. One piece of dark green, embossed, beer bottle, two shards of aqua glass bottles, two pieces of white china and one piece of willow pattern. These all came from the mid terrace, southern section, surface finds, Plate 23.

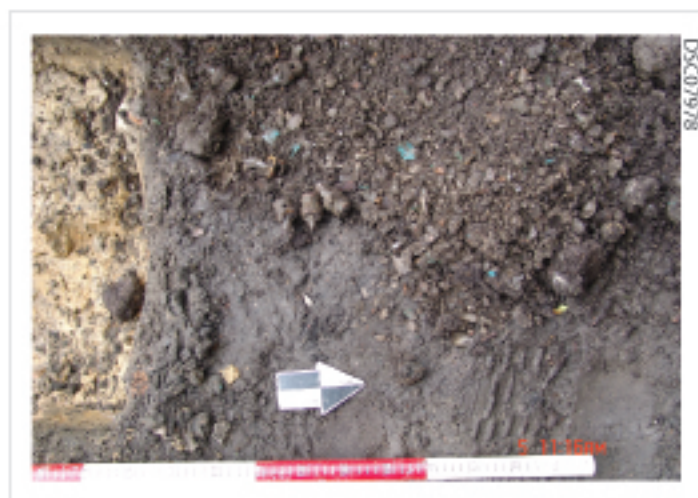
Plate 24: Fill of broken light bulbs, mid terrace abutting upper terrace

Just to the north of TP2, against the upper terrace wall was a small deposit of broken light bulbs, Plates 24 & 25.

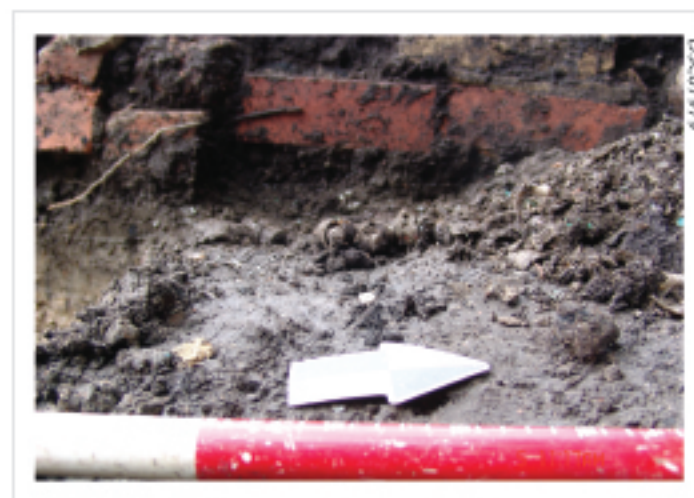
Plate 25: Fill of broken light bulbs, mid terrace abutting upper terrace, (close up)
