# Cawdor Hall, Newcastle Emllyn Watching Brief

# Cawdor Hall Newcastle Emlyn Watching Brief

Trysor Project No. 2014/396

## Watching Brief

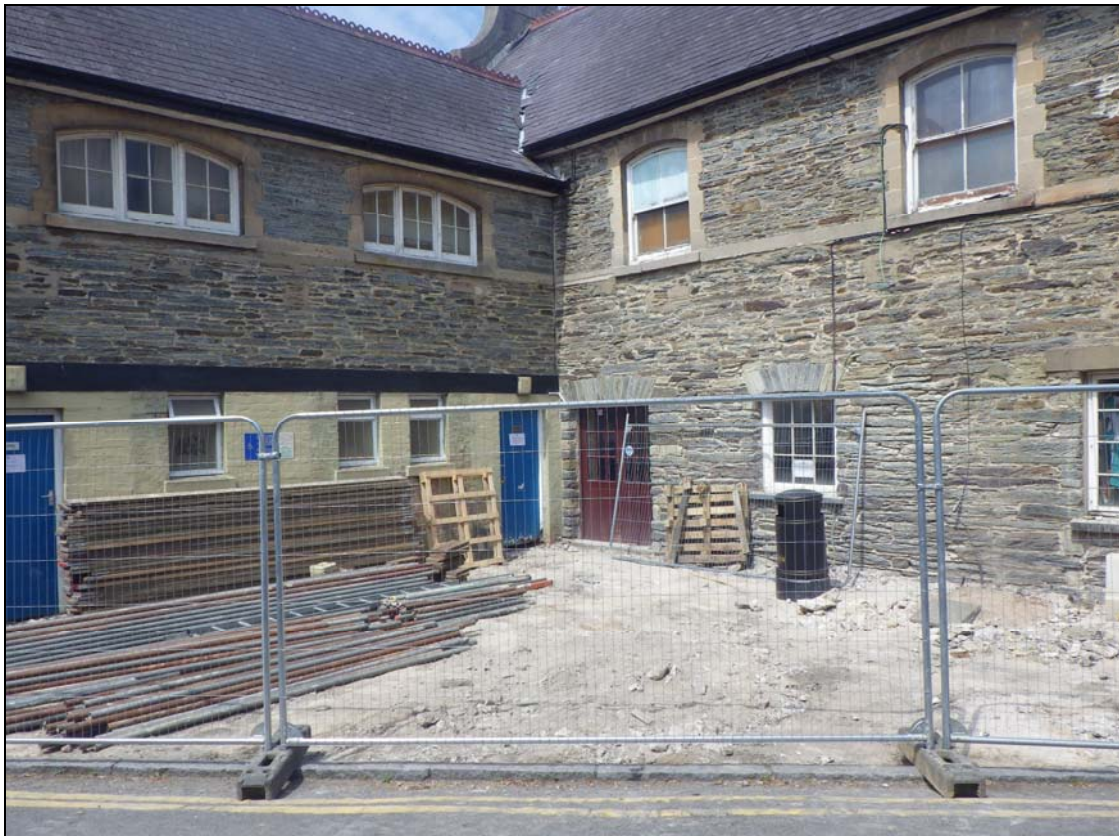
*Plate 1: CHN2014\_102: The rear of Cawdor Hall, looking northwest. To the left is the rear elevation of the 1892 extension, with brick reveals and voissours to its windows. To the right is the southern lateral wall of the earlier Market Hall, with original stone voissours remaining above the doorway and one window. The yellow brickwork in the upper floor shows that the roof of the original Market Hall was raised in 1892.*

7.2 Map evidence and scrutiny of the fabric of the present Market Hall shows that the rear or eastern wing of the building is in fact the pre-1892 Market Hall. It would appear that the original building was extended along its west-facing side, with a new façade added along the street front at that time. Evidence of this development was seen during the watching brief, when it was observed that a cobbled pavement (Context No, 007), running parallel to the southern lateral wall of the original Market Hall, had been truncated by the 1892 extension (see Context Catalogue in 9.2 below). Internally, the extension included ground floor shop units, which survived within living memory. During the second half of the 20<sup>th</sup> century the shop units were replaced by a public toilet, which closed in recent times.

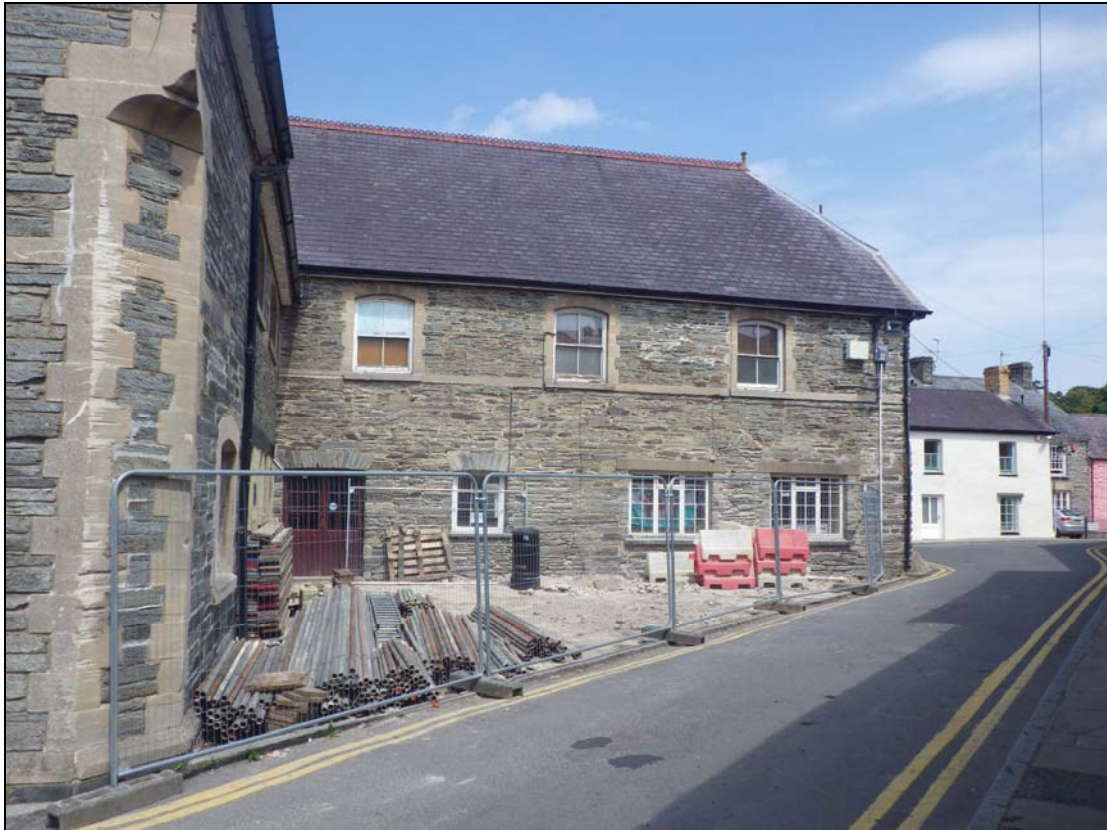
*Plate 2: CHN2014\_101: The rear of Cawdor Hall, after the removal of the paving slabs, context 002, looking north northeast.*

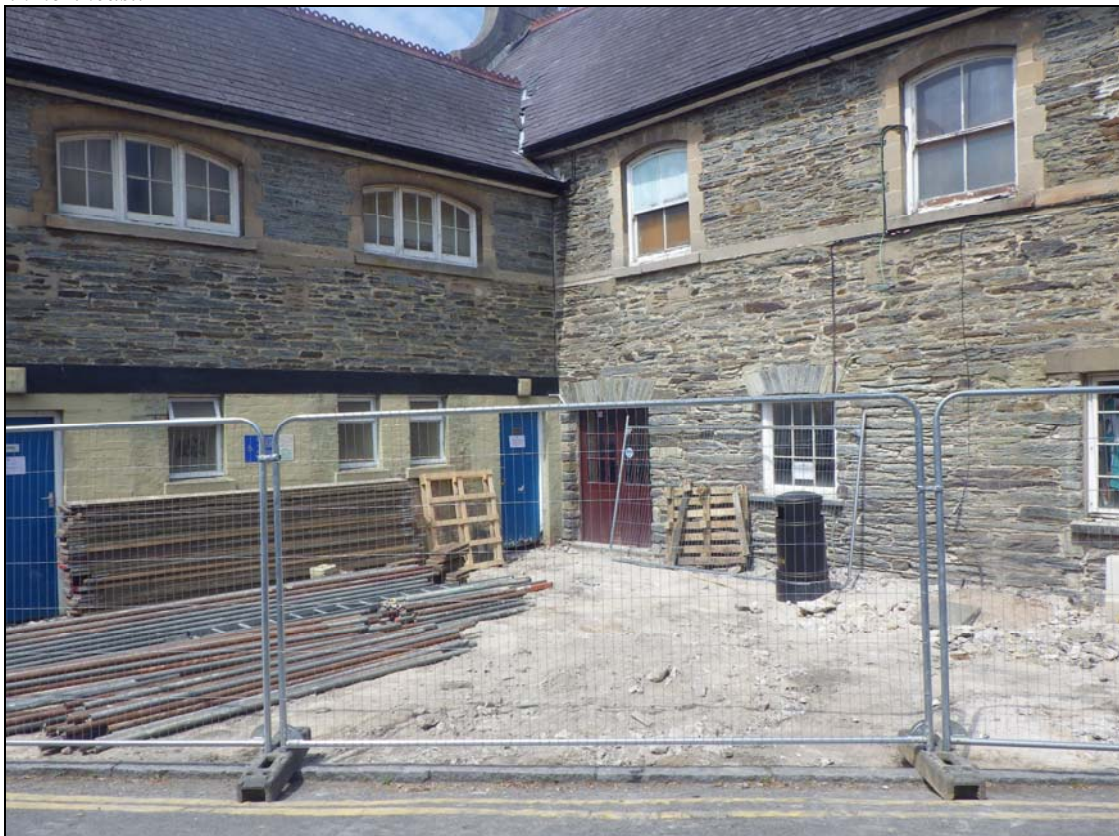
*Plate 3: CHN2014\_102: The rear of Cawdor Hall, after the removal of the paving slabs, context 002, looking northwest.*

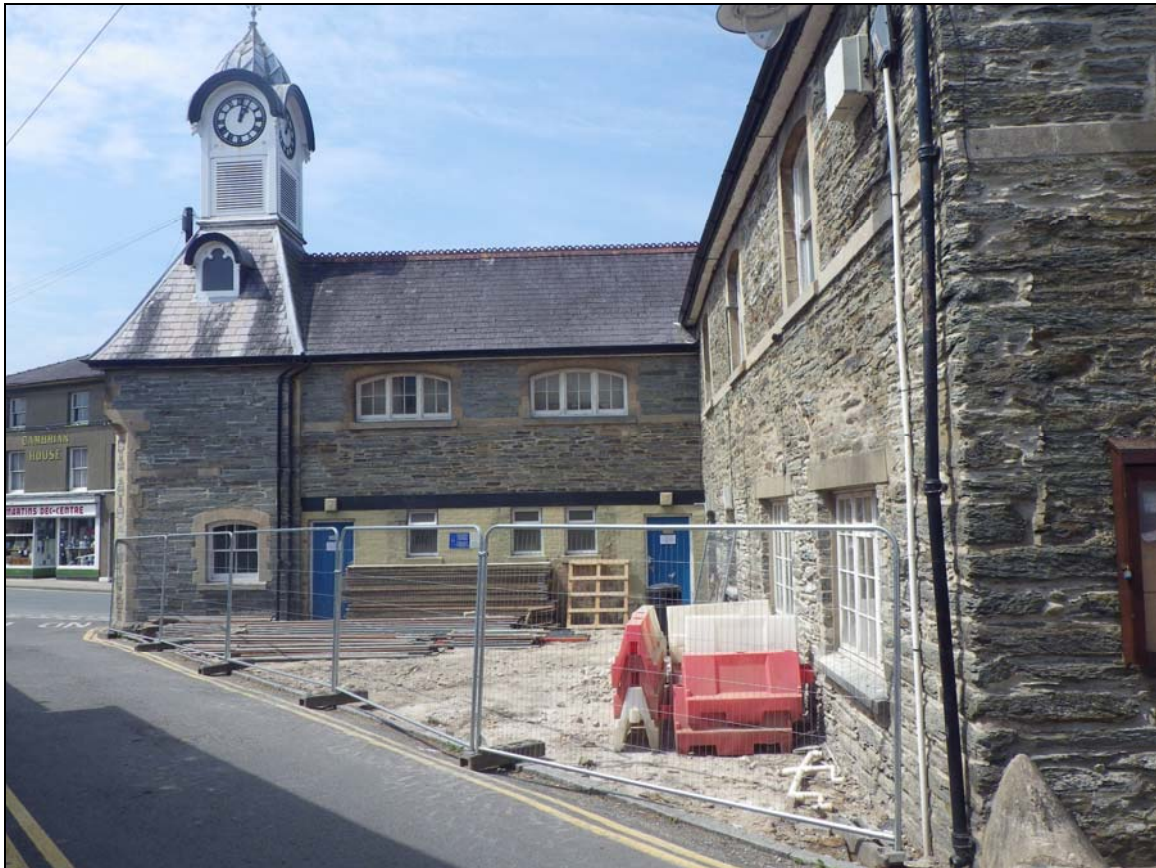
Plate 4: CHN2014\_103: The rear of the Cawdor Hall, after the removal of the paving slabs, context 002, looking west.

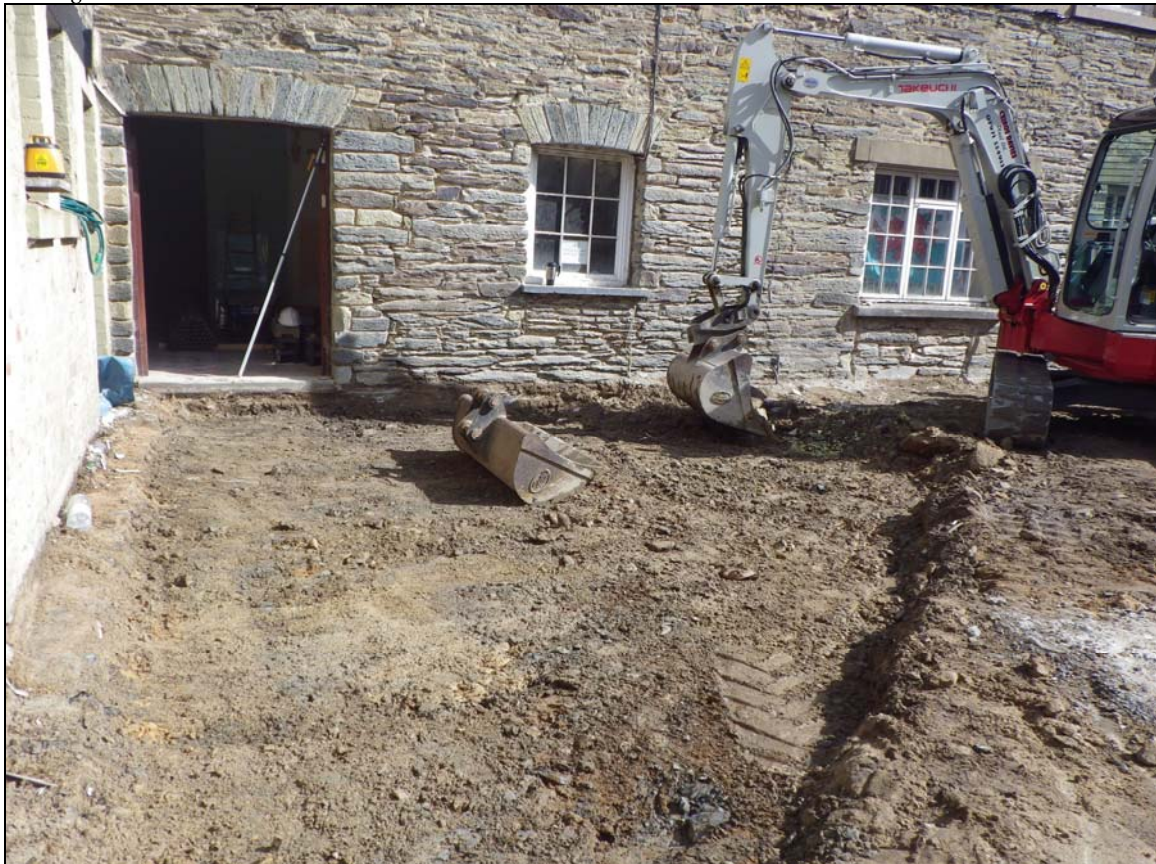
Plate 5: CHN2014\_104: During removal of 003, the bedding layer below paving slabs 002, looking north.

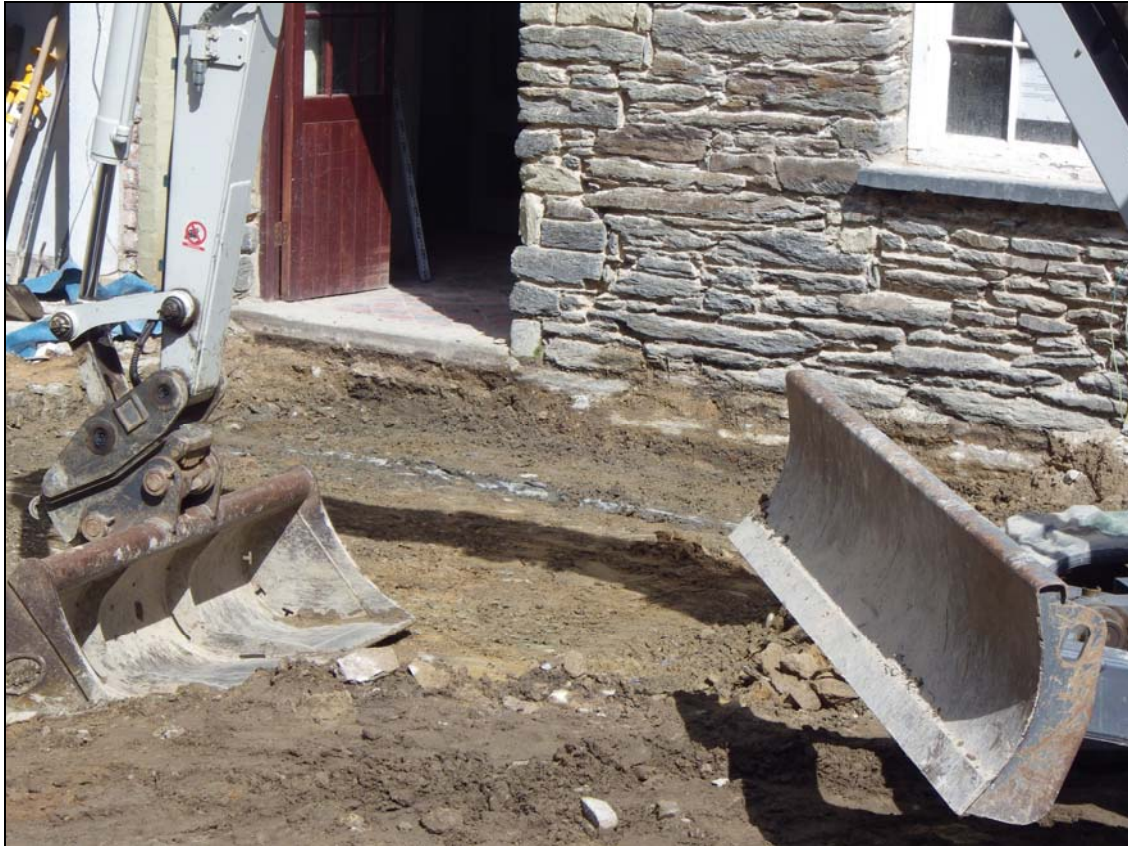
Plate 6:CHN2014\_105: Cobbles 004 and upright edging slabs 005 of pavement 007 revealed after removal of 003, looking northwest.

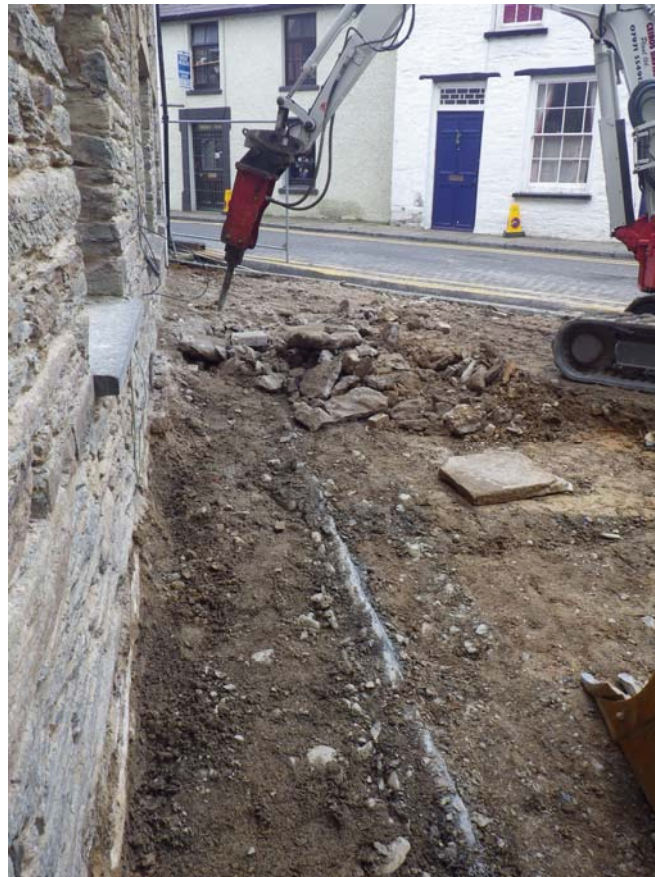
Plate 7:CHN2014\_106: Removing concrete 001, the base of a former telephone box, from above cobble pavement 007, the up right edging, 005, of which is visible in the foreground, looking east southeast.

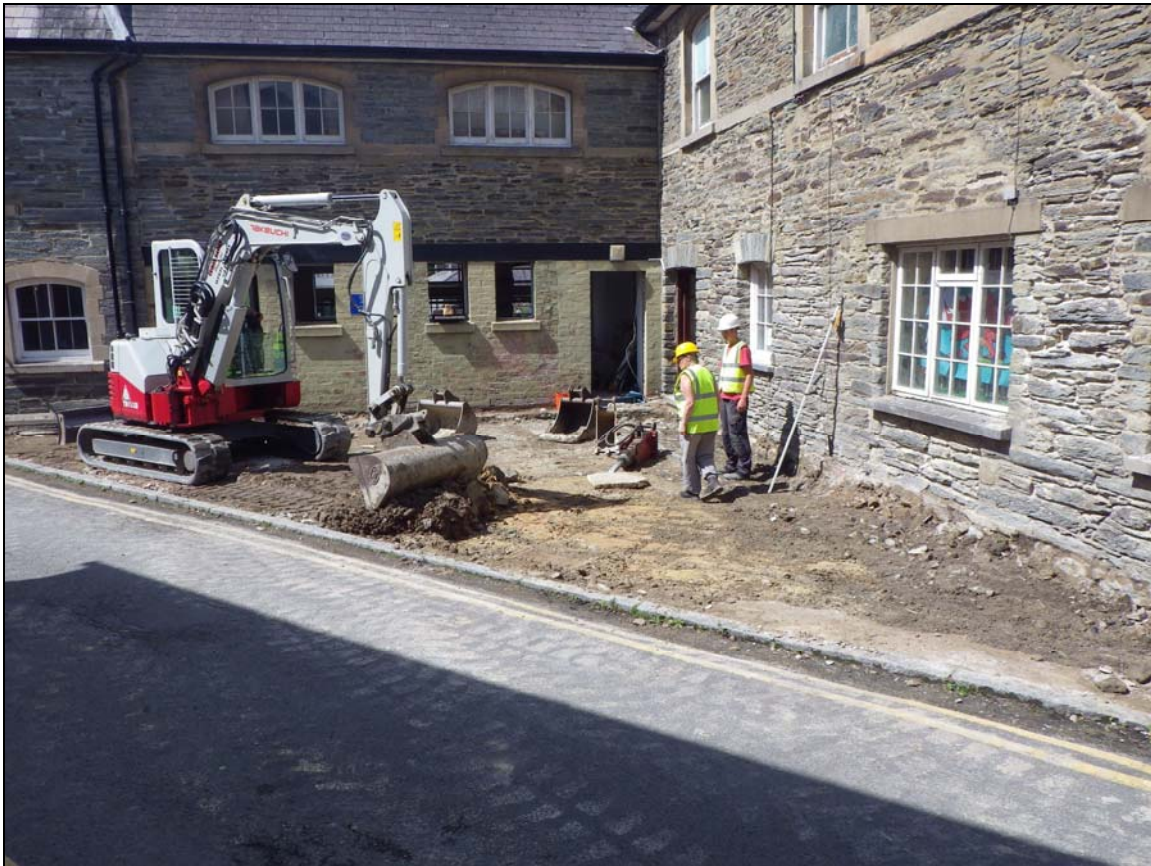
Plate 8: CHN2014\_107: During removal of 003, revealing 014, a loose layer of mortar and stone and the natural subsoil 015, looking west northwest.

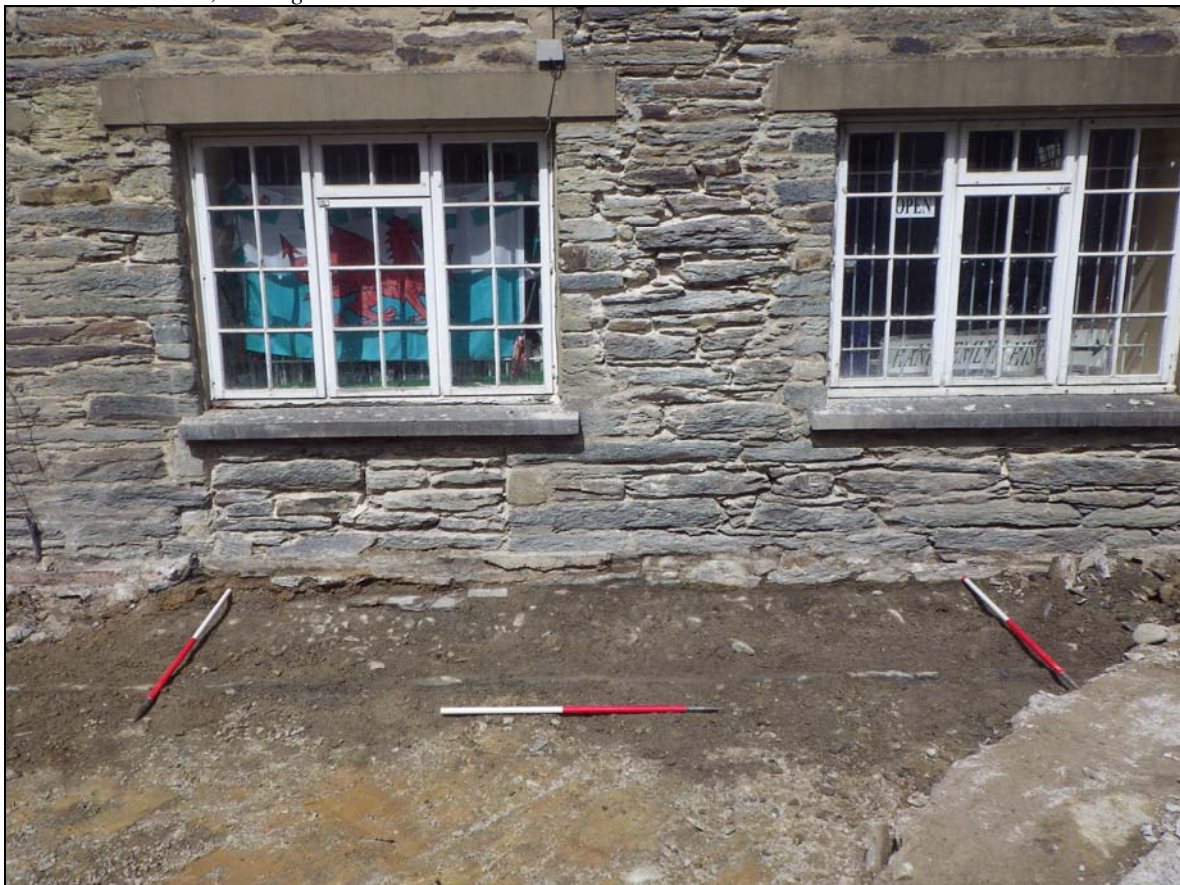
Plate 9: CHN2014\_108: The eastern part of cobbled pavement 007, looking north northeast.

<b>CHN2014_108</b>	The eastern part of cobbled pavement 007.	11/08/2014	Looking north northeast.
<b>CHN2014_109</b>	Cobbled pavement 007	11/08/2014	Looking west northwest.
<b>CHN2014_110</b>	Cobbled pavement 007	11/08/2014	Looking west northwest.
<b>CHN2014_111</b>	One of 11 photos, photographing pavement 007, metre by metre 0 to 1 metre, showing step up to current doorways from pavement 007	11/08/2014	Looking north northeast.
<b>CHN2014_112</b>	One of 11 photos, photographing pavement 007, metre by metre 1 to 2 metres.	11/08/2014	Looking north northeast.
<b>CHN2014_113</b>	One of 11 photos, photographing pavement 007, metre by metre 2 to 3 metres.	11/08/2014	Looking north northeast.
<b>CHN2014_114</b>	One of 11 photos, photographing	11/08/2014	Looking north

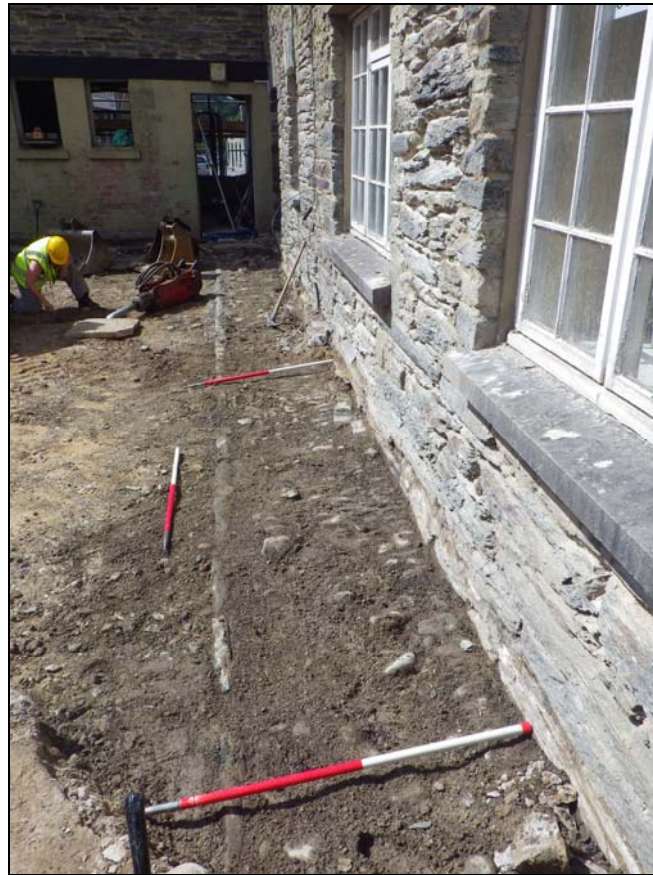
Plate 10: CHN2014\_109: Cobbled pavement 007, looking west northwest.

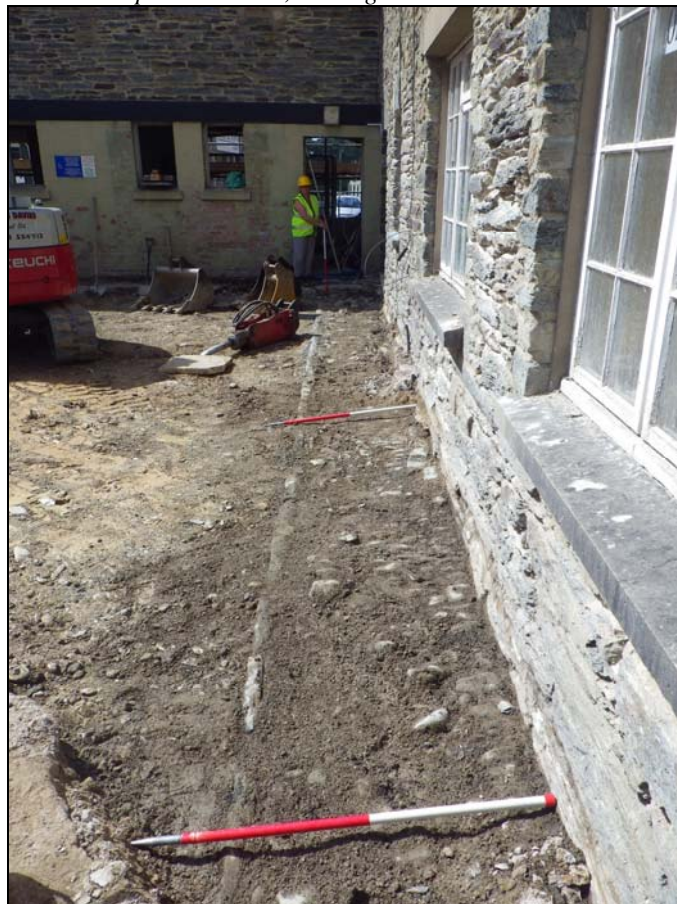
Plate 11: CHN2014\_110: Cobbled pavement 007, looking west northwest.

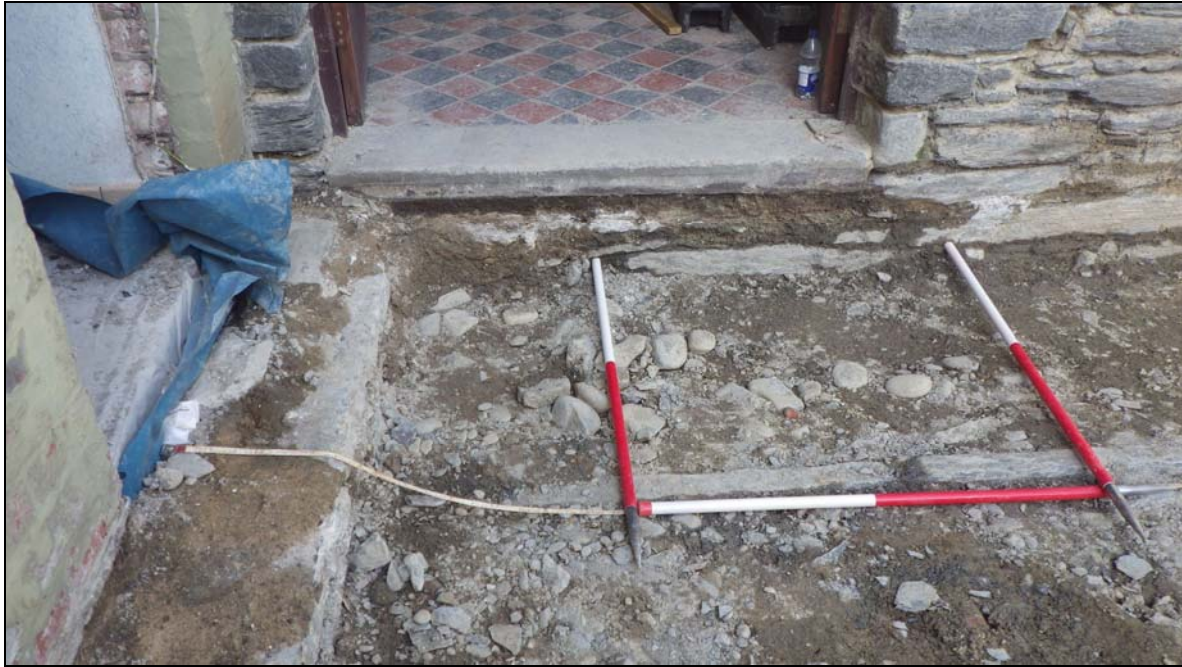
*Plate 12: CHN2014\_111: One of 11 photos, photographing pavement 007, metre by metre. 0 to 1 metre, showing step-up to current doorways from pavement 007, looking north northeast.*

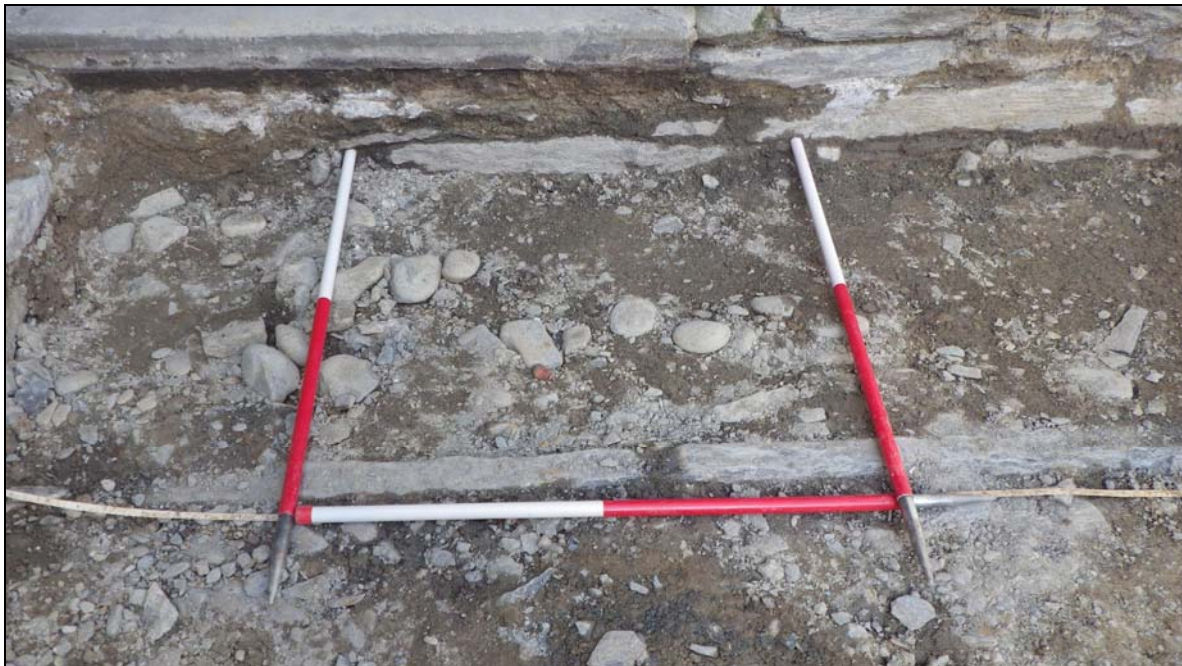
*Plate 13: CHN2014\_112: One of 11 photos, photographing pavement 007, metre by metre. 1 to 2 metres, looking north northeast.*

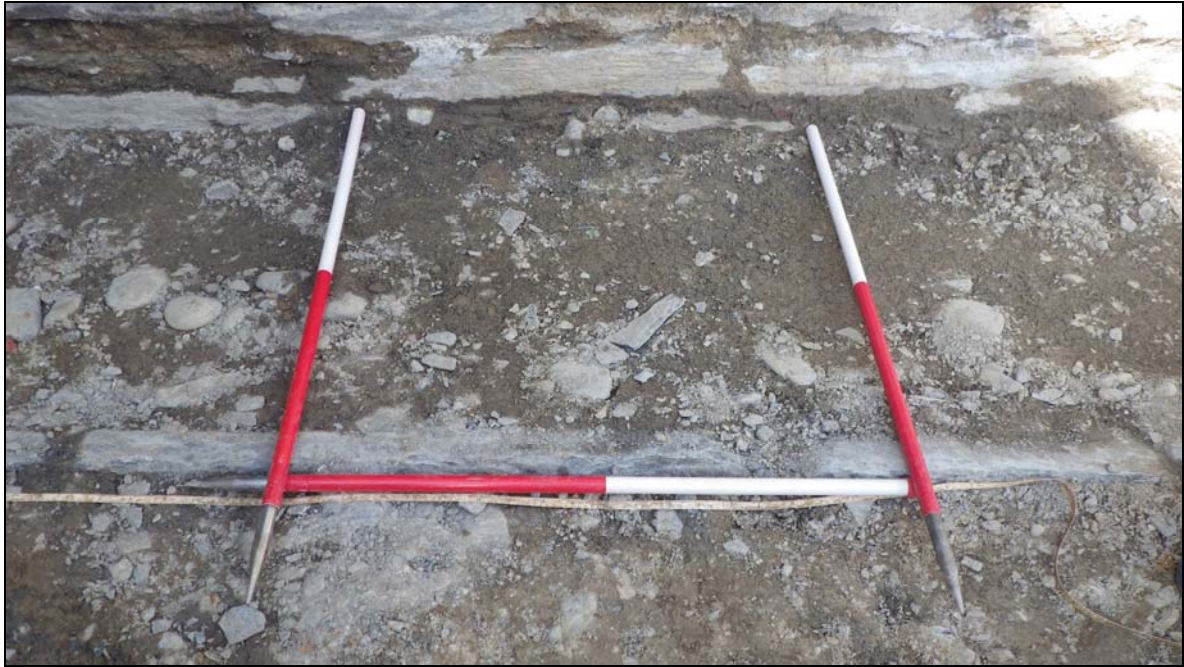
Plate 14: CHN2014\_113: One of 11 photos, photographing pavement 007, metre by metre. 2 to 3 metres, looking north northeast.

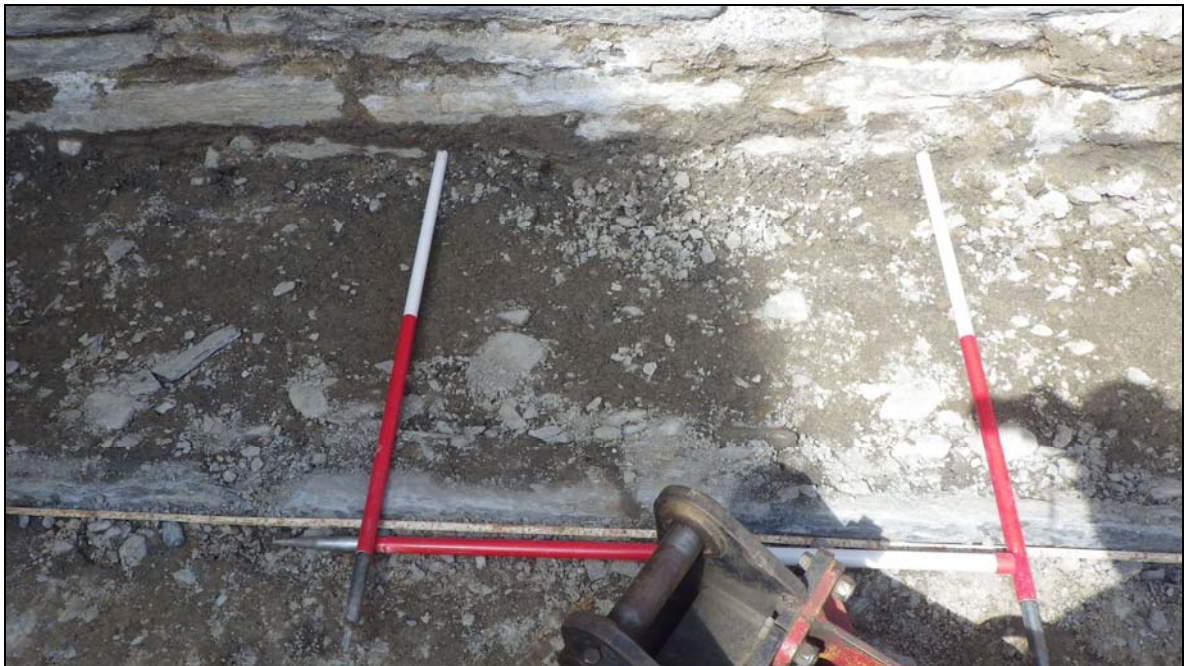
Plate 15: CHN2014\_114: One of 11 photos, photographing pavement 007, metre by metre. 3 to 4 metres, looking north northeast.

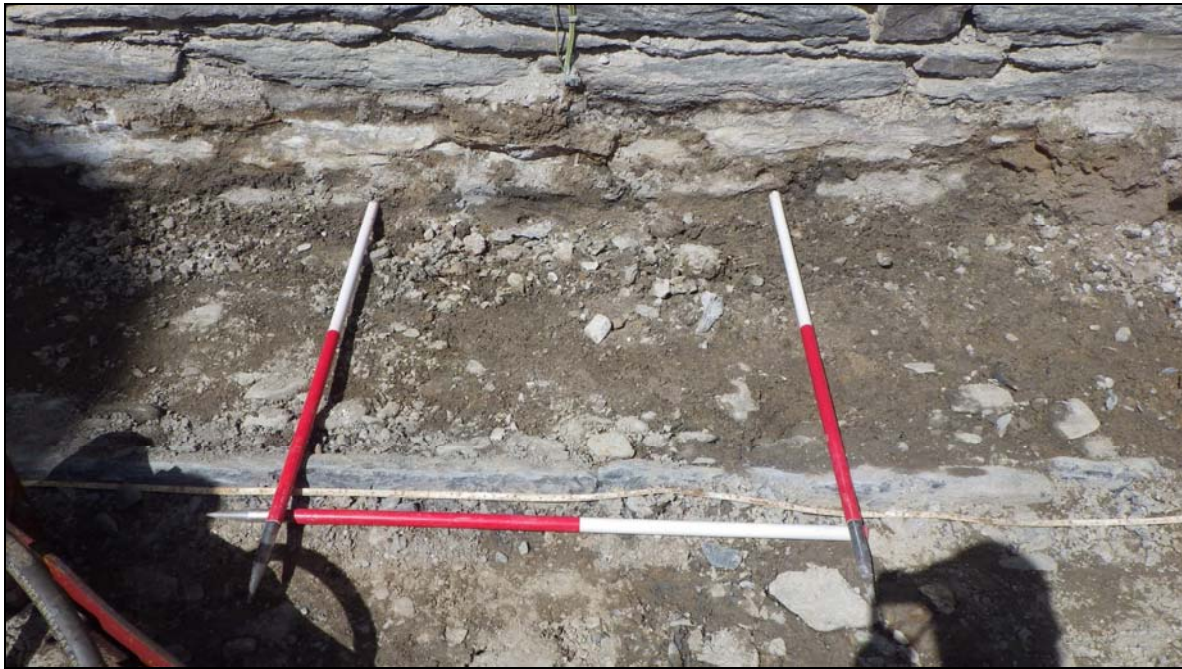
Plate 16: CHN2014\_115: One of 11 photos, photographing pavement 007, metre by metre. 4 to 5 metres, looking north northeast.

pavement 007, metre by metre 3 to 4 metres.		northeast.
<b>CHN2014_115</b>	One of 11 photos, photographing pavement 007, metre by metre 4 to 5 metres.	11/08/2014	Looking north northeast.
<b>CHN2014_116</b>	One of 11 photos, photographing pavement 007, metre by metre 5 to 6 metres.	11/08/2014	Looking north northeast.
<b>CHN2014_117</b>	One of 11 photos, photographing pavement 007, metre by metre 6 to 7 metres.	11/08/2014	Looking north northeast.
<b>CHN2014_118</b>	One of 11 photos, photographing pavement 007, metre by metre 7 to 8 metres.	11/08/2014	Looking north northeast.
<b>CHN2014_119</b>	One of 11 photos, photographing pavement 007, metre by metre 8 to 9 metres.	11/08/2014	Looking north northeast.
<b>CHN2014_120</b>	One of 11 photos, photographing pavement 007, metre by metre 9 to 10 metres.	11/08/2014	Looking north northeast.
<b>CHN2014_121</b>	One of 11 photos, photographing pavement 007, metre by metre 10 to 11 metres.	11/08/2014	Looking north northeast.

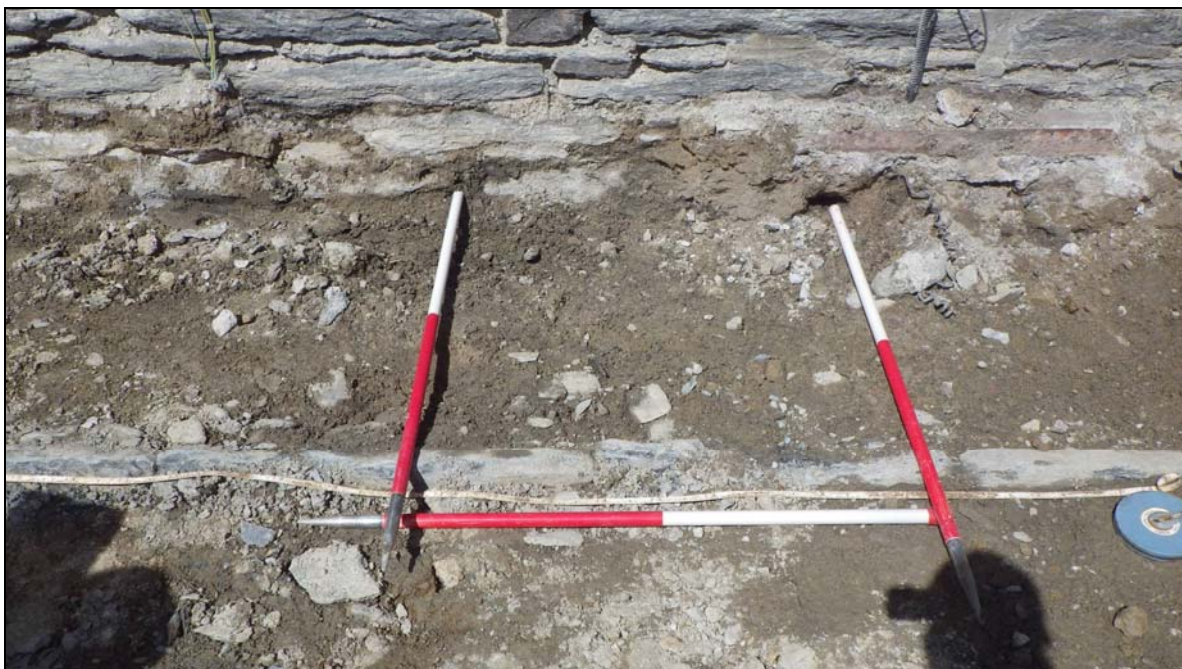
Plate 17: CHN2014\_116: One of 11 photos, photographing pavement 007, metre by metre. 5 to 6 metres, looking north northeast.

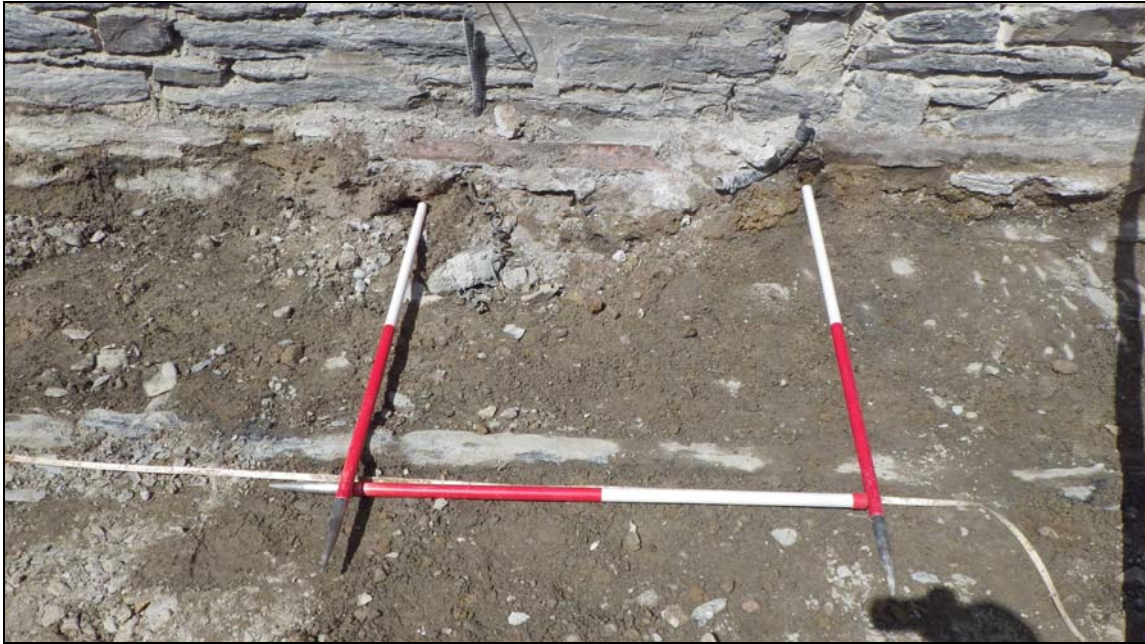
Plate 18: CNH2014\_117: One of 11 photos, photographing pavement 007, metre by metre. 6 to 7 metres, looking north northeast.

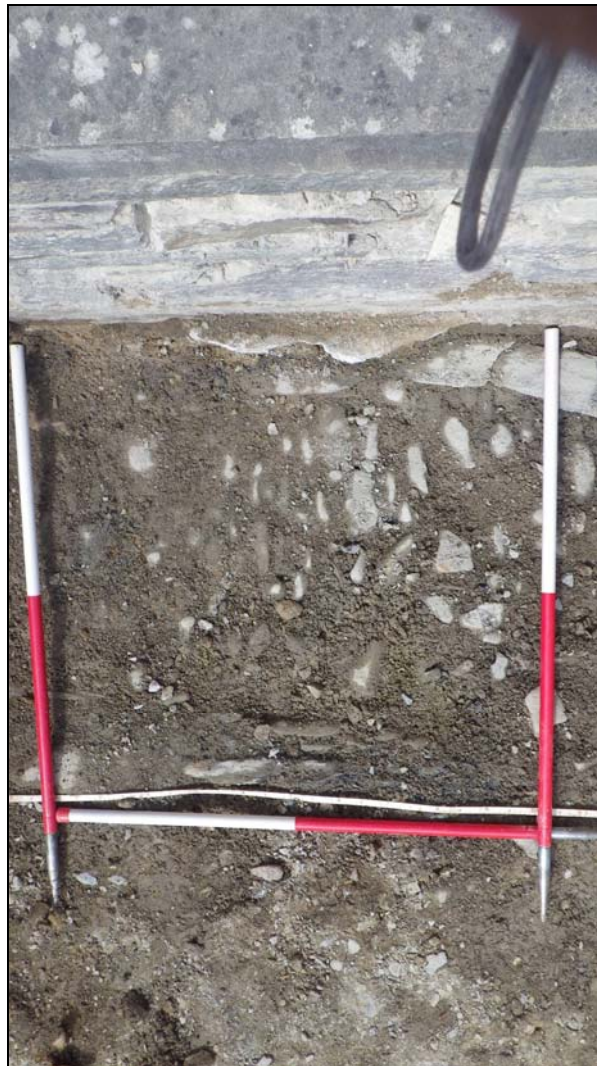
Plate 19: CNH2014\_118: One of 11 photos, photographing pavement 007, metre by metre. 7 to 8 metres, looking north northeast.

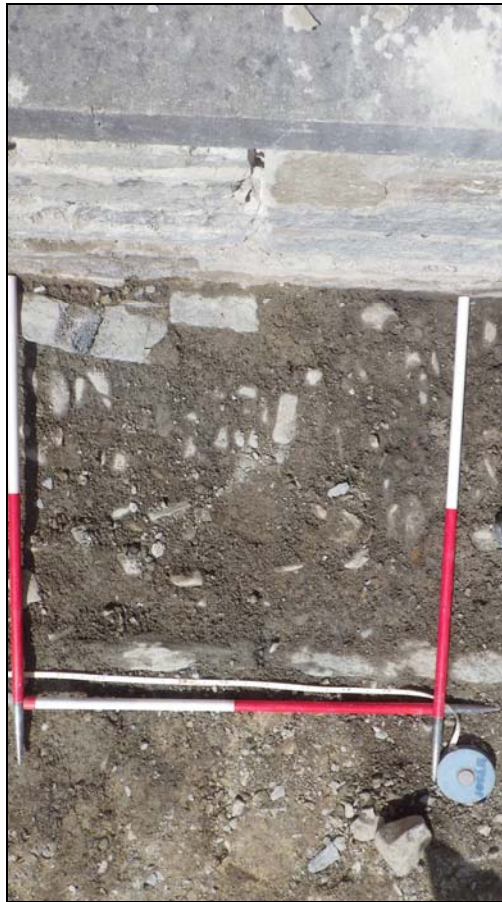
*Plate 20: CNH2014\_119: One of 11 photos, photographing pavement 007, metre by metre. 8 to 9 metres, looking north northeast.*

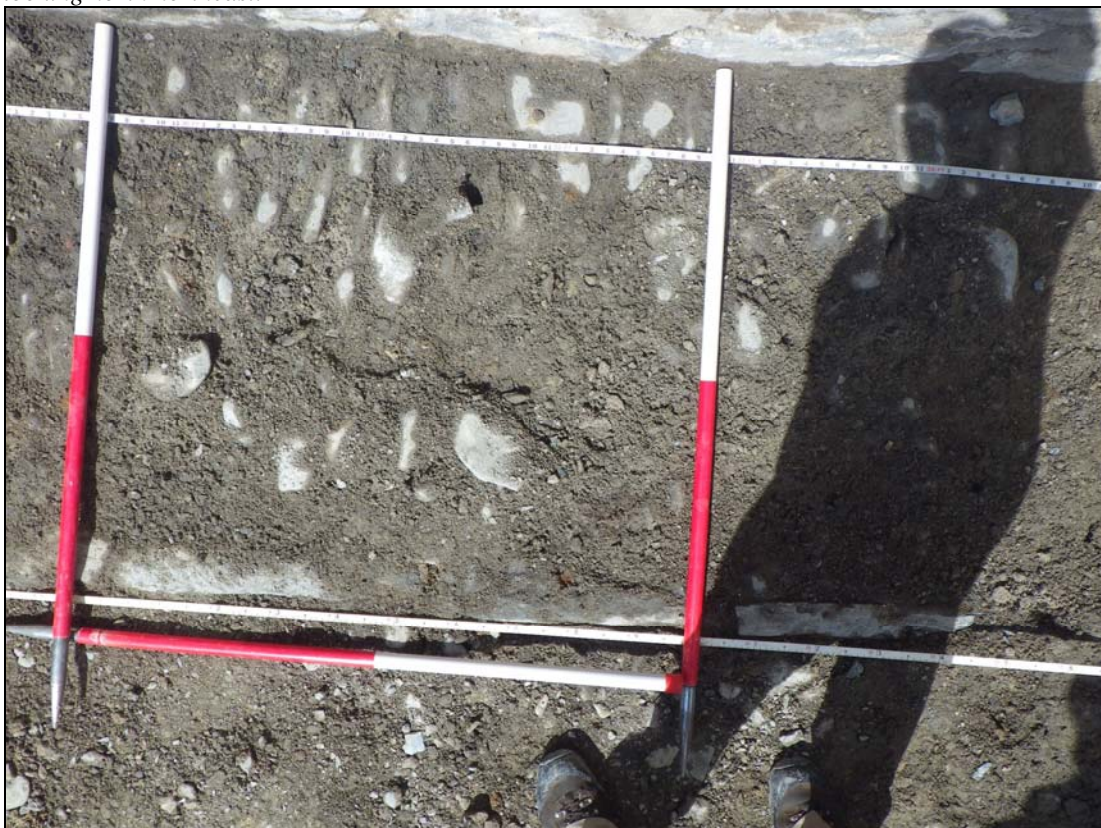
*Plate 21: CNH2014\_120: One of 11 photos, photographing pavement 007, metre by metre. 9 to 10 metres, looking north northeast.*

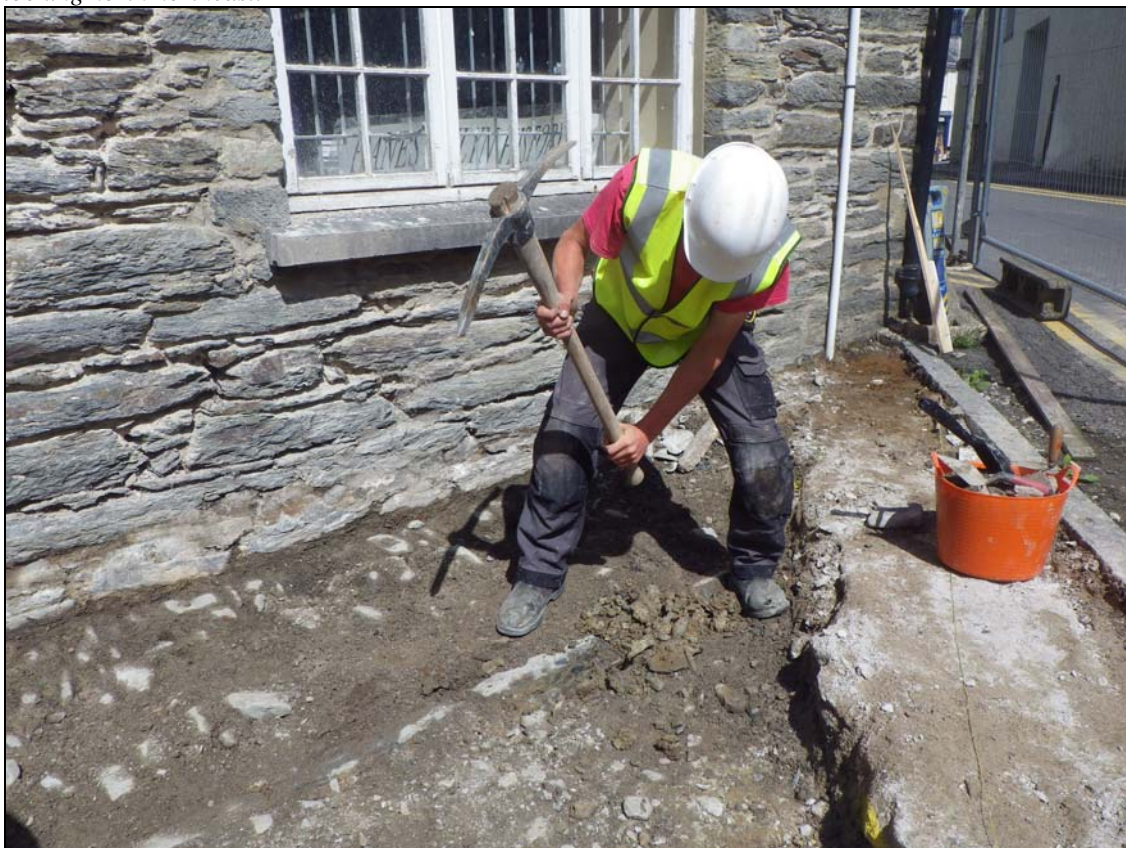
Plate 23: CHN2014\_122: Removal by hand of part of 005, the edging of cobble pavement 007, prior to mechanical excavation of foundation trench, looking northeast.

<b>CHN2014_122</b>	Removal by hand of part of 005, the edging of cobble pavement 007, prior to mechanical excavation of foundation trench.	11/08/2014	Looking northeast
<b>CHN2014_123</b>	Removal by hand of part of 005, the edging of cobble pavement 007, prior to mechanical excavation of foundation trench.	11/08/2014	Looking east northeast
<b>CHN2014_124</b>	Edging slab, 005, part of cobbled pavement 007, after removed.	11/08/2014	Looking east
<b>CHN2014_125</b>	The cobbled pavement, 007, after the foundation trench for the new structure had been mechanically excavated	11/08/2014	Looking east southeast.
<b>CHN2014_126</b>	Eastern end of the cobbled pavement, 007, after the foundation trench for the new structure had been mechanically excavated.	11/08/2014	Looking east southeast.
<b>CHN2014_127</b>	Detail of where the foundation trench cut the cobbled pavement 007, showing 003, 004, 005	11/08/2014	Looking east.

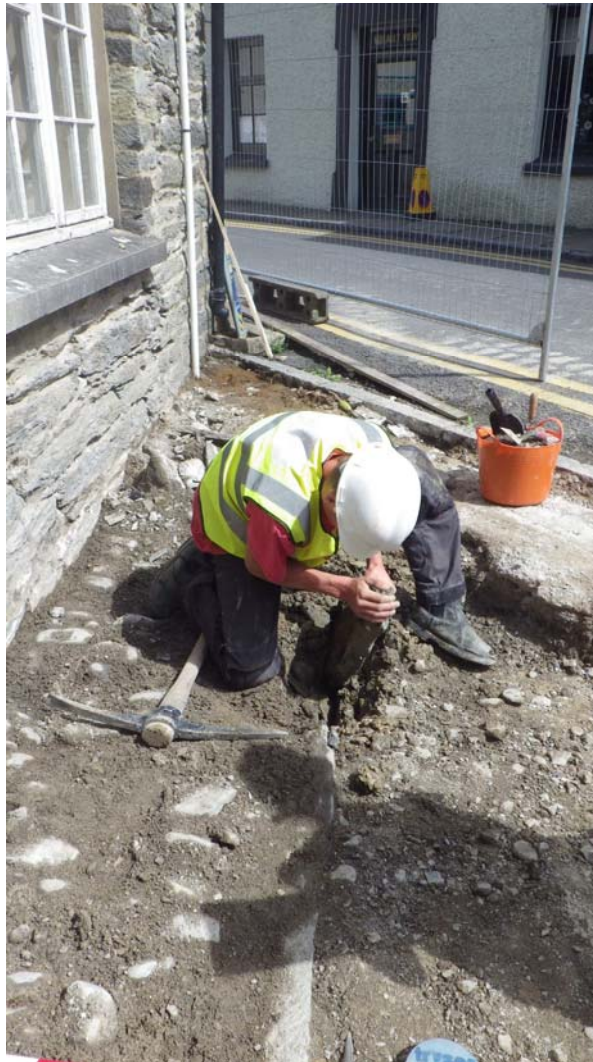
*Plate 24: CHN2014\_123: Removal by hand of part of 005, the edging of cobble pavement 007, prior to mechanical excavation of foundation trench, looking east northeast.*

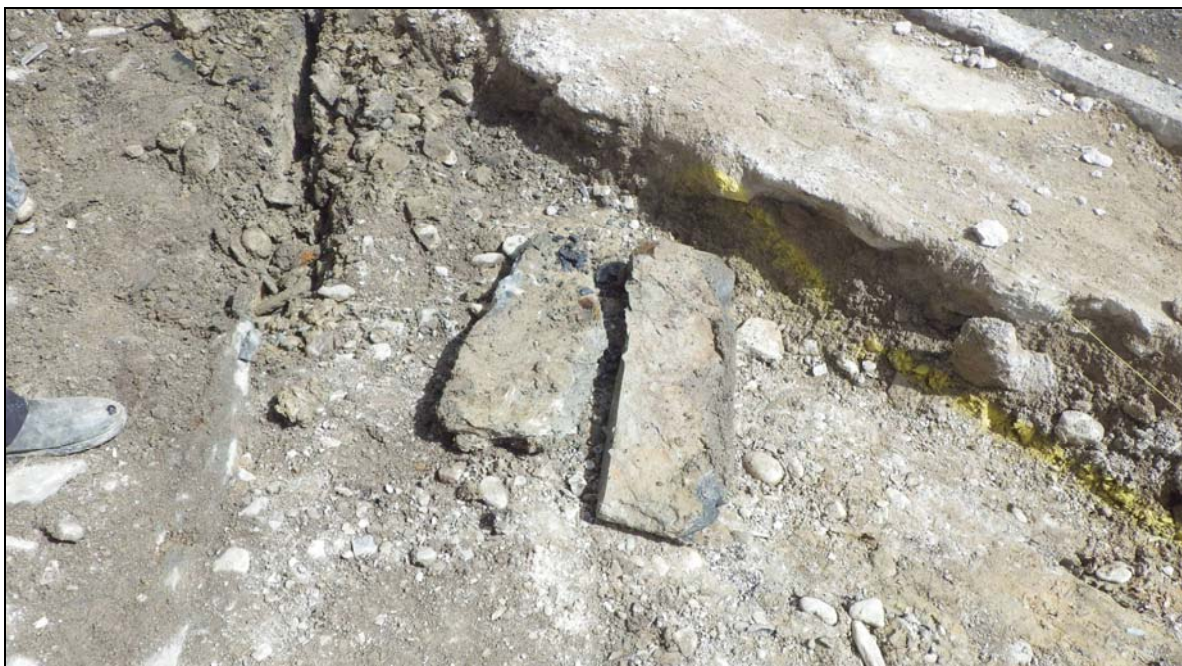
*Plate 25: CHN2014\_124: Edging slab, 005, part of cobbled pavement 007, after removed, looking east.*

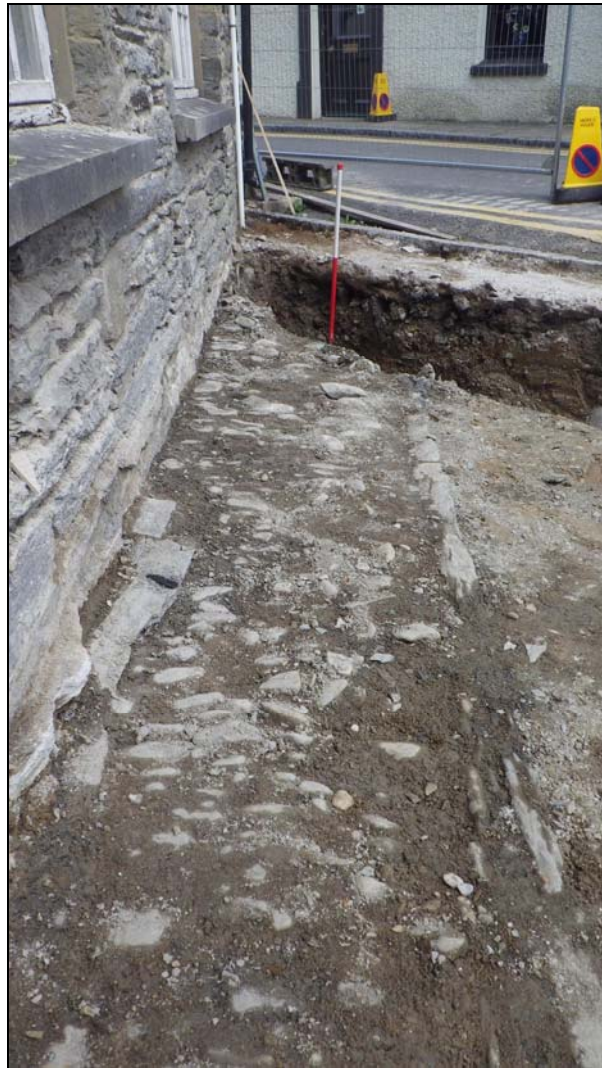
*Plate 26: CHN2014\_125: The cobbled pavement, 007, after the foundation trench for the new structure had been mechanically excavated, looking east southeast.*

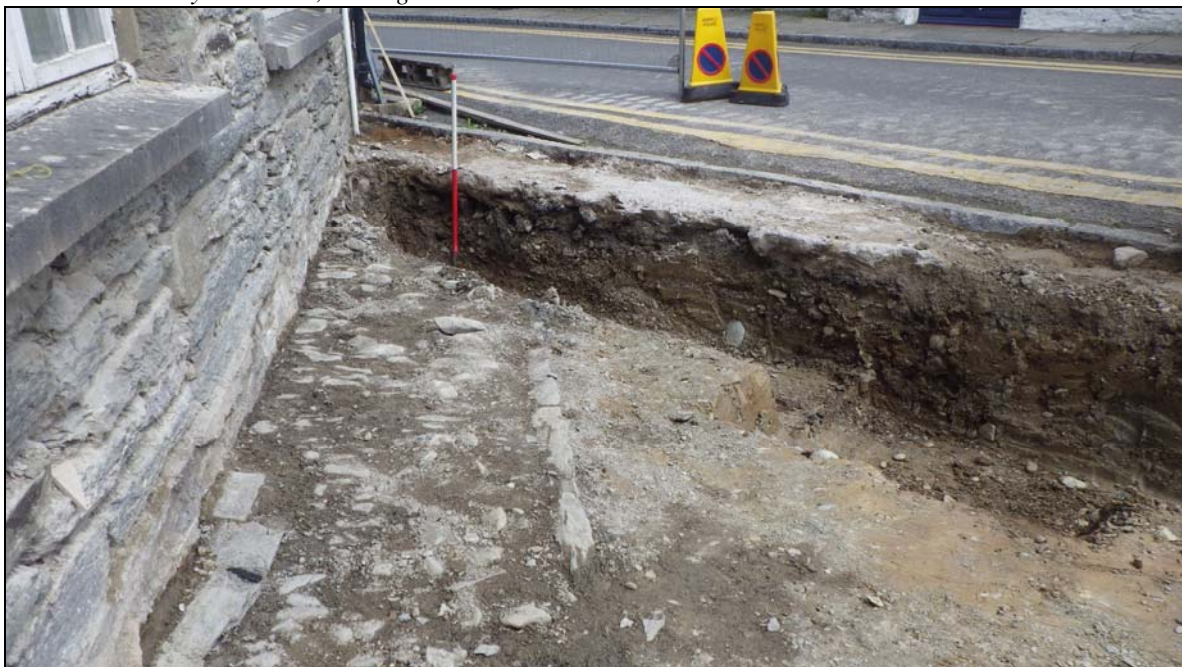
*Plate 27: CHN2014\_126: Eastern end of the cobbled pavement, 007, after the foundation trench for the new structure had been mechanically excavated, looking east southeast*
