# Cawdor Hall, Newcastle Emllyn Watching Brief

# Cawdor Hall Newcastle Emlyn Watching Brief

Trysor Project No. 2014/396

## Watching Brief

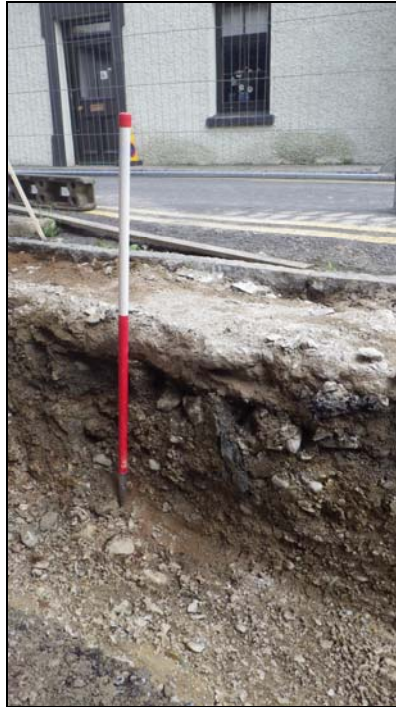
*Plate 28: CHN2014\_127: Detail of where the foundation trench cut the cobbled pavement 007, showing 003, 004, 005, looking east.*

<b>CHN2014_122</b>	Removal by hand of part of 005, the edging of cobble pavement 007, prior to mechanical excavation of foundation trench.	11/08/2014	Looking northeast
<b>CHN2014_123</b>	Removal by hand of part of 005, the edging of cobble pavement 007, prior to mechanical excavation of foundation trench.	11/08/2014	Looking east northeast
<b>CHN2014_124</b>	Edging slab, 005, part of cobbled pavement 007, after removed.	11/08/2014	Looking east
<b>CHN2014_125</b>	The cobbled pavement, 007, after the foundation trench for the new structure had been mechanically excavated	11/08/2014	Looking east southeast.
<b>CHN2014_126</b>	Eastern end of the cobbled pavement, 007, after the foundation trench for the new structure had been mechanically excavated.	11/08/2014	Looking east southeast.
<b>CHN2014_127</b>	Detail of where the foundation trench cut the cobbled pavement 007, showing 003, 004, 005	11/08/2014	Looking east.

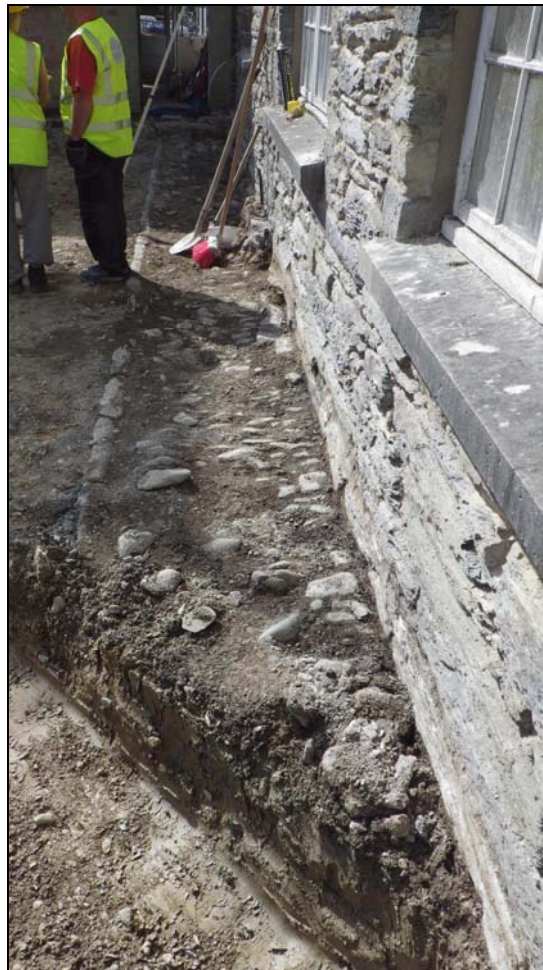
*Plate 29: CHN2014\_128: The foundation trench cutting cobbled pavement 007, looking west northwest.*

<b>CHN2014_128</b>	The foundation trench cutting cobbled pavement 007	11/08/2014	Looking west northwest.
<b>CHN2014_129</b>	Mechanically excavated foundation trench	11/08/2014	Looking southwest
<b>CHN2014_130</b>	Fill 008 of posthole cut 009	11/08/2014	Looking south

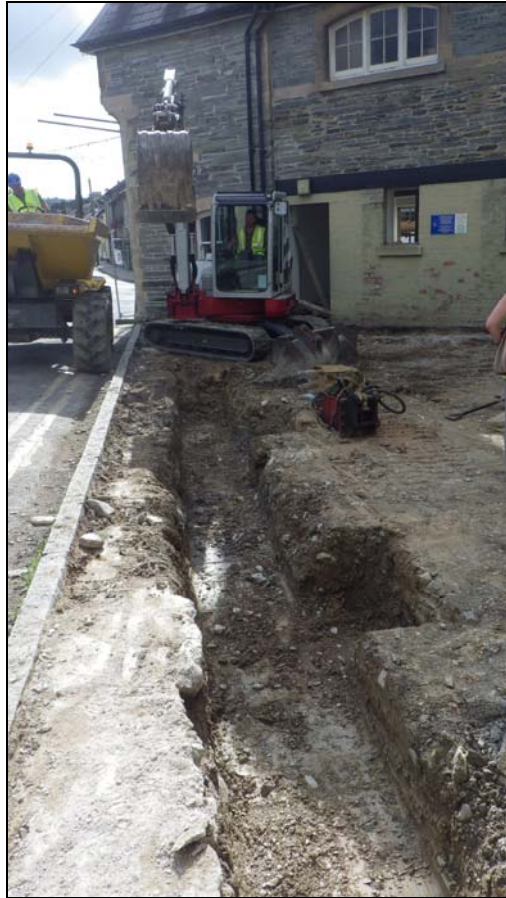
*Plate 30: CHN2014\_129: Mechanically excavated foundation trench, looking southwest.*

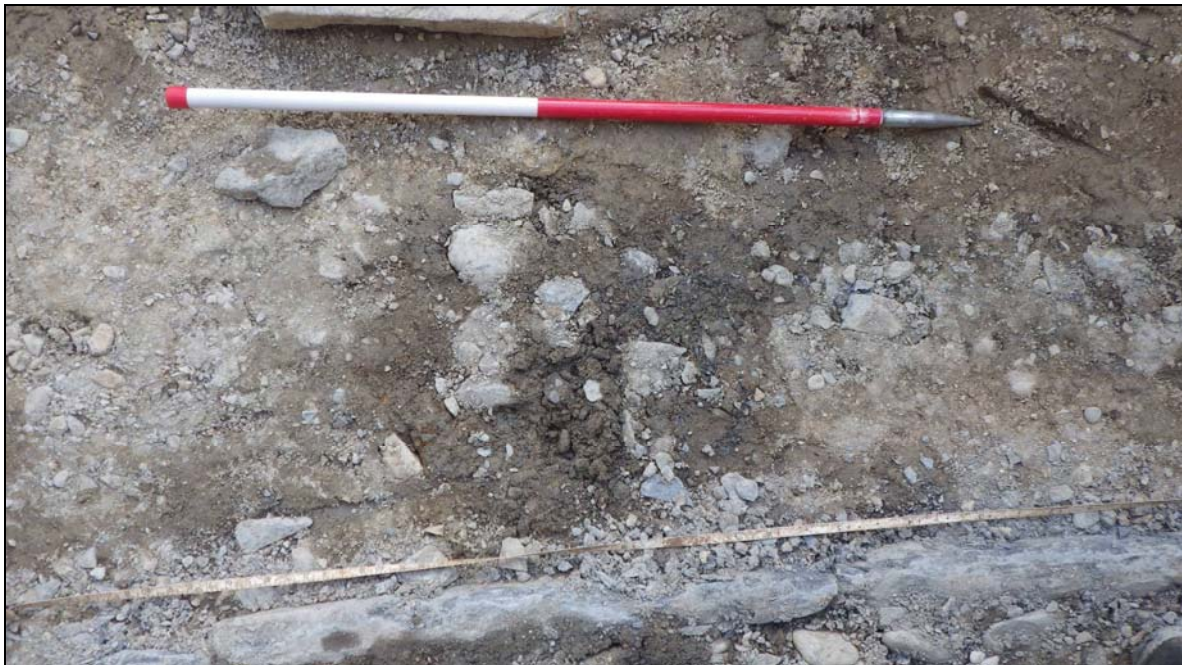
*Plate 31: CHN2014\_130: Fill 008 of posthole cut 009, looking south.*

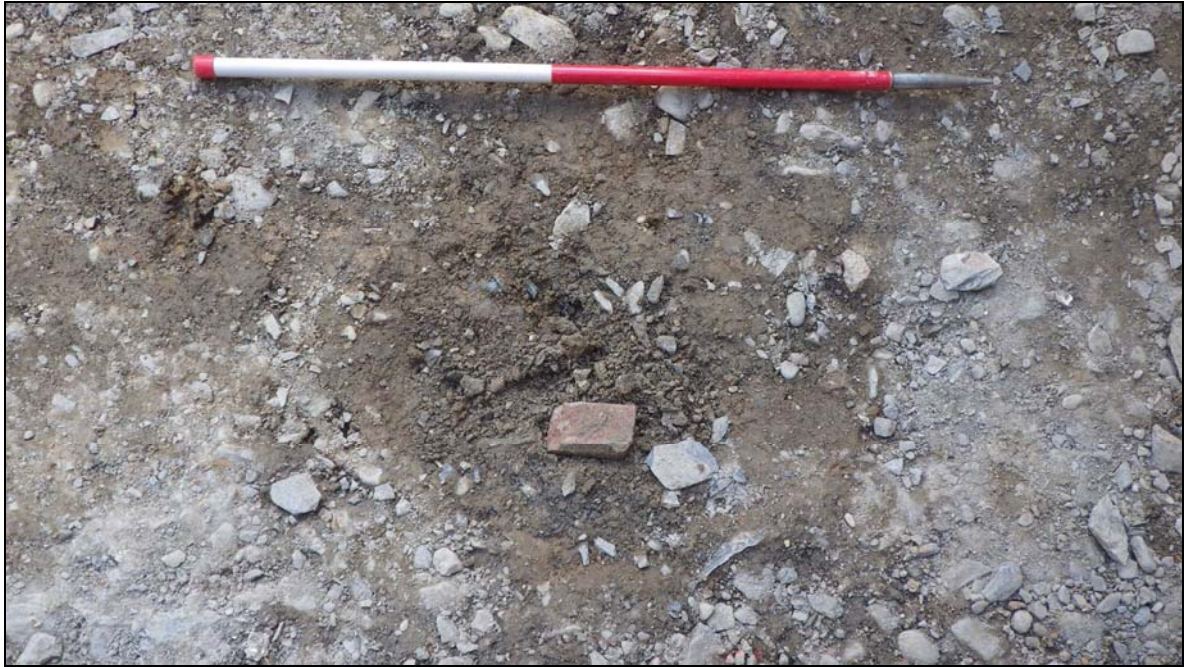
*Plate 32: CHN2014\_131: Fill 010 of posthole cut 011, looking south.*

<b>CHN2014_131</b>	Fill 010 of posthole cut 011	11/08/2014	Looking south
<b>CHN2014_132</b>	Fill 012 of possible drain 013	11/08/2014	Looking approximately south.
<b>CHN2014_133</b>	Fill 012 of possible drain 013	11/08/2014	Looking approximately east.
<b>CHN2014_134</b>	Context 014 overlying 015	11/08/2014	Looking southwest.
<b>CHN2014_135</b>	Natural subsoil 015	11/08/2014	Looking southeast.

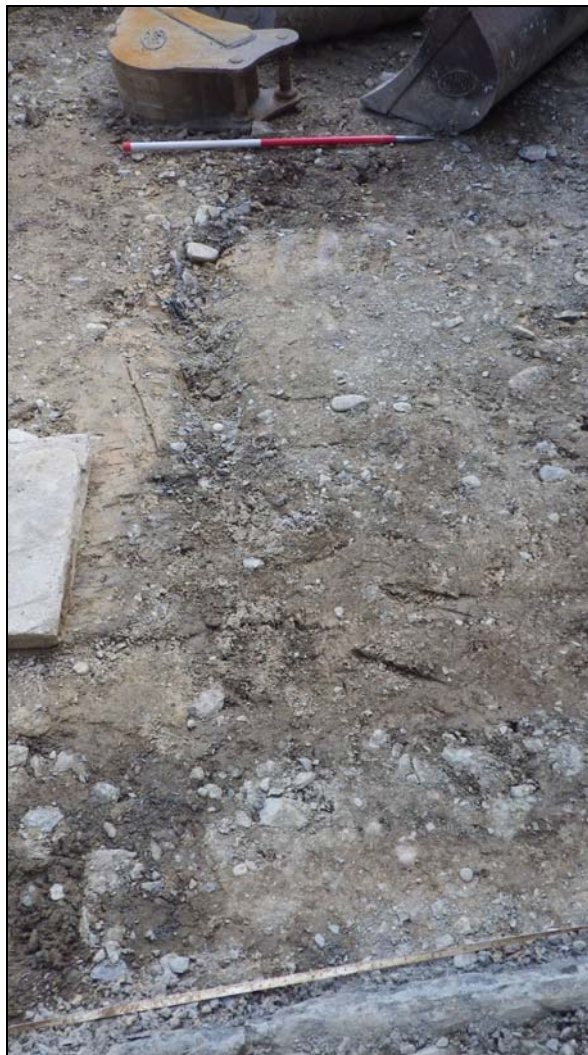
*Plate 33: CHN2014\_132: Fill 012 of possible drain 013, looking south.*

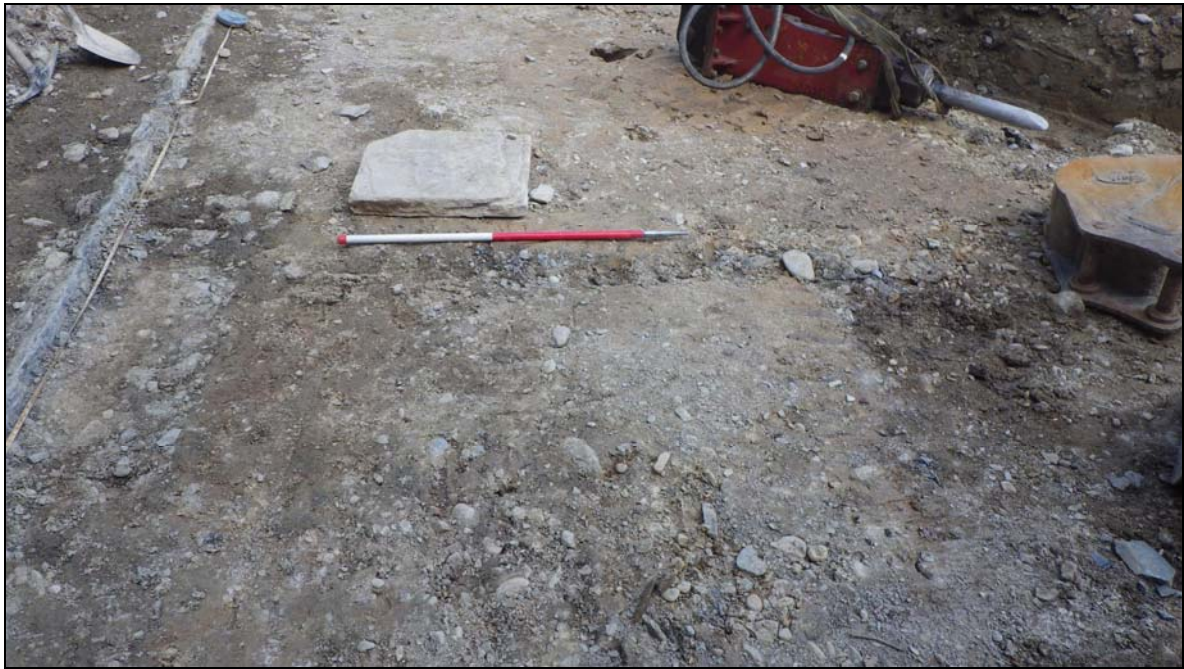
*Plate 34: CHN2014\_133: Fill 012 of possible drain 013, looking east.*

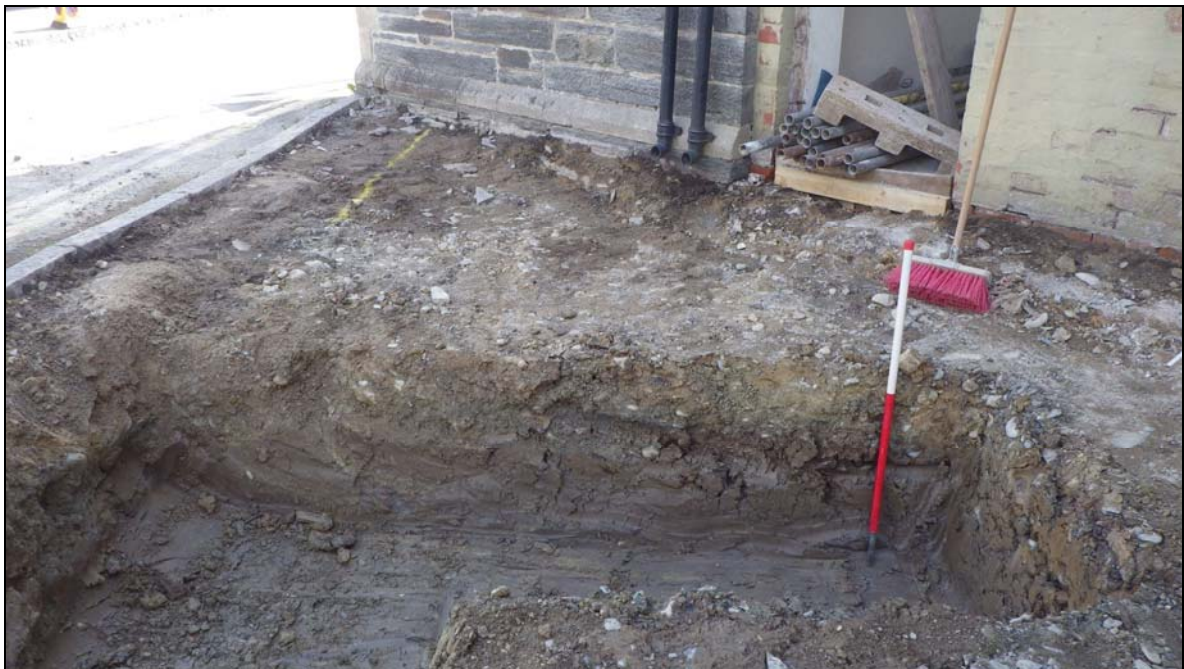
*Plate 35: CHN2014\_134: Context 014 overlying 015, looking southwest.*

<b>012</b>	Not known	FILL 10YR 4/2, dark greyish brown loam with slate fragments., damper than surroundings Not excavated as the feature was not going to be disturbed	Fill of 013
<b>013</b>	Not known	CUT A linear feature 0.20 metres wide running for 2.3 metres away from the pavement 007. It then appears to turn to the southwest and widen out before terminating. Not excavated as the feature was not going to be disturbed	Drain? Exact nature unclear.
<b>014</b>	Up to 0.20 metres	LAYER – 10YR 4/2 dark greyish brown, loosely bound layer of stones and gravel overlying the natural subsoil on the western side of the site.	Building debris – 19 <sup>th</sup> century?
<b>015</b>	-	LAYER 10YR5/2 to 10YR 4/2, greyish brown to dark greyish brown clay with pockets of stone within it, see photos CHN2014_134 and 135.	Natural Subsoil

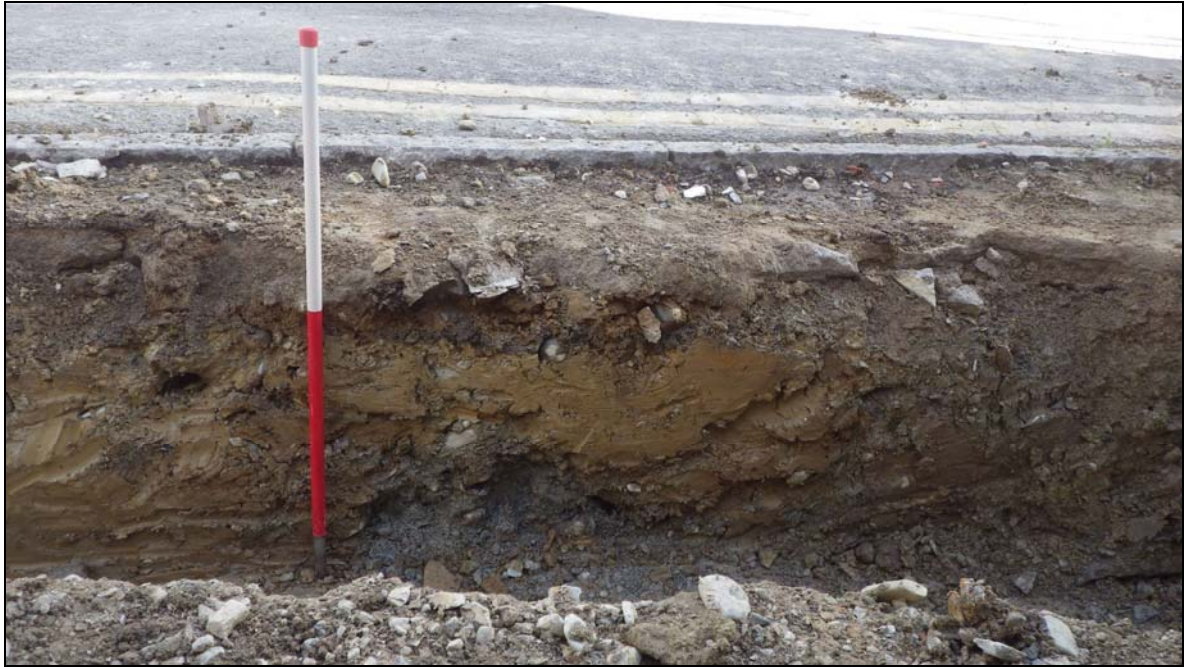
*Plate 36: CHN2014\_135: Natural subsoil 015, looking southeast*
