A470 BLAENAU FFESTINIOG
TO CANCOED IMPROVEMENT

ARCHAEOLOGICAL WATCHING BRIEF AND
RECORDING

G1891

Report number : 717 revision 2

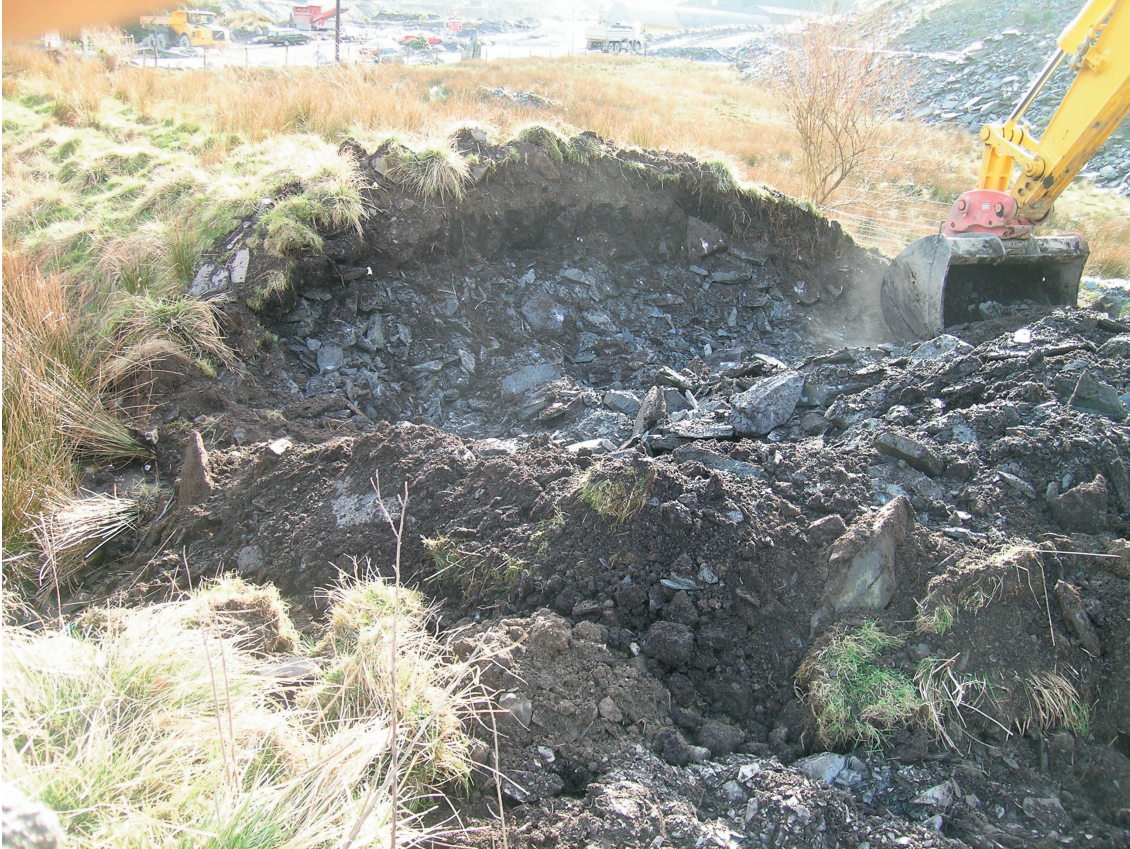
Plate 1 Section through Site 12, tip south of Bryntirion

A section close to the N end of the feature showed the main body to be made of dumped clay with some slate waste. This changed within 5m to slate waste covered by a thin layer (about 0.2m) of clay and soil (Plate 1). A small stream was carried beneath the bank through a reused cast iron pipe. The remainder of the feature, up to the current quarry entrance, was built from slate waste.

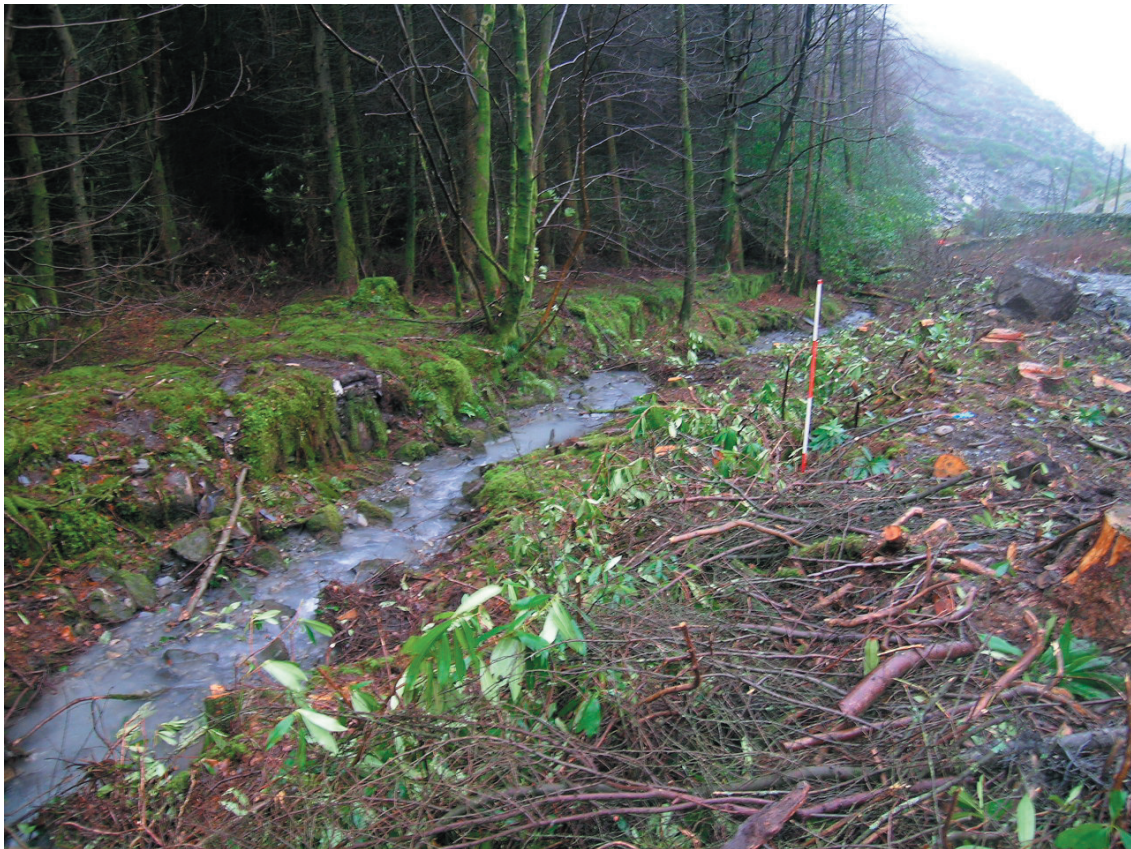
Plate 2 Site 8, Revetting/ walls along stream

The results of the survey are shown on Fig. 8. The revetment on the east side of the feature was extant and well preserved standing to a height of around 0.7m (Plate 2). There were several collapses in the masonry but it survived to its original height for most of its length. It had been truncated at the south end presumably when the line of the river changed. A stream passes under the entrance to the Llechwedd complex and runs south. The southern half of the stream runs along the centre of site 8. This does not appear to be an original element of the site because it is not shown on the 1889 OS map. The western bank of the stream was steeply sloping and topped by a few boulders. The bank was disturbed in several places during the removal of tree roots but no traces of revetment were revealed. The line of the bank turned to the west at the north of the feature, following the line of the path shown on the 1889 map, suggesting that there had been no major disturbance in this area. It therefore seems likely that there had never been a revetment on the west side of feature 8. A wall built against the road revetment and shown on the 1889 map apparently blocked the southern end of site 8. This survived in good condition on the western side and had mostly collapsed on the east.

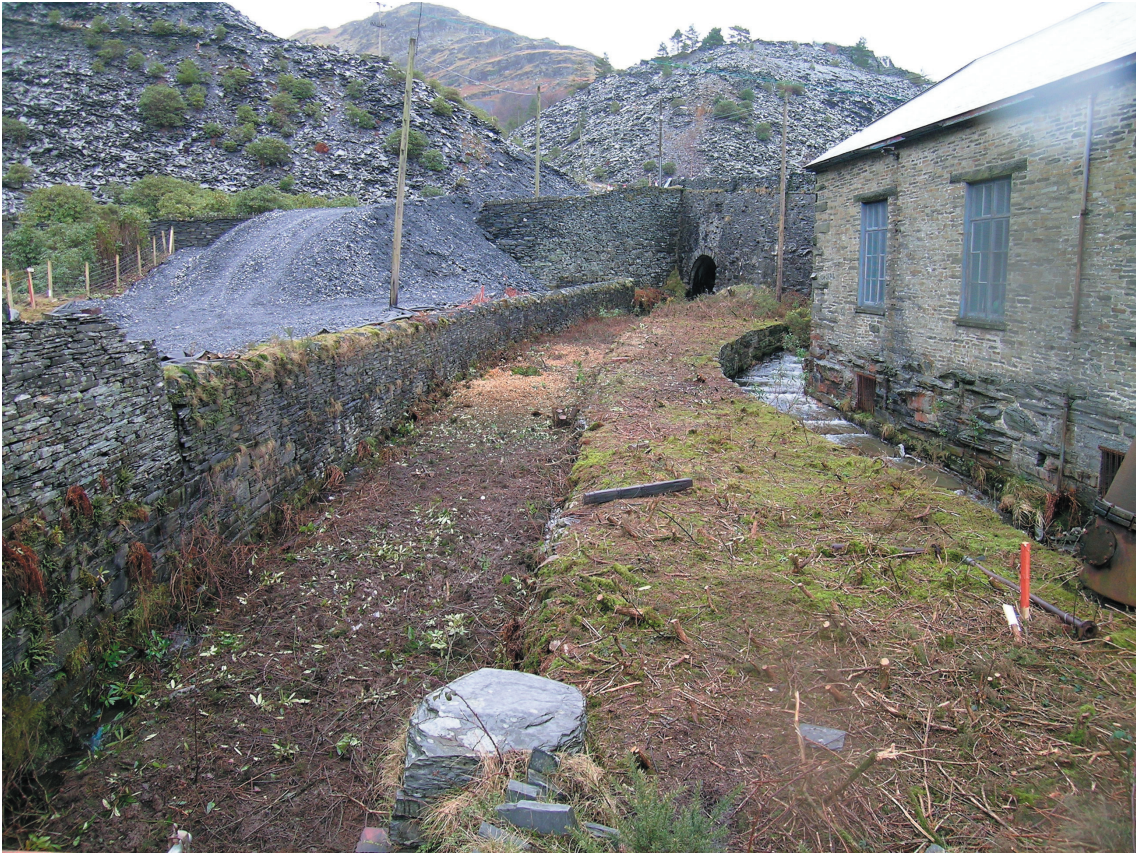
Plate 3 Site 3(16) Llechwedd to Ffestiniog Railway link after clearance

The area was very overgrown with gorse, Rhododendron and small trees. This was cut down and chipped and a detailed record was made of the Railway link. All standing masonry was photographed using a digital SLR camera. The side walls of the link trackbed were photographed as a series of overlapping images with a levelled camera and two scales per frame which were set upright using a spirit level. The scales were set at a standard width of either 2m or 3m apart. General photographs were taken of the area as works progressed. A written description was made of all structures that were revealed after the clearance of the vegetation. Plate 3 shows the area after clearance

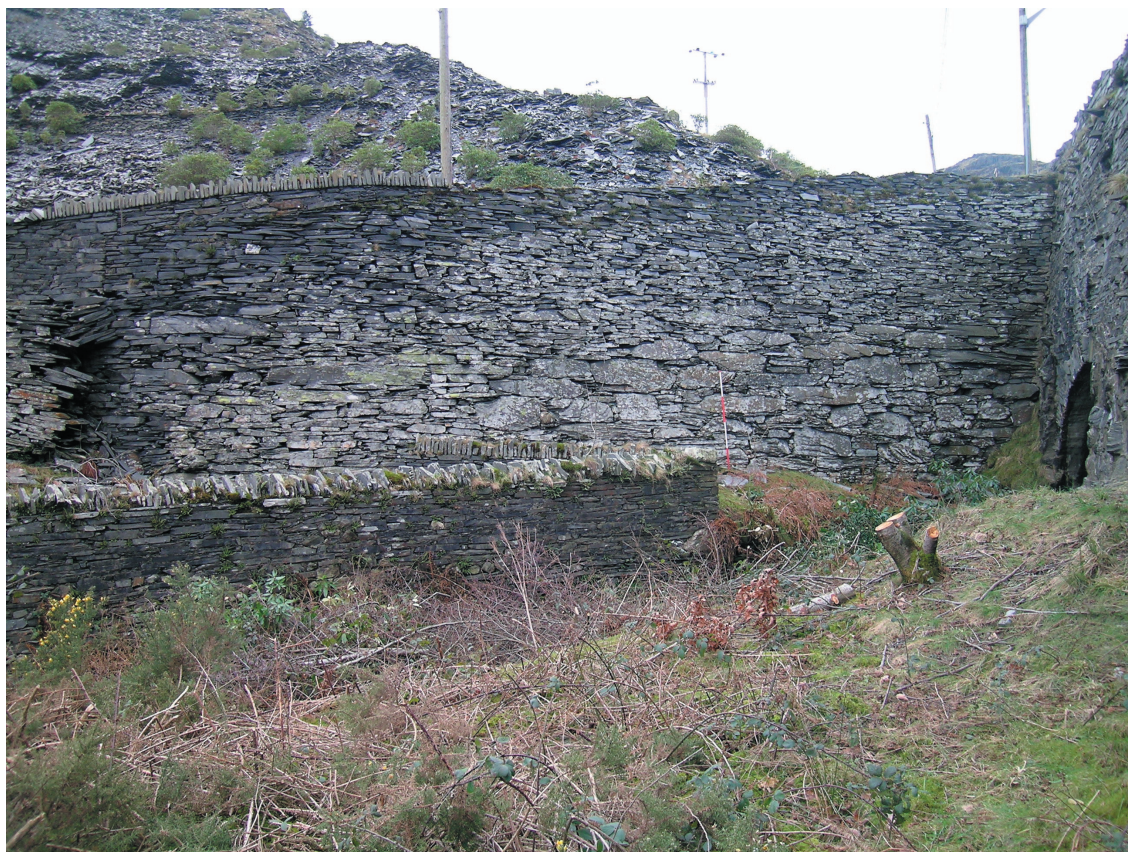
Plate 6 Site 3(17) Slate retaining wall

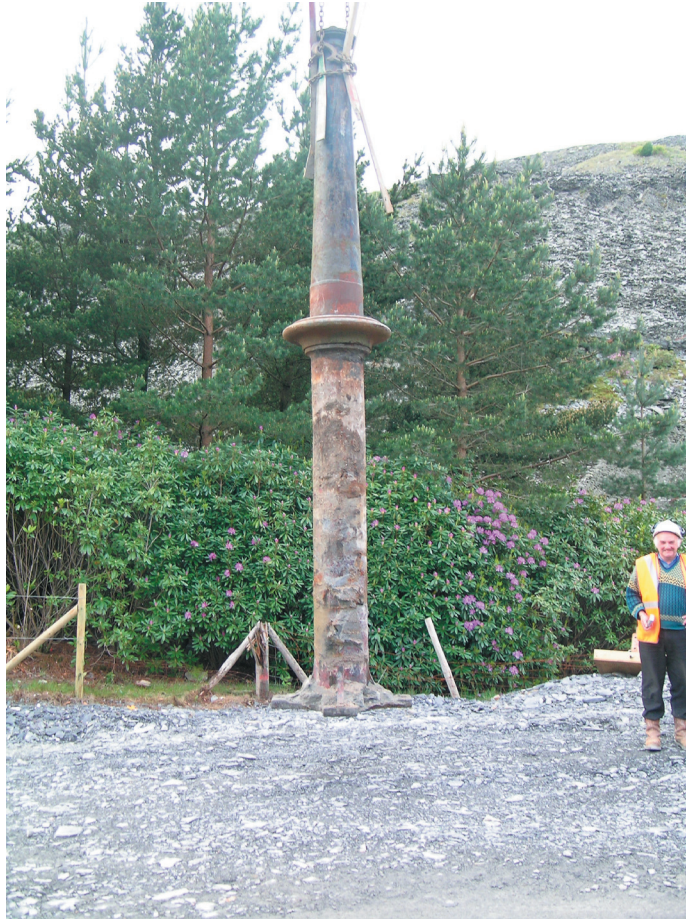
Plate 9 Site 1(13) The crane pillar

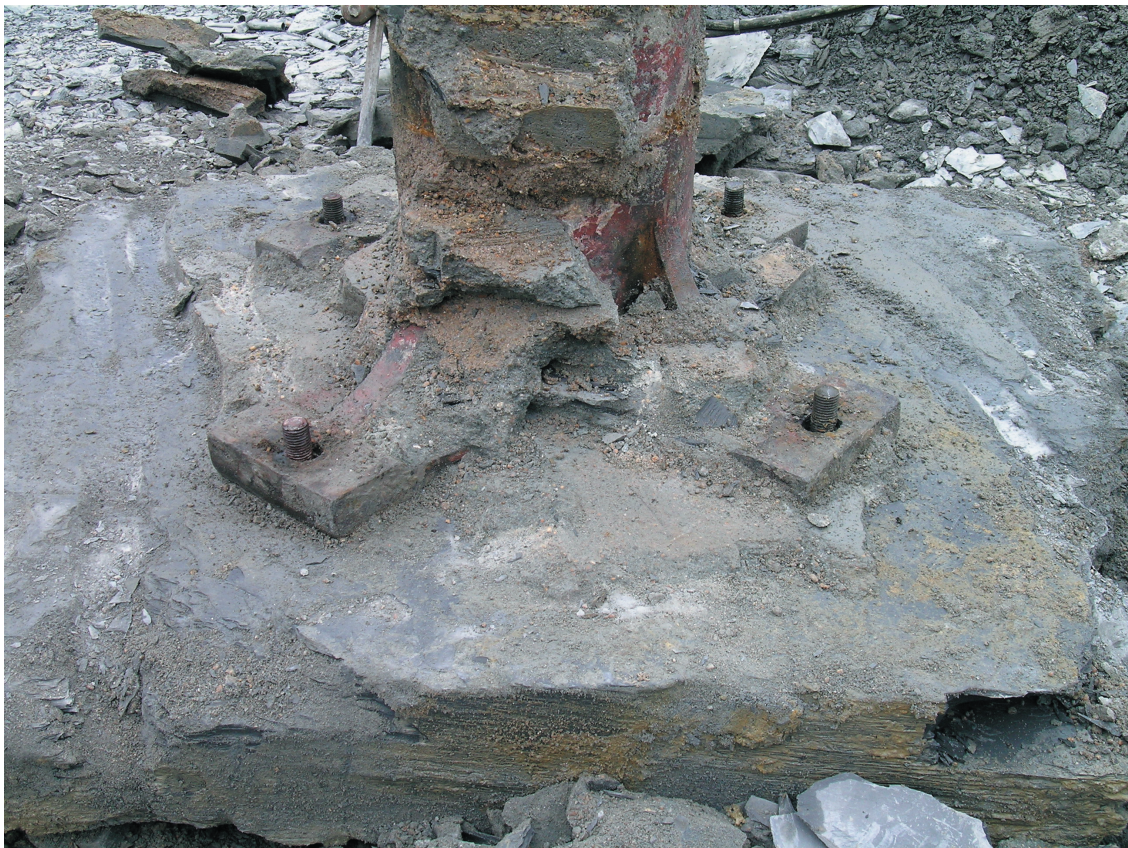
Plate 10 Site 1(13) The crane pillar: flanges and block

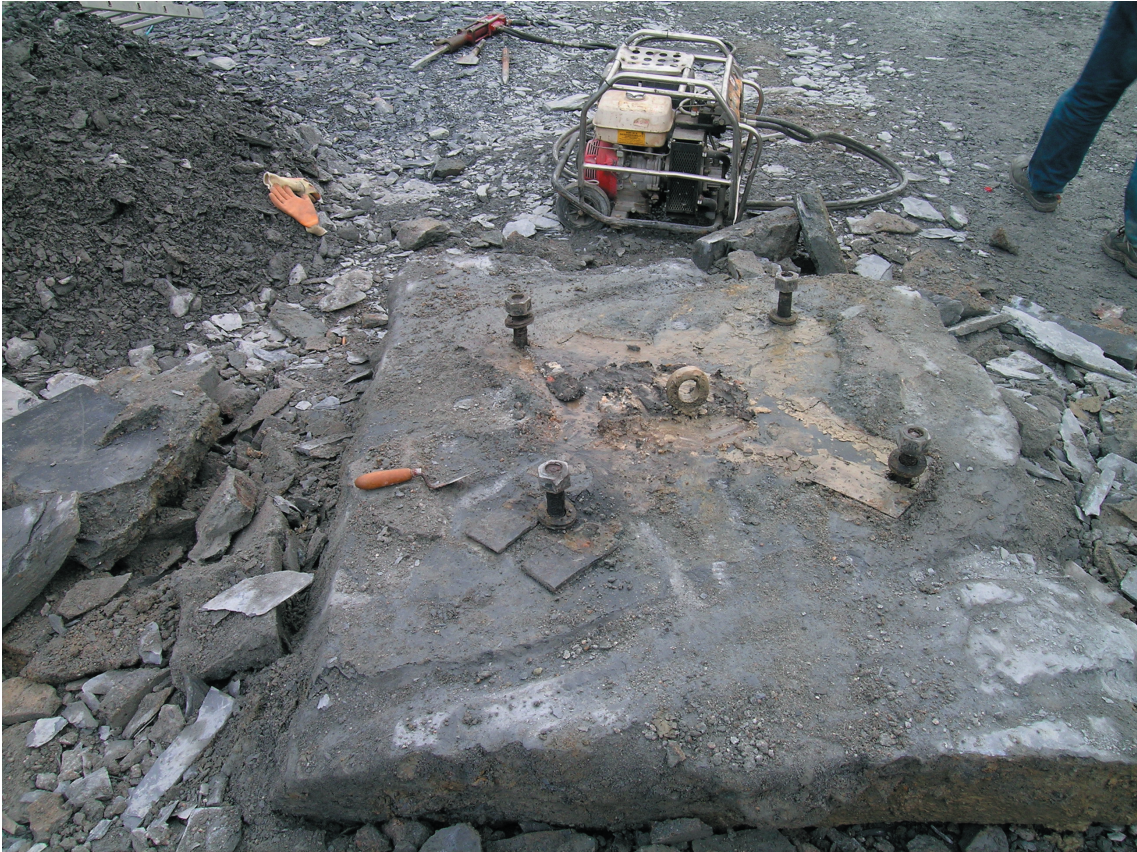
Plate 11 Site 1(13) The crane: Slate block showing hook, shims and bolts

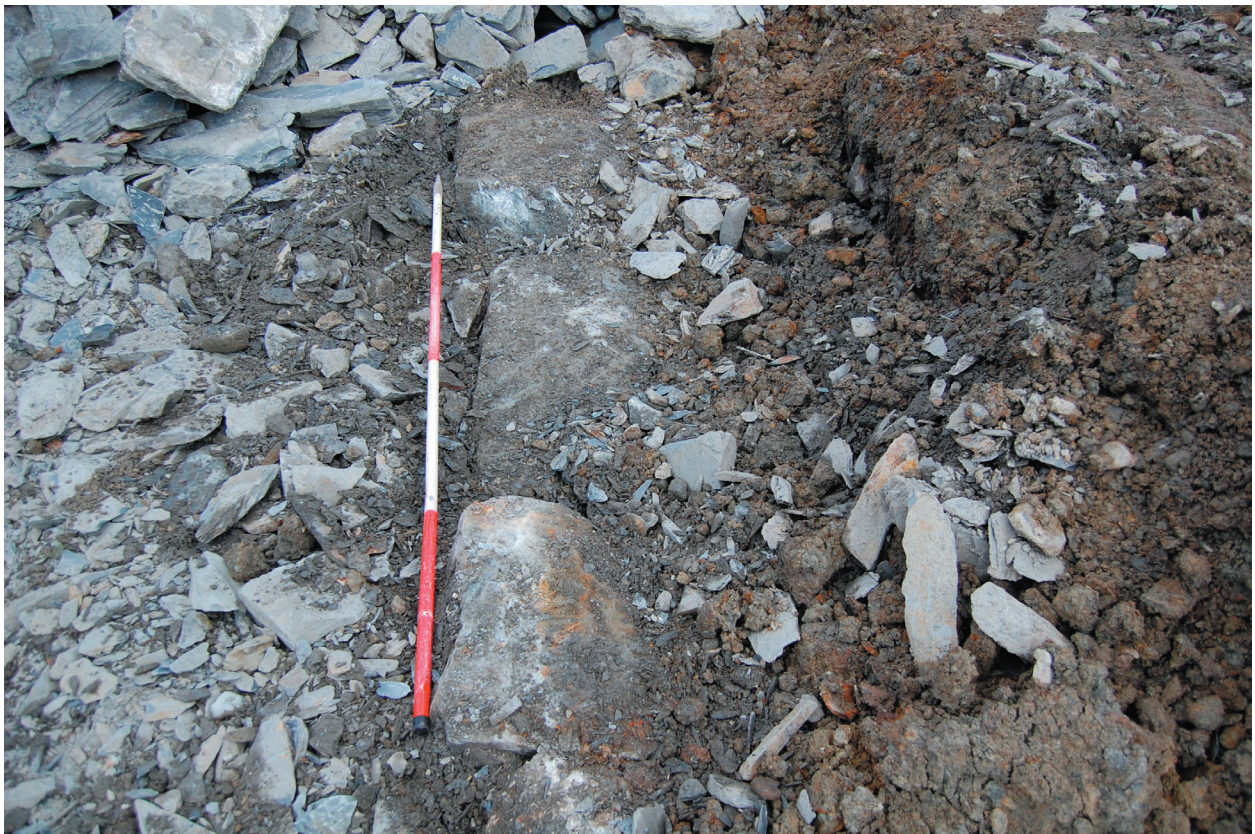
Plate 12 Site 3(3) Road Causeway: Phase 1 revetment between Link and Barlwyd tunnels

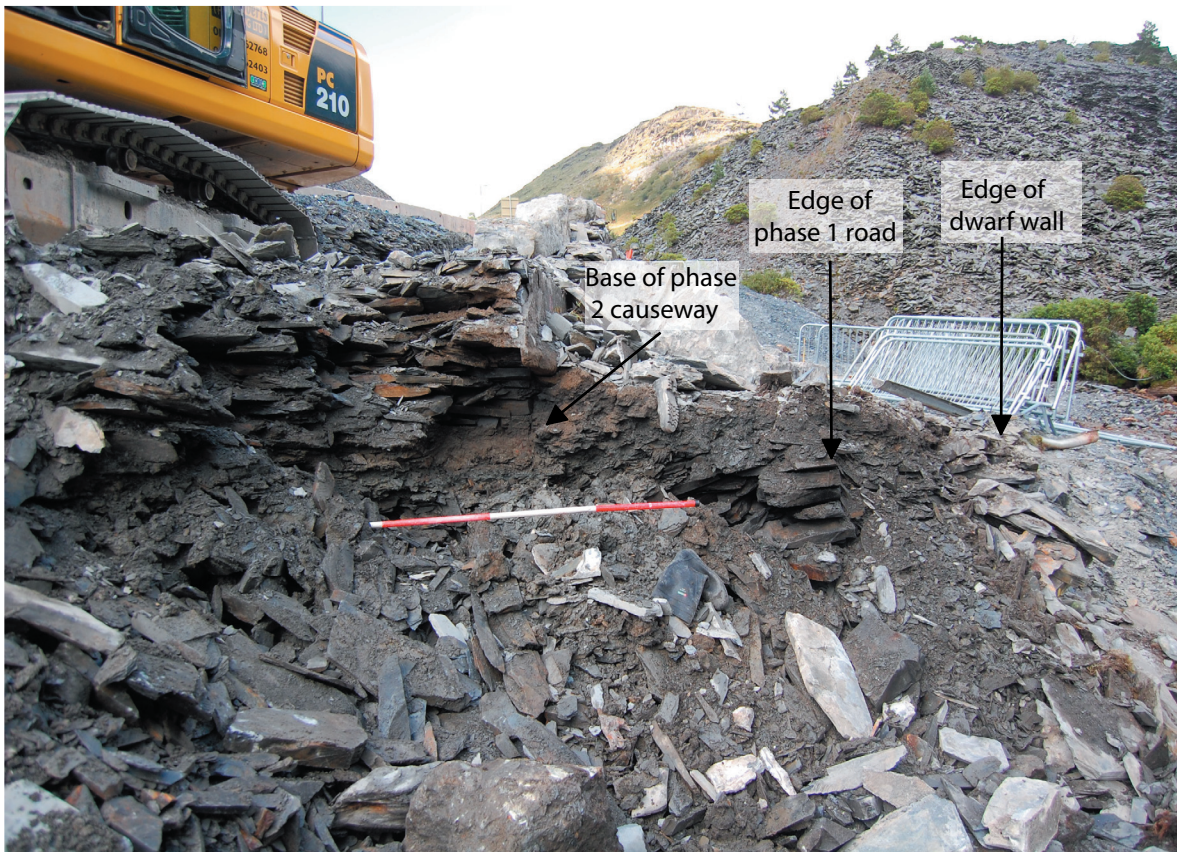
Plate 13 Site 3(32) Road causeway: Section through causeway and phase 1 road, N of Barlwyd tunnel

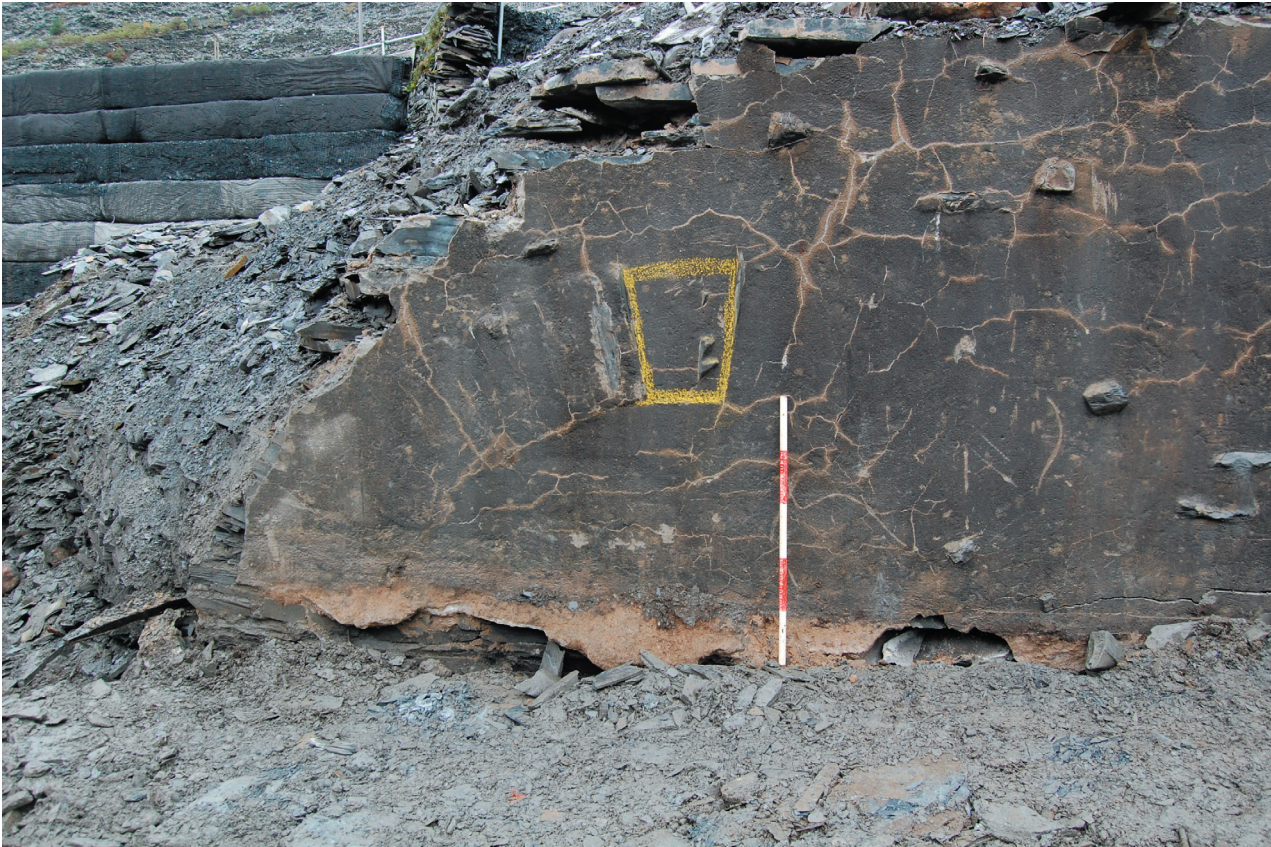
Plate 14 Site 3(32) Road causeway: Blocked incline arch in E side of causeway

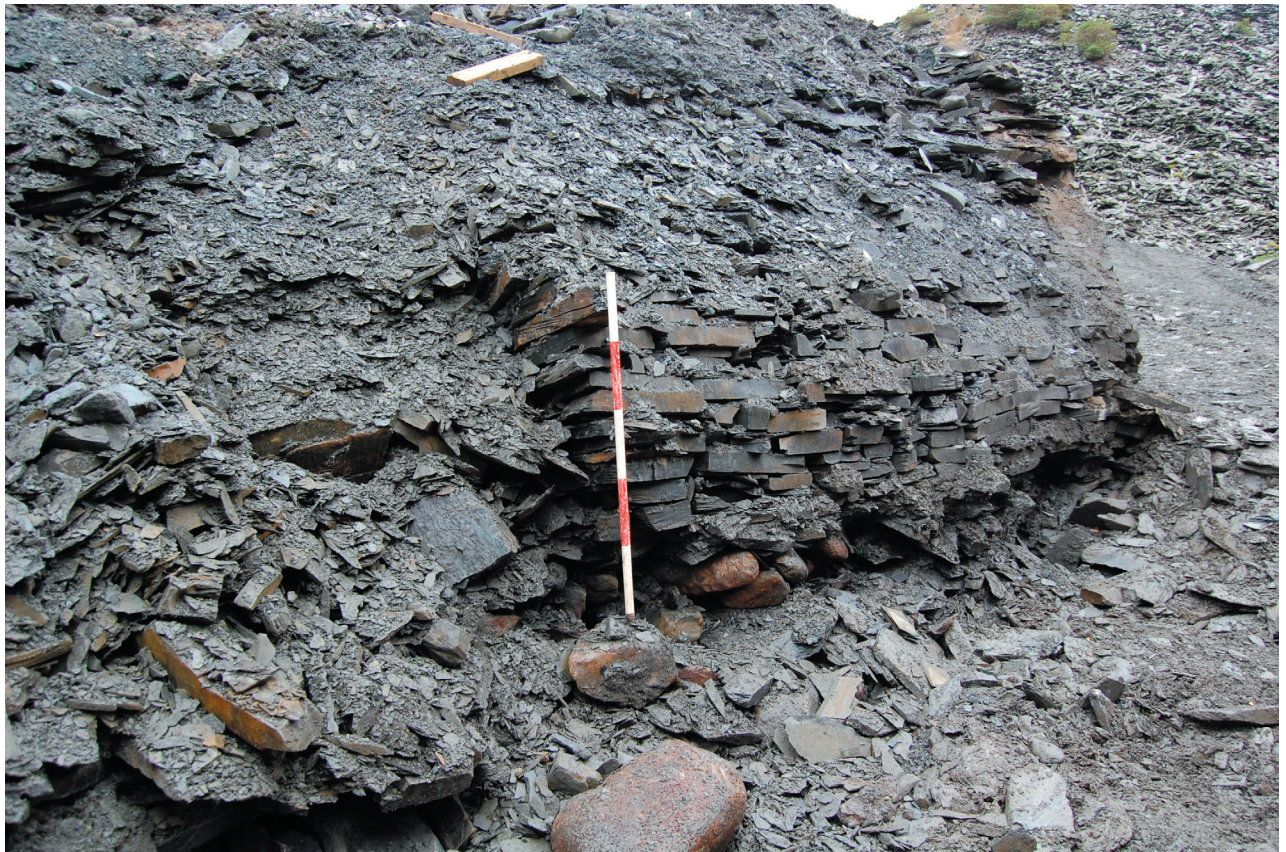
Plate 15 Site 3(5) incline tunnel after removal of road causeway, joint in masonry

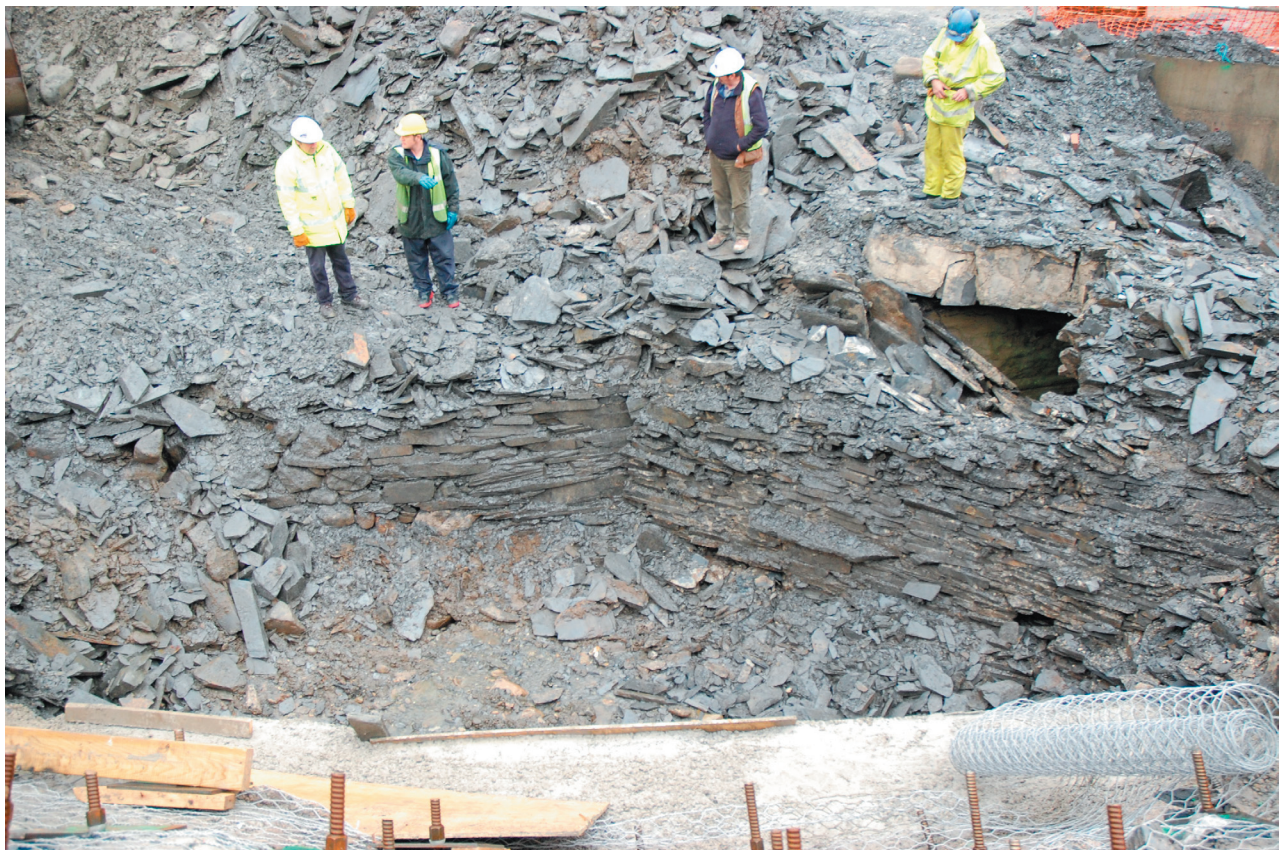
Plate 16 Site 3(3) Road causeway: Phase 1 revetment to the east of the incline tunnel

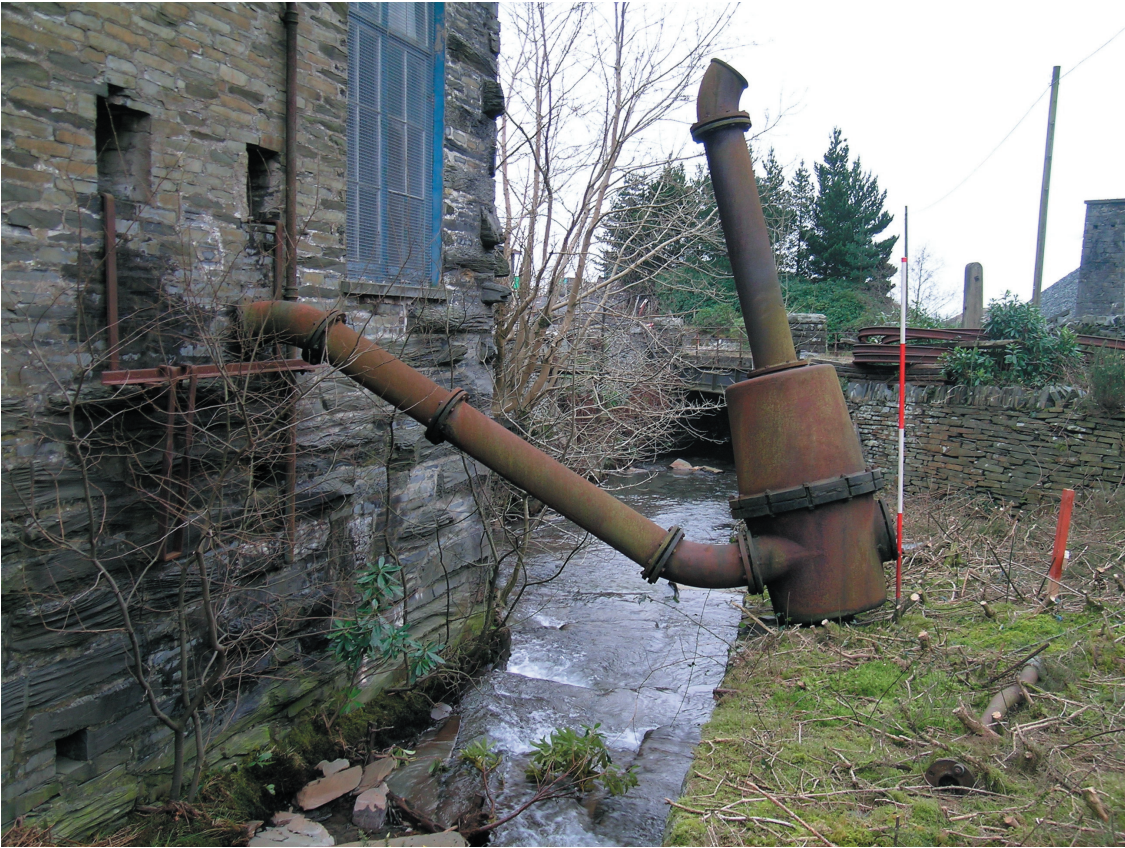
Plate 17 Site 3(1) Hydroelectric power station: Iron vessel

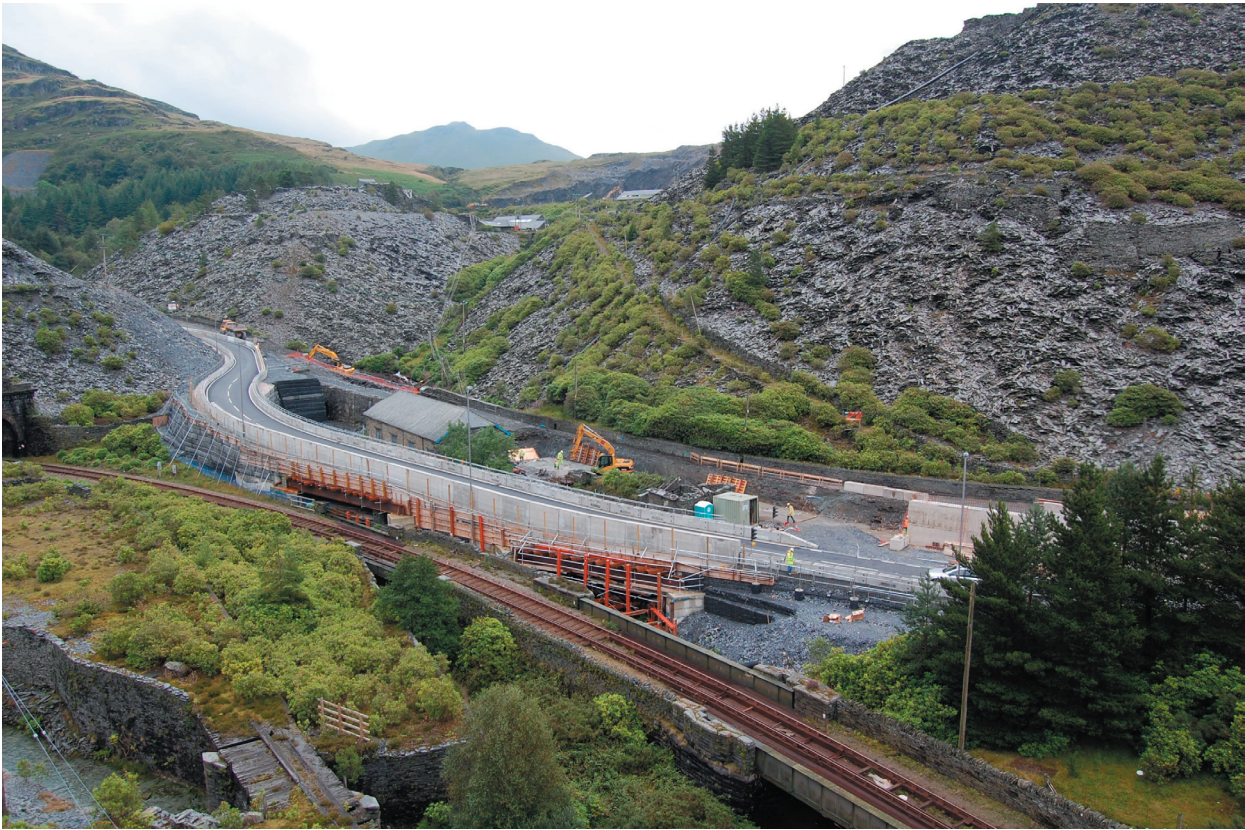
Plate 19 The temporary diversion

The trackbed was covered with geotextile and the sidewalls protected with plywood. The trackbed was then filled with slate waste. The raised coping on the western side was protected by laying wooden sleepers alongside it. All other upstanding parts of the western wall were demolished and the stone was stored in order that the walls could be reconstructed. The temporary diversion was built on top of the infilled trackbed (Plate 19).

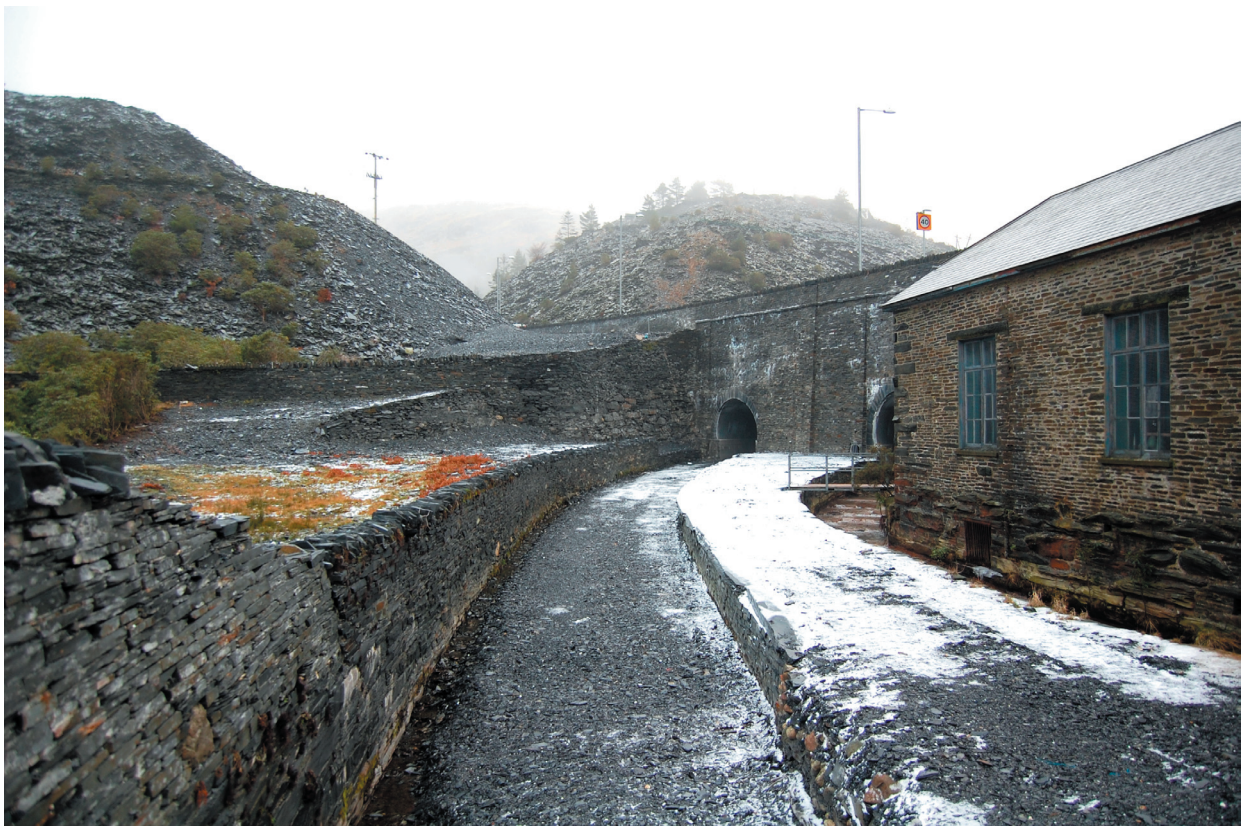
Plate 20 Llechwedd Quarry to Ffestiniog Railway Link 3(16). Trackbed after reinstatement

The temporary diversion was removed at the end of the construction phase. A short length of the western trackbed wall collapsed during the removal of the slate waste. This revealed another wall face set back by 0.4m. This presumably marked an earlier phase but there was no opportunity for further study. The collapsed masonry was rebuilt in the same style as the original wall and using the original stone. The base of the trackbed was left with a covering of slate waste at the request of the landowner. The parts of the western wall that had been demolished prior to the construction of the temporary diversion were reconstructed using the stored stone (see Plate 20).
