ARCHAEOLOGICAL OBSERVATION

The Old Forge Grosmont Monmouthshire

NGR: SO 40464 24496 HER Fieldwork Ref: (E003391) JOB NO: BA0927RRATOFSG

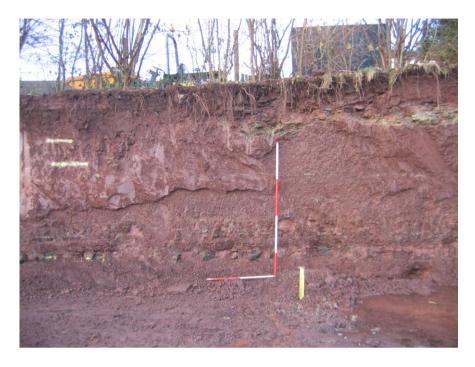
Plate 1: Possible quarry [137], (138) to left of ranging rod. Green sandstone (130) can be seen to the right. The cut [132] containing dumped material (131) is located above and to the left of the parallel yellow painted lines.

A possible quarry on the E-facing wall of the trench for the proposed garage was observed, comprising a cut [137] and associated fill (138) (plate 1). A layer of green sandstone (130) was evident, probably representing the material quarried. This stone did not appear in the wall of the trench S of [137] and (138). A deposit of dumped modern material (131) in cut [132] located immediately to the S of (138) may also have filled a void left by the quarry. No dating evidence was observed in the quarry feature. The cut may have extended some distance down the hillside being subsequently filled and levelled using waste material. The quarry may possibly represent a source of building stone for the castle or for construction activity elsewhere in the town.

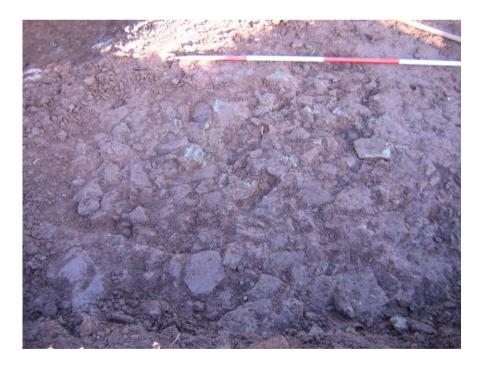
Plate 2: Cleaned portion of stone surface feature (135)

The earliest feature for which there was dating evidence was a pavement or floor (135) composed of flat pieces of green or red sandstone up to $0.24\text{m} \times 0.18\text{m}$ in size, some of which had the appearance of worn flagstones (*plate 2, fig. 3*). There were several large pieces of animal bone present, together with eight small abraded sherds of possibly Herefordshire A5 or A6 ware, which would date this feature to 13^{th} – early 15^{th} century. Both wares were used to make jugs and costrels. A sherd of possible Midlands Purple Ware (Worcestershire fabric 108), which was in use from the late 14^{th} through to the 18^{th} century, was also included.

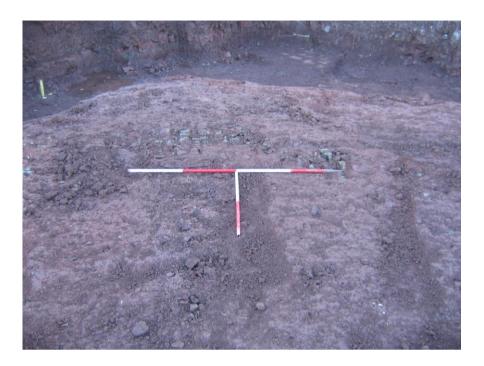
Plate 3: Crescent-shaped scatter of stones (136) 2m W of pavement (135)

Located some 2m to the W of (135) was a further, crescent-shaped stone scatter (136) (*plate 3*) possibly representing part of the same building. This feature produced a sherd of A5/A6 and one of possible Herefordshire A8, dating to the 12th and early 13th century.

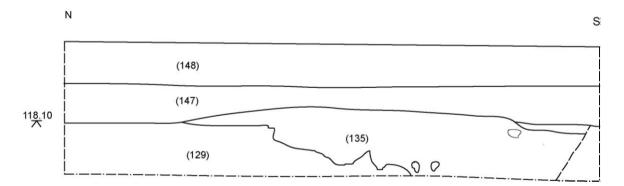
Fig. 3: W-facing section through surface (135) with topsoil layer (128) removed

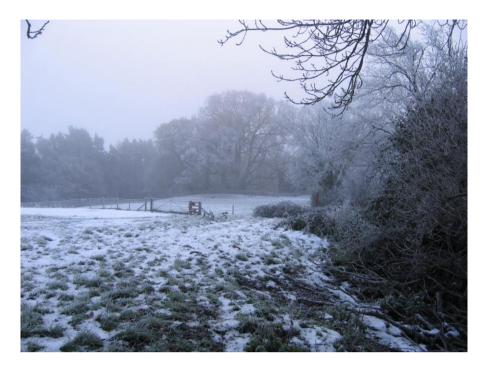
Plate 4: View of hedgebank (133) (right) with the castle in the background

A hedgebank (133) forming the SW side of a hollow-way and possibly of medieval origin extended around the NE side of the property. Eight shrub species were counted within the 27m length removed during the groundworks providing a rough assessment of the possible antiquity of this feature.

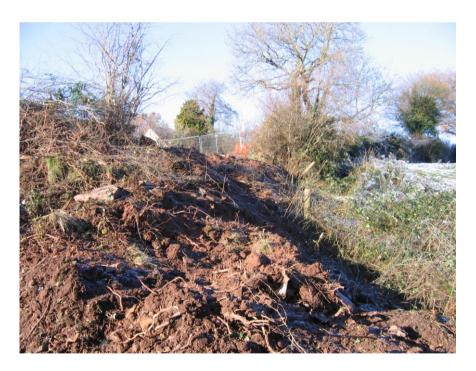
Plate 5: Hedgebank (133) after hedge removal showing hollow-way to right

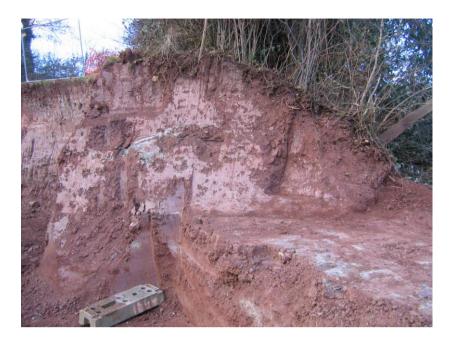
Plate 6: Hedgebank (133) after removal of bank

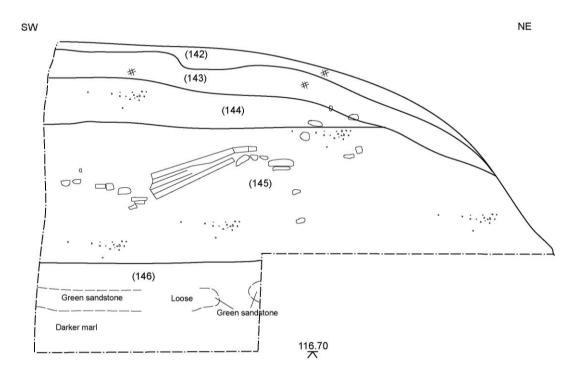
Fig 4: SE-facing section through hedgebank (133)

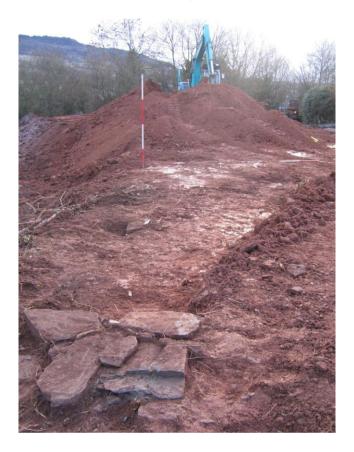
Plate 7: House platform structure (140) showing the intact wall base in the foreground; the ranging rods mark the extent of the foundation walls. The dark soil on the left side of the wall line is (141)

A post-medieval house platform (140) was observed at the SE end of the removed section of hedgebank (133), comprising a short length of sandstone masonry wall measuring $0.75m \times 0.50m$ forming part of a structure of some $8m \times 4m$ (plate 7). Two linear deposits of masonry about 0.3m wide made up the two sides of the building still visible; no structural remains were evident at the NW extent. Set within the construction platform were a toilet pipe and the remains of a coal store. The character of the masonry and some of the finds indicated an earlier post-medieval origin for the building. This was mixed with the soil of hedgebank (133), which suggests it was demolished and dumped into the bank. On the SE side, it was partly covered by (141), a dump of soil containing modern waste such as iron and plastic,

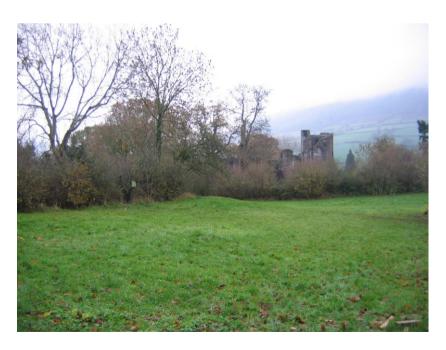
Plate 8: Post-medieval house platform (140) before excavation represented by the raised area in the centre of the photograph

which may have originated from the filling station and garage at the base of the hill. This earthwork is visible on the pre-excavation photographs of the site (plate 8).

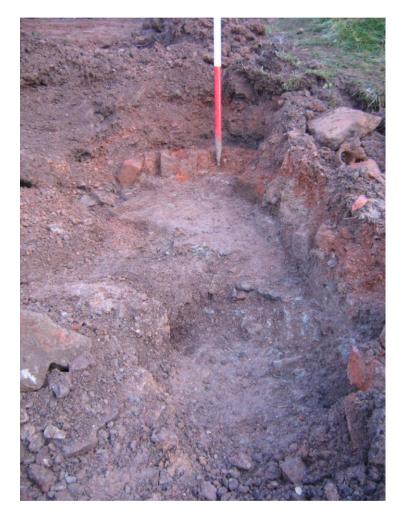
Plate 9: Remnant of the floor (116) that may have been part of the smithy or the forge

The only evidence for these activities is a stone floor level (116) below the layer of brick. Its location appears consistent with the position of a small structure (its gable-end facing the viewer) visible in the centre of an undated photograph (*plate 10*), to the right of the white building. Large pieces of clinker were found within and beneath this feature.

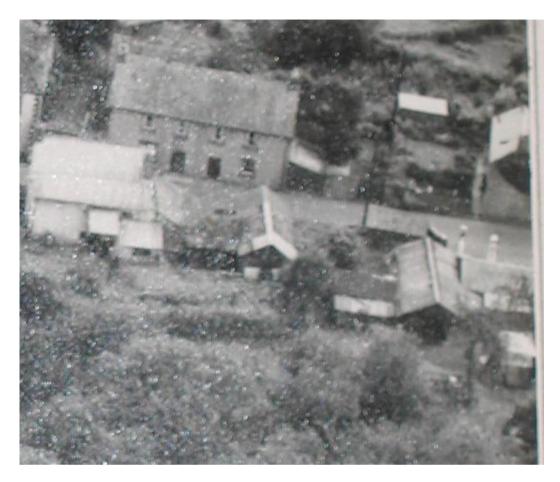
Plate 10: Undated aerial photograph which shows structures on the Old Forge property, near the road (buildings to the right of the white house in the foreground), the building in the centre with its apex facing the viewer probably being the blacksmith's premises or forge workshop

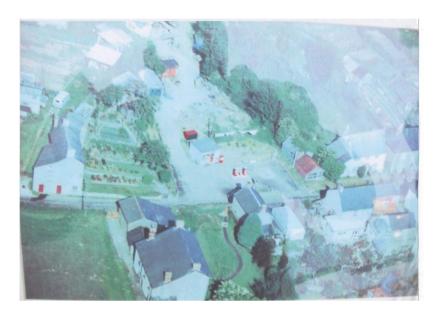
Plate 12: Oblique aerial view looking W showing the filling station (centre). The red building on the slope above was probably the vehicle repair garage. The building with the corrugated iron roof and the taller extension adjoining to the rear on the right of the photograph may represent the site of the former smithy and forge.

The most recent feature to occupy this site was the filling station and vehicle repair workshop (*plate 12*). The filling station is the small flat-roofed building with the petrol pumps in front of it. Modern waste was recorded in (117)/[118] and (131)/[132]. Contexts (101)-(110), (115), (116), and (121)-(127) probably represented part of the 20th century building phase on the site.

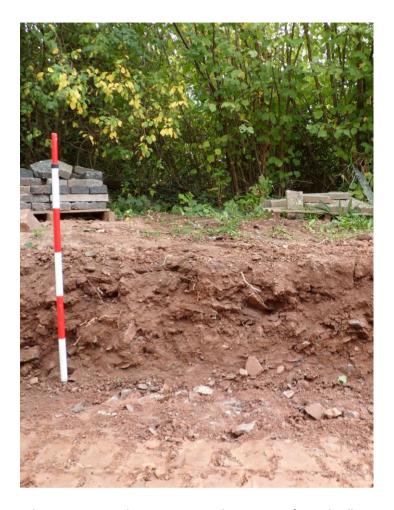
Plate 13: View SE showing excavated area to SE of new dwelling

Further ground reduction works were observed in this location, where the upper deposits (119, 117) had previously been removed under archaeological supervision. The excavations extended roughly $20m \times 5m \times 0.75m$ and revealed natural marl deposits (301) overlying fragmented mudstone/sandstone (302). No archaeological features or deposits were present (plates 13 & 14).
