# Heritage Impact Assessment, Park Street United Reform Church, Newtown, SY16 1EE

# **Heritage Impact Assessment, Park Street United Reform Church, Newtown, SY16 1EE**

Trysor Project No. 2023/893  
HER Event Record PRN – CPAT 215543

Summary	1
<b>1.</b> Introduction	2
<b>2.</b> Methodology	5
<b>3.</b> Heritage Impact Assessment Stage 1	5
<b>4.</b> Heritage Impact Assessment Stage 2	6
<b>5.</b> Statement of Significance	8
<b>6.</b> Heritage Impact Assessment Stage 3	9
<b>7.</b> Heritage Impact Assessment Stage 4	12
<b>8.</b> Bibliography	13
Appendix A: Photographs	14
Appendix B: Table of Changes	49

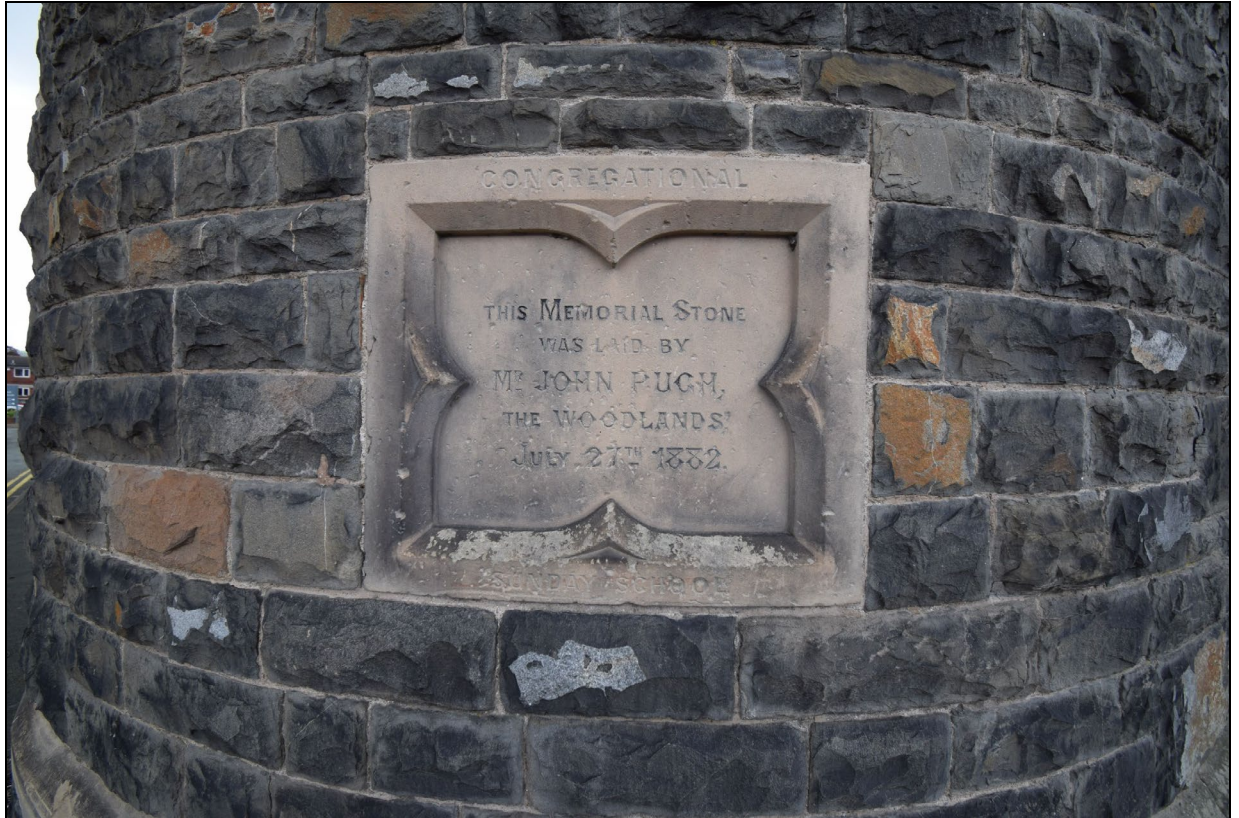
Plate 3: PSC2023\_003, A view of a memorial stone in the wall of Park Street schoolroom, dating to 1882. Looking west.

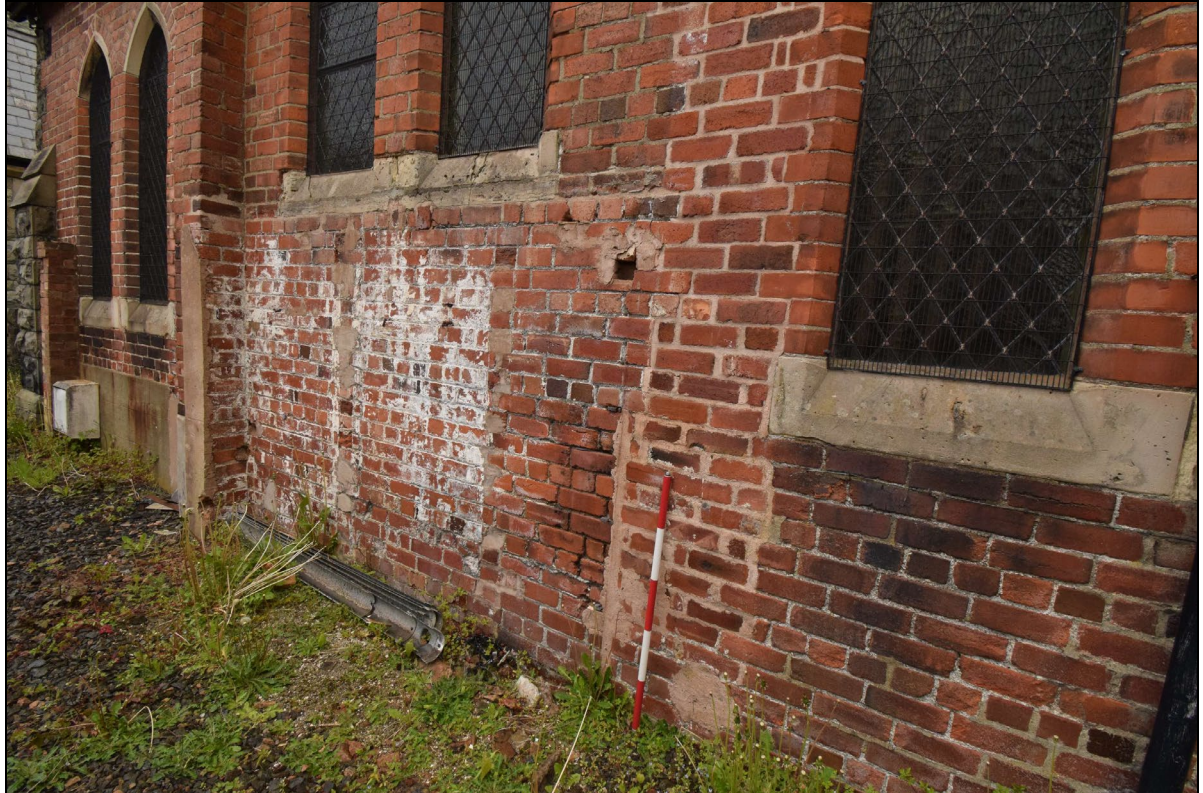
*Plate 6: PSC2023\_006, An external view of the southwest wall showing the brickwork of the schoolroom and a scar where a small structure once stood against the wall, and some repairs to the brickwork. Looking north-northwest.*

5.3 The schoolroom is a plainer building than the chapel but also uses snecked masonry and freestone dressings but with no stained glass in the windows. The southwest wall is built of brick but the windows still have stone dressing.

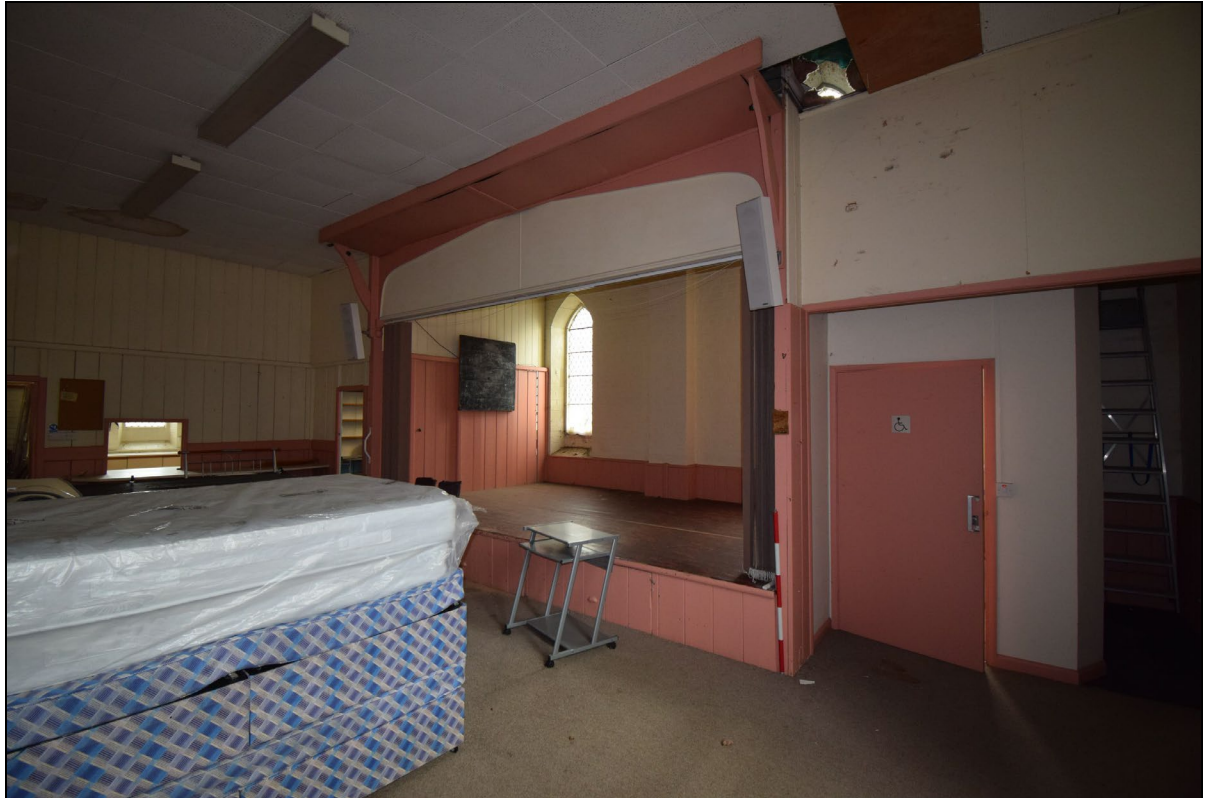
Plate 10: PSC2023\_010, A view inside the main hall of the schoolroom, showing the stage. Looking east.

*The chapel and schoolhouse were built a few years apart in the 1870s/1880s. The chapel is in the decorated Gothic Style and few changes have been made to the exterior since it was built. Notable features of the chapel are the large stained-glass window at the northwest end and the impressive organ which defines the layout at the southeastern end. The schoolroom is a plainer building with simpler style but copying the snecked masonry and freestone dressings. Internally there are few features of note that reflect its use as a schoolroom. A stage was inserted in the 20<sup>th</sup> century reflecting a change of use.*

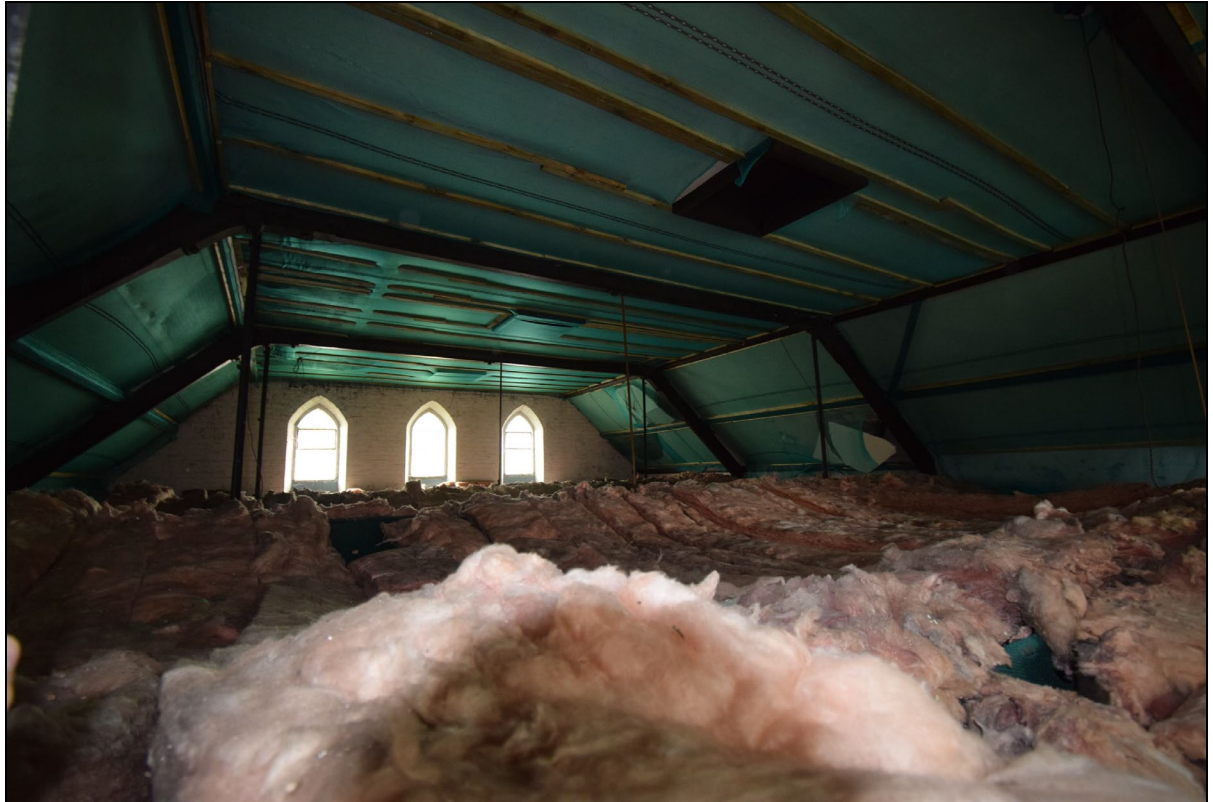
*Plate 16: PSC2023\_016, A view inside the roof space of the schoolroom. Looking northwest.*

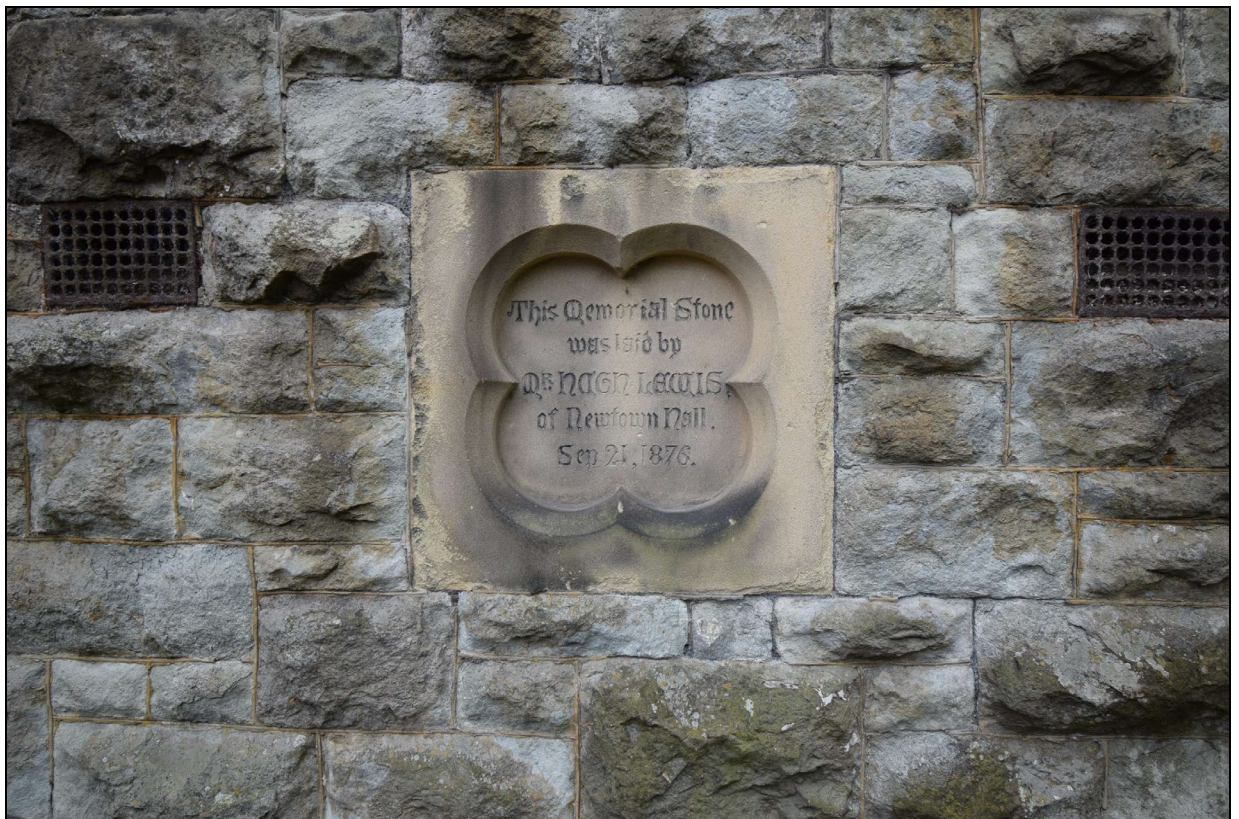
*Plate 25: PSC2023\_025, A memorial stone in the façade of the chapel, laid when the building was under construction in 1876. Looking southeast.*

4.5 A special service was held in Newtown Baptist Chapel on September 20<sup>th</sup>, 1876 to begin the proceedings surrounding the laying of the foundation stone of the new chapel. On the following day a large crowd assembled at the site for addresses from church and civic leaders, in advance of the laying of the foundation stone by Mr Hugh Lewis, Newtown Hall (Newtown and Welshpool Express - September 26th 1876). A time capsule was sealed inside the stone, which included "the autographs of the minister and seven deacons.

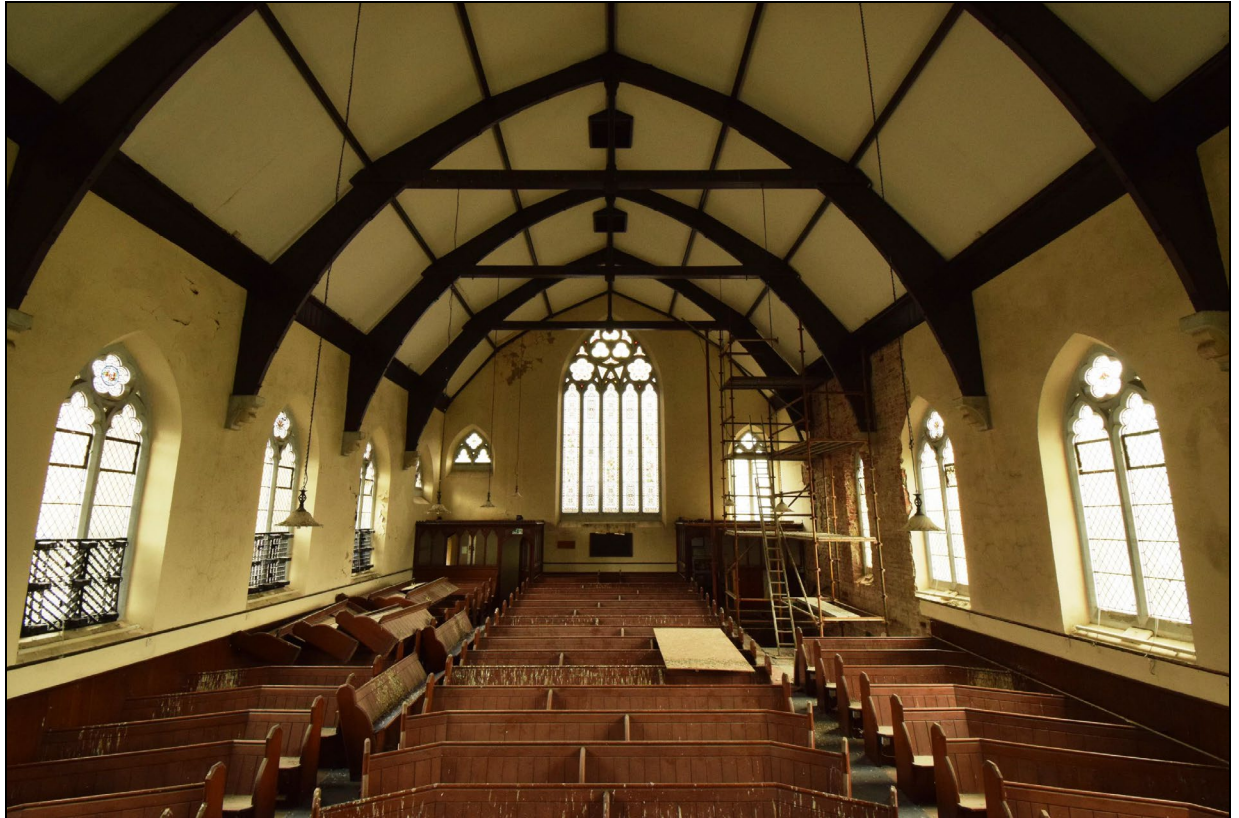
*Plate 26: PSC2023\_026, A view inside Park Street United Reform Chapel, viewed from the pulpit. Looking northwest.*

5.2.2 There is a large stained-glass window at its northeast end, see Plate 31 and small stained-glass detail at the top of other windows, see Plates 26 & 33. The large stained-glass window bears the inscription *This stained-glass window was added through the liberality and exertions of Miss Lewis of Newtown Hall 1877.*

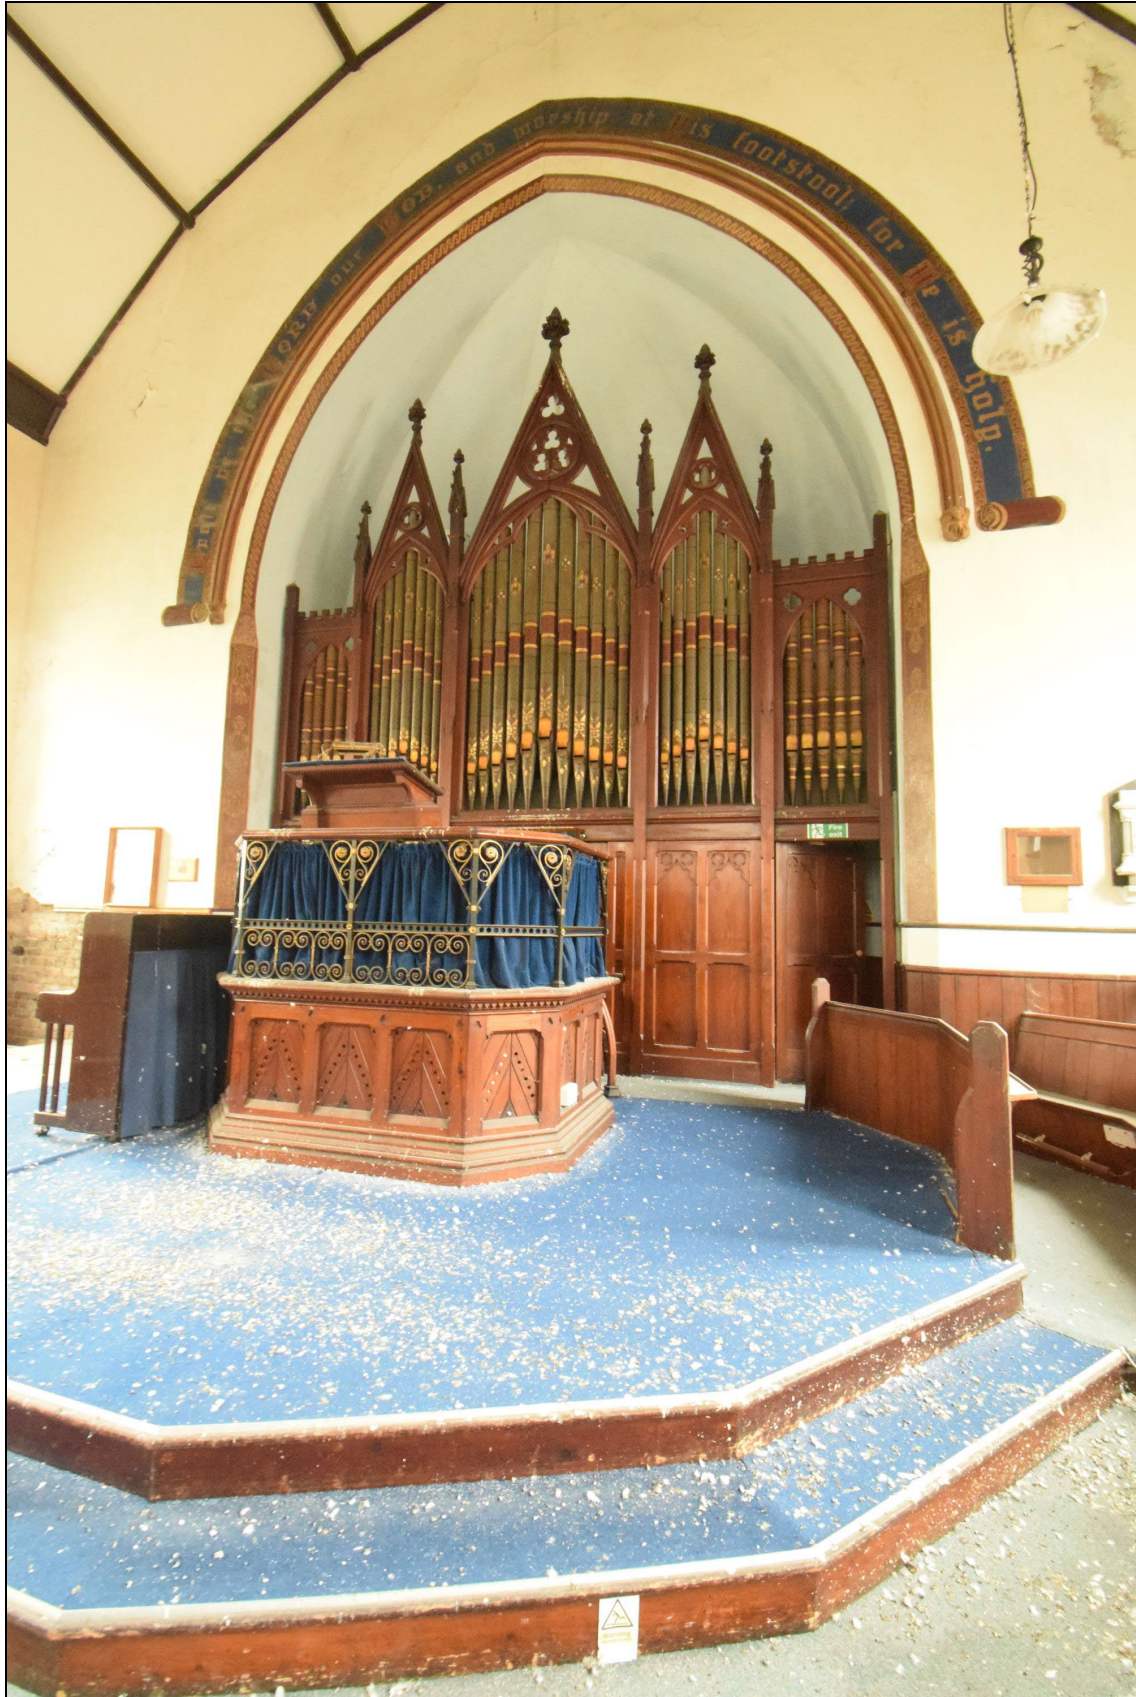
Plate 30: PSC2023\_030, A closer view of the pulpit and pipe organ. Looking east-southeast. The wording around the arch above the organ reads "Exalt at the Lord our God and worship at His footstool for He is holy" taken from Psalms 99 v5

6.2.2 Internally the new layout respects some of the important aspects of the chapel, leaving doorways, lobbies and the organ in place. Both the organ towards the southeast end, and the large, central stained-glass window at the northwest end will be allowed space within the building. A broad hallway will be created across the width of the chapel in front of these features, and the 1st and 2nd floors will have a gallery to allow views of both to their full height. From outside the new floors will not be directly behind the window.

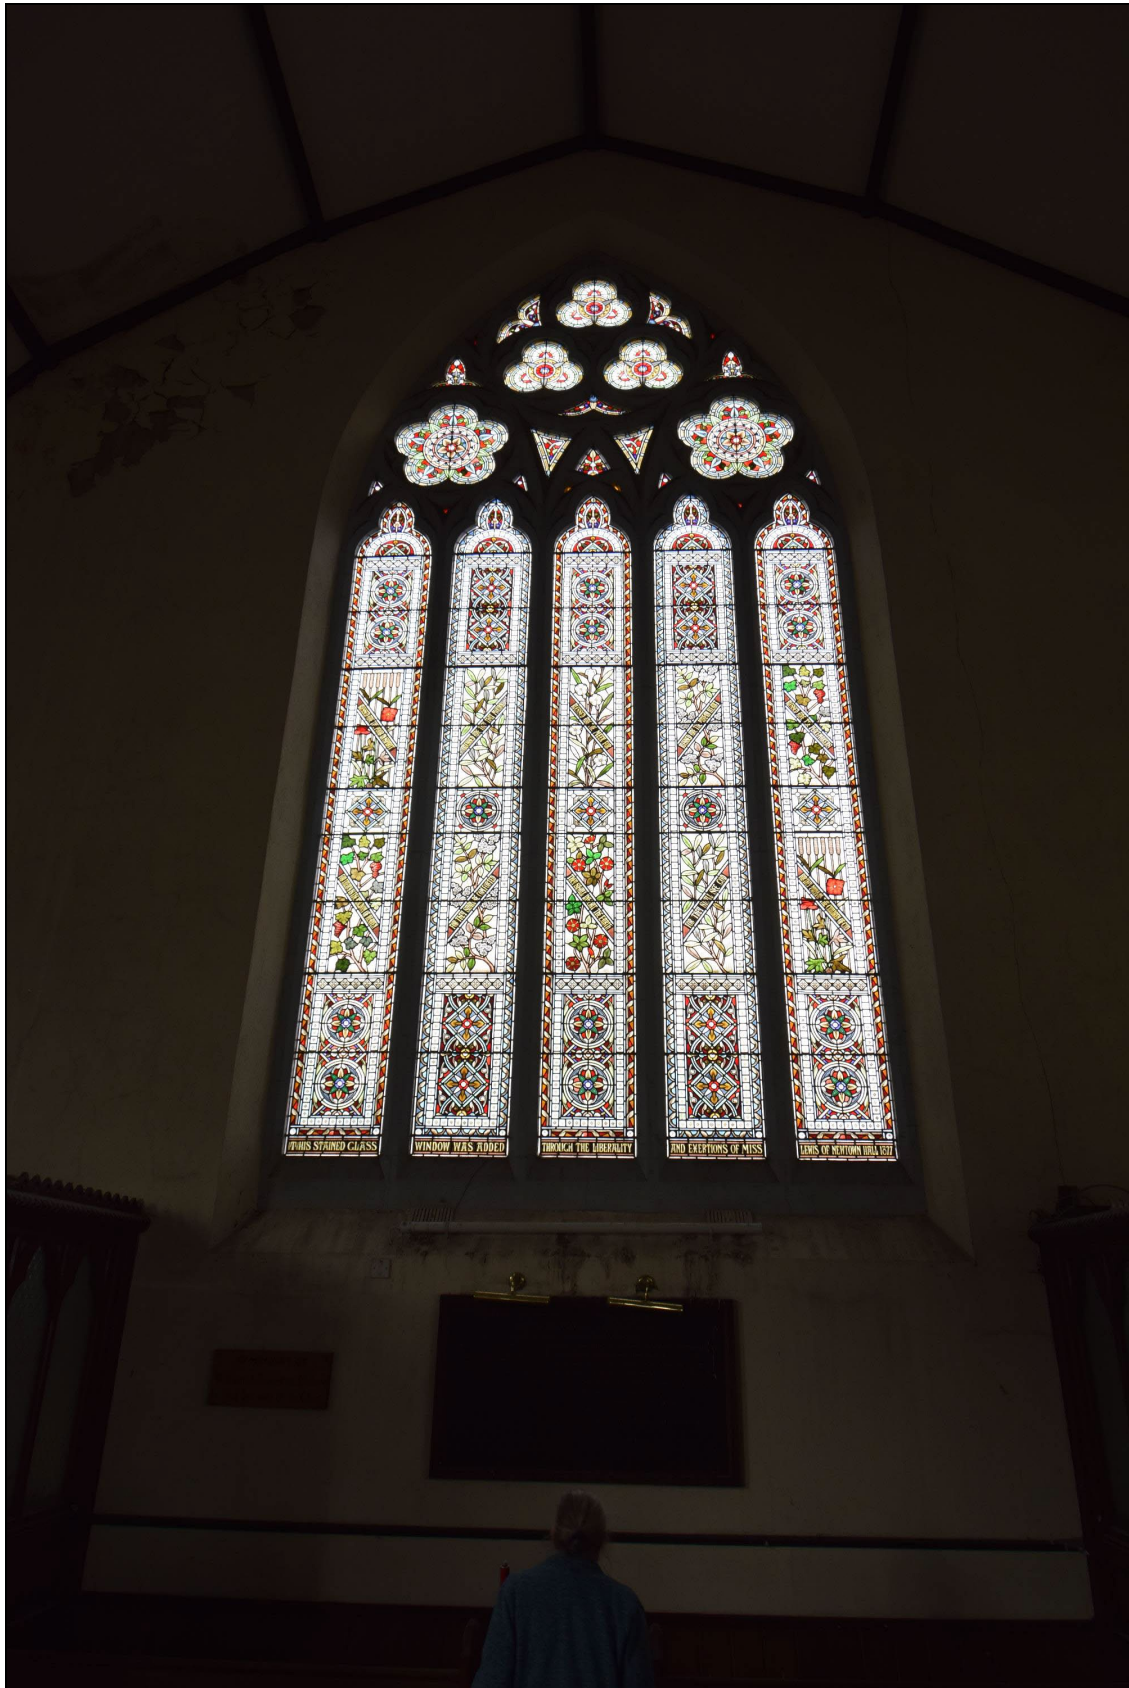
*Plate 31: PSC2023\_031, A view of the stain glassed window in the northwest gable wall of the chapel. Looking northwest. The stained glass has geometric patterns at the top and bottom with the central section displaying five different plants*

- The impressive stained-glass window will be retained and allowed space in the full height hallway at the northwest end of the chapel. It will not have any secondary glazing retaining its character.

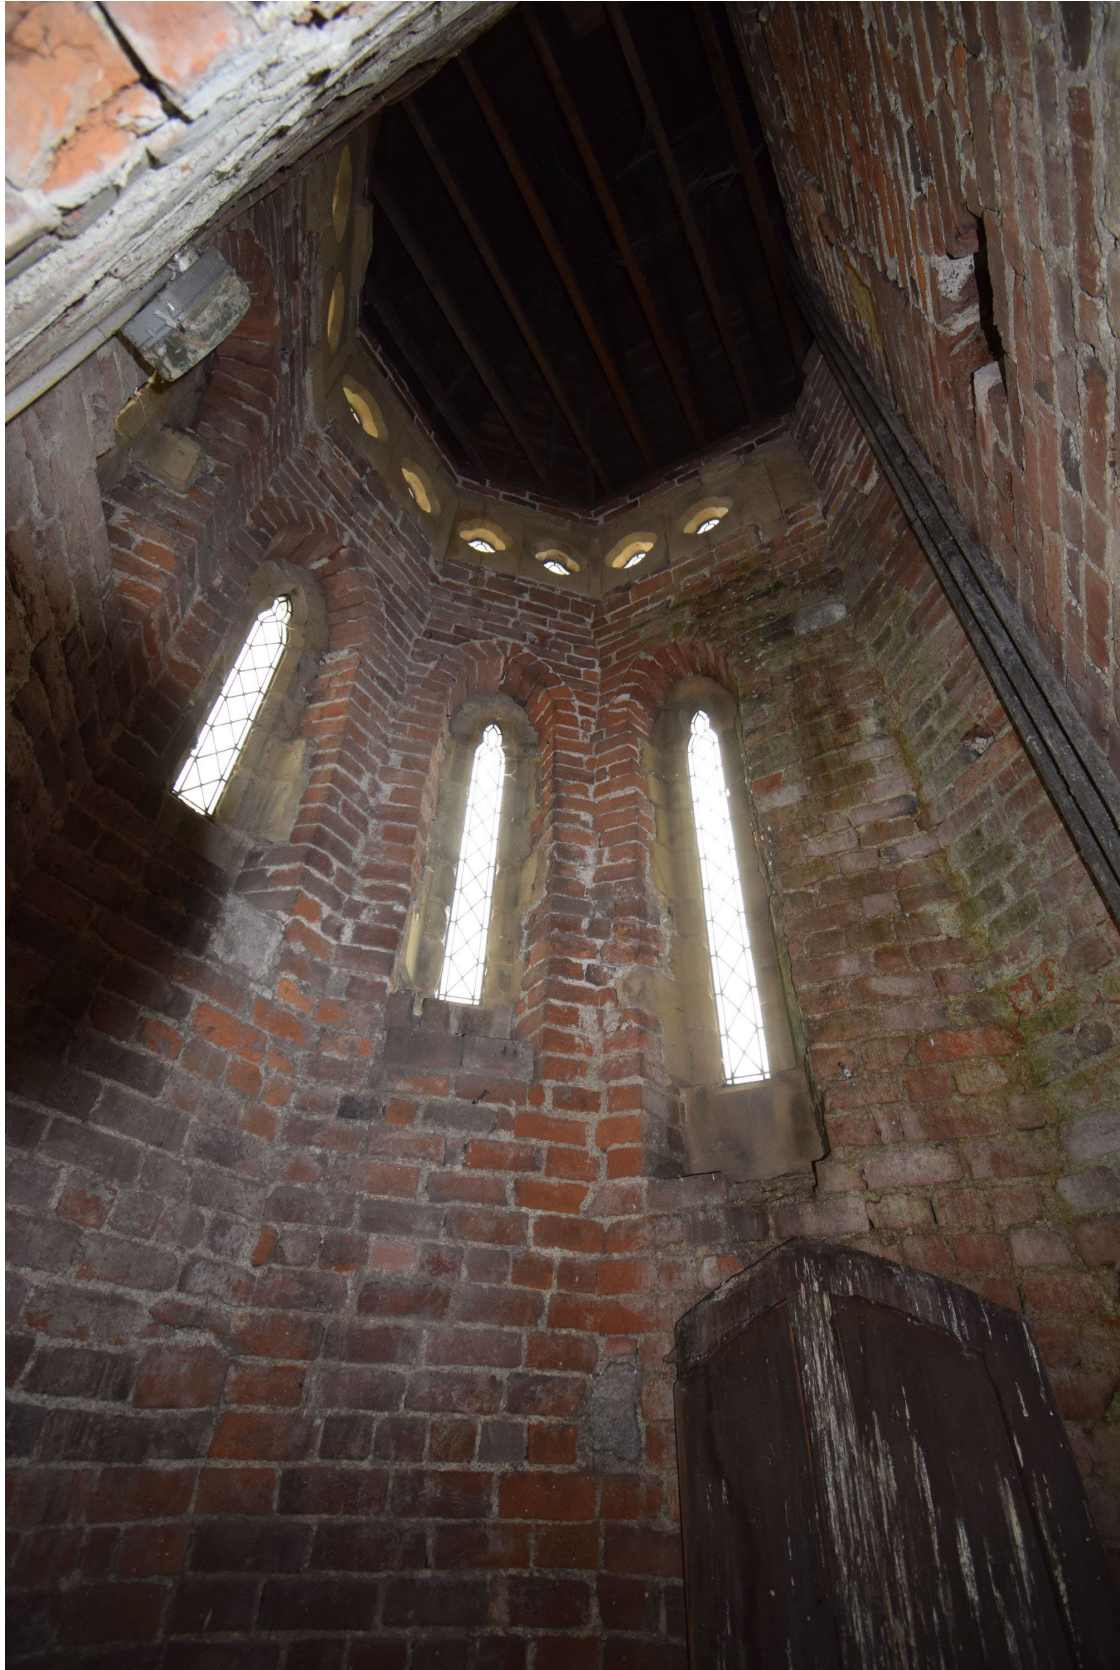
*Plate 32: PSC2023\_032, A view inside the "tower" at the north corner of the chapel. It seems that only the base was built initially, and the upper part of the tower was never added. Looking southeast.*

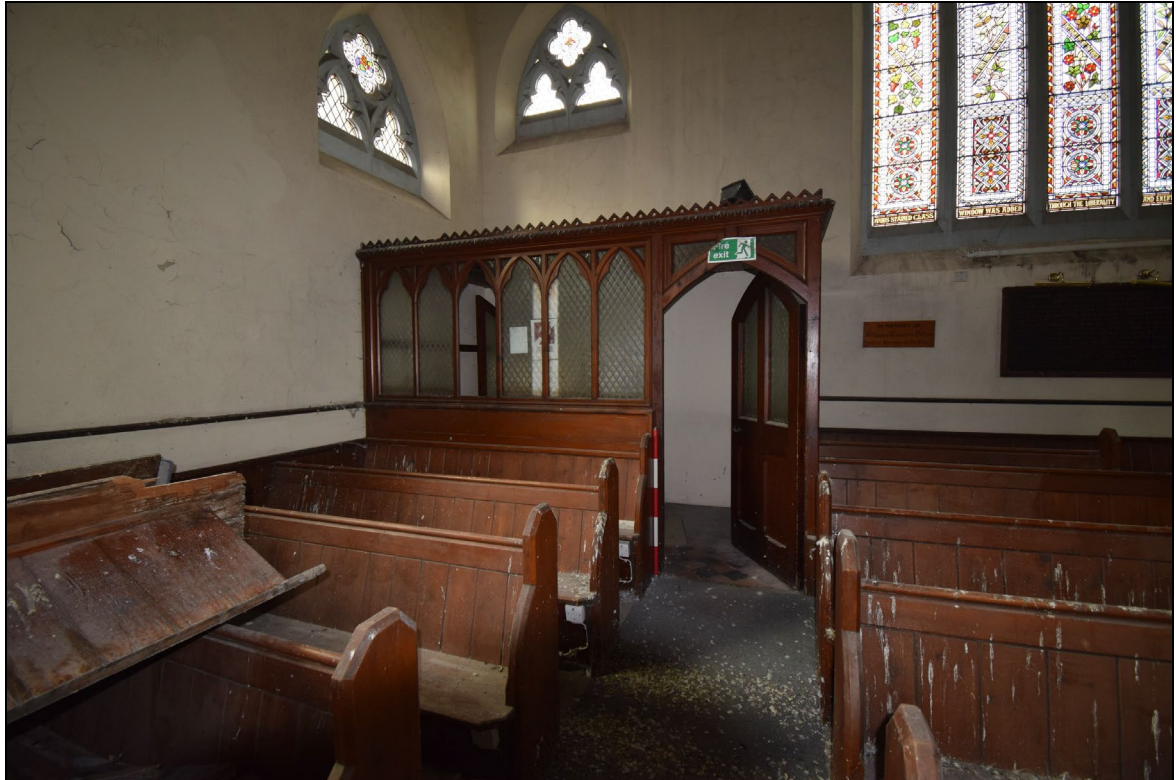
*Plate 33: PSC2023\_033, A view of the wooden partition, creating an inner vestibule inside the main entrance from Park Street. Looking northwest.*

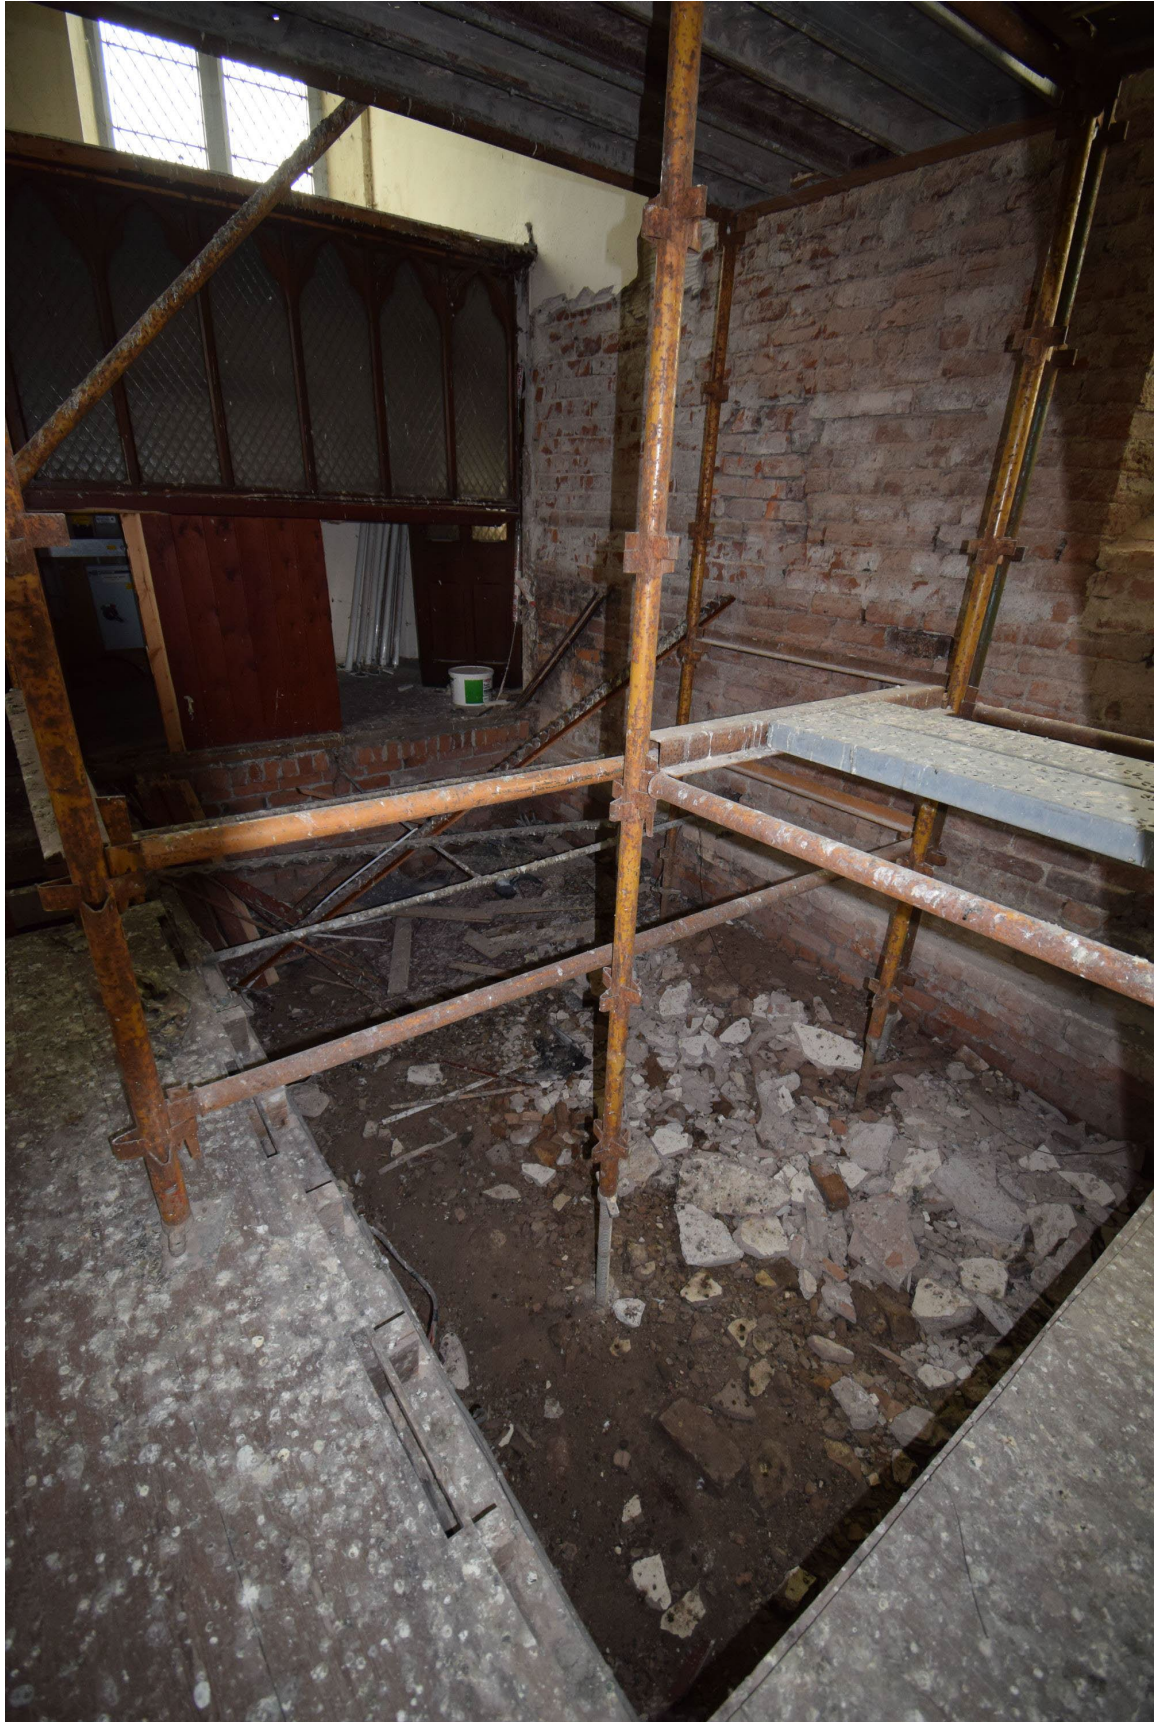
*Plate 34: PSC2023\_034, A view of a section of floor which has been taken up inside the inner vestibule inside the entrance into the chapel from New Church Street. Looking north.*

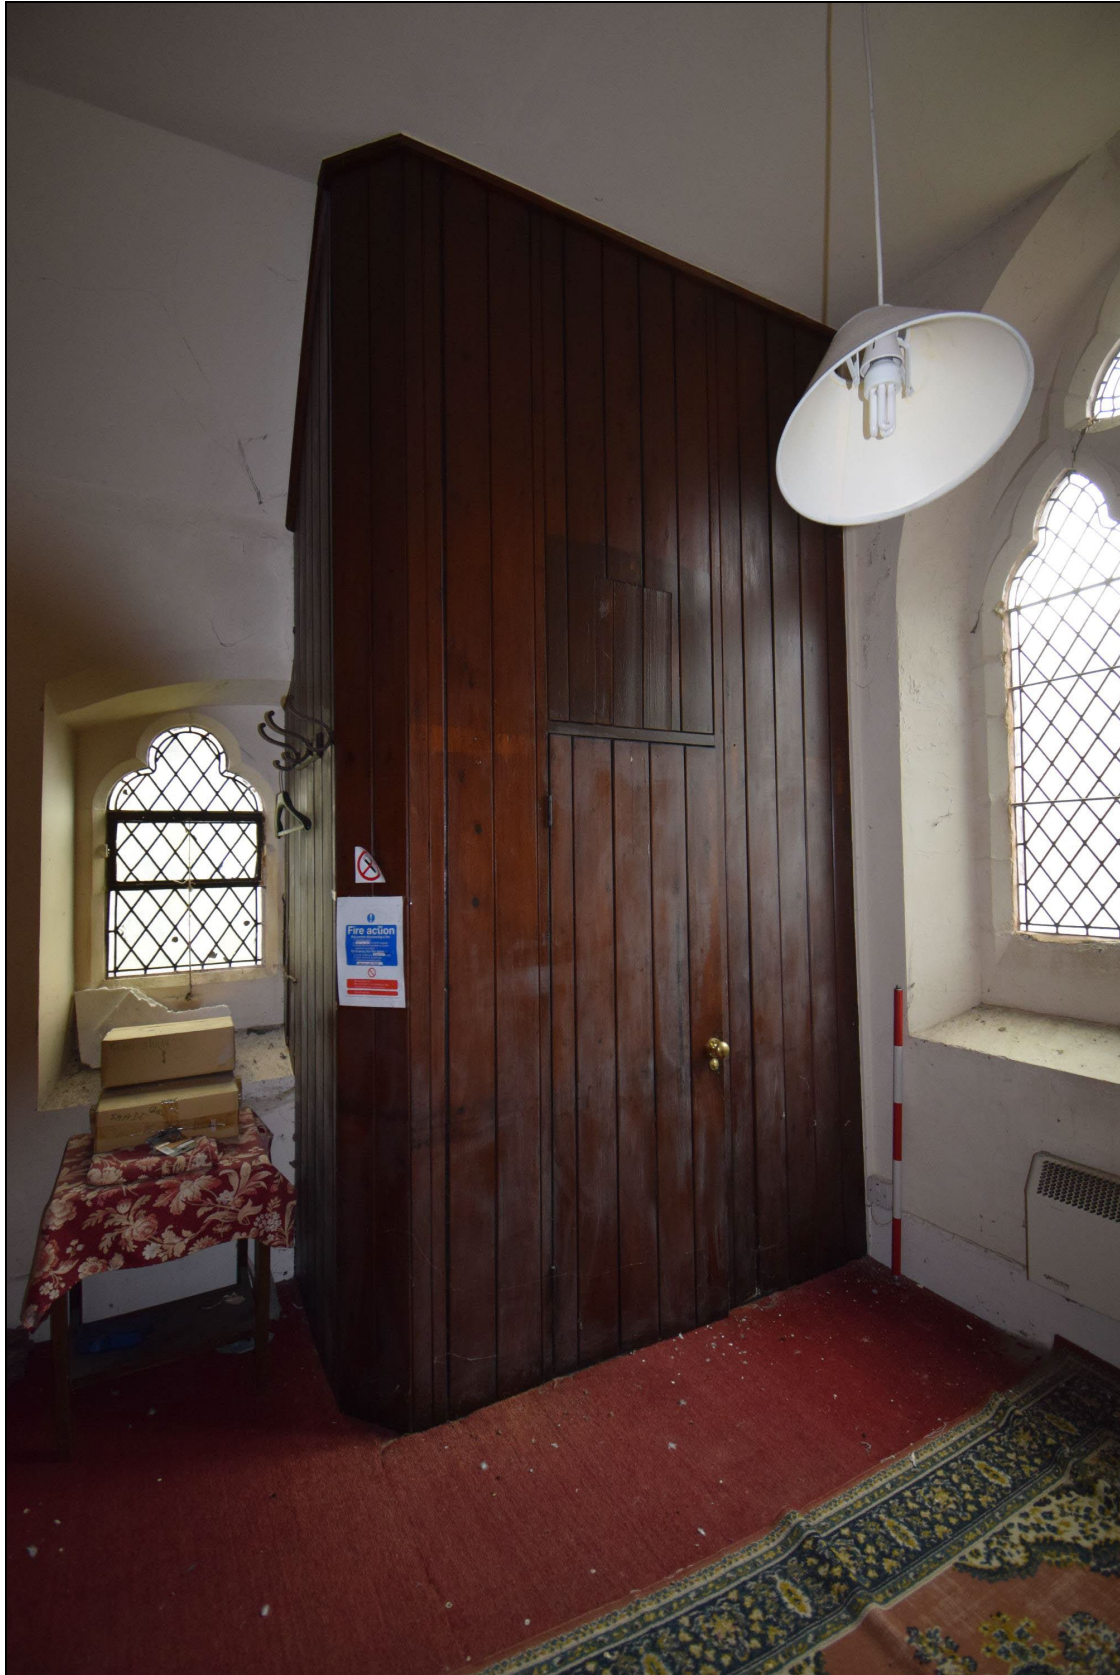
*Plate 36: PSC2023\_-36, A view inside the vestry at the south corner of the chapel, showing the wooden-walled water closet inside the vestry. Looking south.*

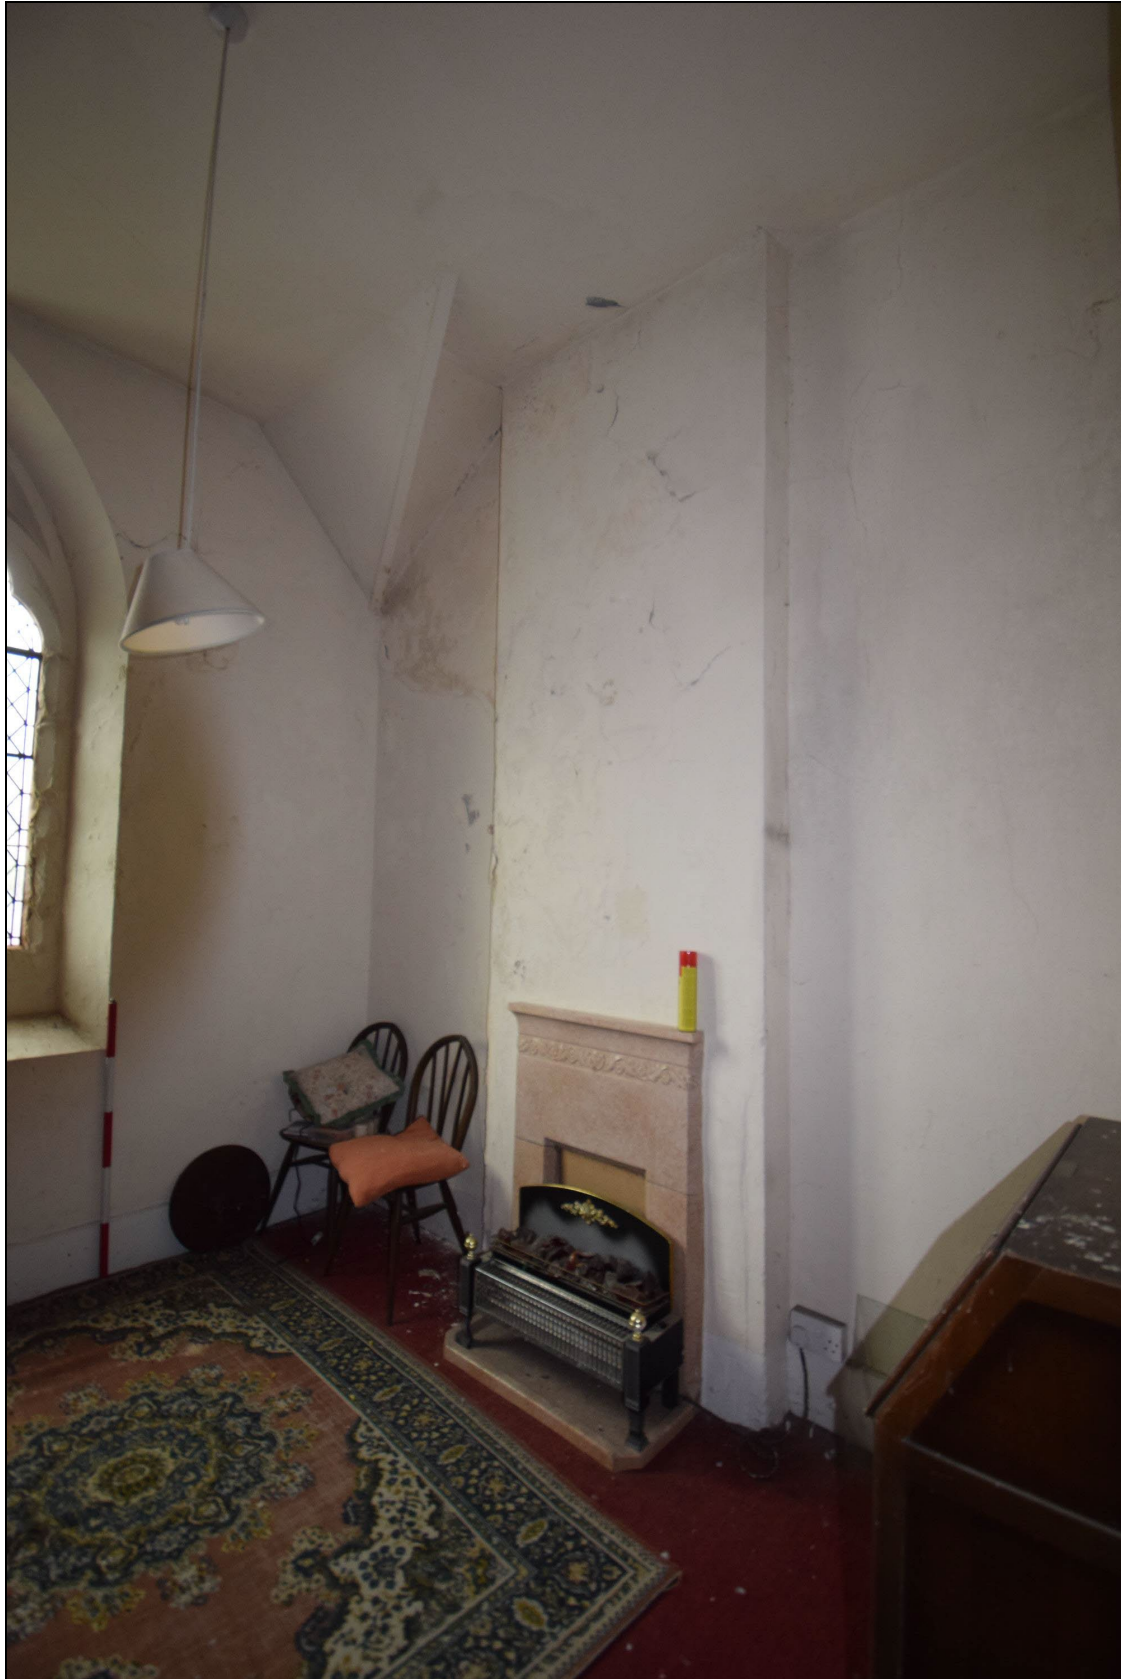
*Plate 37: PSC2023\_037, A view inside the vestry at the south corner of the chapel. Looking west.*

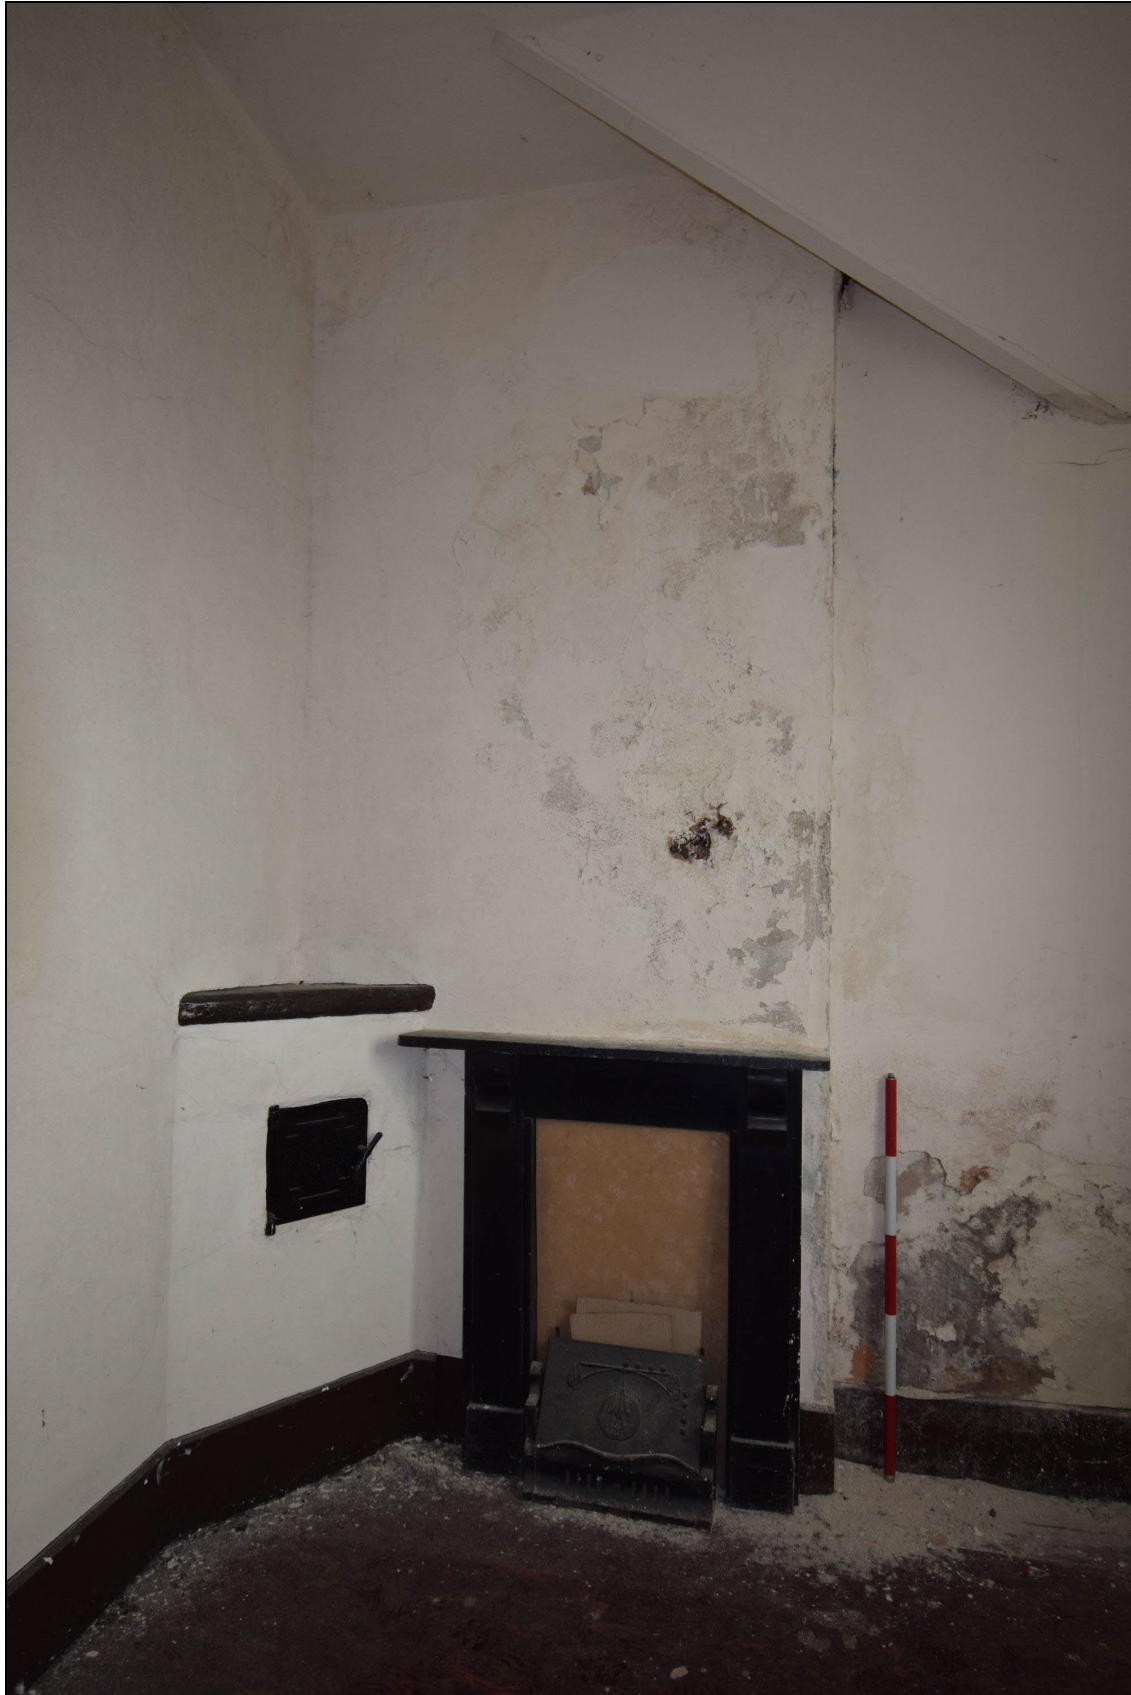
*Plate 38: PSC2023\_038, A view inside the vestry at the south corner of the chapel, showing the fireplace. Looking west-northwest.*
