# Heritage Impact Assessment, Park Street United Reform Church, Newtown, SY16 1EE

# **Heritage Impact Assessment, Park Street United Reform Church, Newtown, SY16 1EE**

Trysor Project No. 2023/893  
HER Event Record PRN – CPAT 215543

Summary	1
<b>1.</b> Introduction	2
<b>2.</b> Methodology	5
<b>3.</b> Heritage Impact Assessment Stage 1	5
<b>4.</b> Heritage Impact Assessment Stage 2	6
<b>5.</b> Statement of Significance	8
<b>6.</b> Heritage Impact Assessment Stage 3	9
<b>7.</b> Heritage Impact Assessment Stage 4	12
<b>8.</b> Bibliography	13
Appendix A: Photographs	14
Appendix B: Table of Changes	49

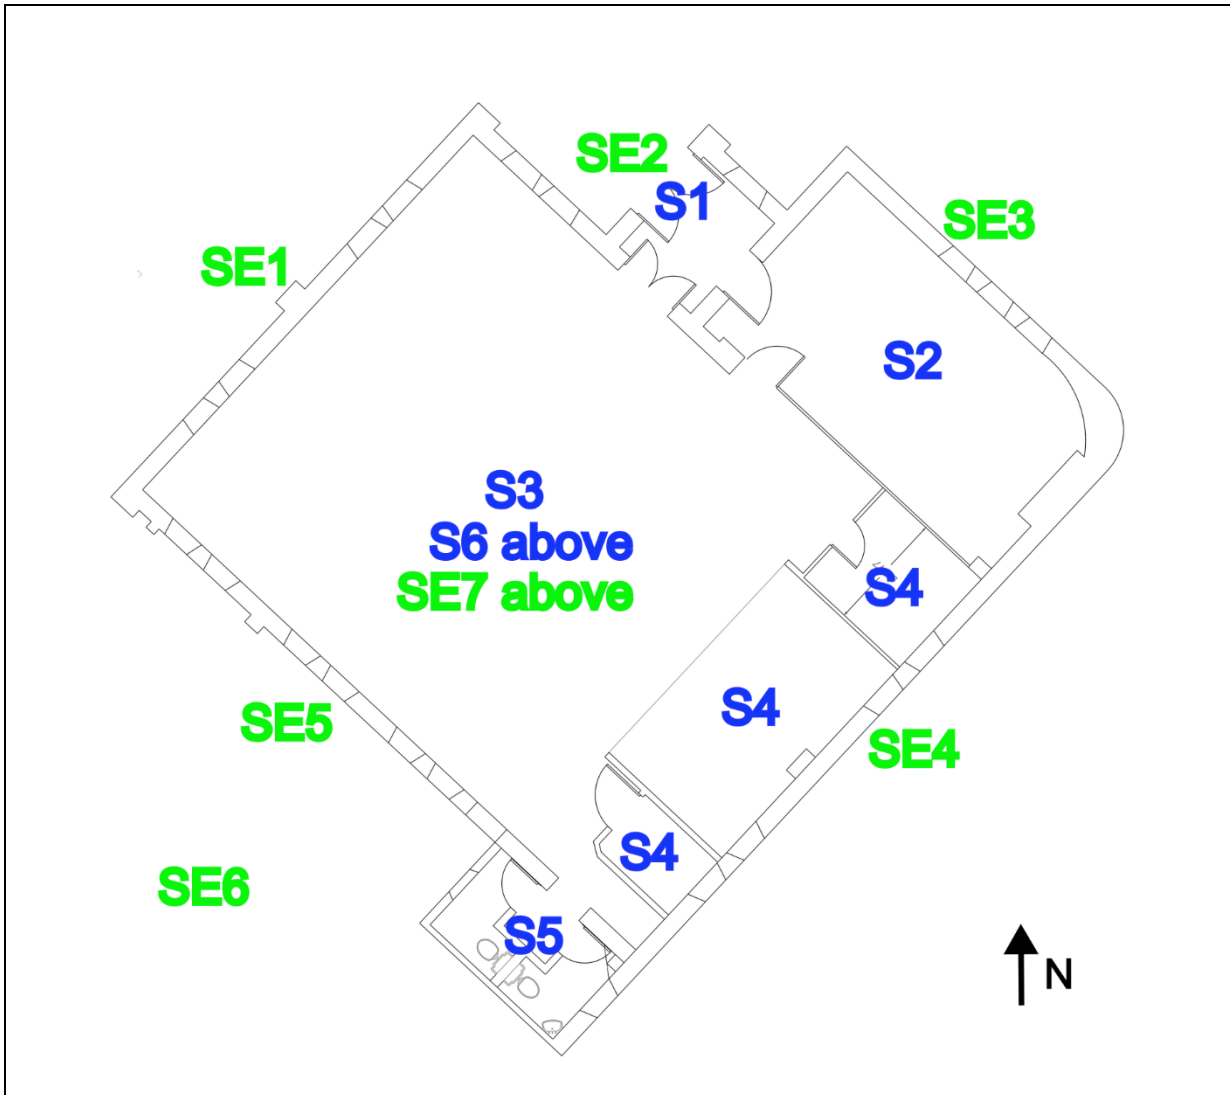
Figure 7; Location of changes to the schoolroom listed below giving the feature number.

SCHOOLHOUSE - INTERNAL			
Feature Number	Description	Impact	Comment
S1	Entrance Lobby	The entrance lobby will be retained as it is other including the double doors into the schoolroom hall	<b>Level 3 building record before change to preserve by record</b>
S2	Kitchen	The kitchen will be removed and wall lined and improved on one side. The wood panelling on the other side of the wall, and	<b>Level 3 building record before change to preserve by record</b>

<b>SCHOOLHOUSE - EXTERNAL</b>			
Feature Number	Description	Impact	Comment
	northeast	change to this face of the building	
SE4	External wall - southeast	There will be no change to this face of the building	
SE5	External wall - southwest	There will be a new doorway created where the two northern windows are currently. The upper part of the windows will be retained including the brick and stone arch	<b>Level 3 building record before change to preserve by record</b>
SE6	Boundary to the southwest	Boundary will be retained	
SE7	Roof	The slate roof will be retained and repaired but 5 pairs of rooflights will be inserted to allow light into the newly created floors on the first floor.	<b>The rooflights will be conservation lights and recessed into the roof so that they do not protrude.</b>
