# Aden, Bethel, Caernarfon Historic Environment Assessment

For: WindFlow Hammer Ltd

September 2015

Trysor Project No. 2015/474

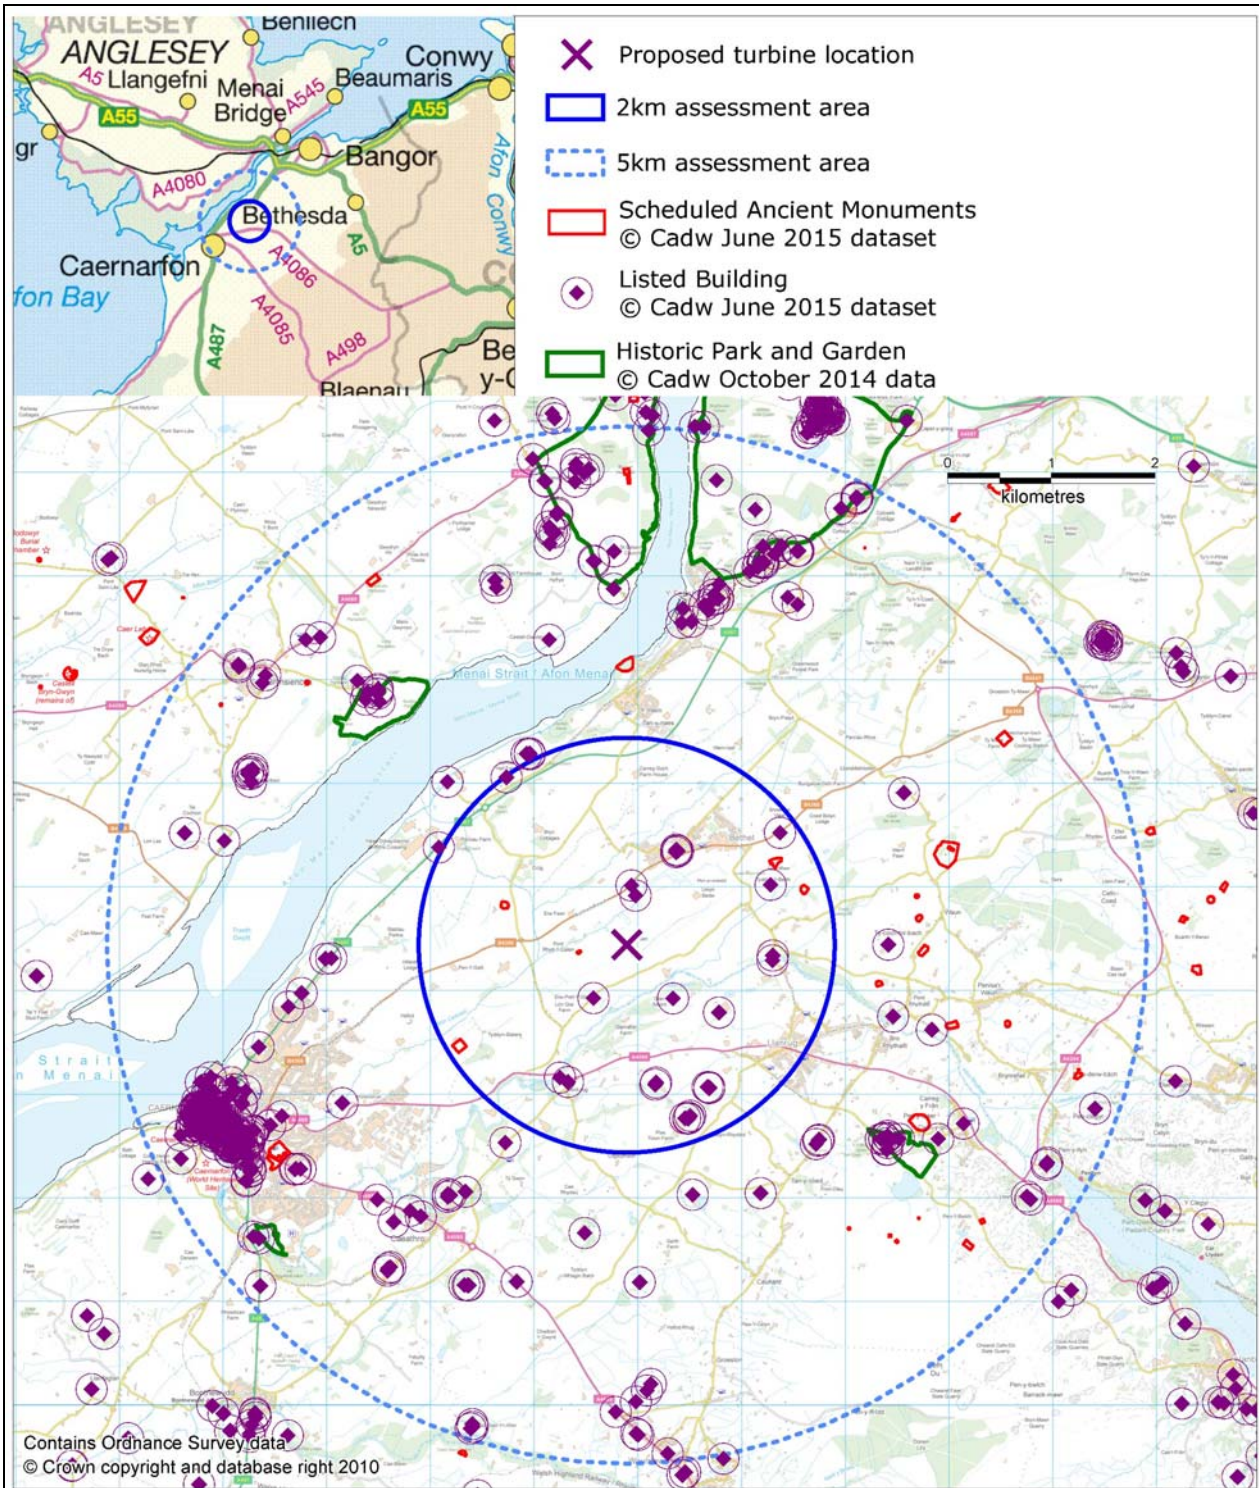
Figure 1: Location of the proposed turbine, showing the 2km, and the 2km to 5km assessment areas.

- 4.1 It is proposed that a single turbine, 38 metres to hub and 60.5 metres to the upright blade tip, is located at approximately SH5189564437 to the south of the buildings at Aden Farm, Bethel, Caernarfon, LL551UB see Figure 1 and Appendix F.
- 4.2 A foundation hole, less than 10 metres by 10 metres in plan, will be excavated for the turbine base through the subsoil. An area of hardstanding, 20 metres by 8 metres, will be created to the northwest of the turbine.
- 4.3 A short track will run to the turbine from the farm track to the southwest.
- 4.4 The cable will run back to a substation southwest of the farm buildings at Aden.

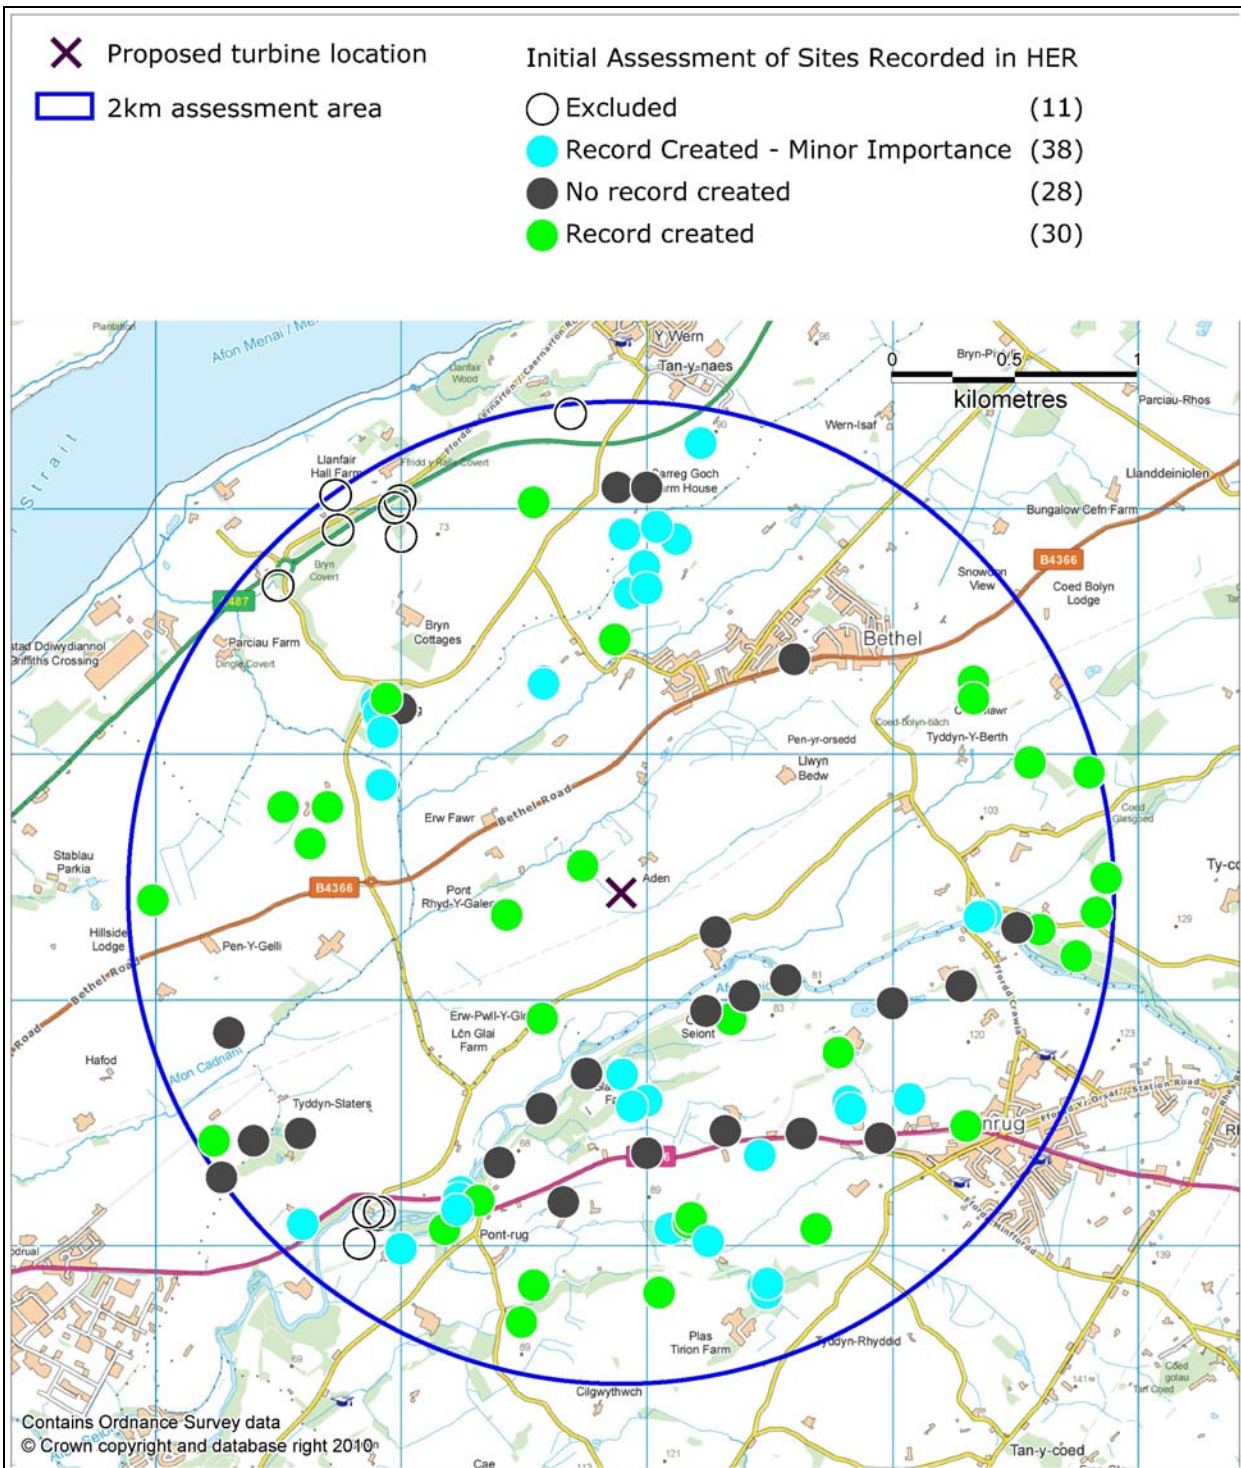
Figure 2: Historic assets excluded from further assessment based on no intervisibility with the turbine and no possible impact on setting, or record that did not relate to a physical historic asset, the location of which could be identified on the ground.

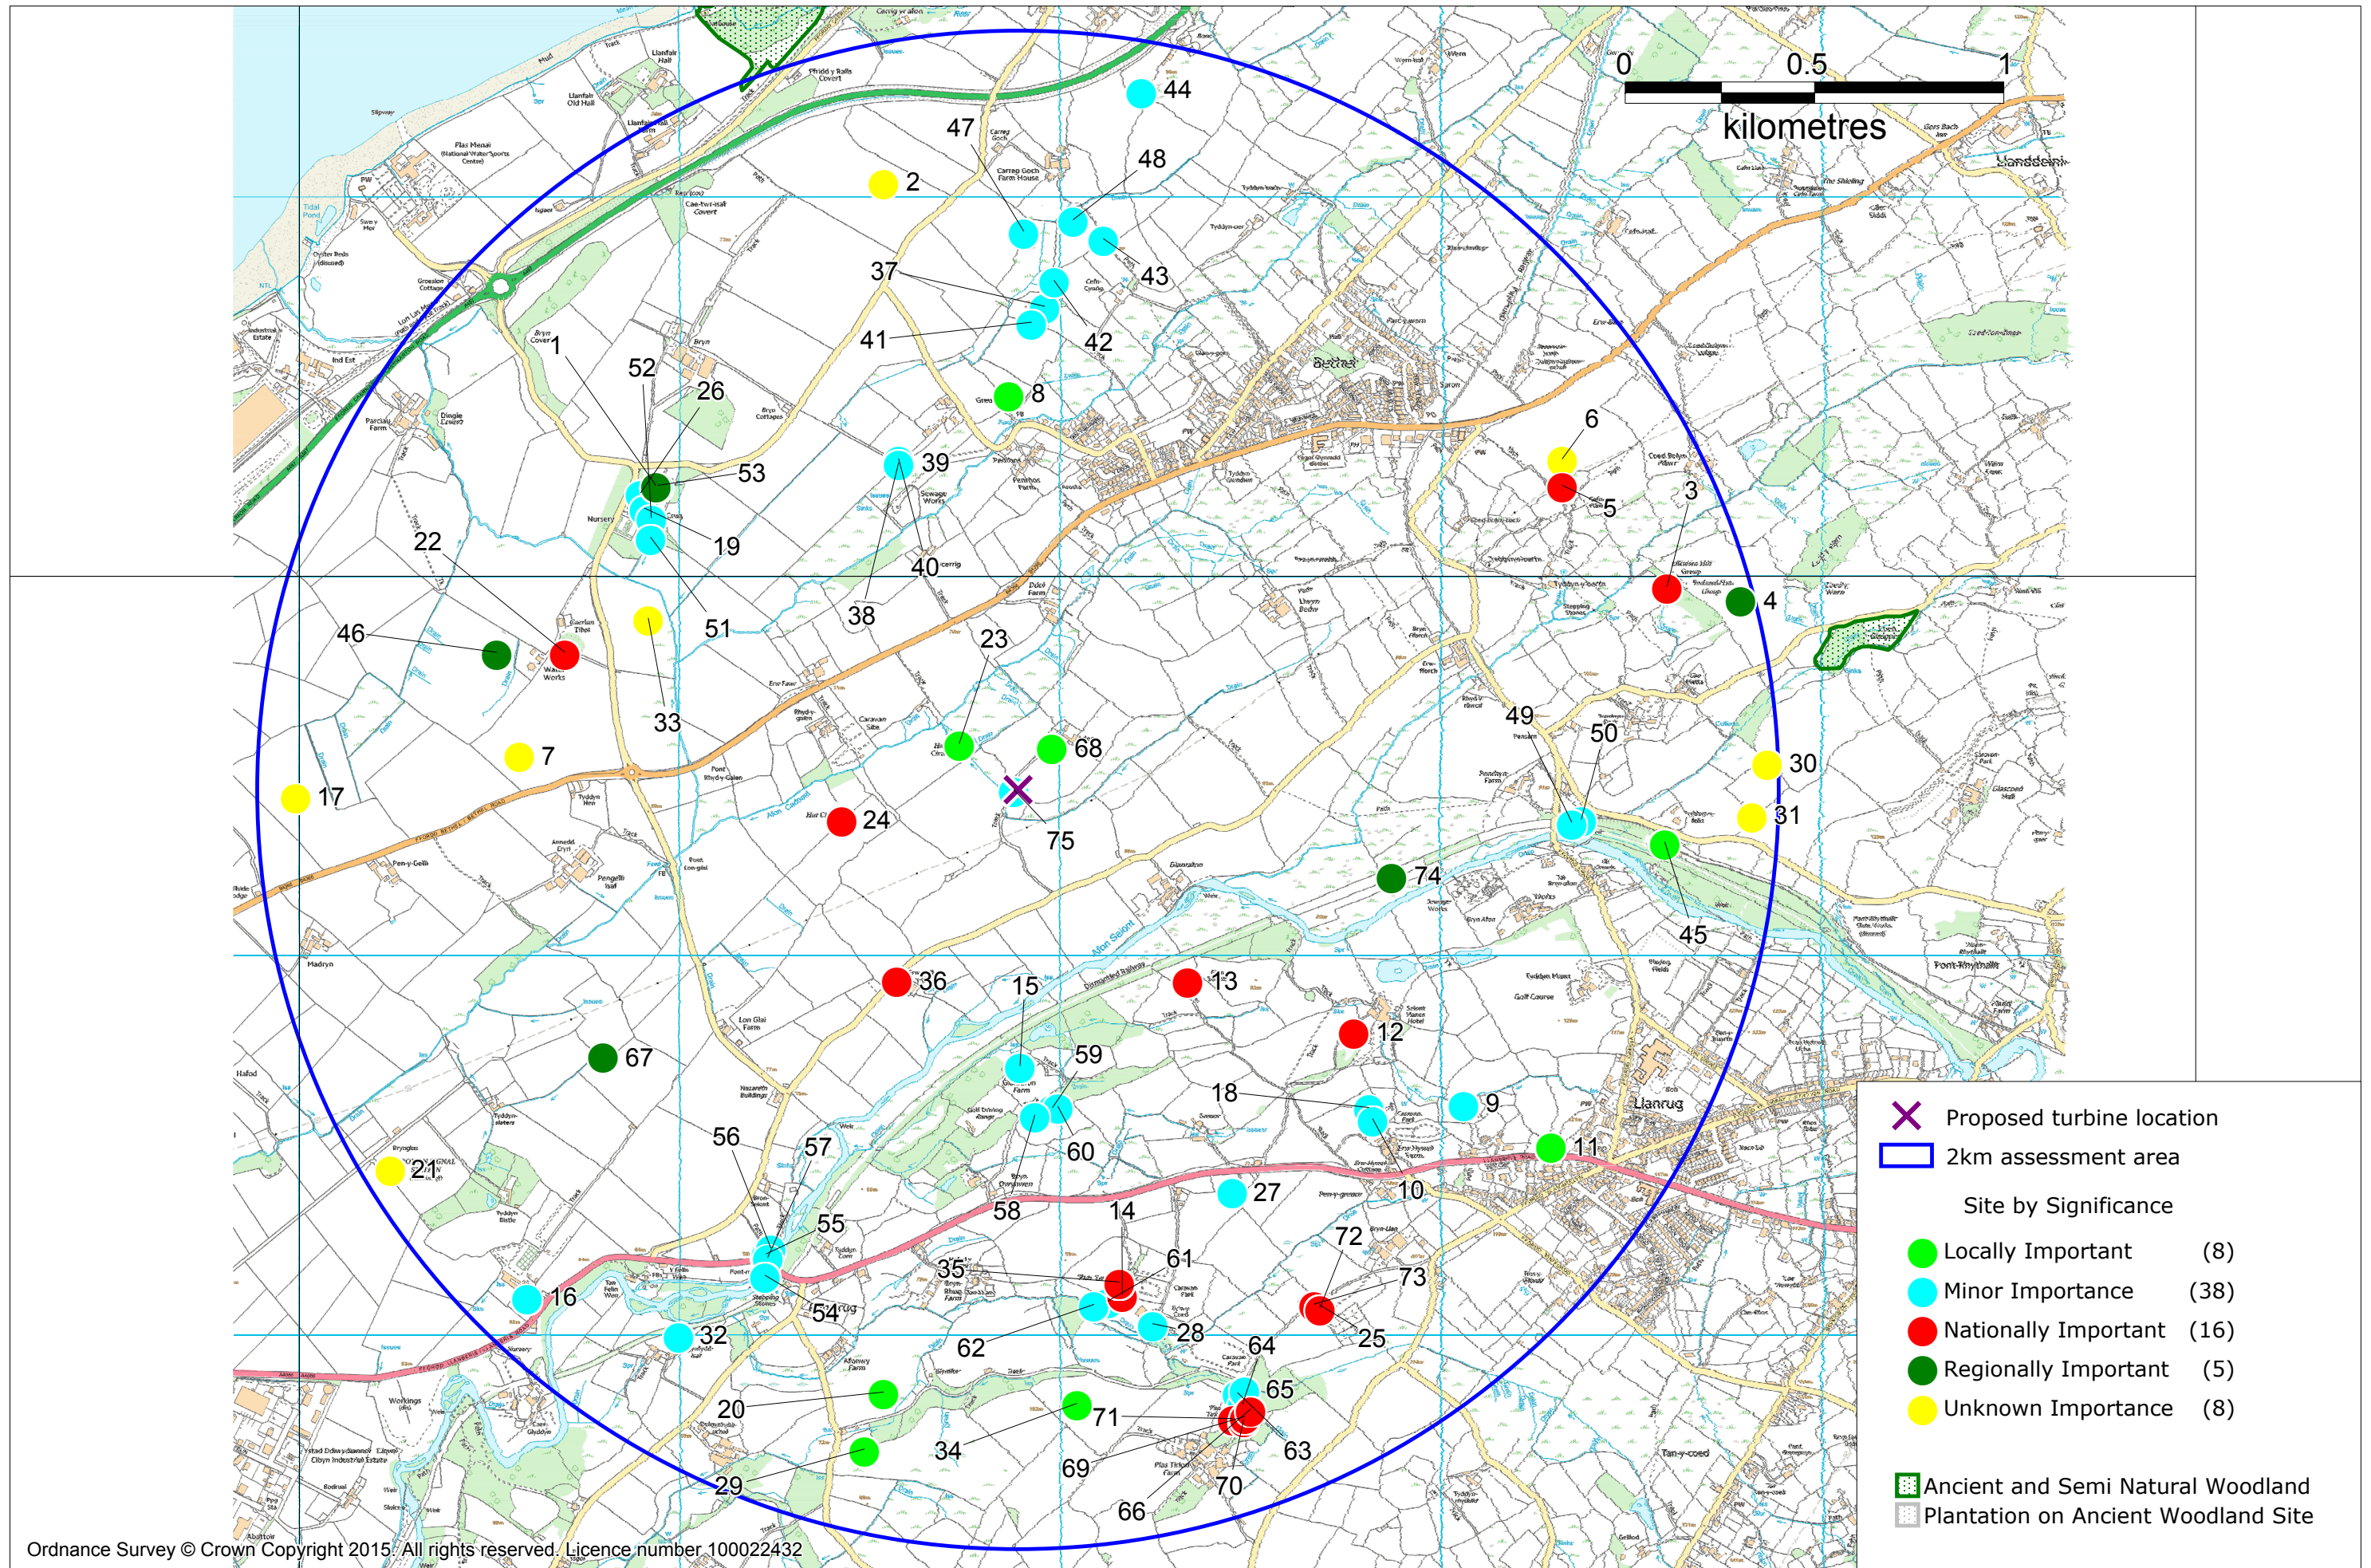
Figure 3: The 2km assessment area showing significance of historic assets within the revised dataset, labelled with Project ID number

10.5.1 Three newly recorded historic assets were noted for this assessment at or near the turbine site. These are Aden Farmhouse and a Boundary Bank at the development site (ID numbers 68 & 75) and a possible ring ditch noted on aerial photographs during this assessment (ID number 67). A short section of Boundary Bank ID number 75 would have to be removed for the turbine development. Details of these sites are included in Table 8, Appendix B and Figures 3 & 5.

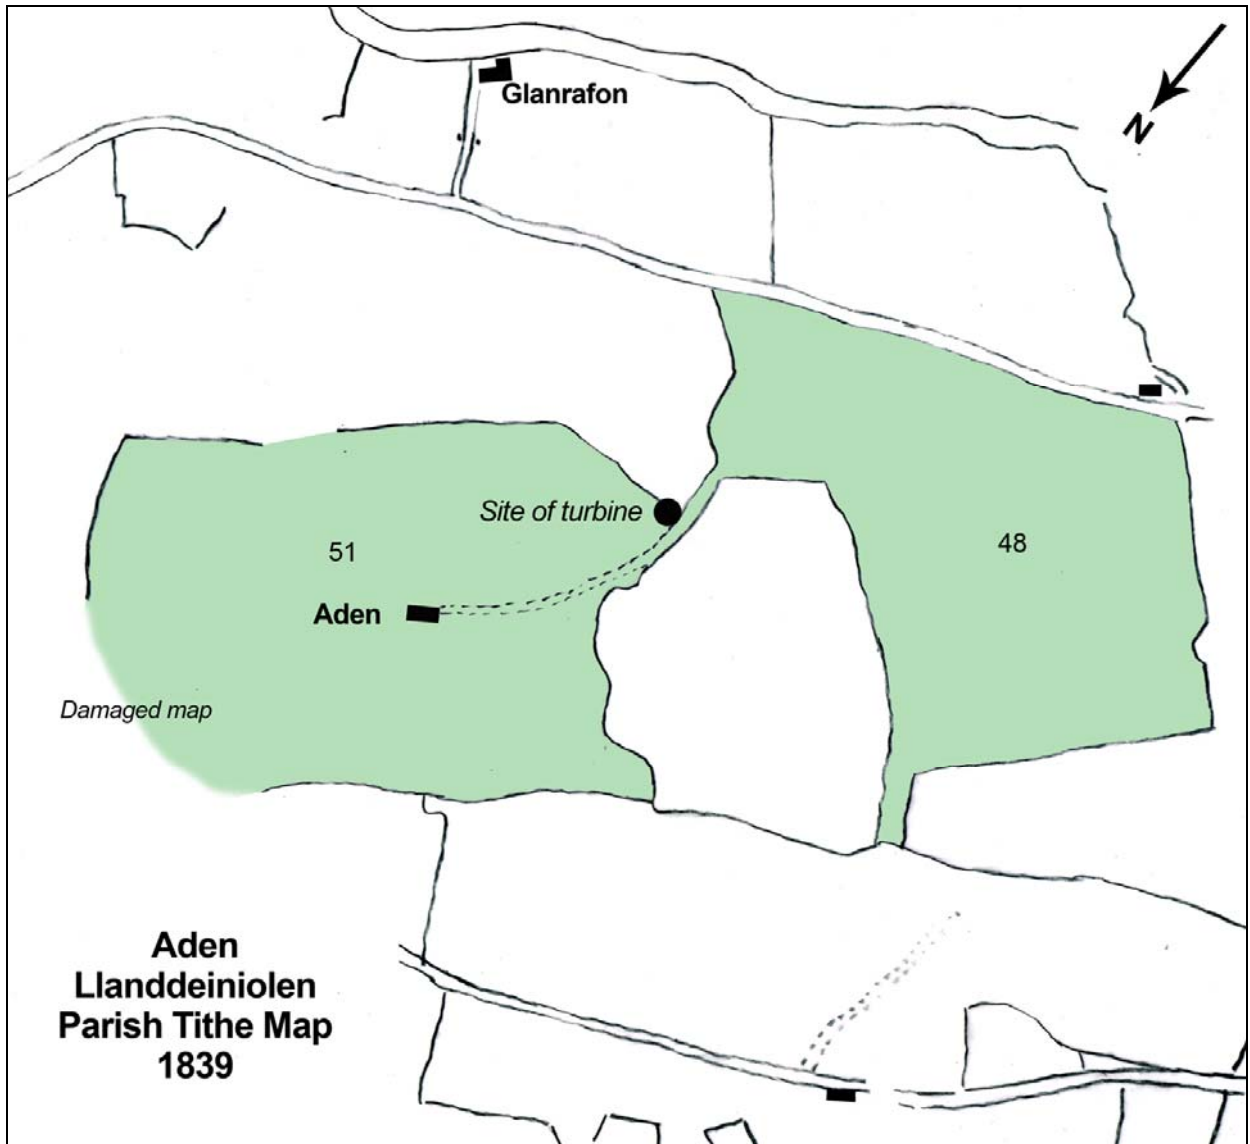
Figure 4: Proposed turbine site, as shown on the Llanddeiniolen parish tithe map of 1839.

8.1.4 The tithe apportionment, which accompanies the map and was also prepared in 1839, only lists the holding name and ownership and tenancy details. The farm was at that time owned by Griffith John Griffiths and occupied by one David Jones. It was composed of two blocks of land, numbered as parcels 51 (51 acres, including the house) and 48 (42 acres). Field names are not provided.

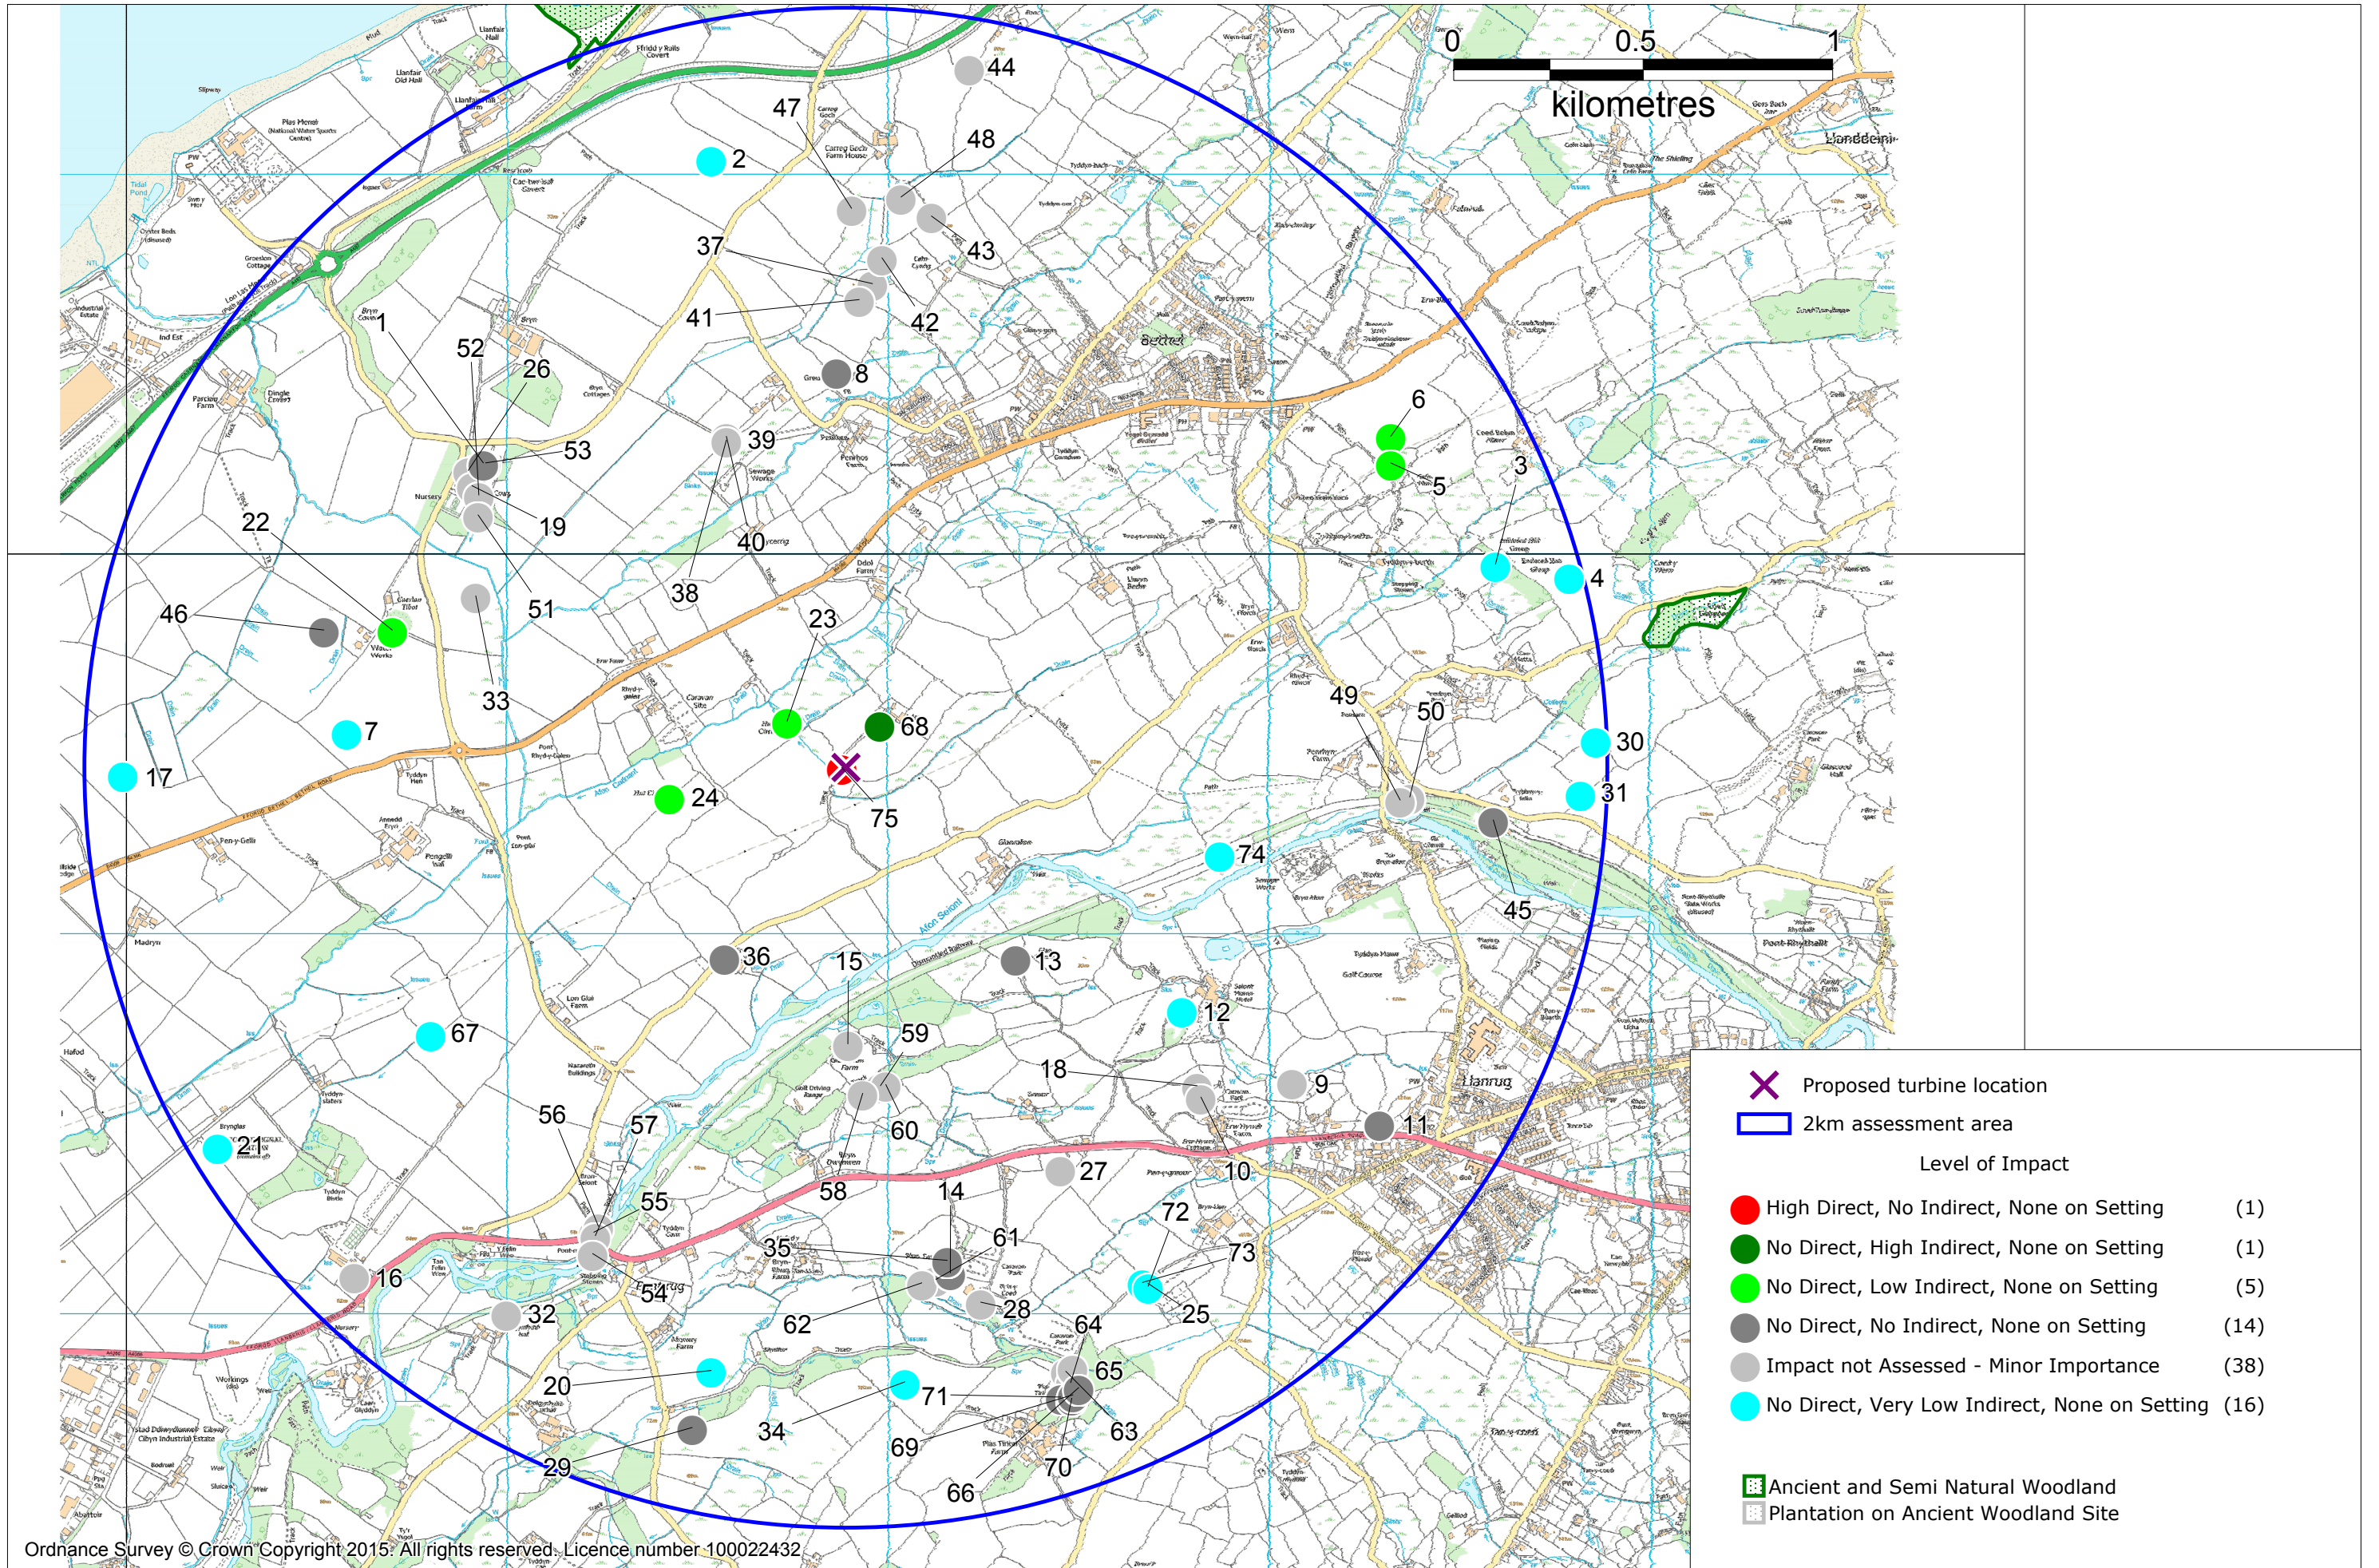
Figure 5: The 2km assessment area showing the level of impact on historic assets, labelled with Project ID number

- 9.7 Within the 37 records there are five Scheduled Ancient Monuments and twelve Listed Buildings
- 9.8 The Direct and Indirect impact on each of these site was assessed taking into account both physical and non-physical impacts. Each impact was assessed within the scale Very Low, Low, Moderate, High and Very High, taken into account the significance of the site and the nature of the impact. A full table is found in Appendix B but a summary is tabulated in Table 2 below and illustrated in Figure 5.

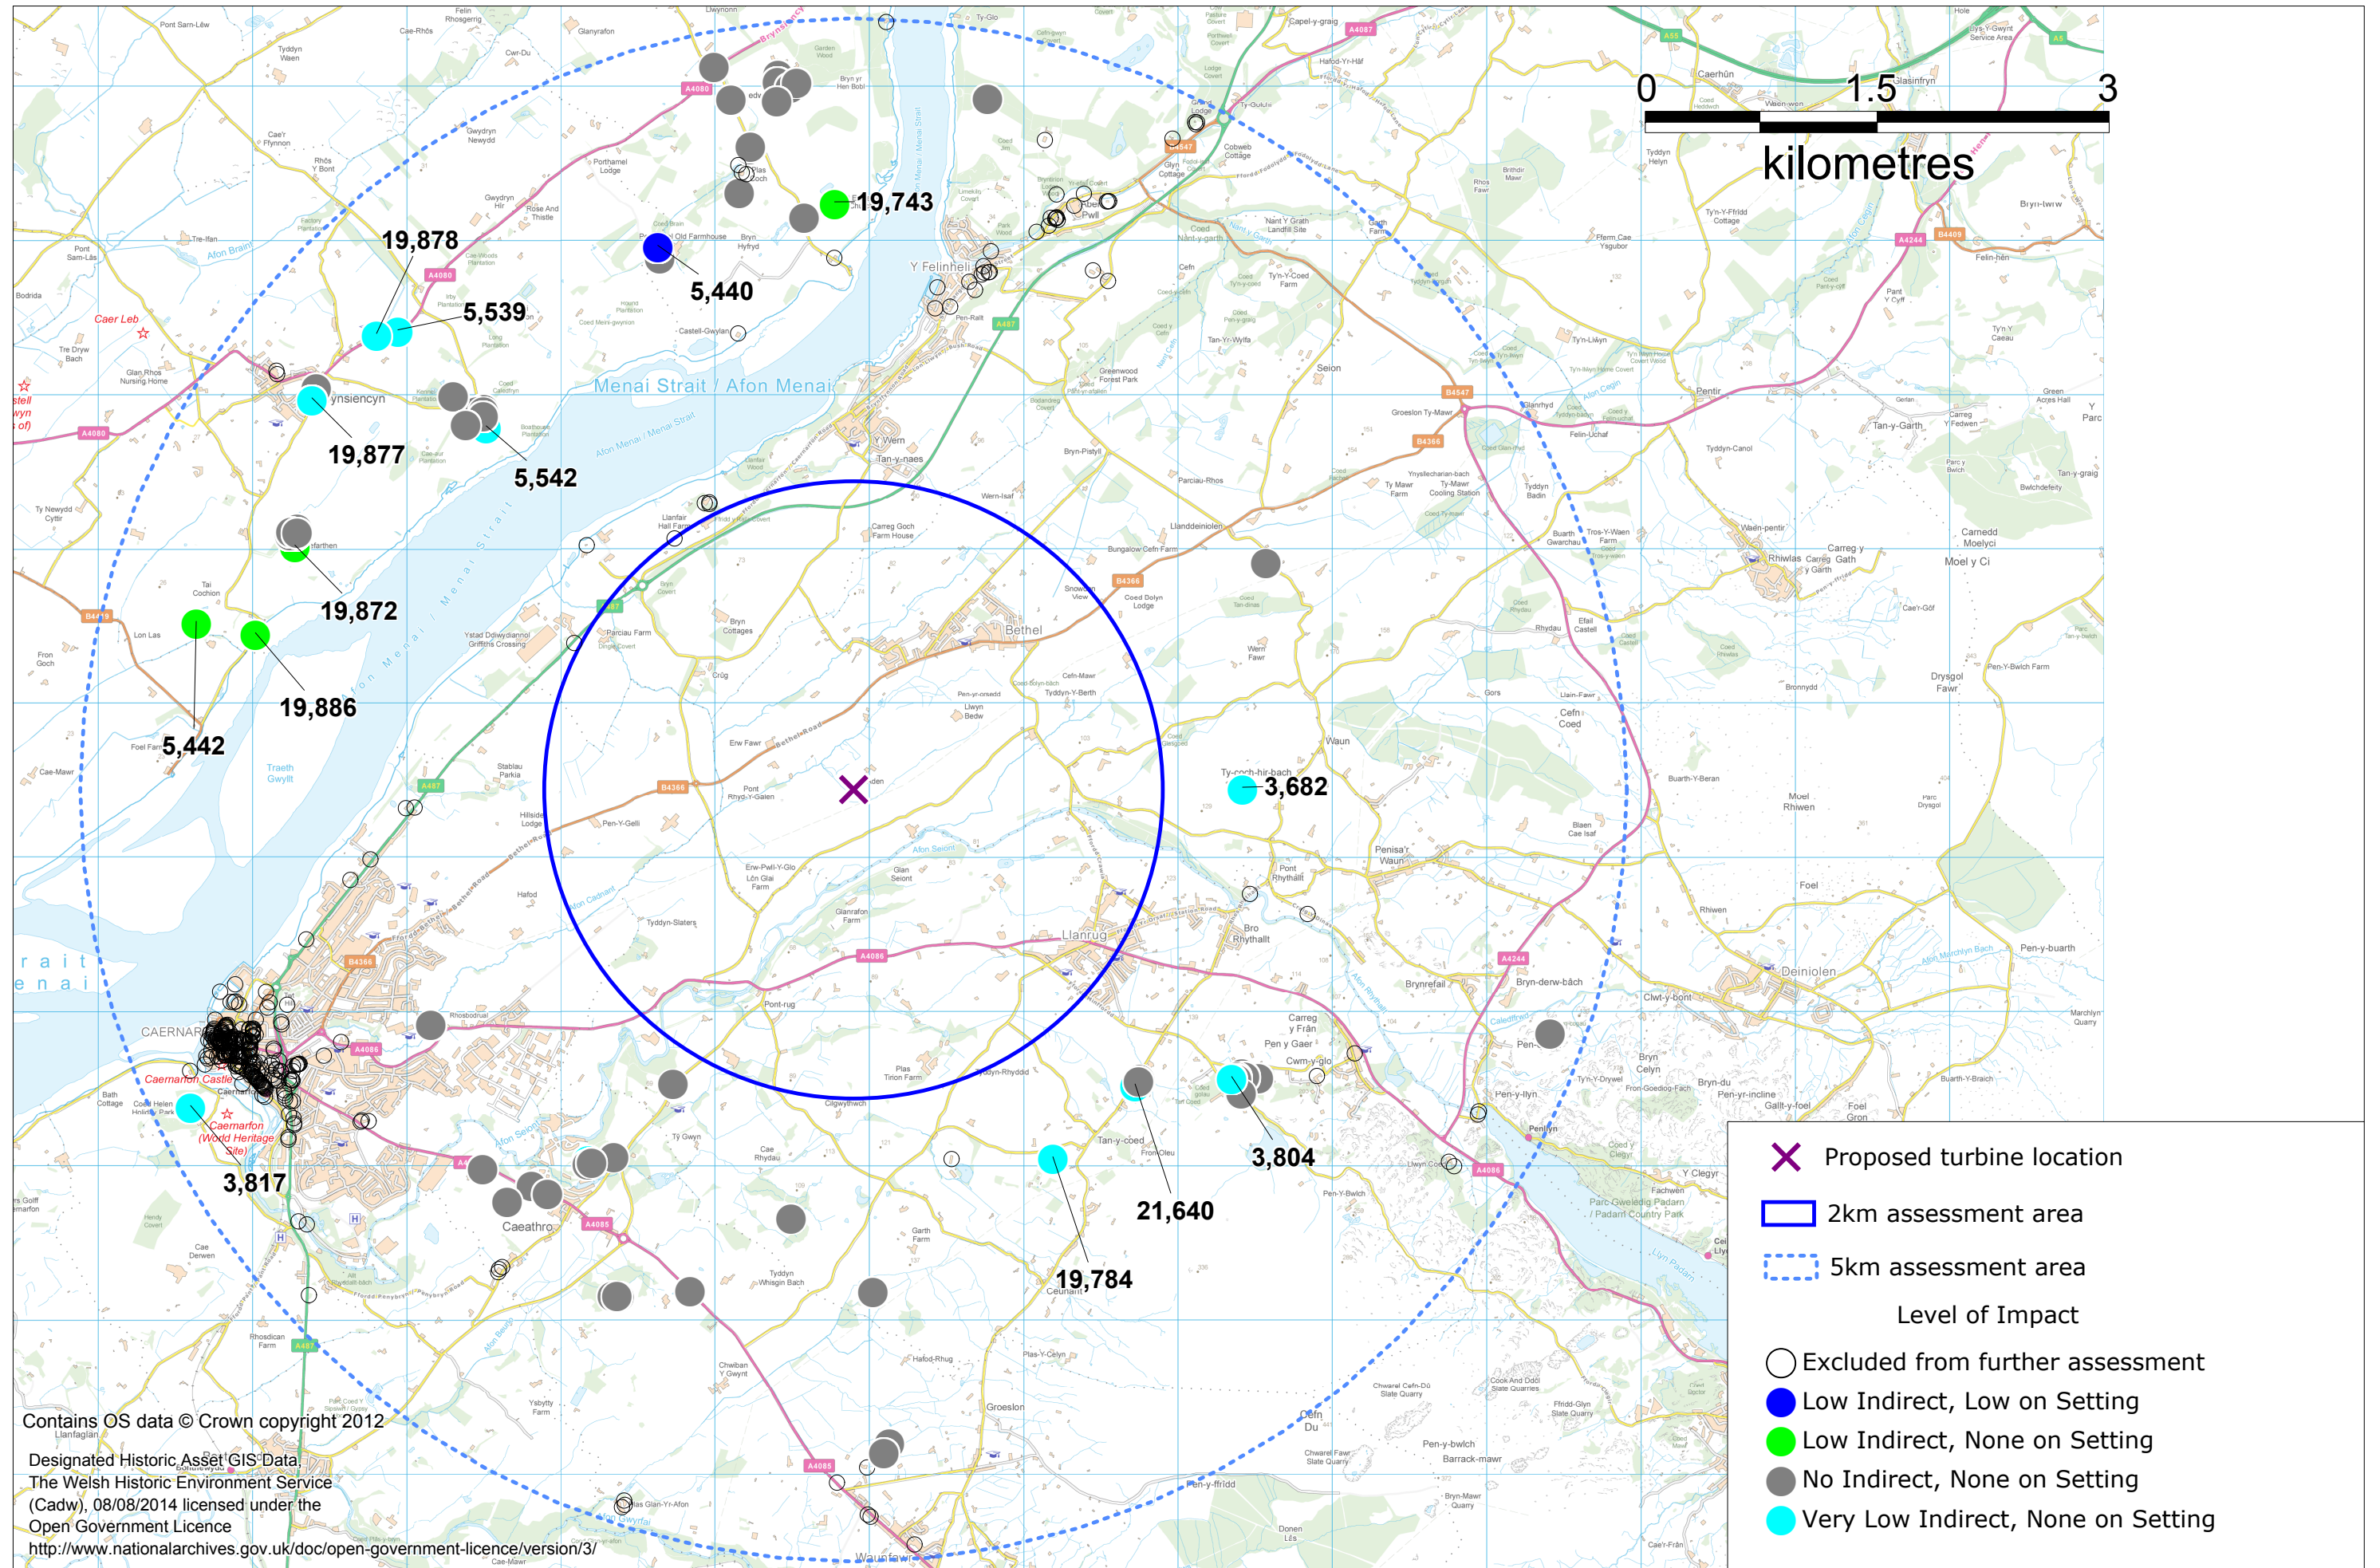
Figure 7: The 2km to 5km assessment area showing the level of impact on Listed Buildings, labelled with LB Number where there is an impact

Full details of the assessment of impact for Listed Buildings can be found in Appendix D and Figure 7.

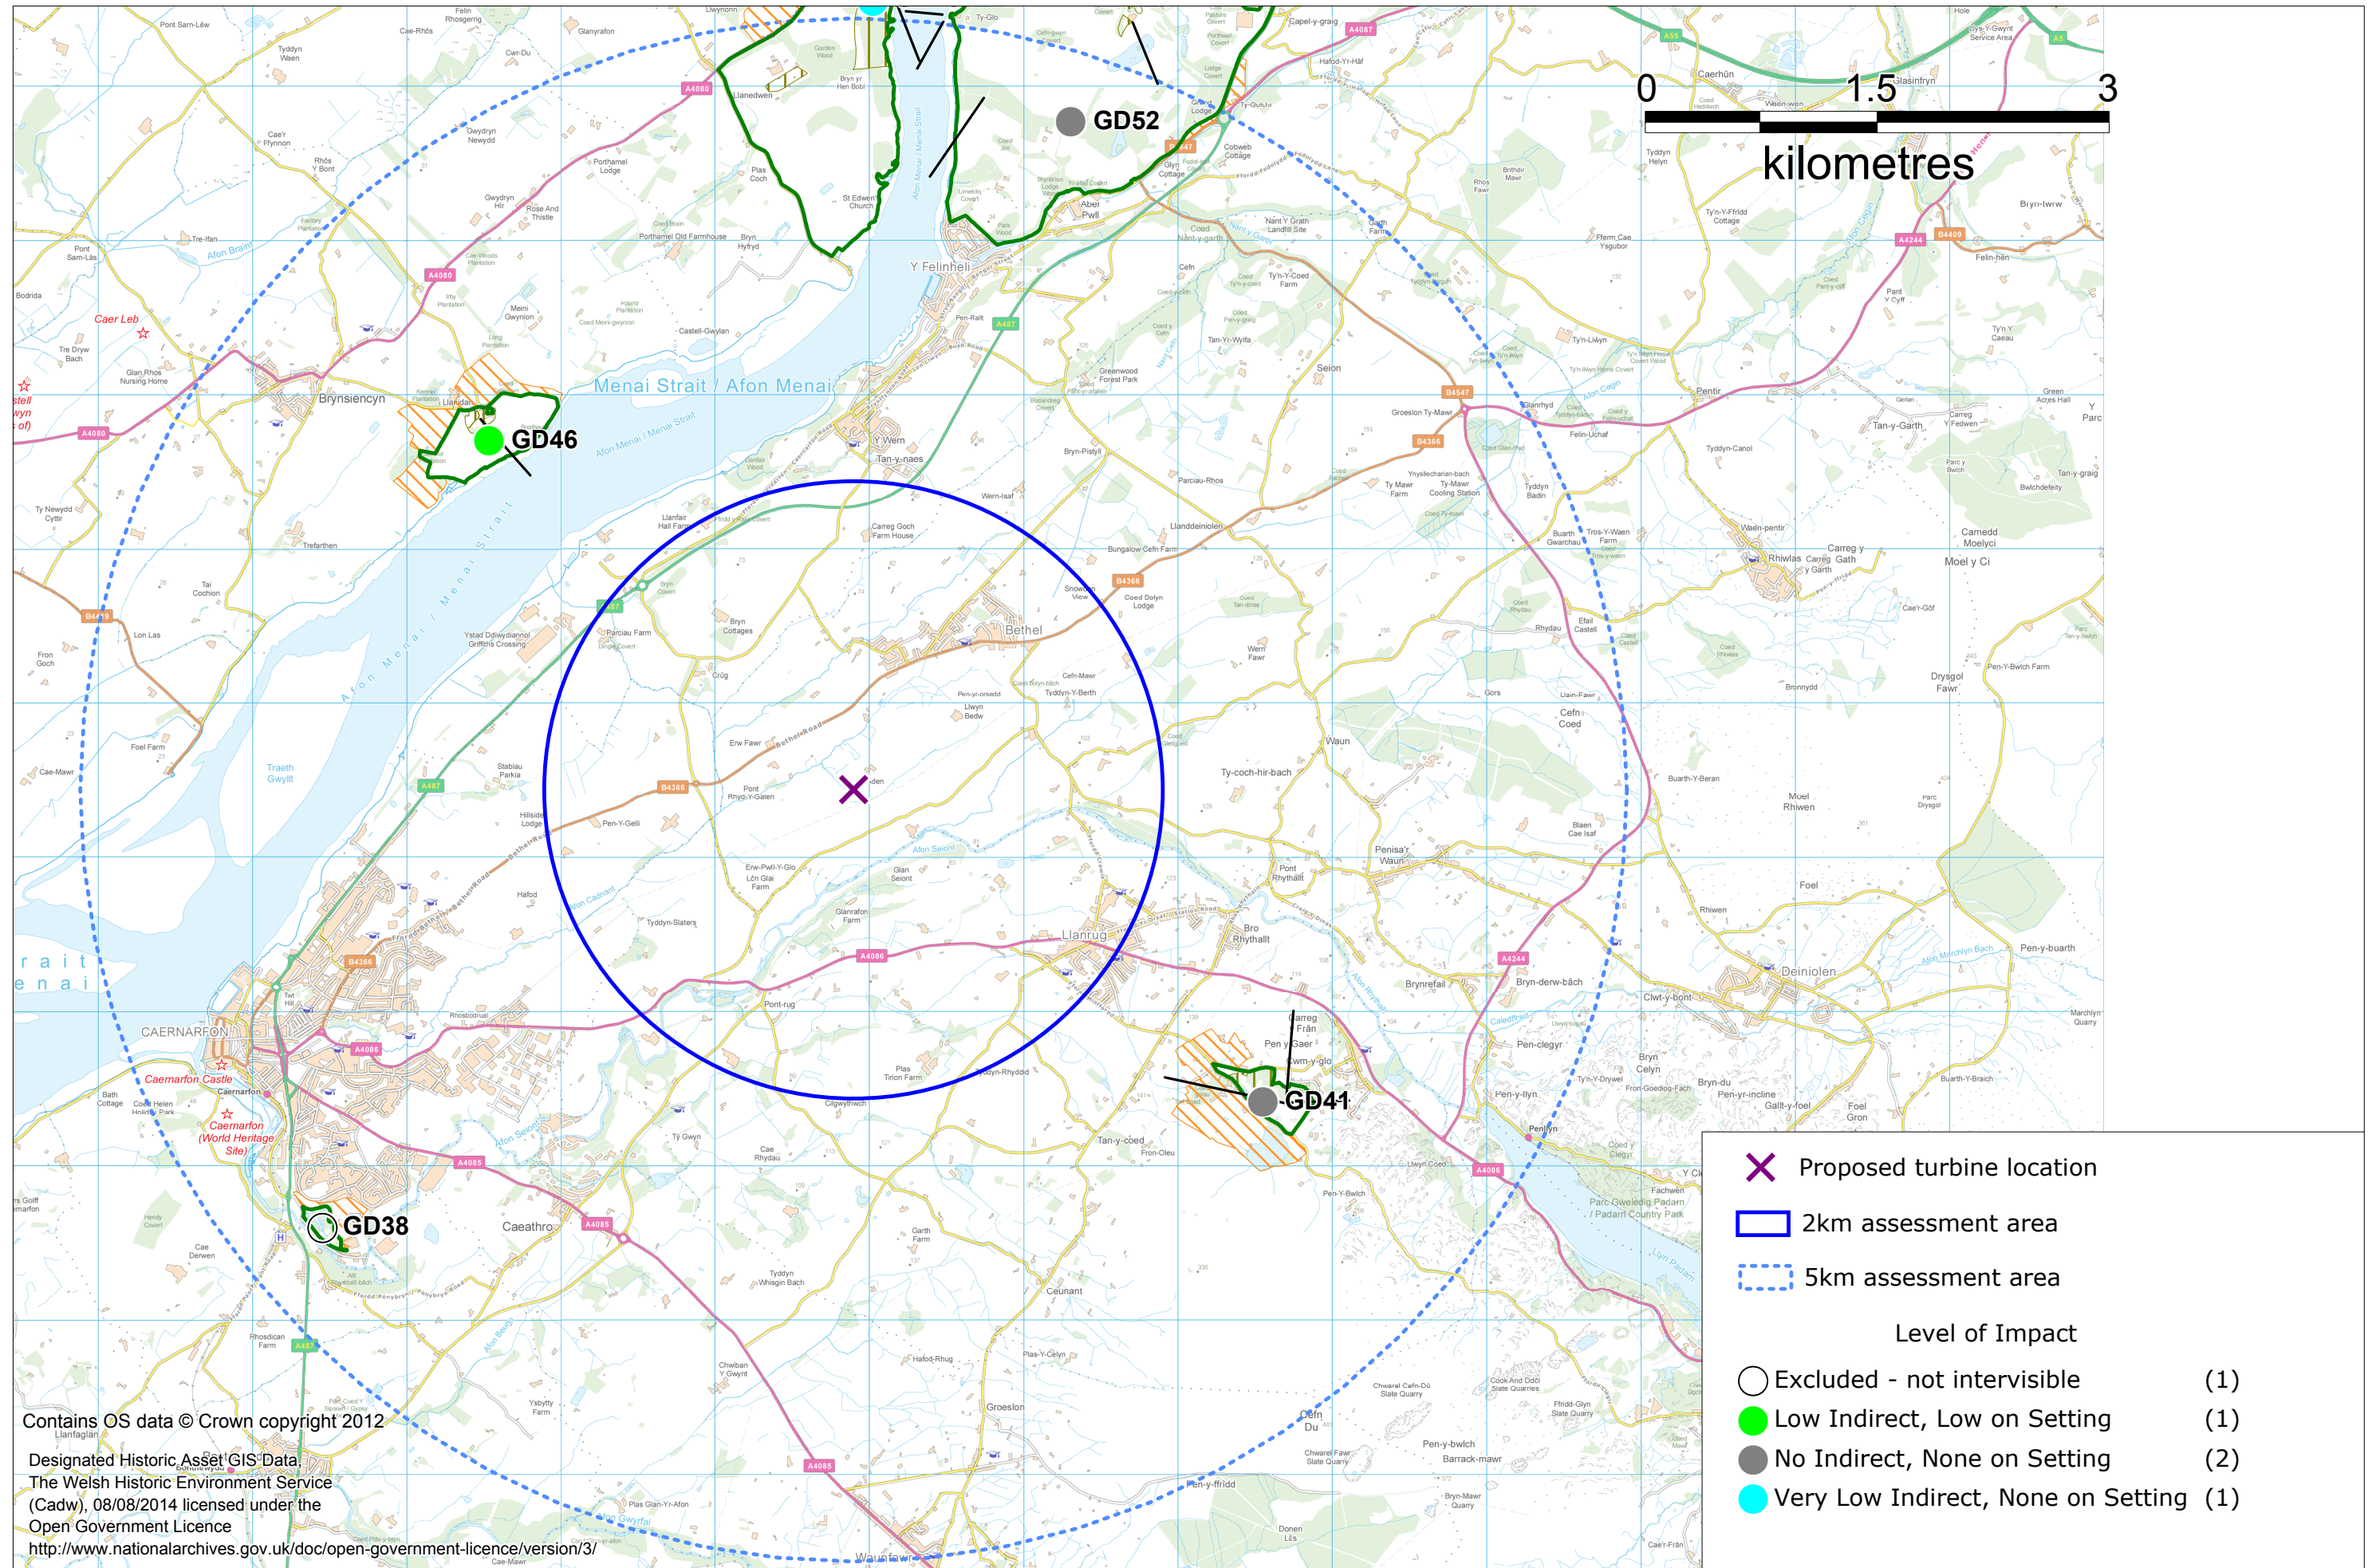
Figure 8: The 2km to 5km assessment area showing the level of impact on registered Historic Parks and Gardens, labelled with Parks and Garden Number

9.13 There are five registered Historic Parks and Gardens within the 2km to 5km assessment area. Three of these would be unaffected by the proposed turbine. Plas Newydd, Anglesey (GD48) would experience a Very Low, indirect, visual impact. Llanidan, Anglesey (GD46) would experience a Low, indirect, visual impact with a Low impact on setting.
