# Aden, Bethel, Caernarfon Historic Environment Assessment

For: WindFlow Hammer Ltd

September 2015

Trysor Project No. 2015/474

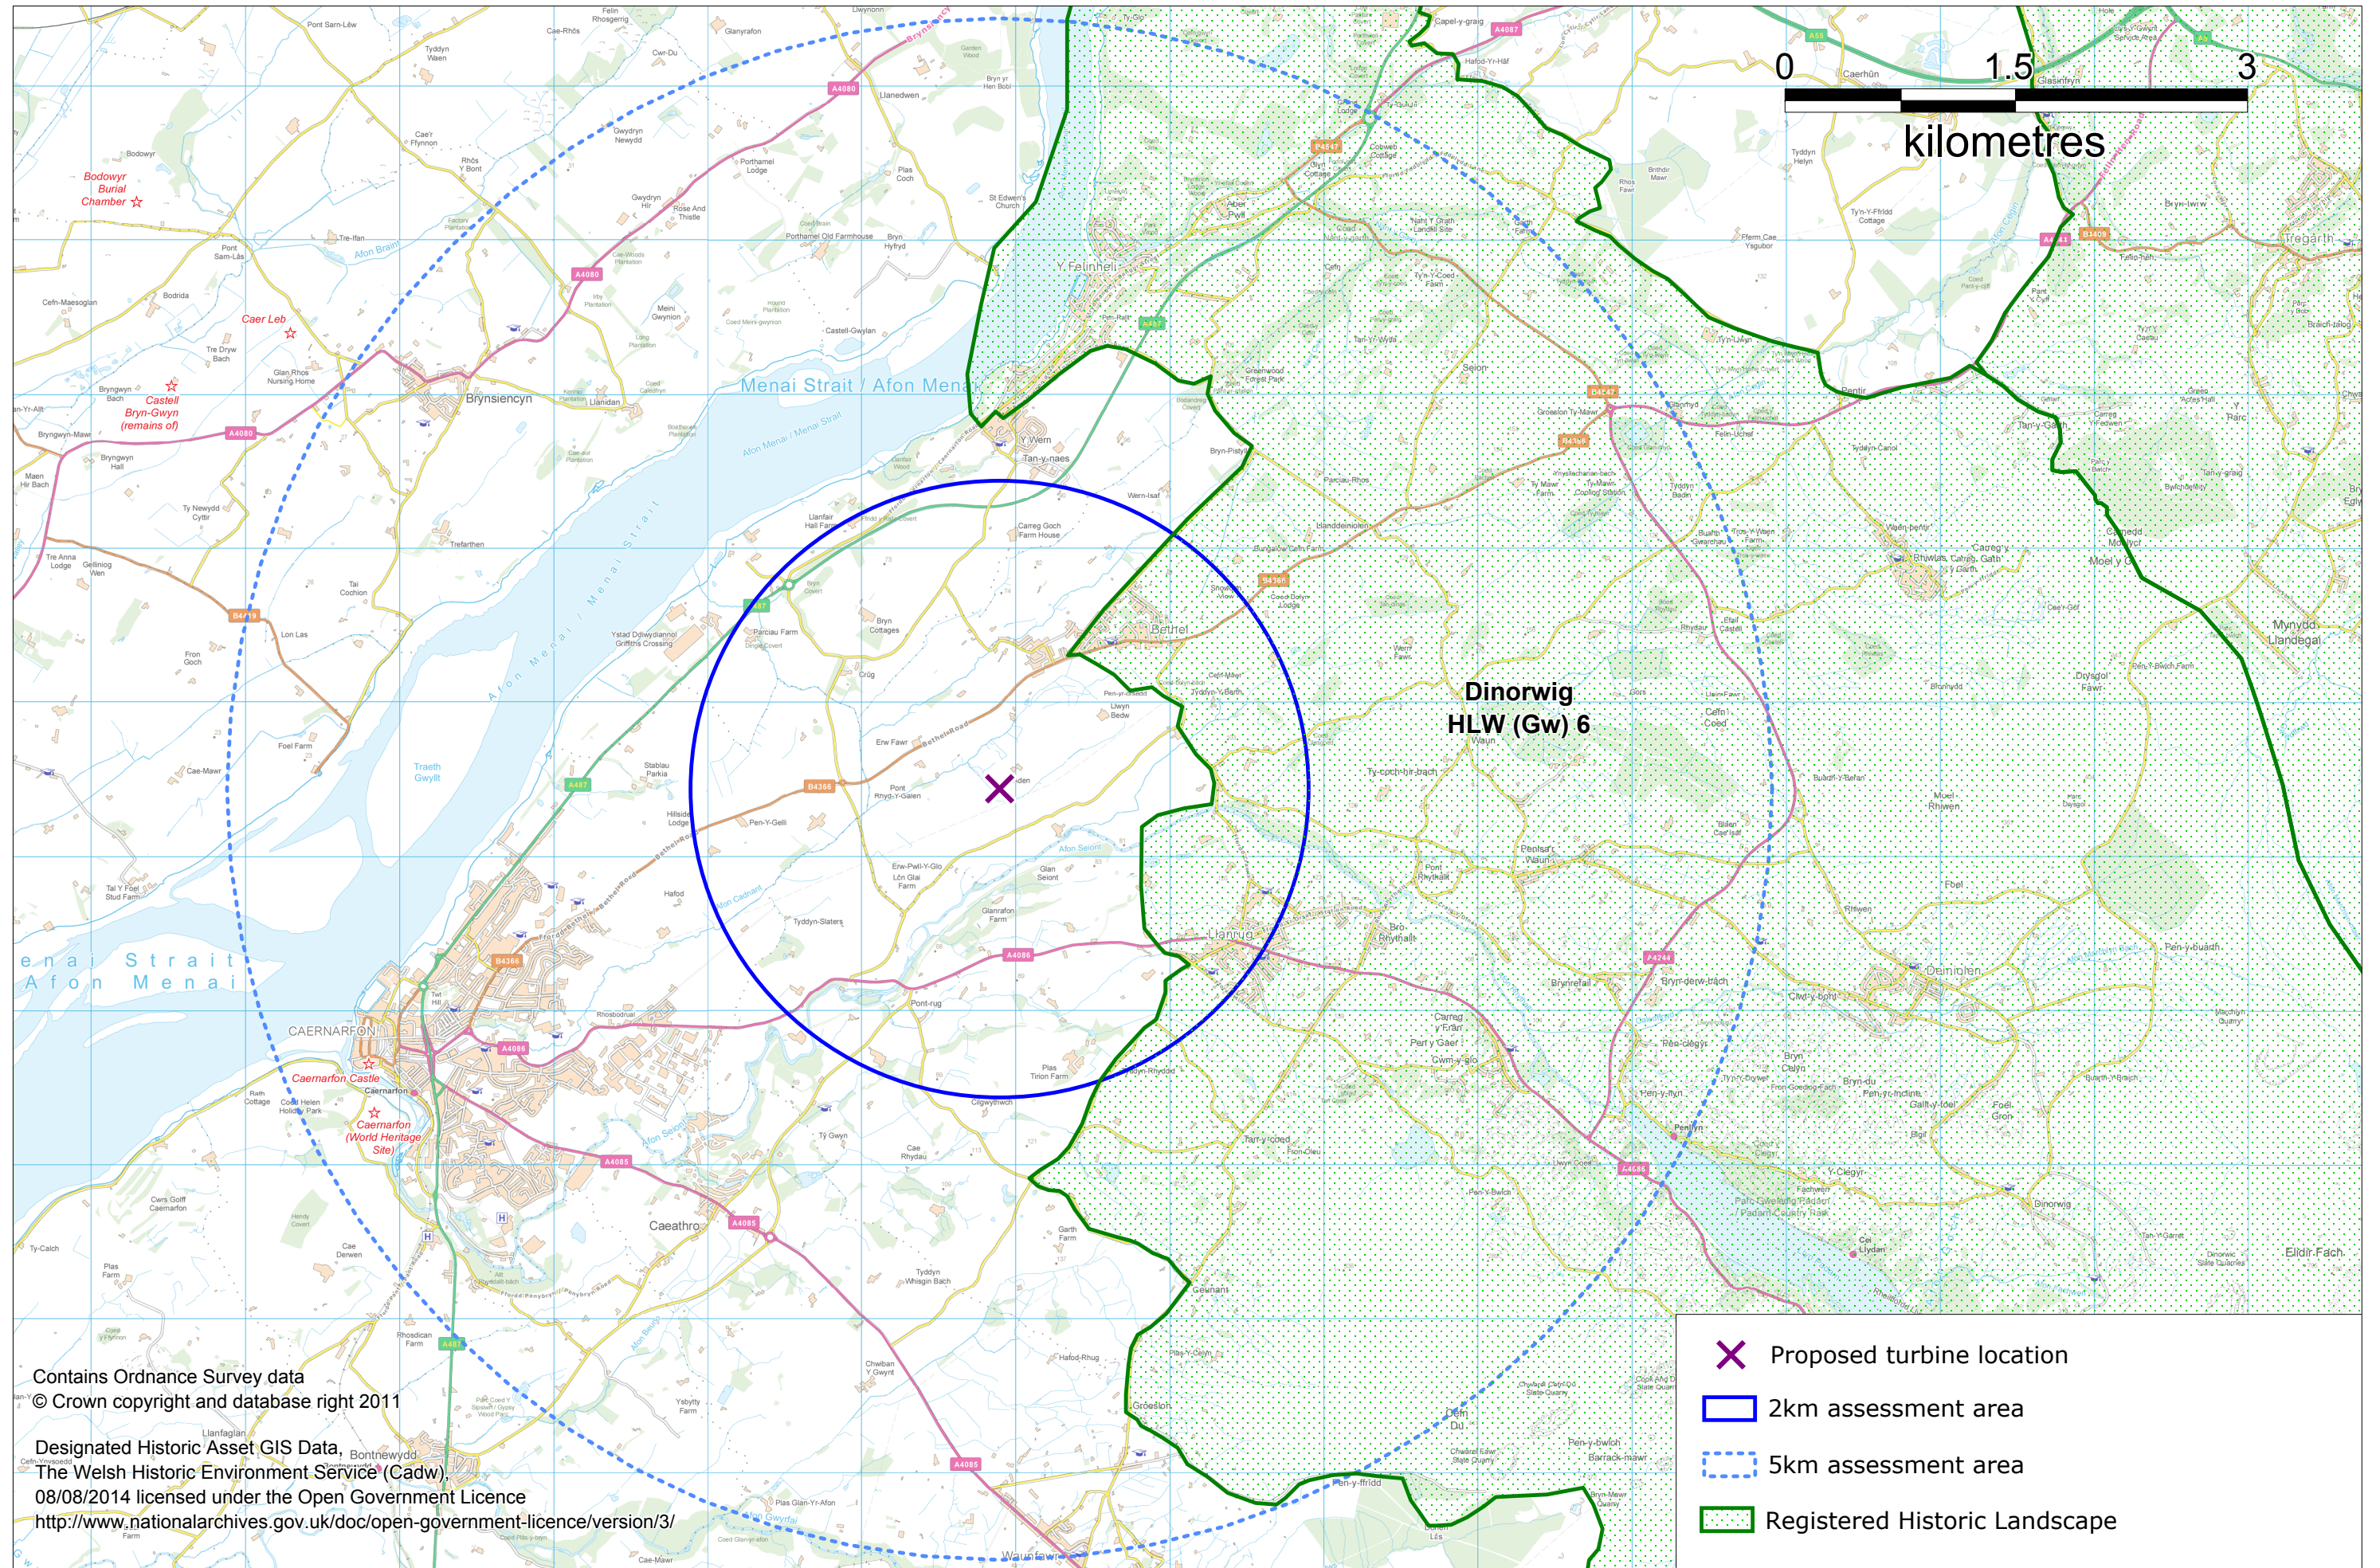
Figure 9: The 2km and 5km assessment areas showing the Dinorwig Historic Landscape, using data supplied by Cadw June 2014

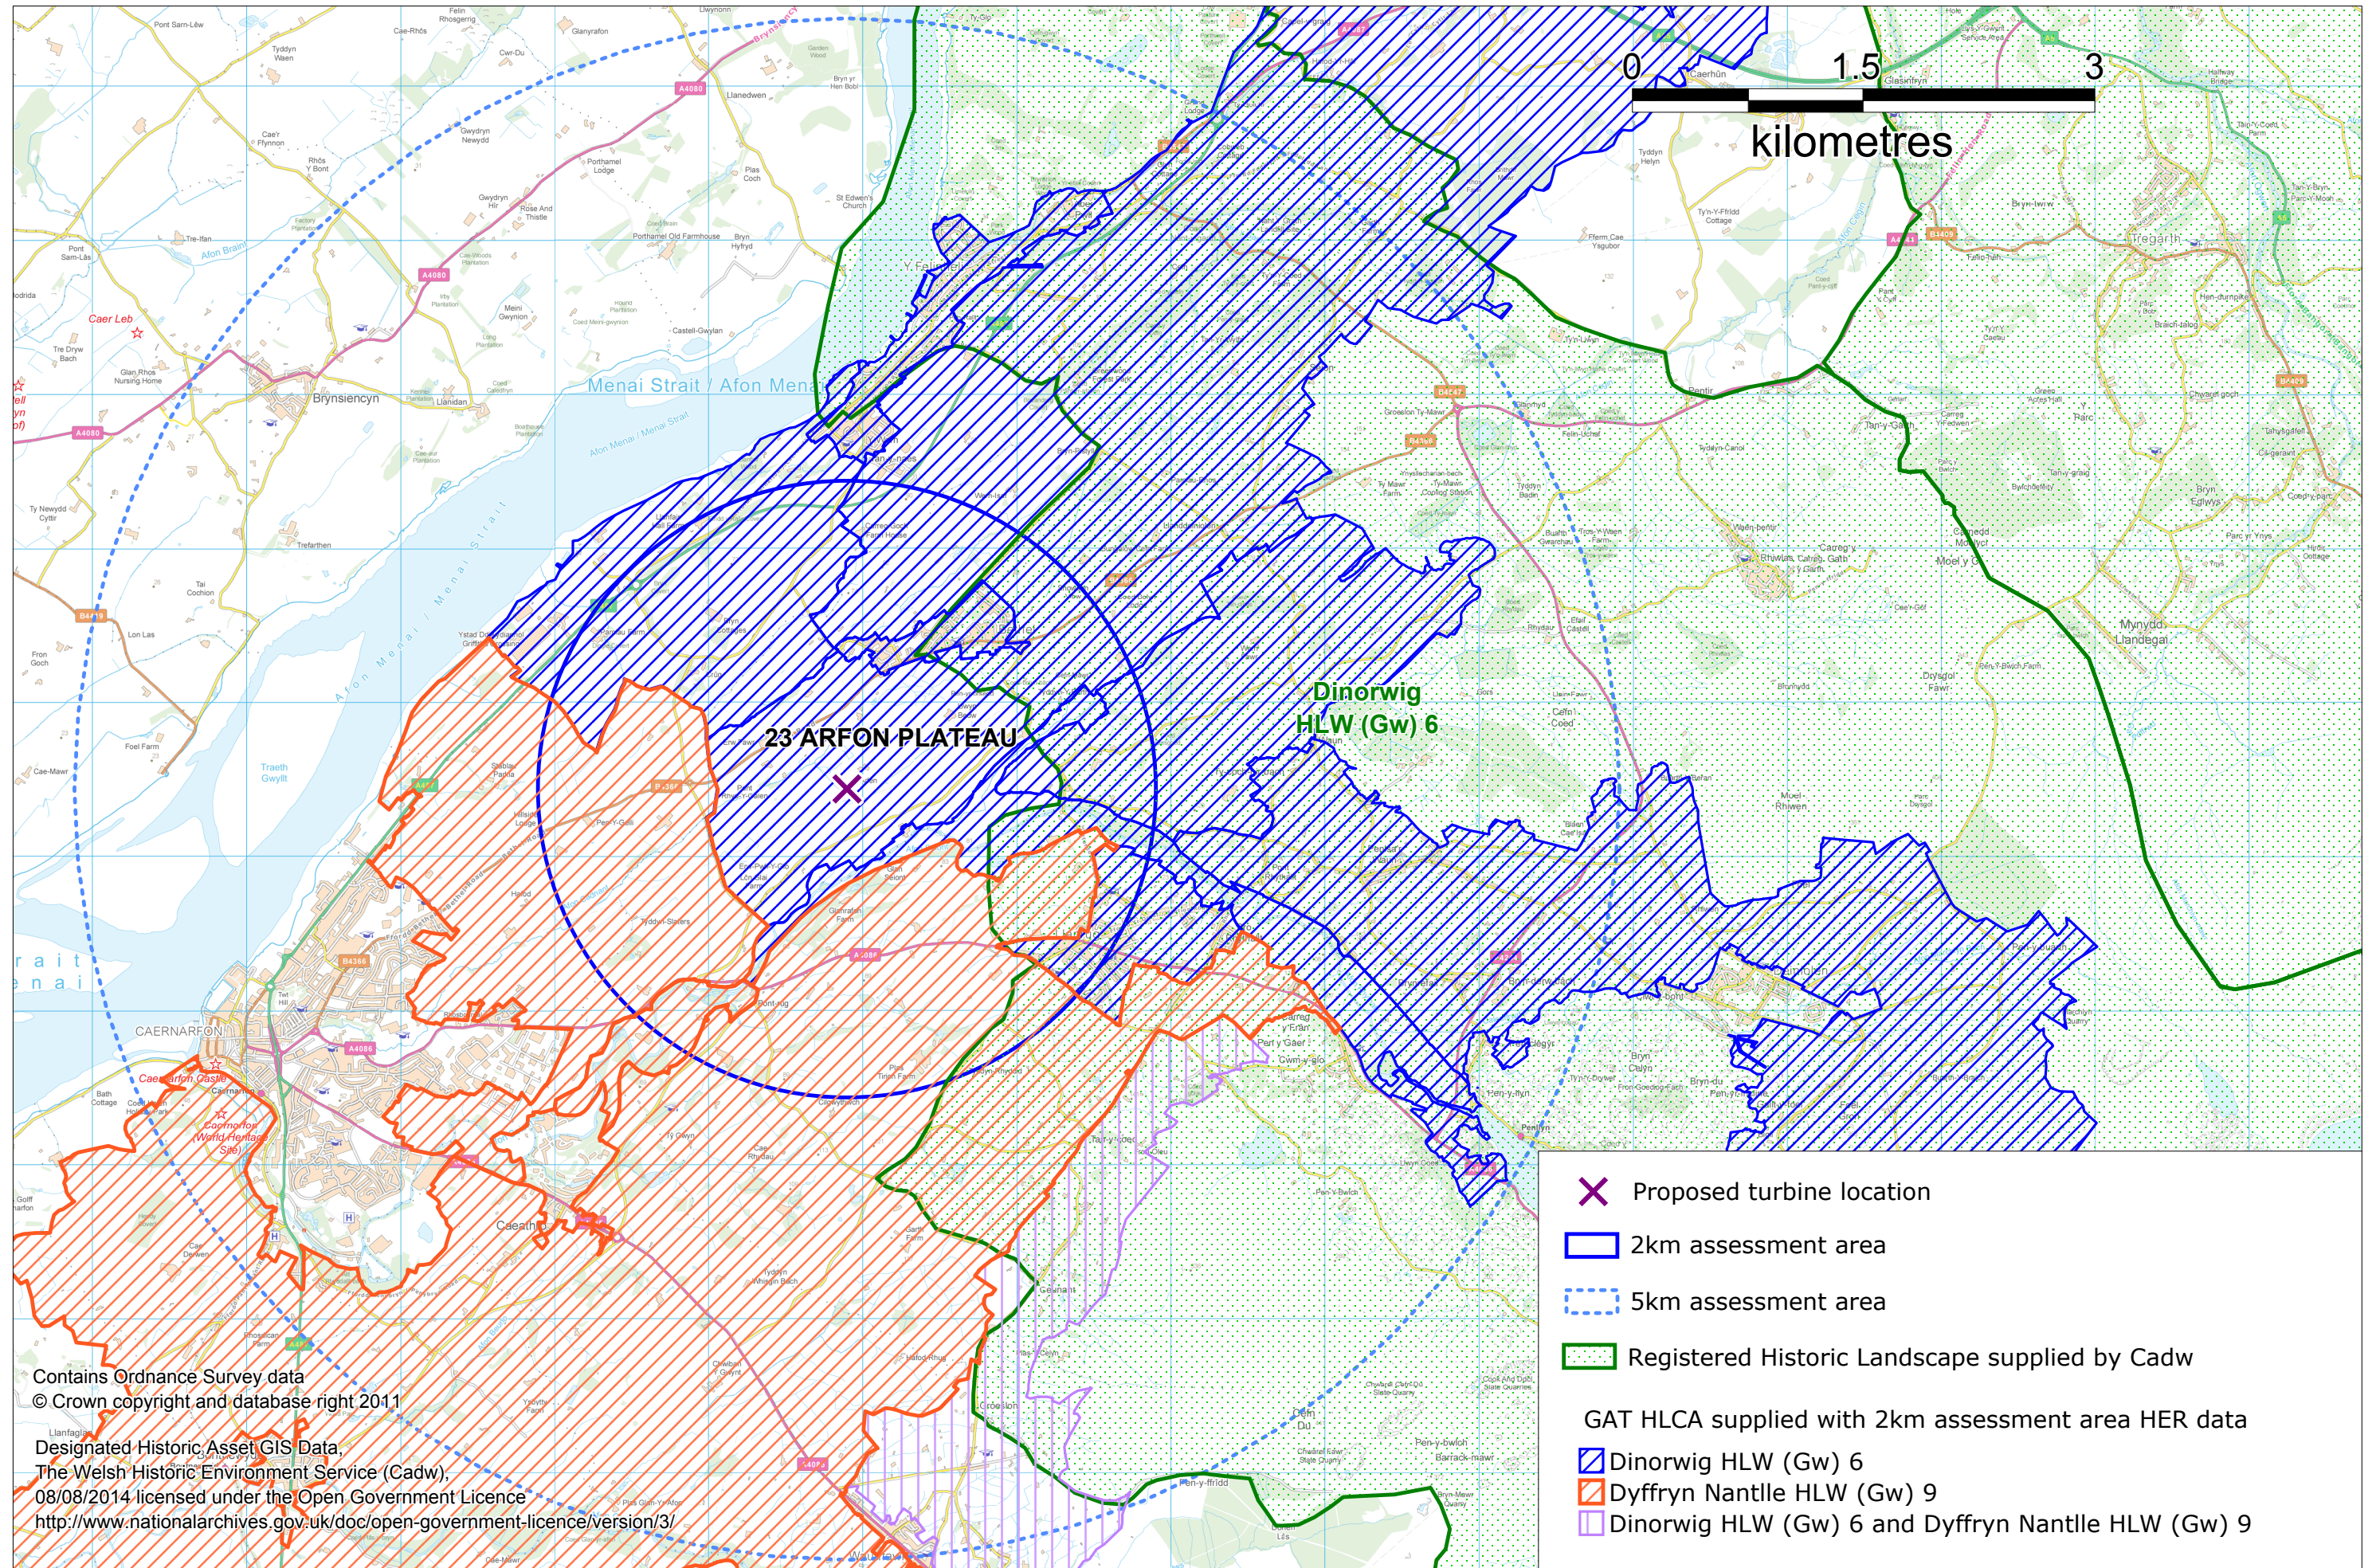
Figure 10: The 2km and 5km assessment areas showing the Historic Landscape Character Areas (HLCAs) as supplied by GAT HER for the 2km assessment area.

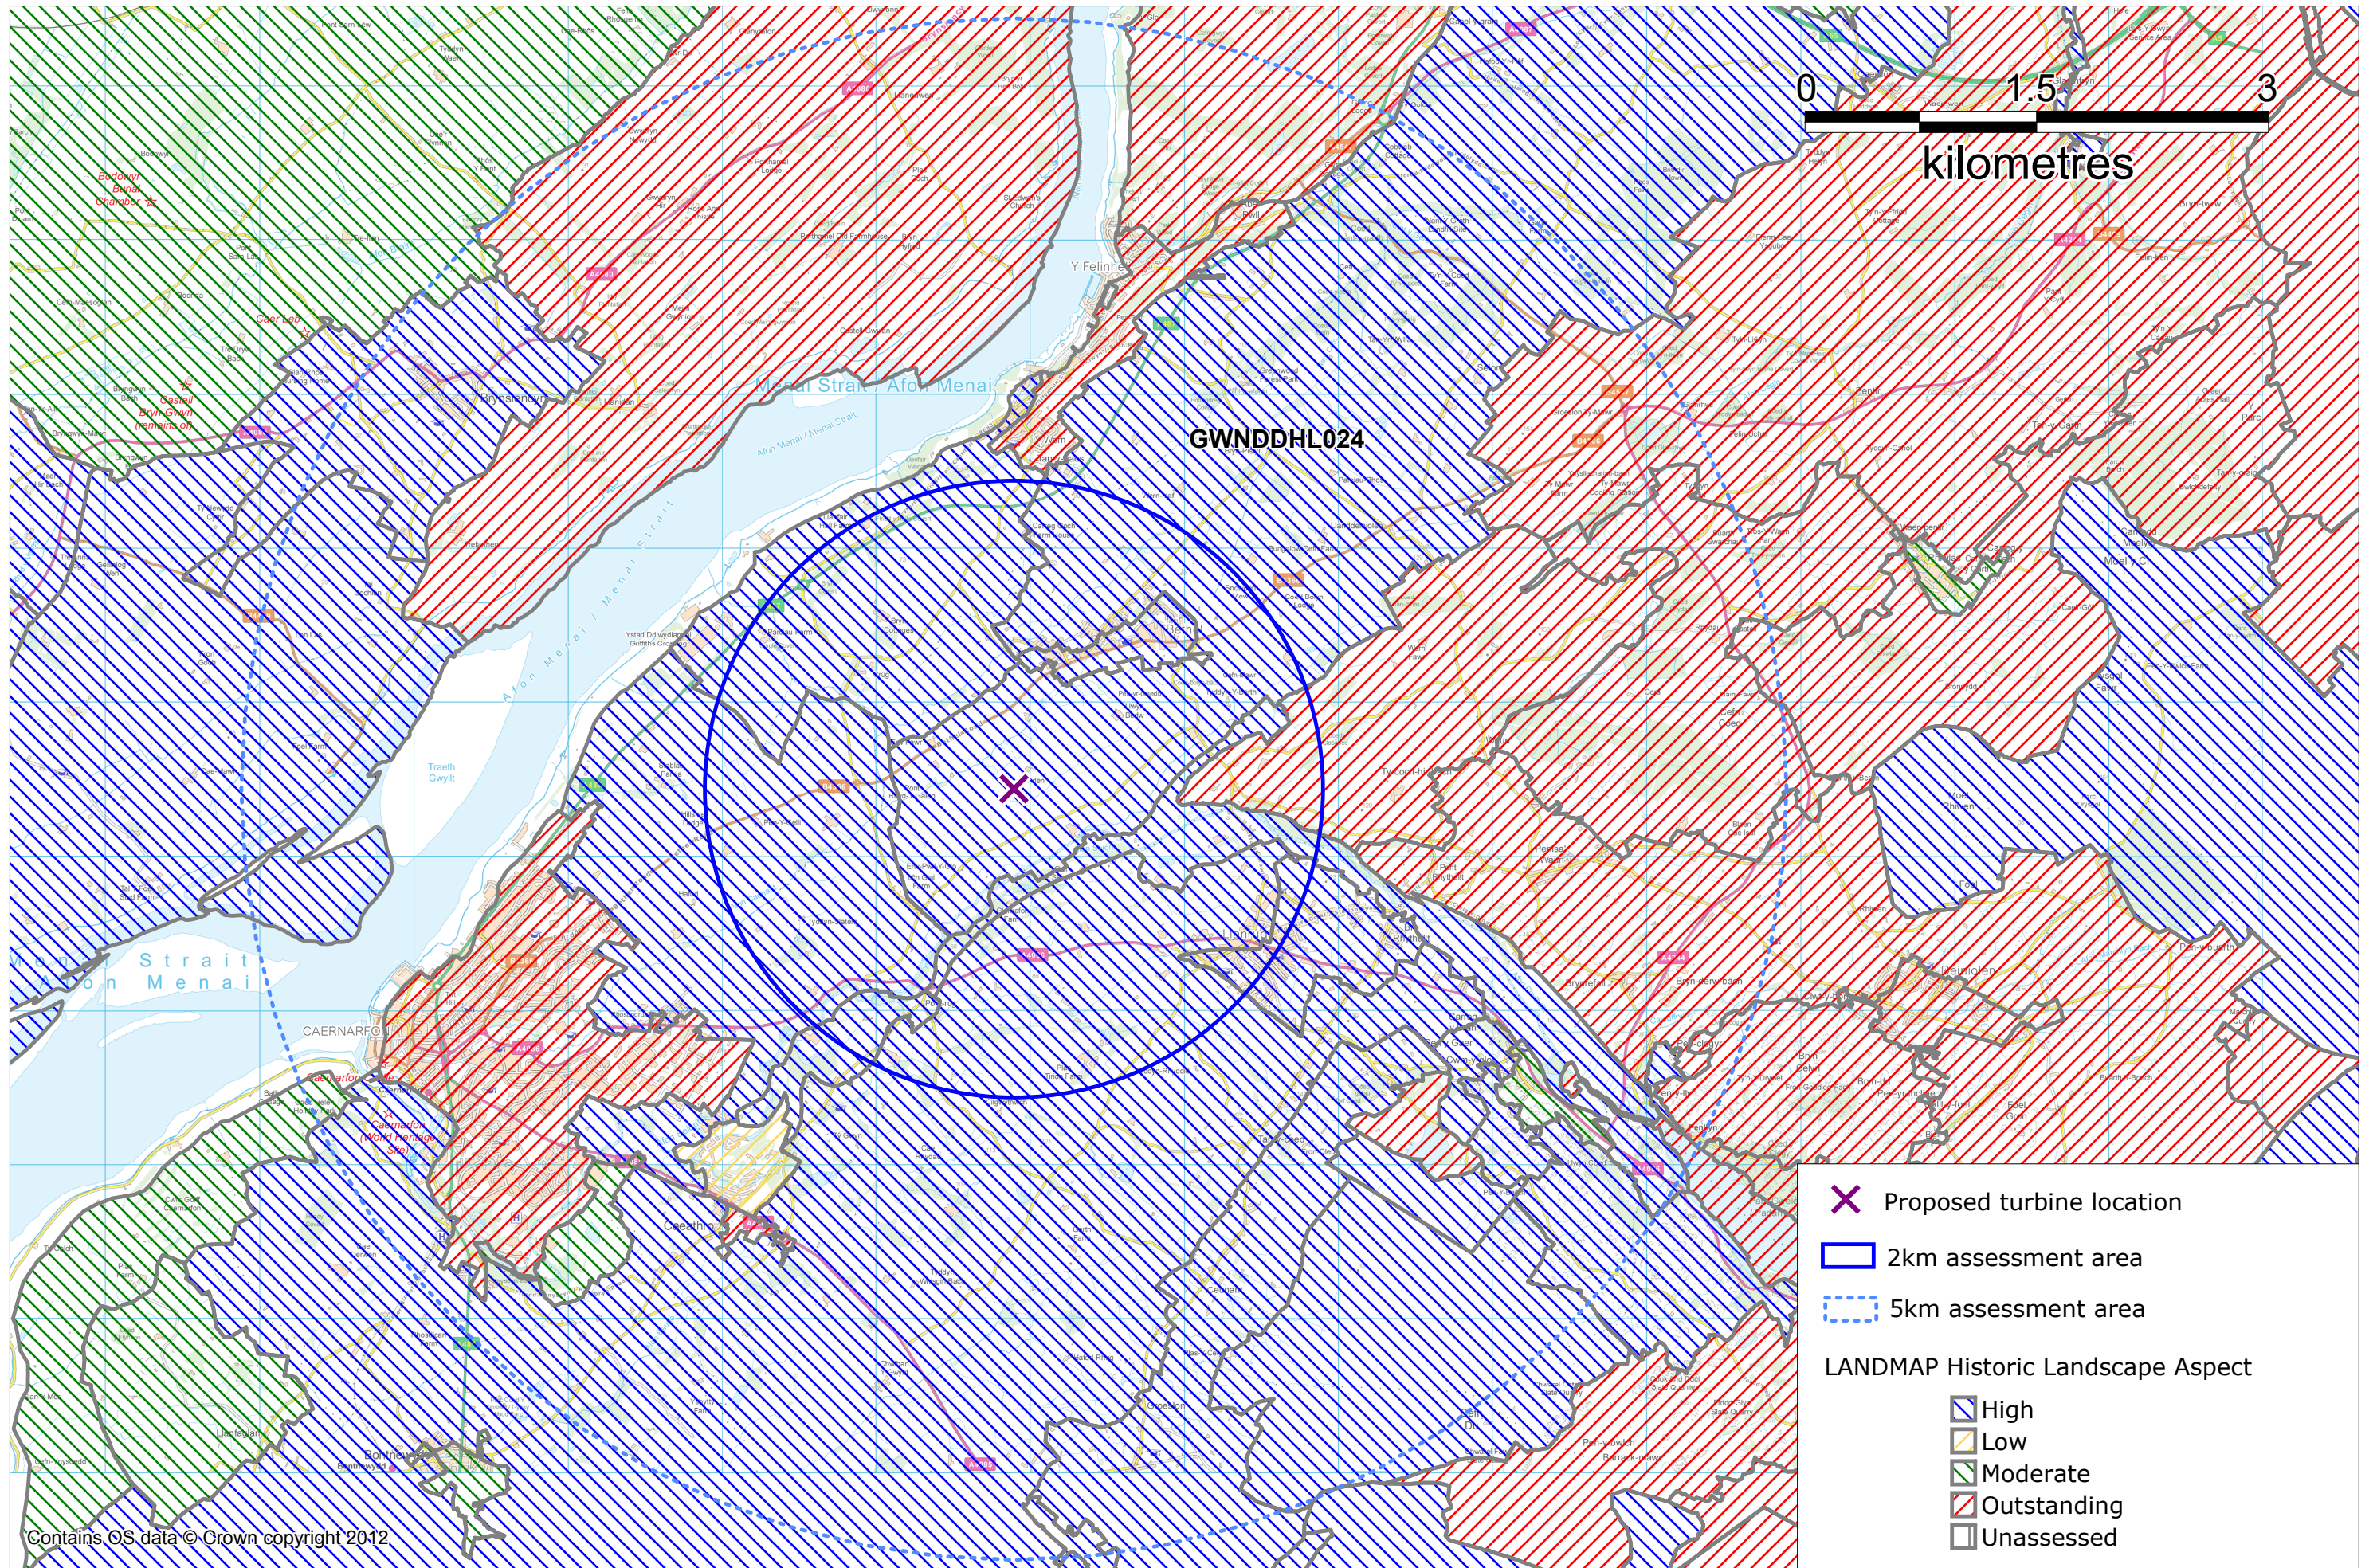
Figure 11: The 2km and 5km assessment areas showing LANDMAP Historic Landscape aspect areas, labelled with LANDMAP Aspect Area Number

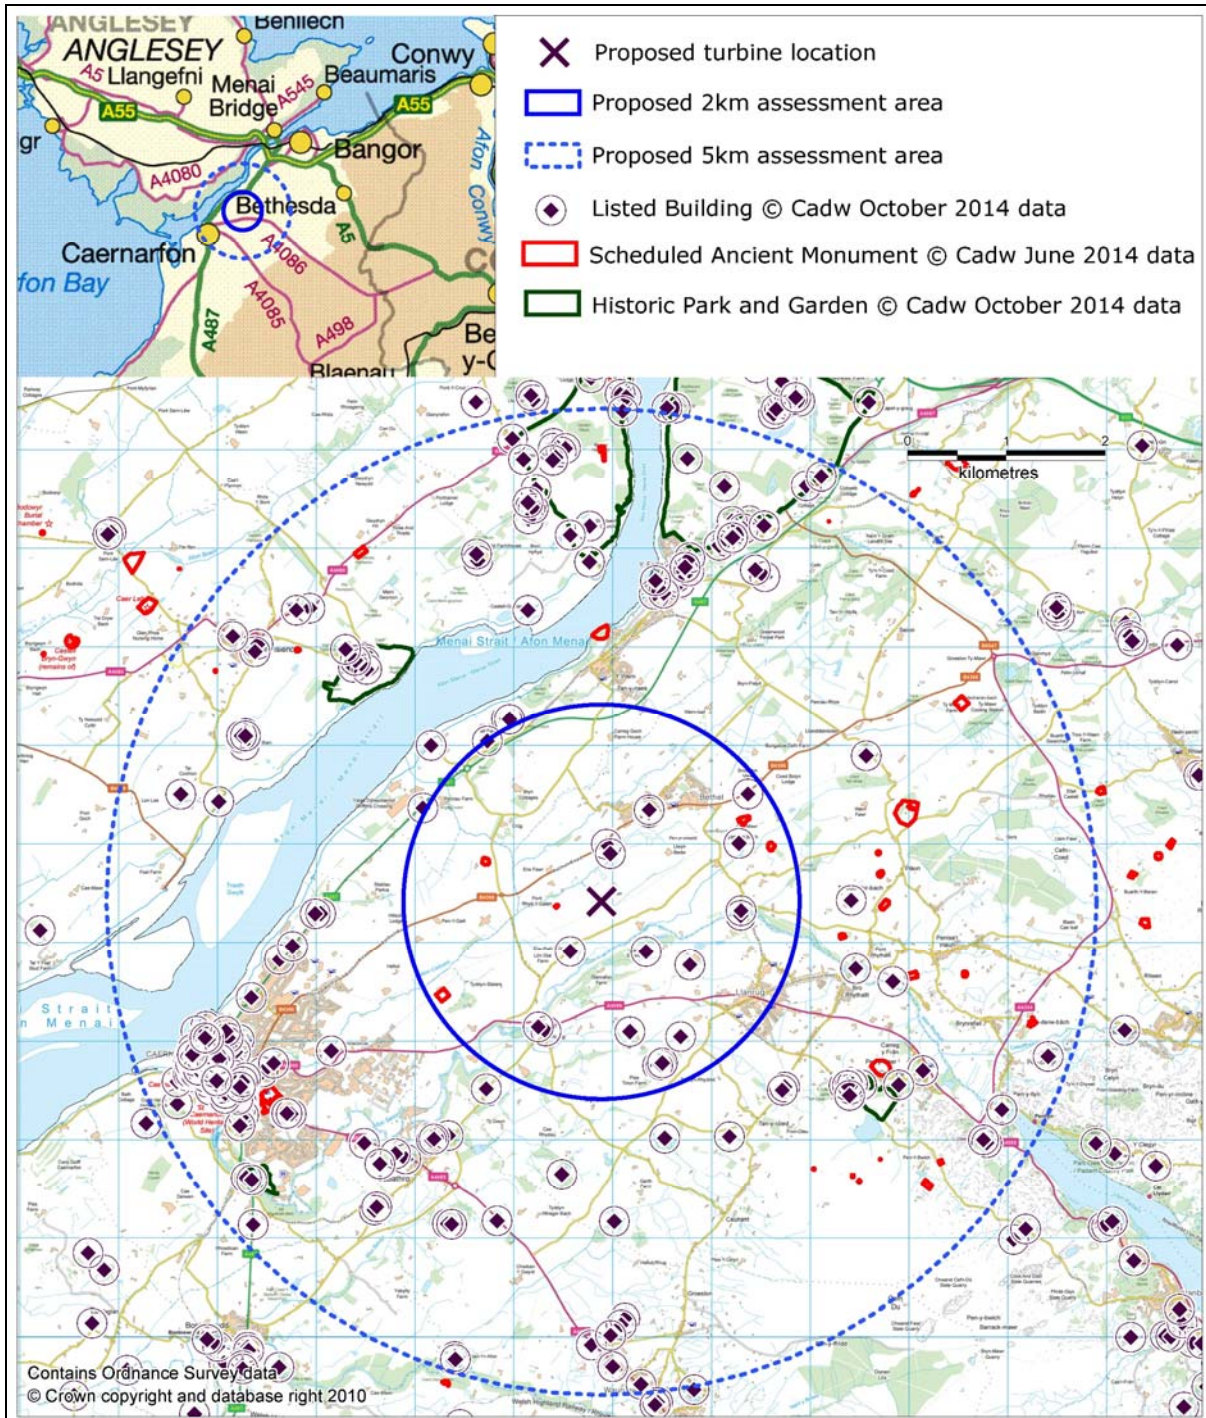
Figure 1: The proposed location of the turbine and the proposed areas of the assessment.

2.2 A foundation hole, less than 10 metres by 10 metres in plan, will be excavated for the turbine base through the subsoil. An area of hardstanding 20 metres by 8 metres will be created to the northwest of the turbine.
