CLIENT	Cadw Welsh Government's historic environment service
PROJECT	Neath Abbey - Tudor Mansion House Phase 3
DRAWING STATUS	CONTRACT

DRAWING TITLE	Ground Floor Plan Indicating boundaries and location of Phase 3, 4 and 5
SIZE & SCALE	A1 at 1:100

JOB NUMBER	237495/04
DRAWING NO.	201
REVISION	A

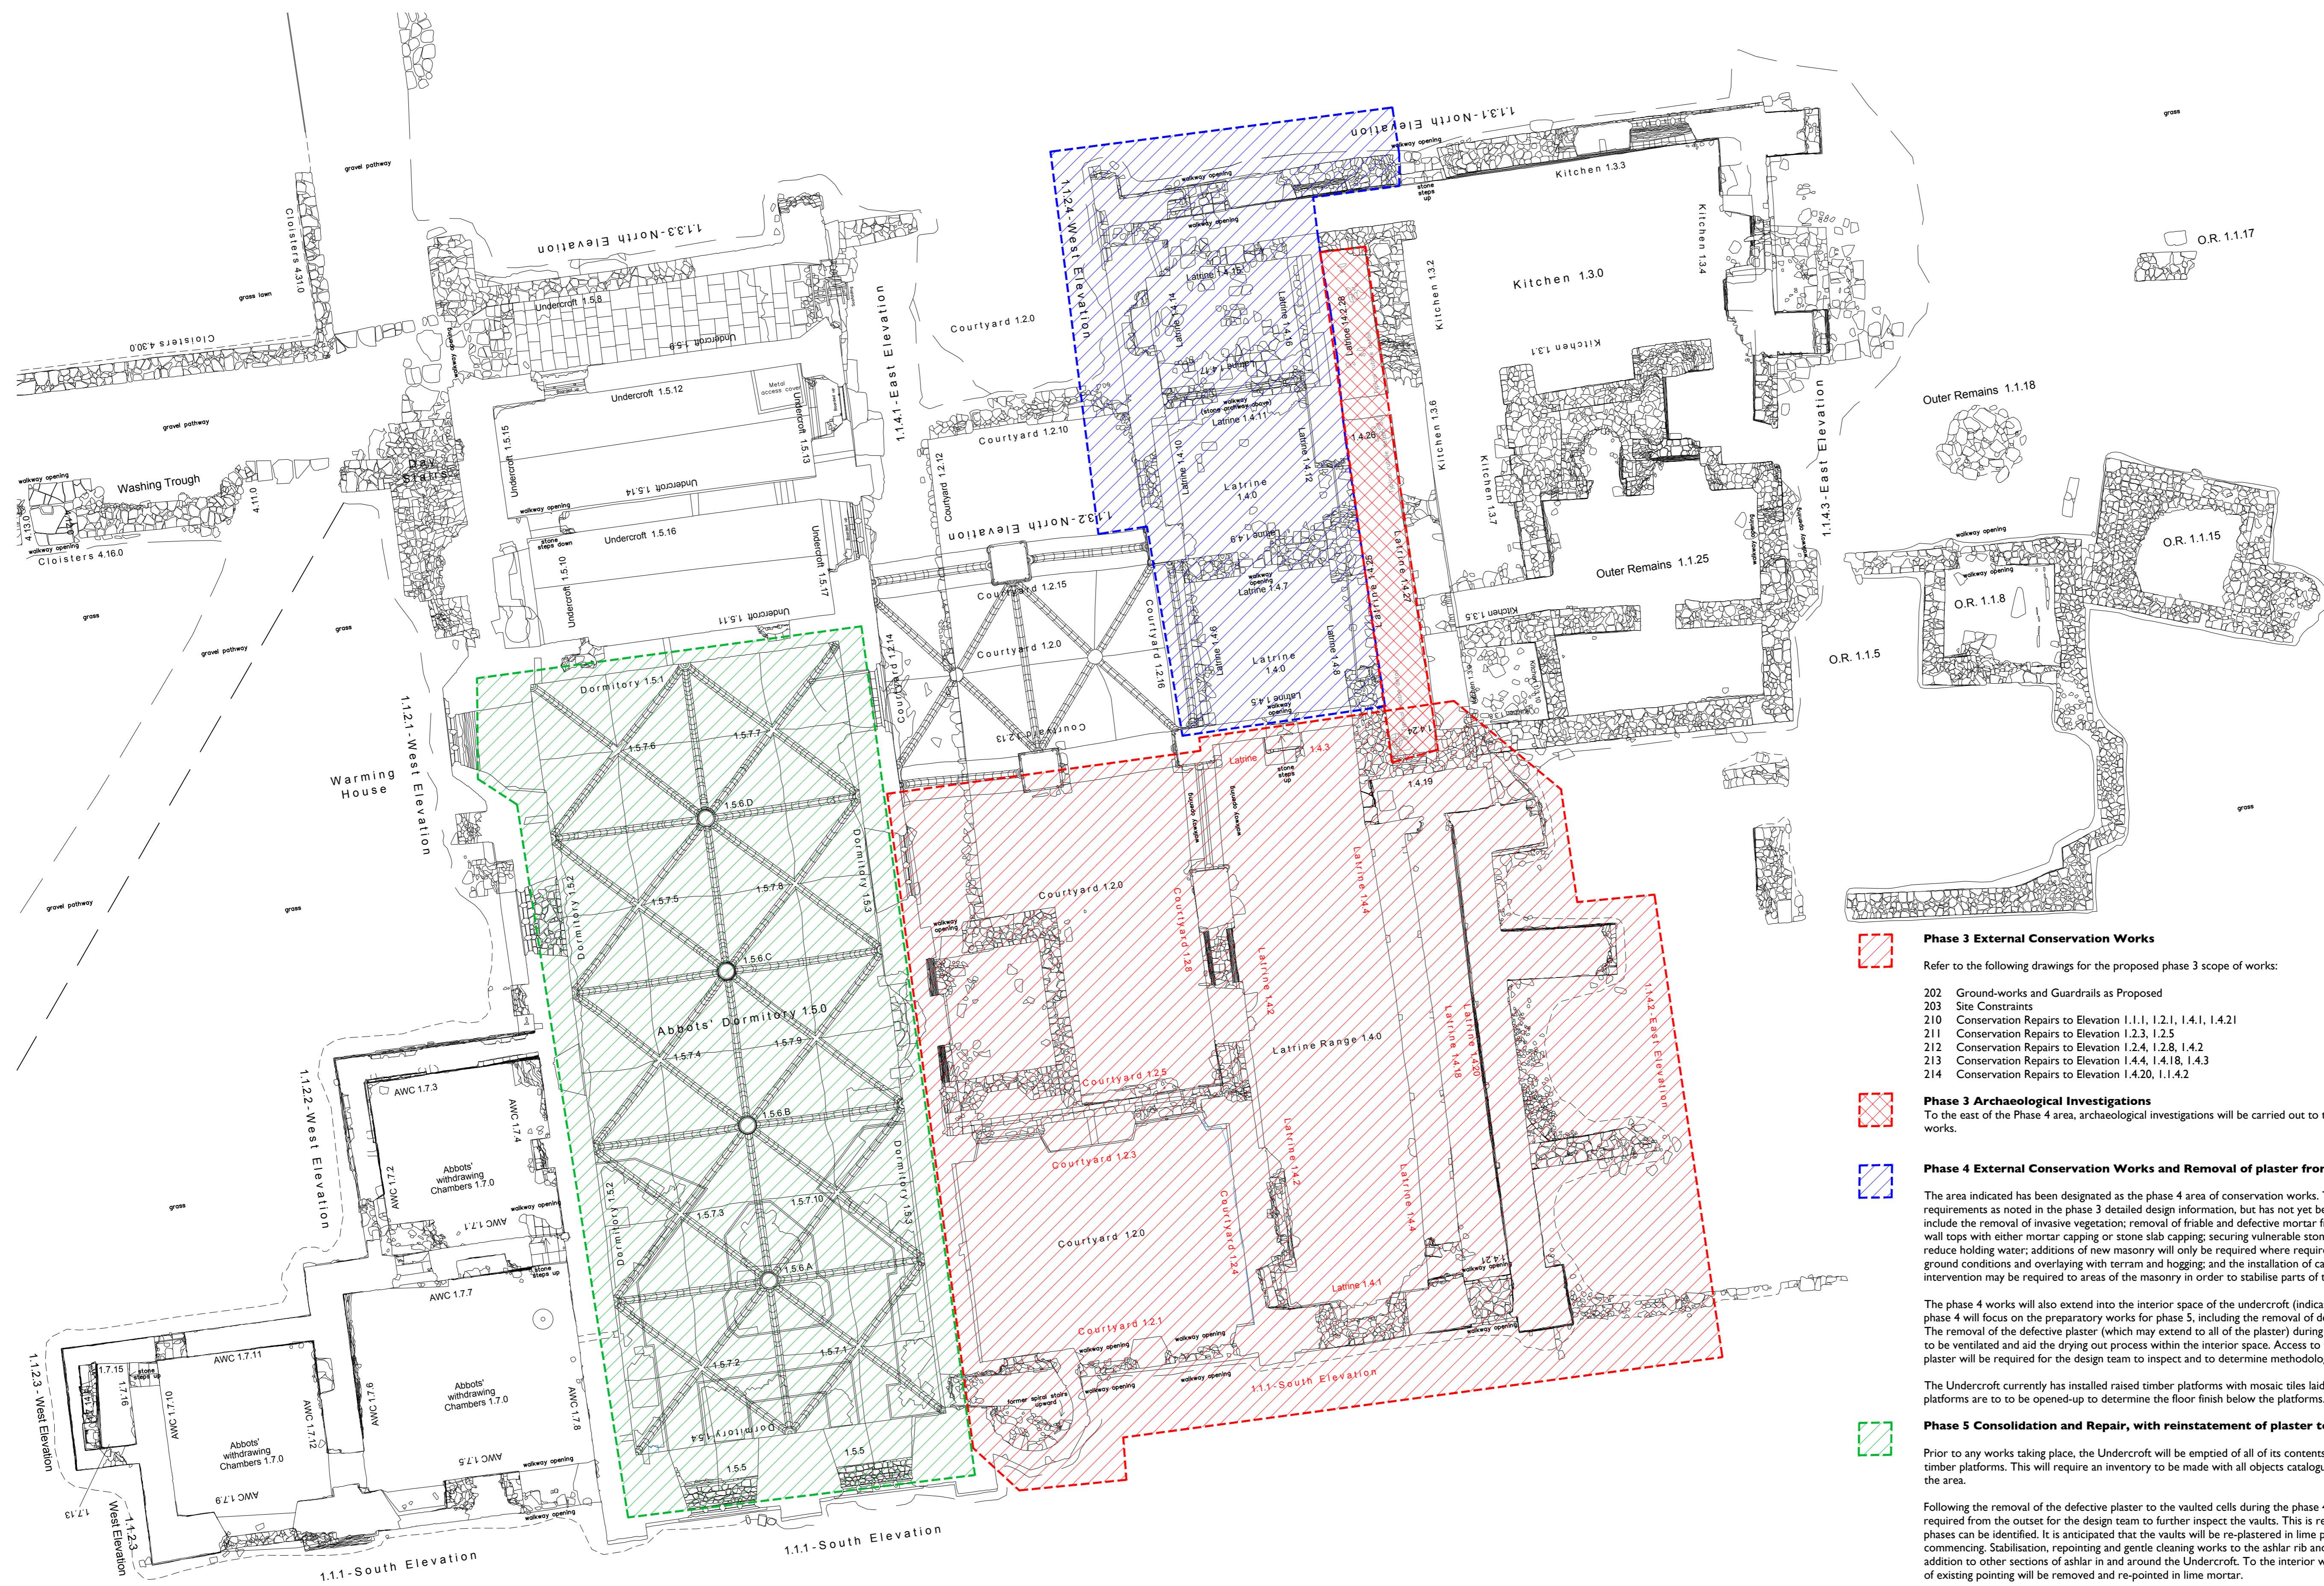
- Phase 4 External Conservation Works and Removal of plaster from the vaulted cells of the Undercroft**
The area indicated has been designated as the phase 4 area of conservation works. The conservation works will include similar repair requirements as noted in the phase 3 detailed design information, but has not yet been fully designed. The conservation works will include the removal of invasive vegetation; removal of friable and defective mortar from joint with the areas re-pointed; consolidating wall tops with either mortar capping or stone slab capping; securing vulnerable stones through dowels/pins; attending to open ledges to reduce holding water; additions of new masonry will only be required where required i.e. to support a relieving arch; consolidating ground conditions and overlaying with terram and hogging; and the installation of cast iron guardrails to reduce risks. Structural intervention may be required to areas of the masonry in order to stabilise parts of the structure.

- The phase 4 works will also extend into the interior space of the undercroft (indicated as phase 5). The works to the undercroft during phase 4 will focus on the preparatory works for phase 5, including the removal of defective plaster to the vaulted cells between the ribs. The removal of the defective plaster (which may extend to all of the plaster) during the phase 4 works will allow the concealed fabric to be ventilated and aid the drying out process within the interior space. Access to the vaulted structure for close inspection of the plaster will be required for the design team to inspect and to determine methodology, approach and new works.

- The Undercroft currently has installed raised timber platforms with mosaic tiles laid to the top surface, in 4 no locations, the timber platforms are to be opened-up to determine the floor finish below the platforms.
