LATER MEDIEVAL AND EARLY POST-MEDIEVAL THREAT RELATED ASSESSMENT WORK 2012: MONASTERIES

RHIF YR ADRODDIAD / REPORT NO. 2012/12
RHIF Y PROSIECT / PROJECT RECORD NO. 102639

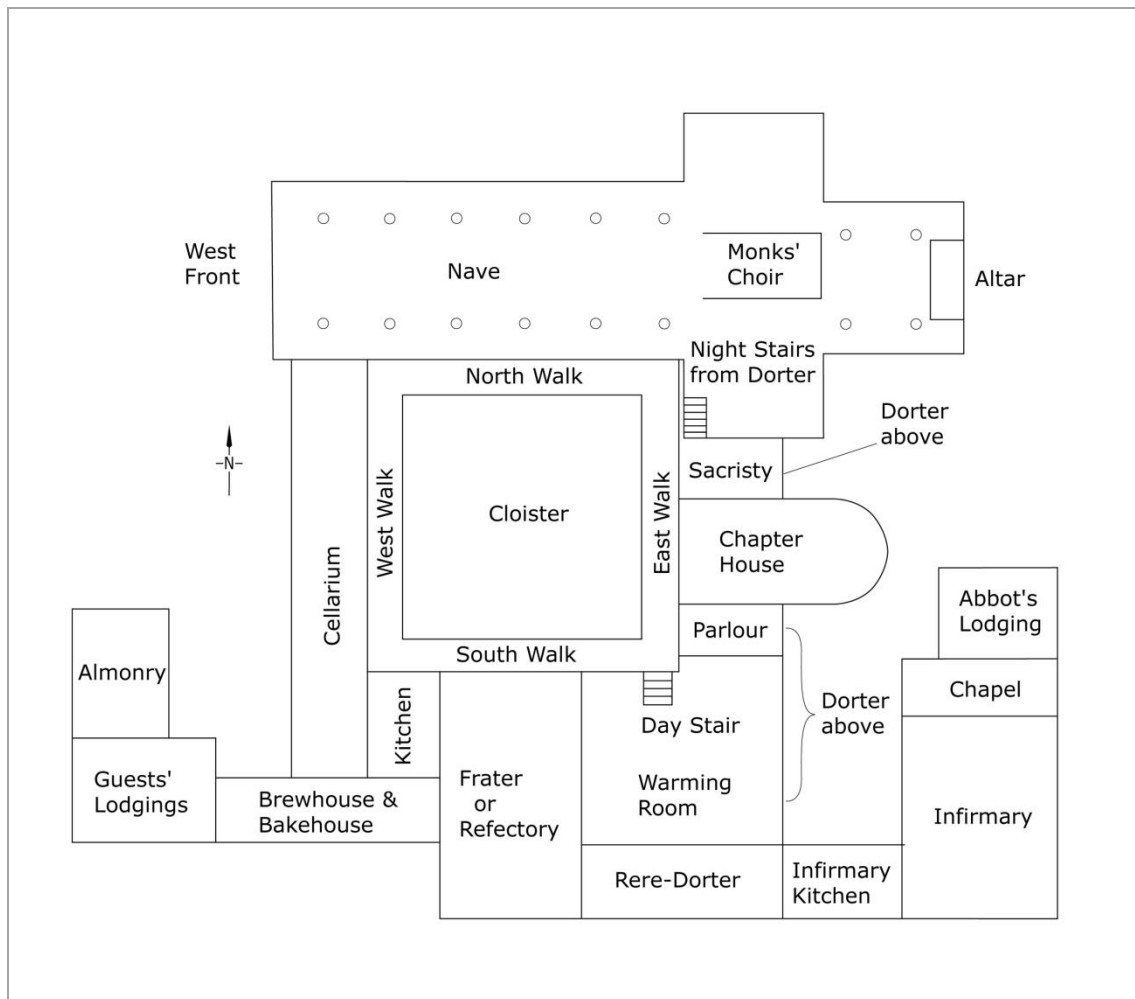
Figure 2: A sketch plan showing the common arrangement between the church and claustral buildings situated within the inner precinct of a medieval monastery.

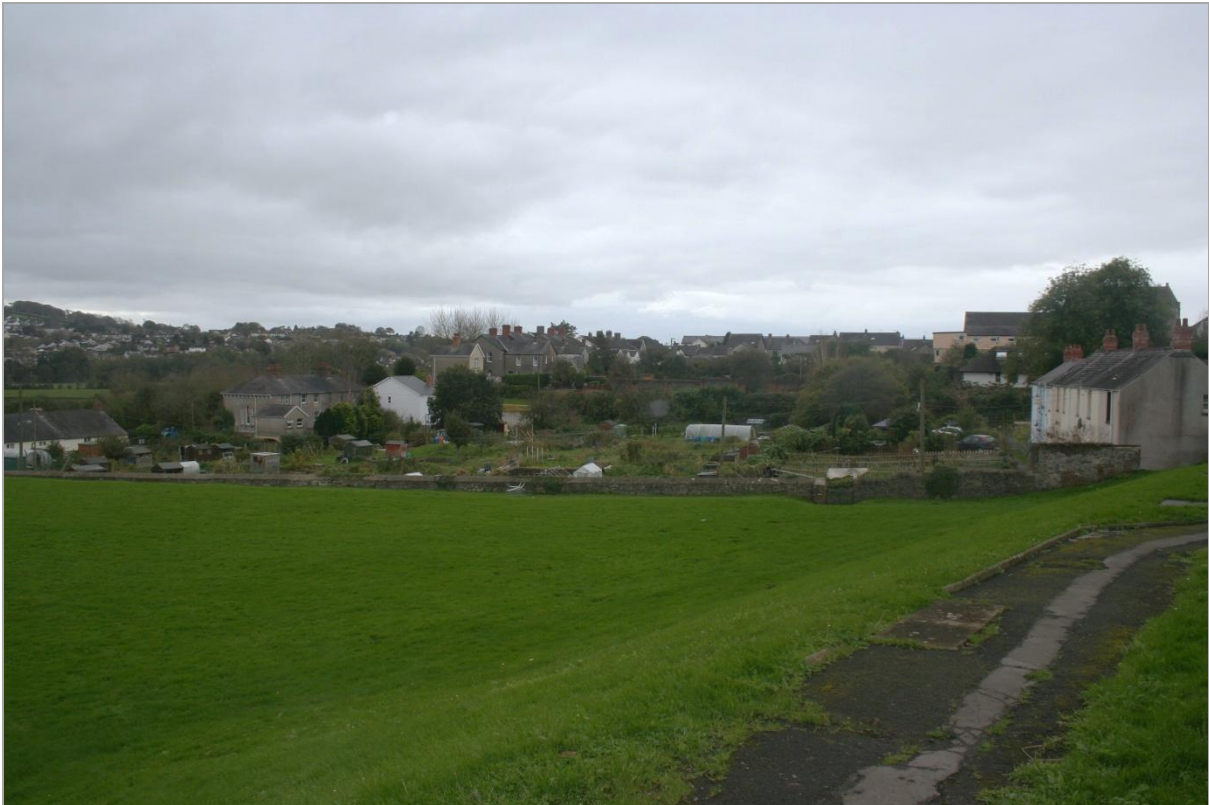
Looking southwest across the playing field and allotments that cover the area of the former precinct of St John's Priory, Carmarthen. The gateway into the precinct has been incorporated into the row of cottages on the right.

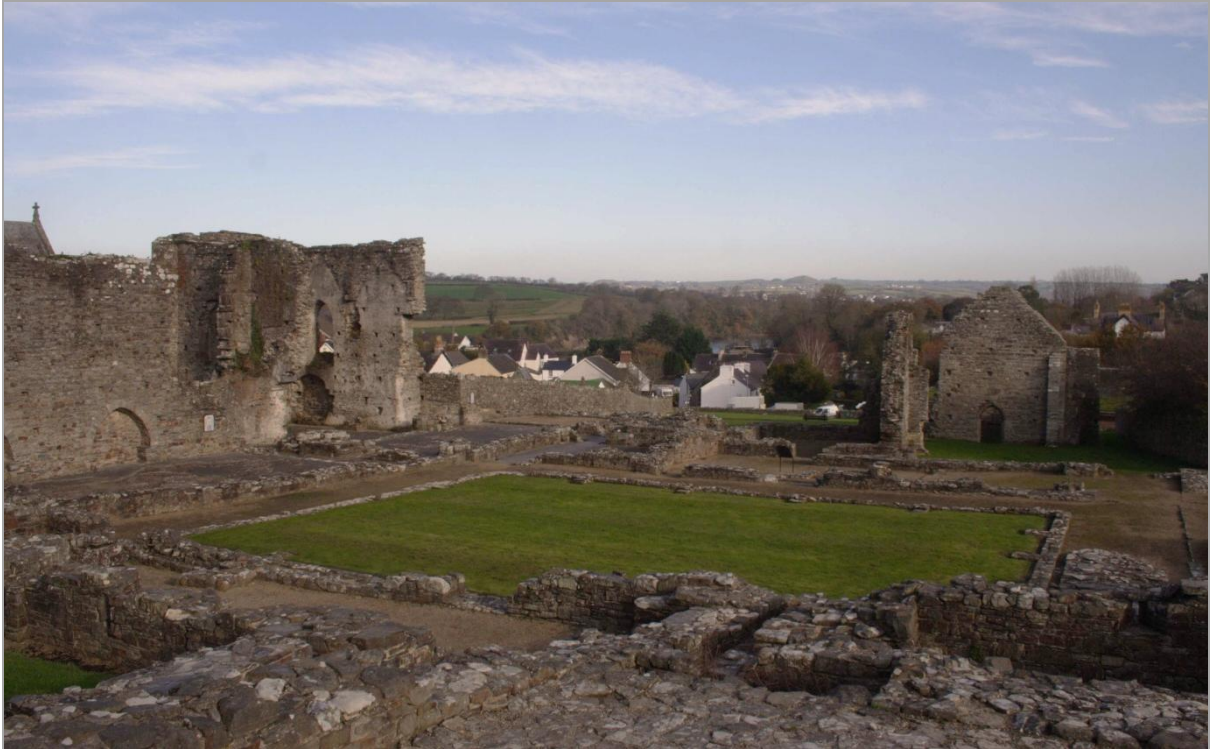
Looking east across the cloister garth of St Dogmael's Abbey. The remaining north wall and transept of the church can be seen on the left and the walls of the infirmary on the right.

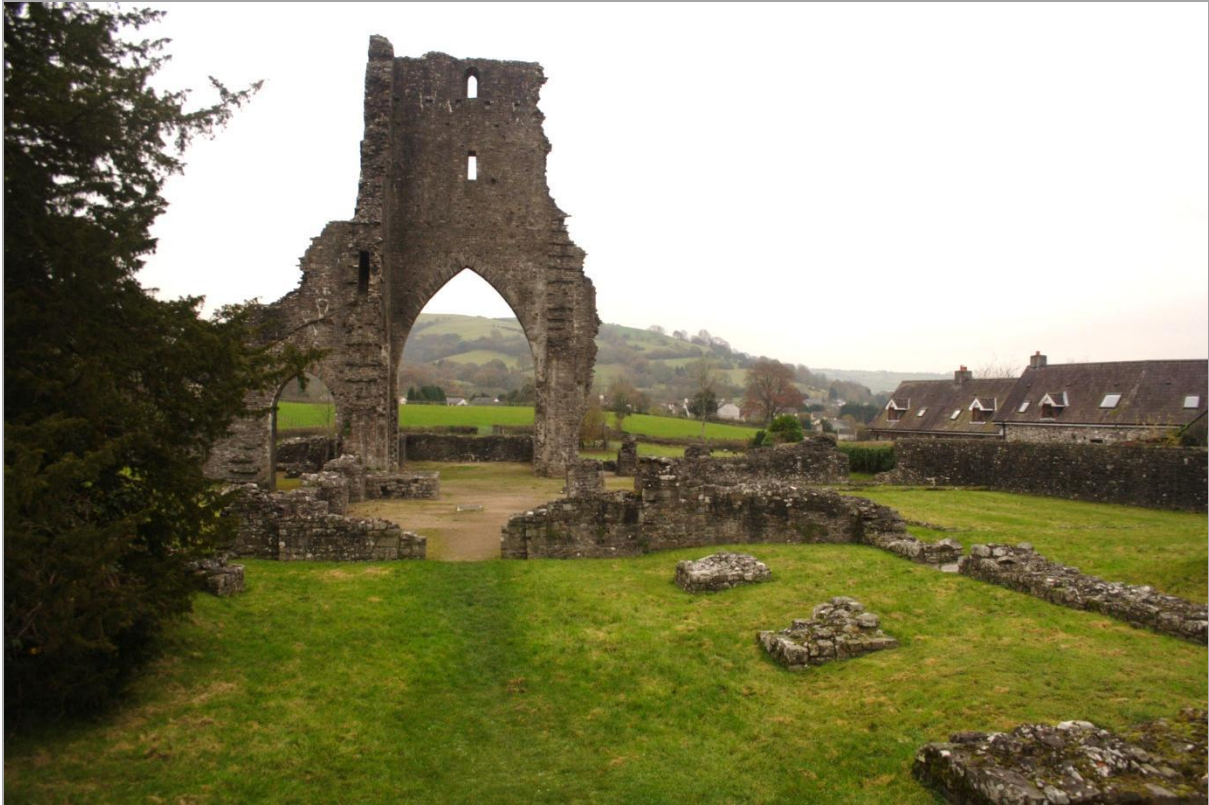
Looking east across ruins of Talley Abbey showing the east wall of the church tower with its supporting arch.

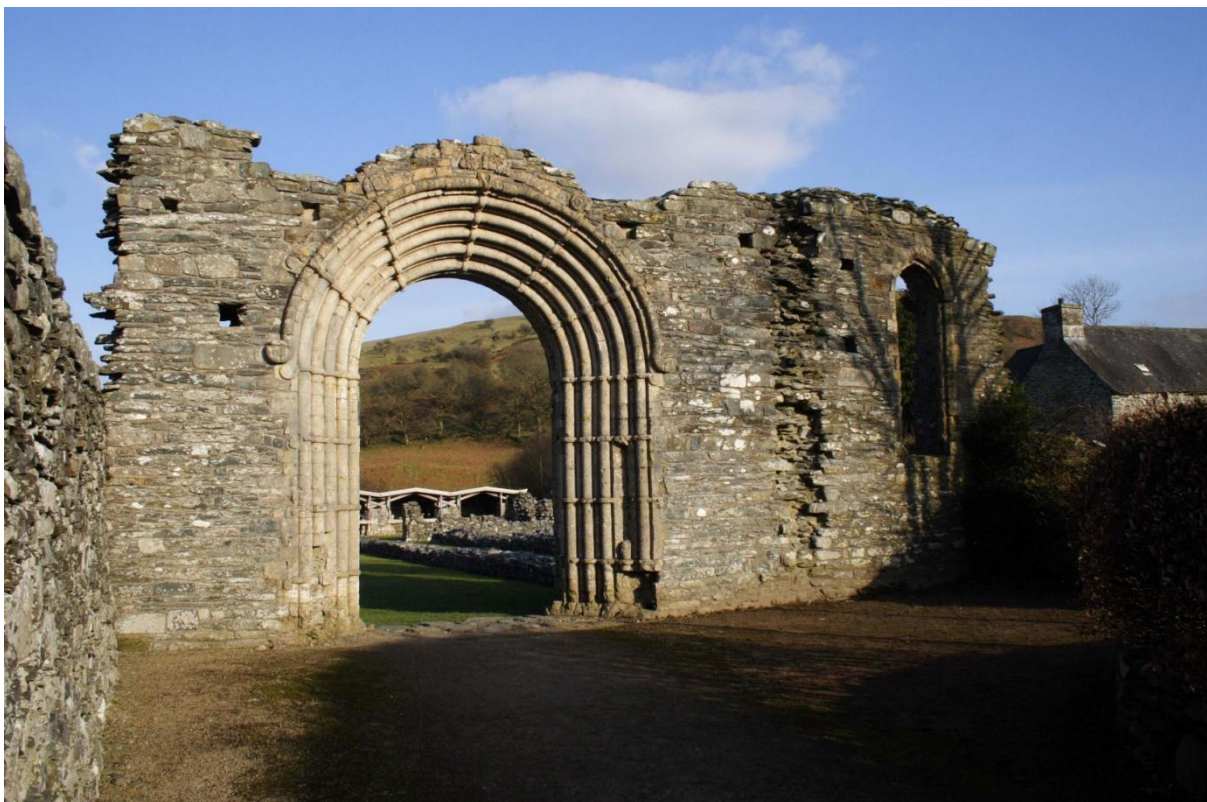
West doorway to Strata Florida Abbey church.

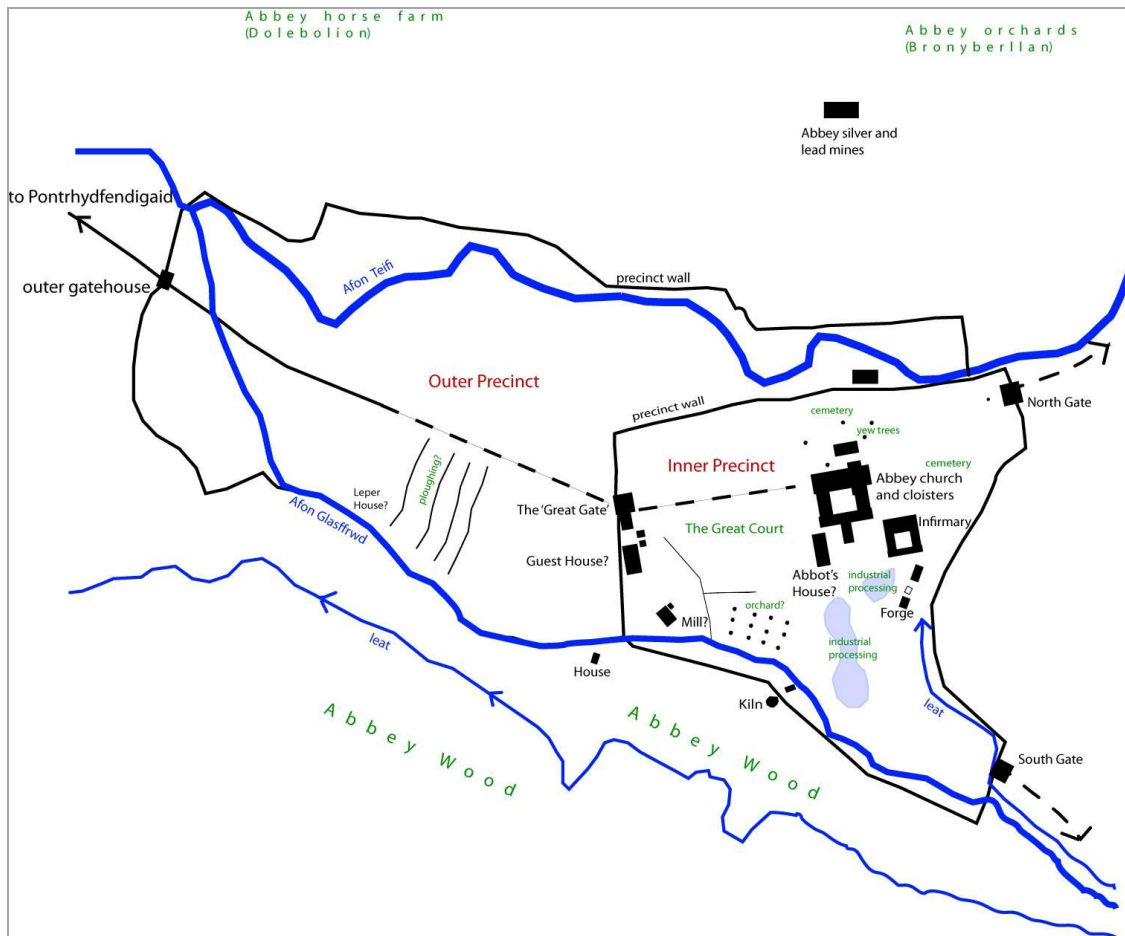
The project has, so far, estimated that the size of the precinct is an impressive c. 45 ha. Geophysical survey has shown that stone buildings are restricted to the Inner Precinct area as they are in most Cistercian houses, but that they are laid out over a larger area (16 ha.) in a much more dispersed pattern than would normally be found. A large inner gatehouse to the west, an infirmary and mill to the south and perhaps a guest-house just south of the gatehouse are suggested. Other buildings seem to include 'back' gates and the refectory. The Outer Precinct, again as at other Cistercian Abbeys, seems from

the geophysics evidence to have no substantial stone buildings with the likelihood that this area was reserved for specialist agrarian and minor industrial activities.

Projected plan of the Inner and Outer Precincts of Strata Florida Abbey (does not include the results of 2011 fieldwork). By kind permission of Department of Archaeology, History & Anthropology University of Wales, Trinity Saint David.

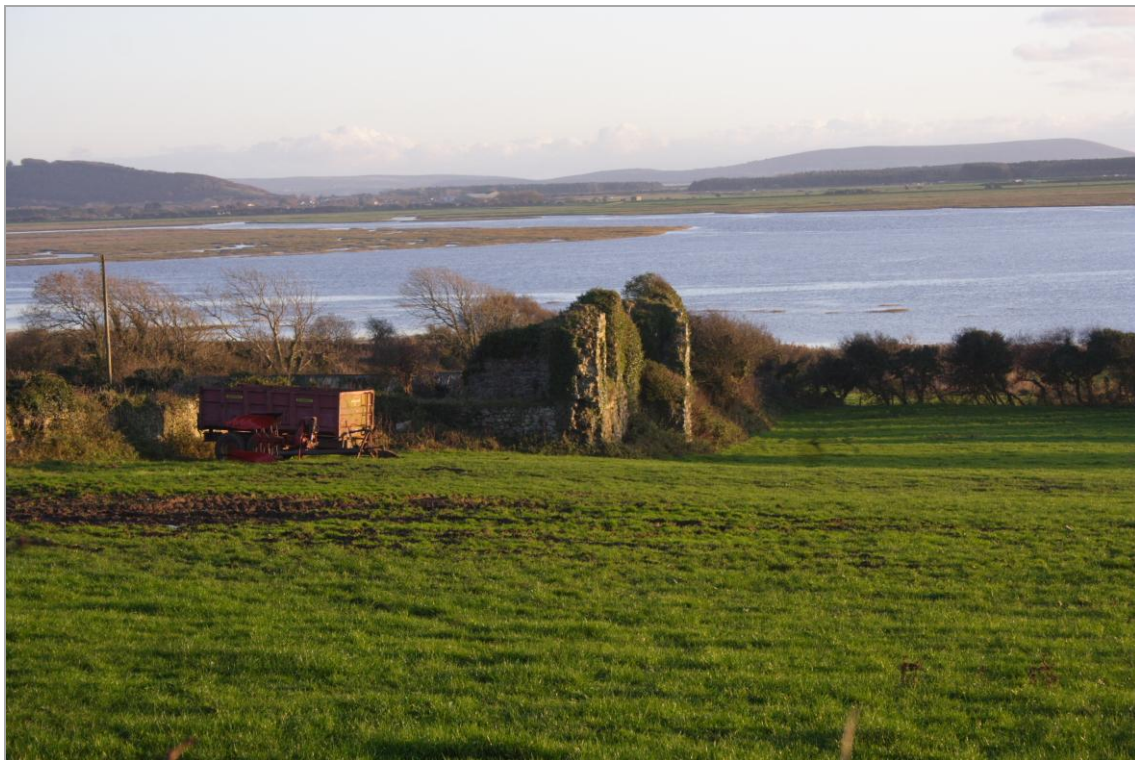
Looking south at the ivy covered ruins of Penallt Grange.

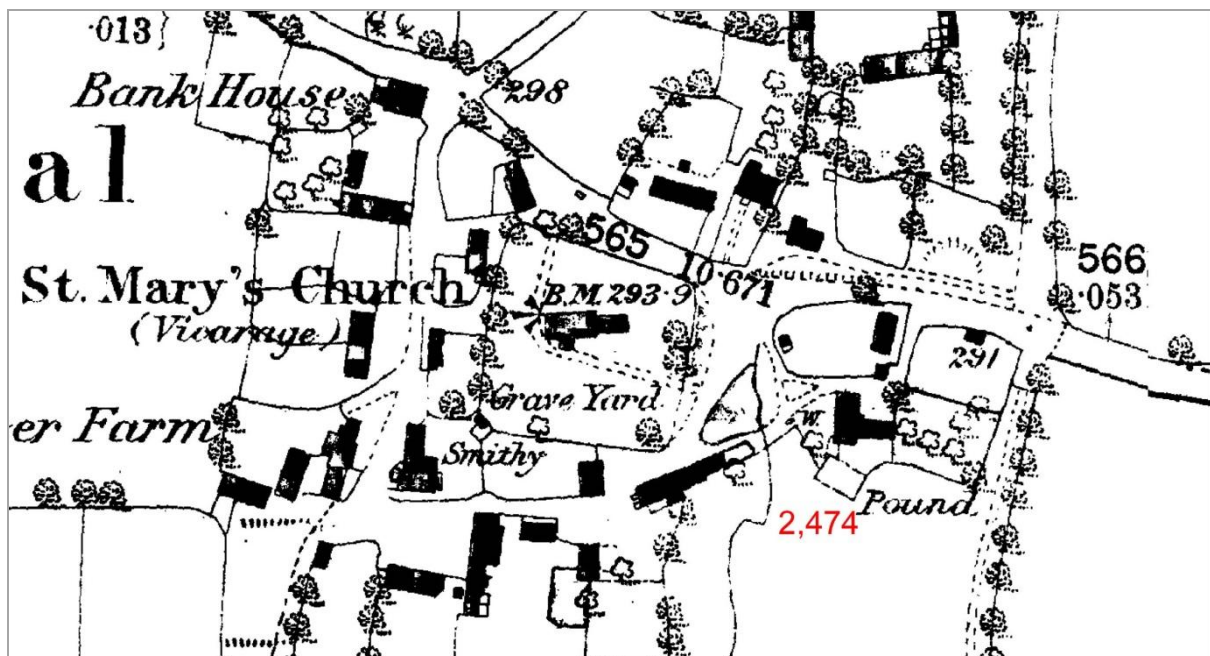
Extract from the 1889 Ordnance Survey 1st edition 25" map of Pembrokeshire. The building thought to have been the former medieval hospice (PRN 2474) is marked as 'pound'.

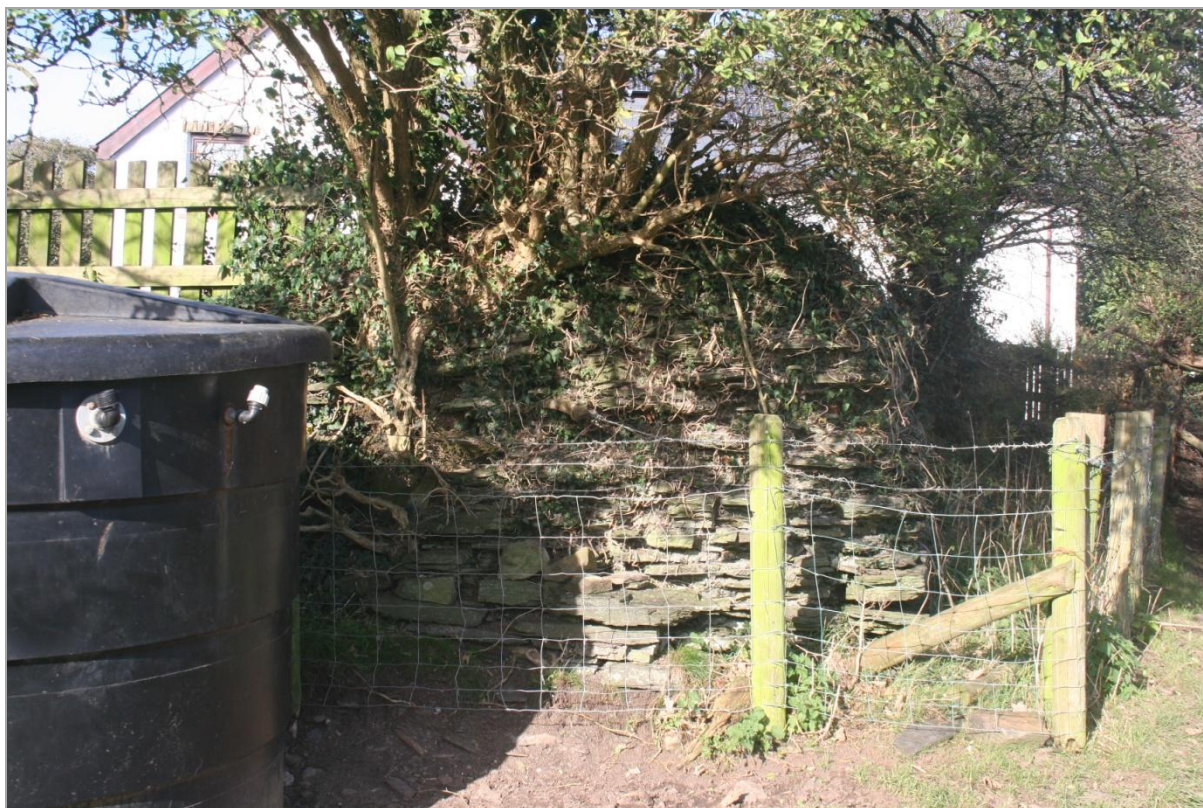
All that remains today of the medieval hospice of St Mary's is a short length of ruined wall that now lies at the end of a modern garden.

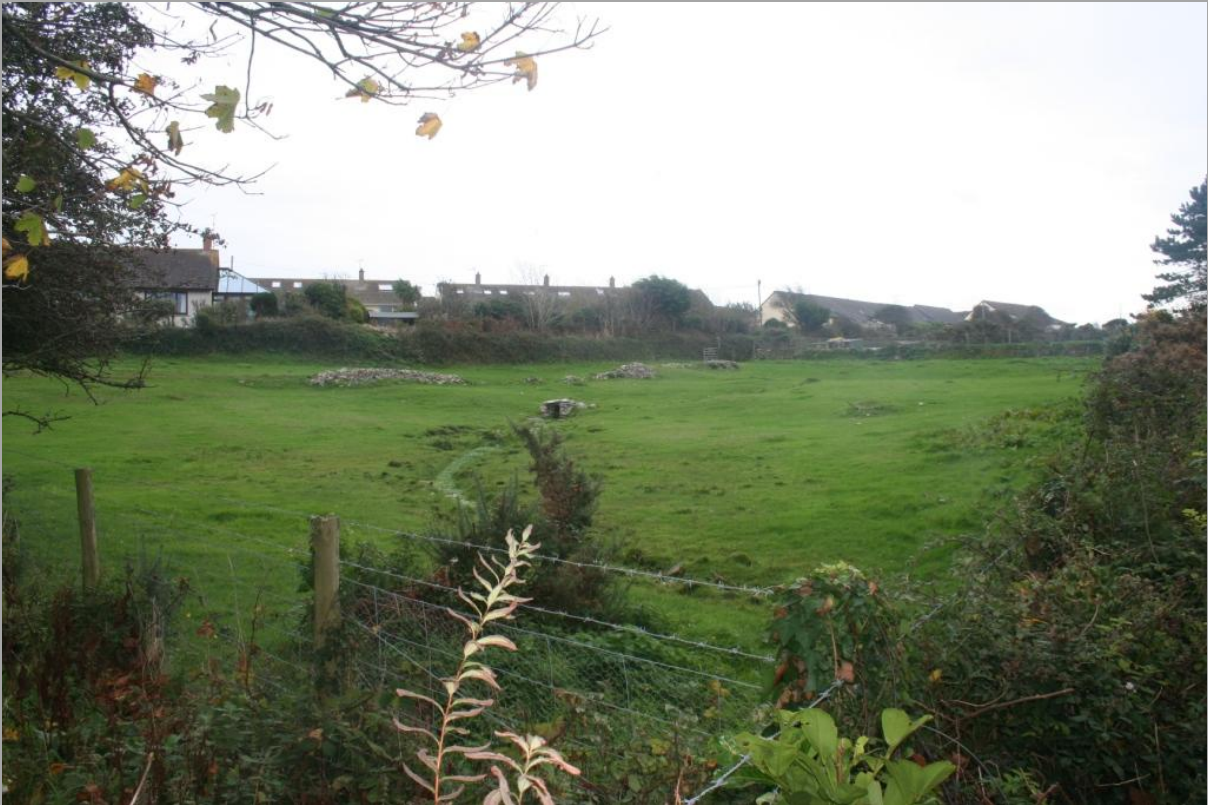
Looking southeast across scheduled area PE482 showing the natural spring of 'White well' towards the centre of the field and the rubble platforms to the east.

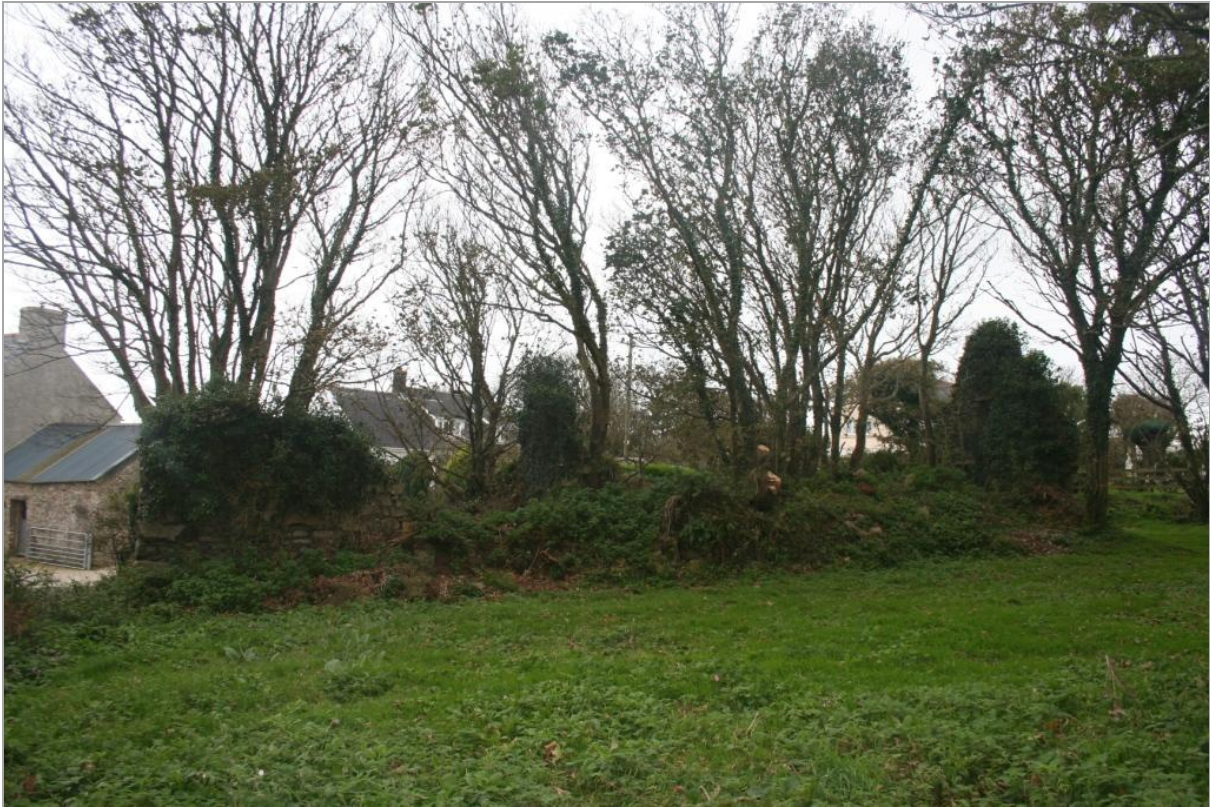
Looking southwest at the overgrown ruins of the medieval Llandruidion Hospice.

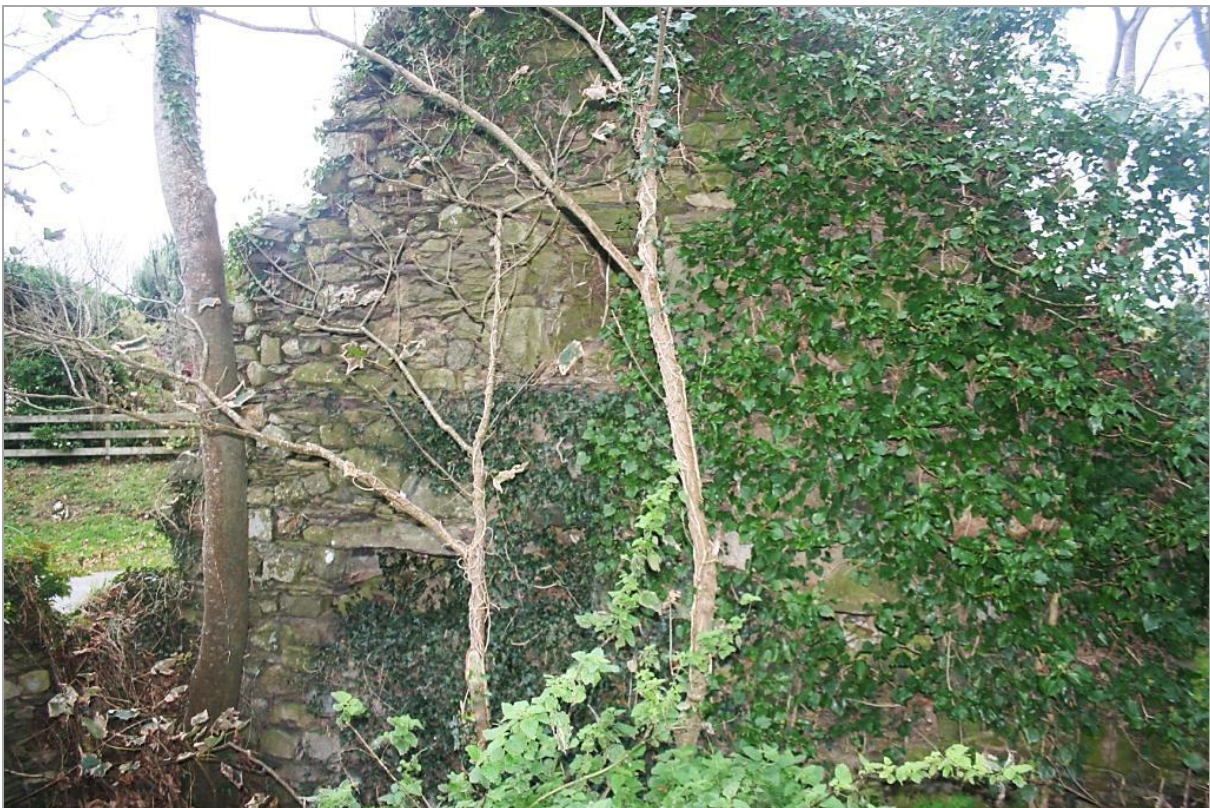
The internal face of the western gable end wall showing detail of the stone lintels of a door and a small window.

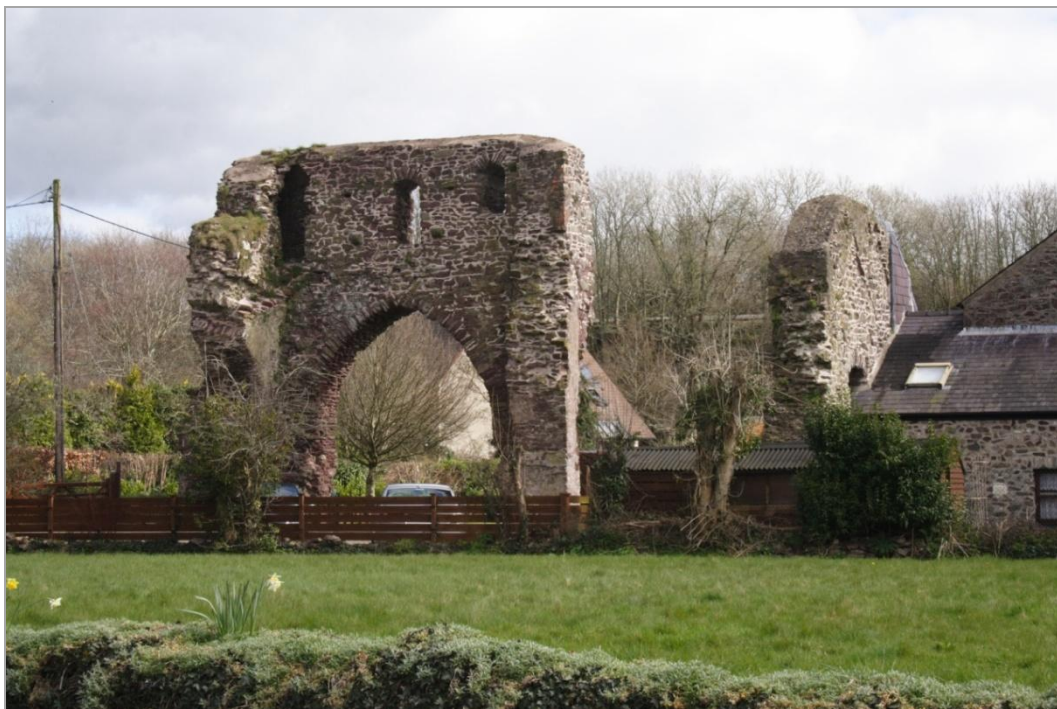
Looking east at the chancel arch of the priory church of Pill Priory.

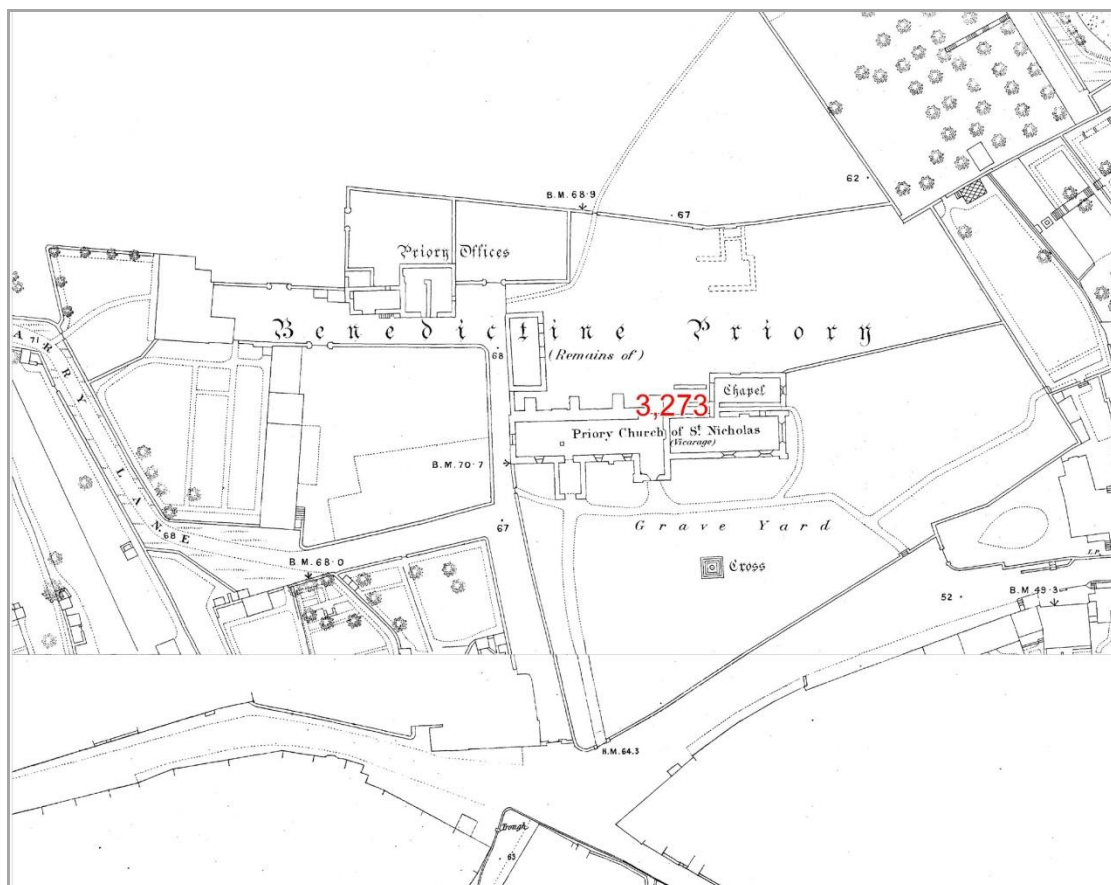
The 1:500 Ordnance Survey 1861 map of Pembroke clearly shows that remains of the claustral buildings were still standing to the north of the priory church at this time.

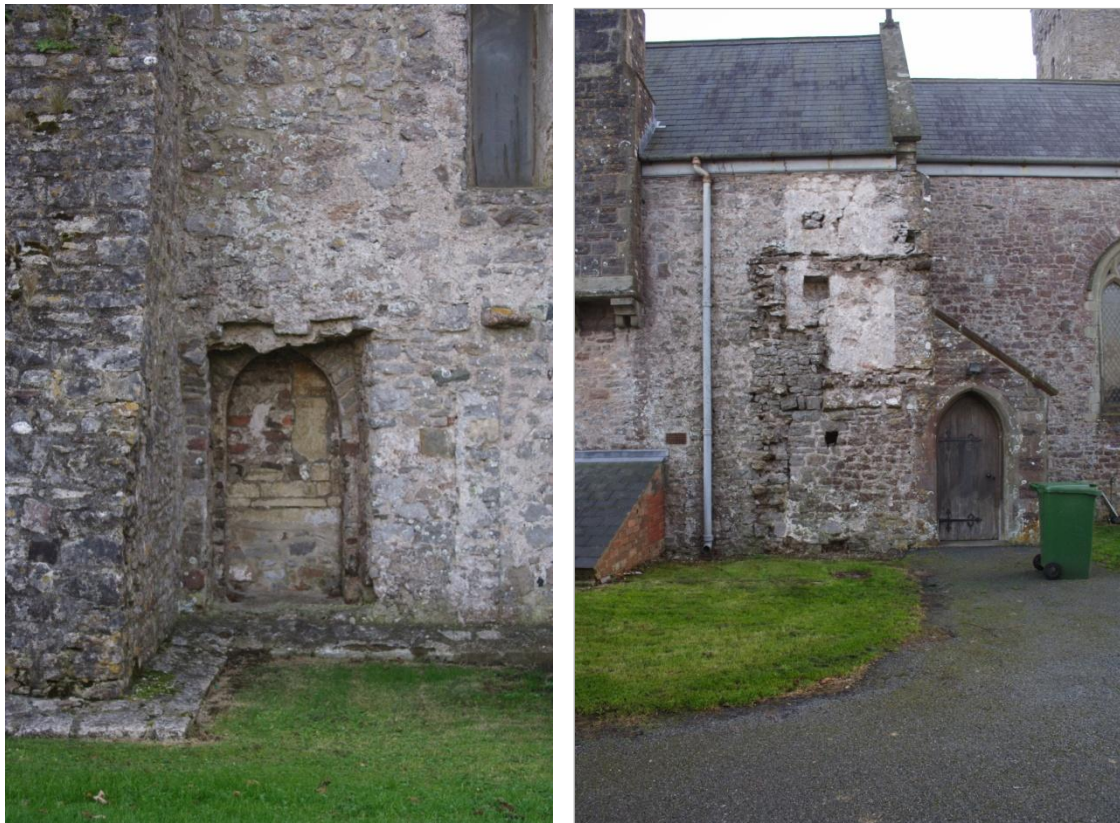
Photograph of the north side of Monkton Priory church showing the blocked doorway (left) and broken masonry (right) of where the nave and the northeast chapel respectively were attached to the former priory buildings.

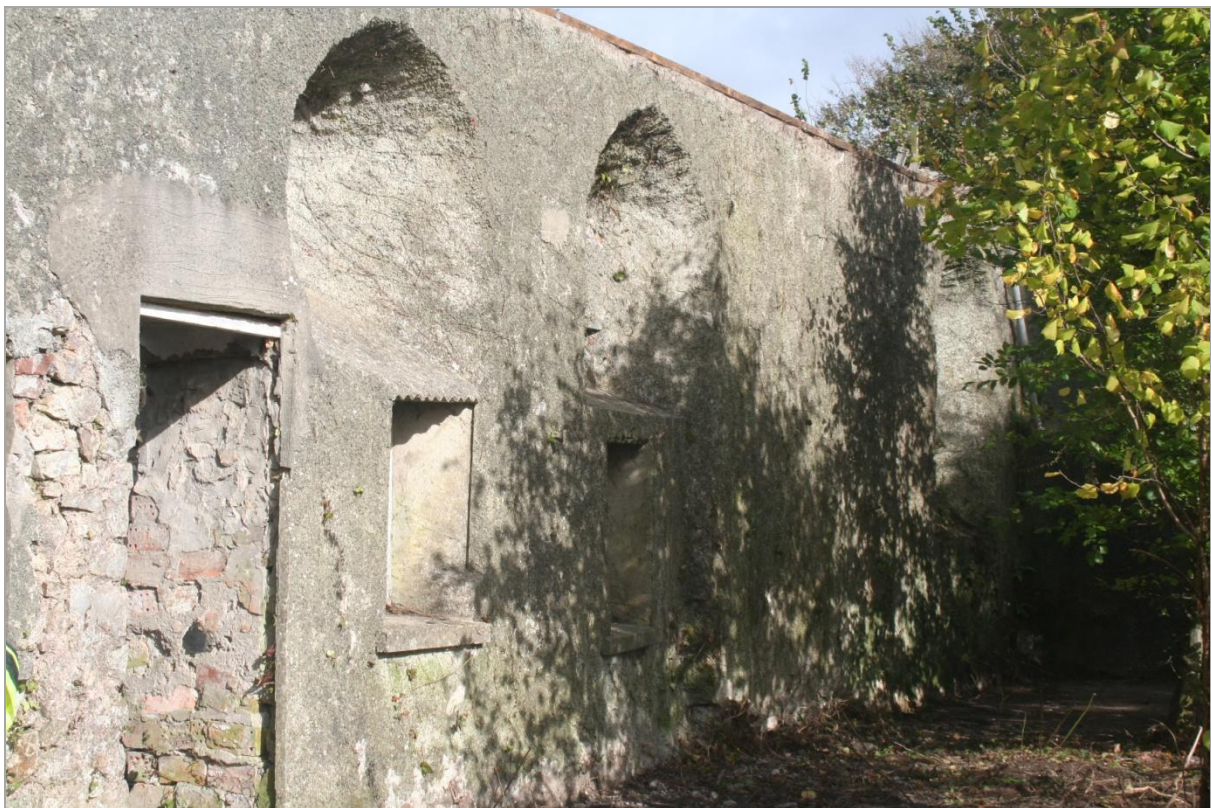
Looking north at the former internal face of the north wall of a medieval chapel, showing the three original blocked lancet windows.

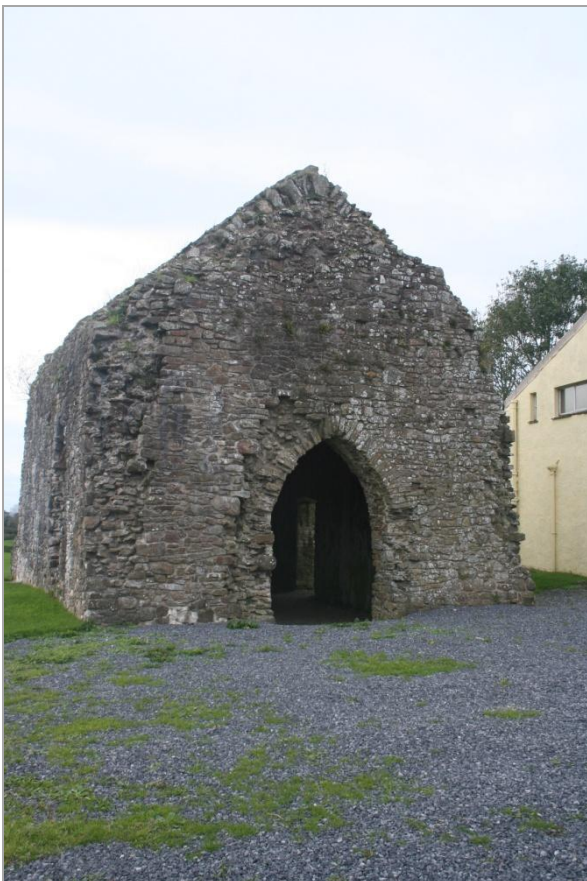
Looking west at the stone
vaulted chapel of Llawhaden
Hospice.

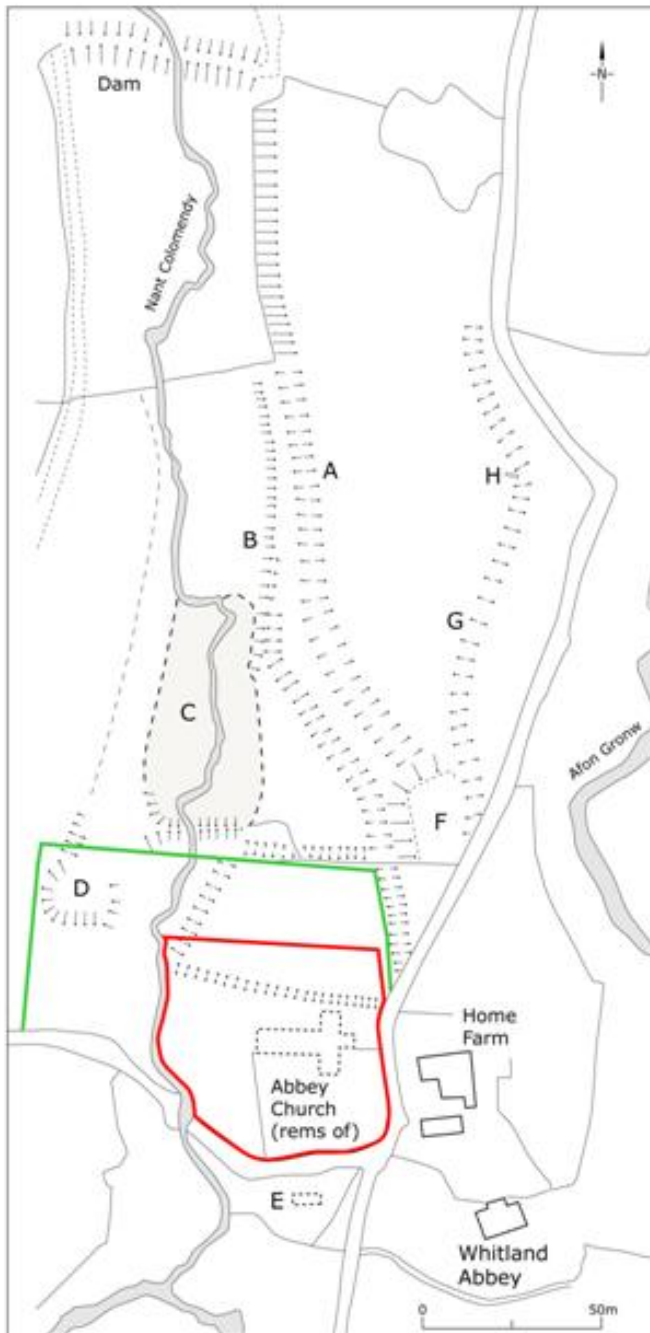
Plan of outer earthworks identified at Whitland Abbey.

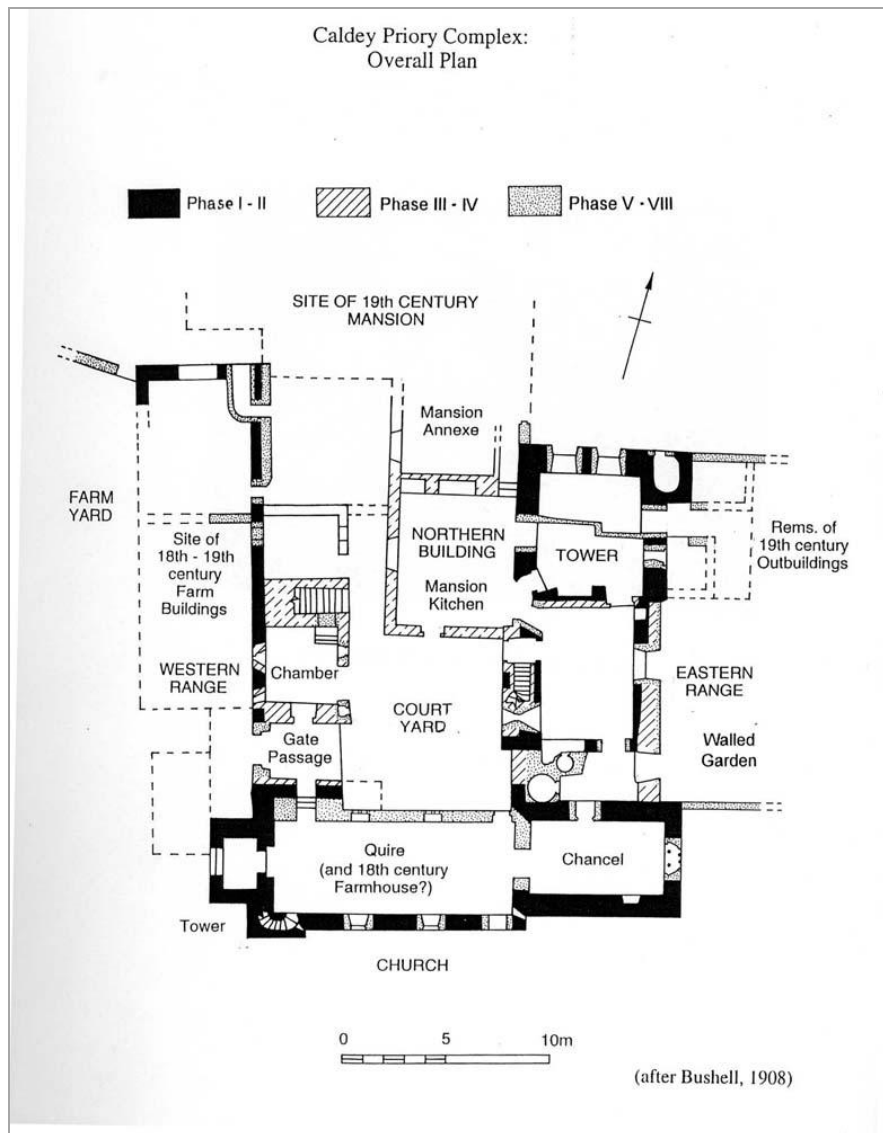
Overall Plan of Caldey Priory Complex taken from 'A Structural Analysis of Caldey Priory, Dyfed' 1994, N. Ludlow, Unpublished Dyfed Archaeological Report, PRN 43253.

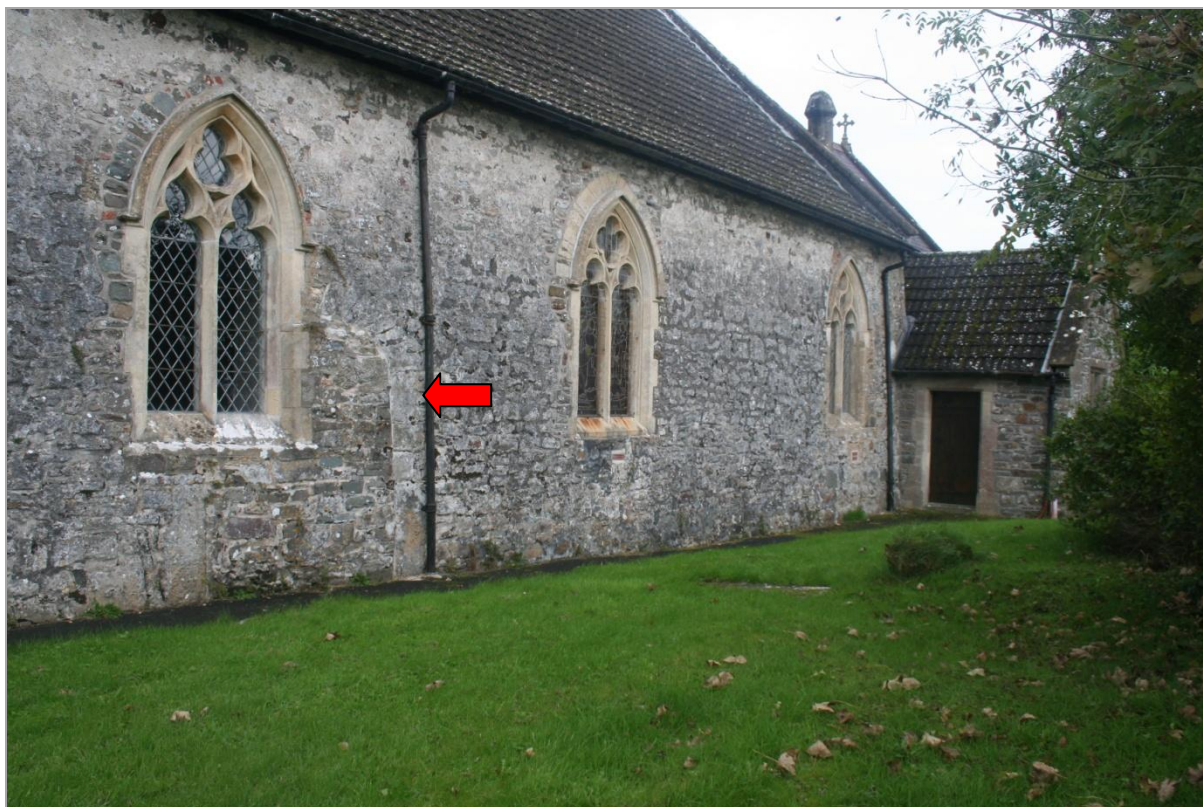
Looking northeast at the blocked doorway in the south wall of the nave of St Clears priory church. This doorway is believed to be the exit from the church into the claustral buildings.
