APPENDIX 1

Photographic Record of Works

Client	Cadw
Job Title	Earl's Chamber
	Chepstow Castle, Monmouthshire
AS CONSTRUCTED

THE EARLS CHAMBER CHEPSTOW CASTLE

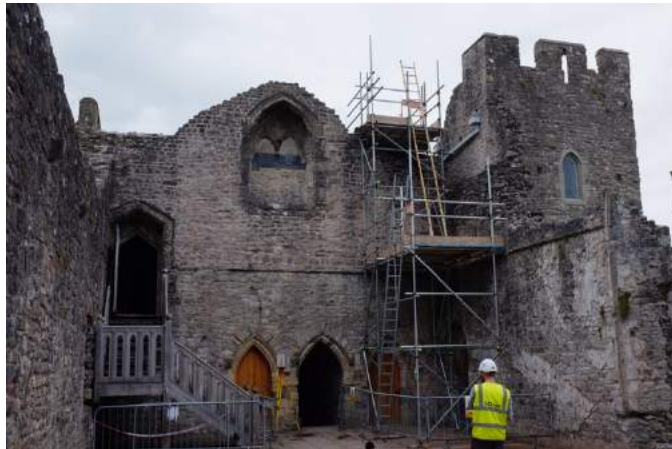
Figure 1: Pre-commencement

South Elevation (facing Great Hall)

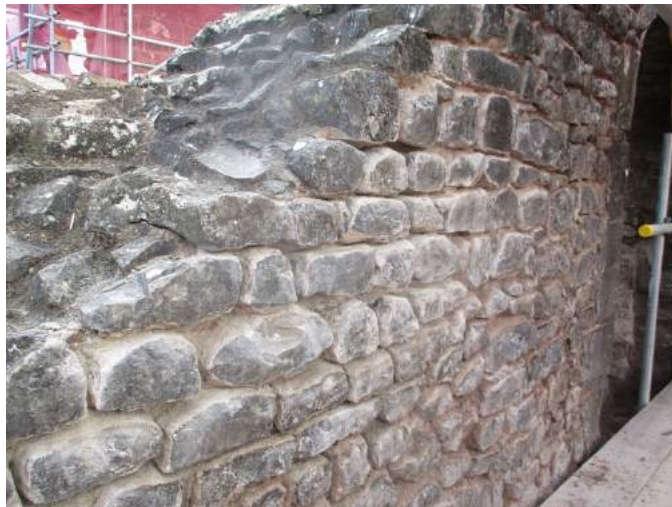
Figure 2: During contract works
(detail of 'raking out' of existing pointing shown)

Existing inappropriate 'clay rich' pointing (from circa 2005 repairs) to be carefully raked out from wall-face (C41/810A). Repoint using NHL3.5 lime/sand mortar (C41/820)

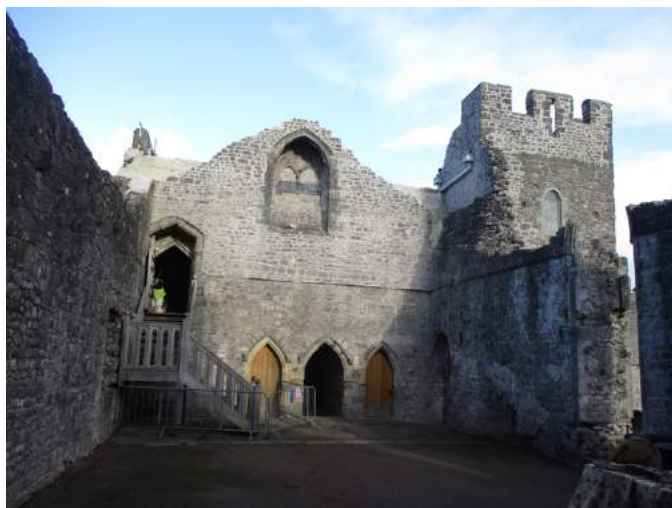
Figure 3: At completion
(note extents of repointing)

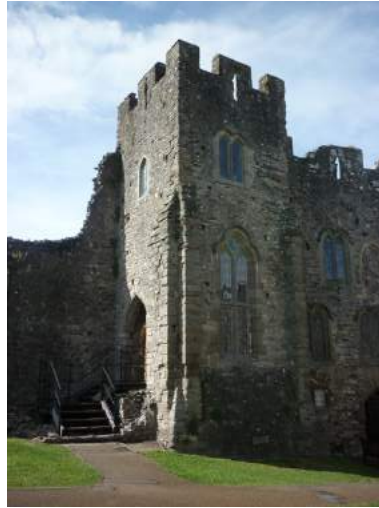
Figure 4: Pre-commencement

Great Hall Porch Tower

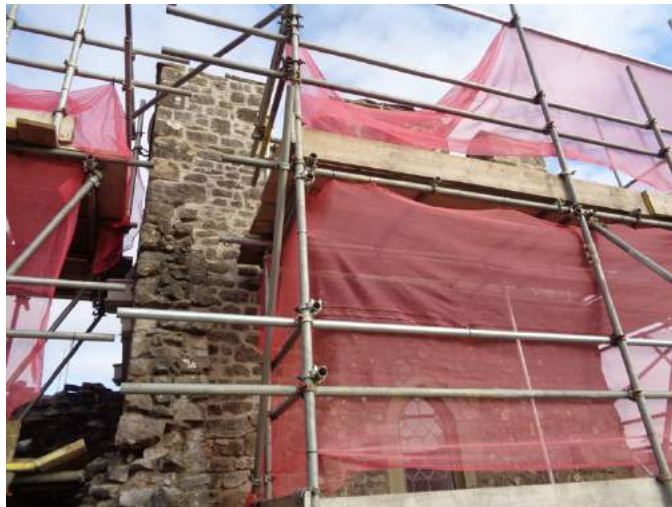
Figure 5: During contract works
(detail of repointing shown)

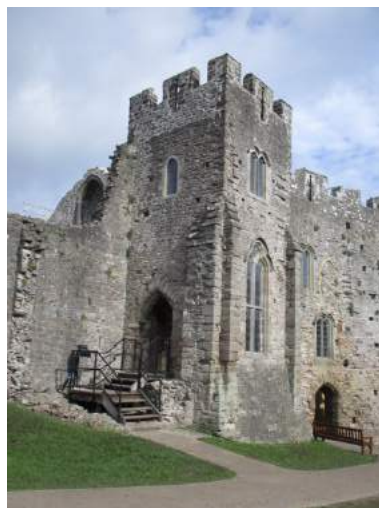
Figure 6: At completion
(note extents of repointing at high-level)

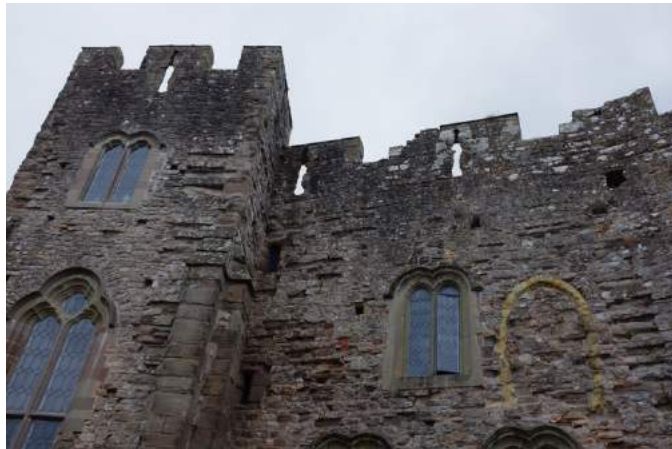
Figure 7: Pre-commencement

East Elevation (facing Lower Bailey)

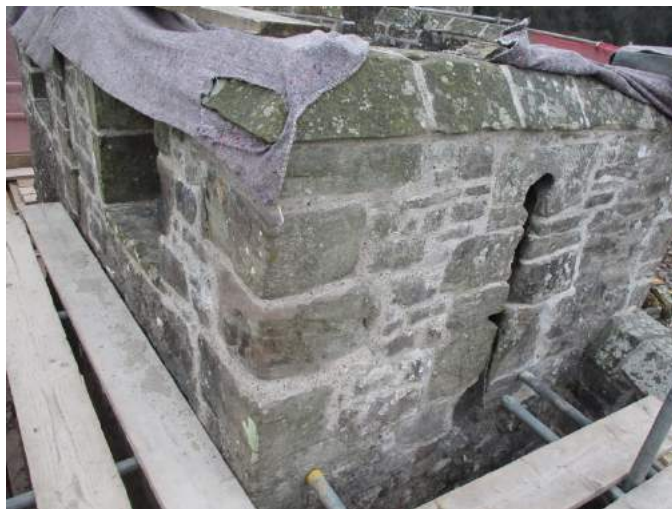
Figure 8: During contract works
(detail of repointing shown)

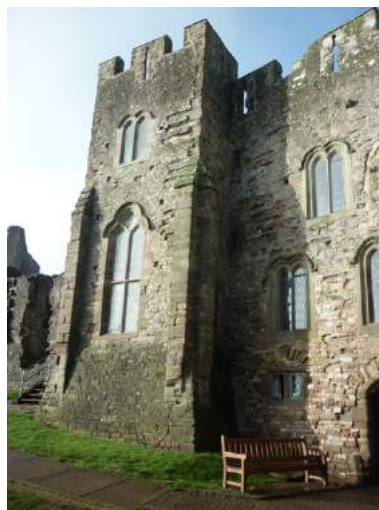
Figure 9: At completion
(note extents of repointing at high-level)

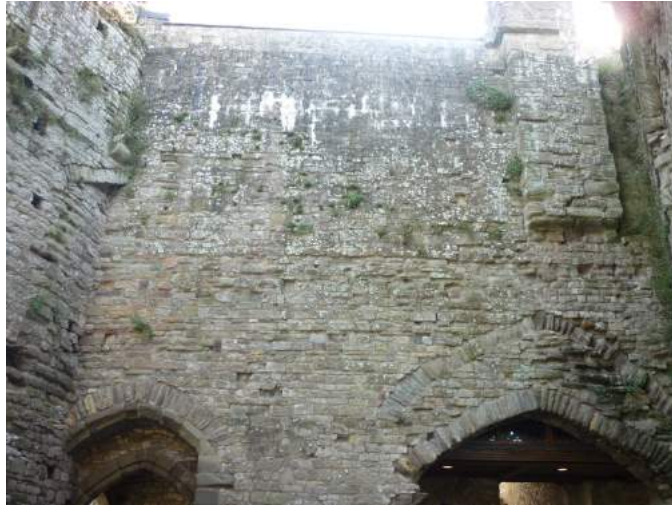
Figure 13: Pre-commencement

North Elevation (facing Lesser Hall)

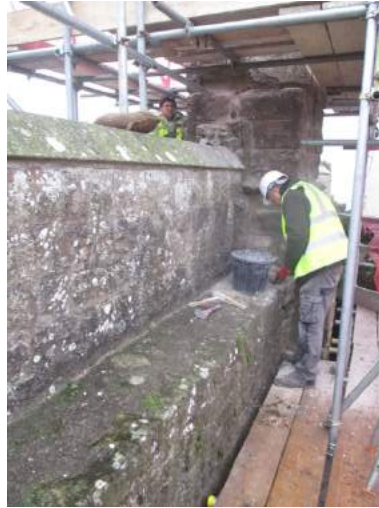
Figure 16: Pre-commencement

Detail of Wall Ledge on North Elevation

Existing inappropriate 'clay rich' pointing (from circa 2005 repairs) to be carefully raked out from rubble core wall-top (C41/810A). Provide lime wash 'slip plane' (M20/01). Finish rubble core wall-top with 2-coat 'Prompt' natural cement/sand render capping (M20/10)

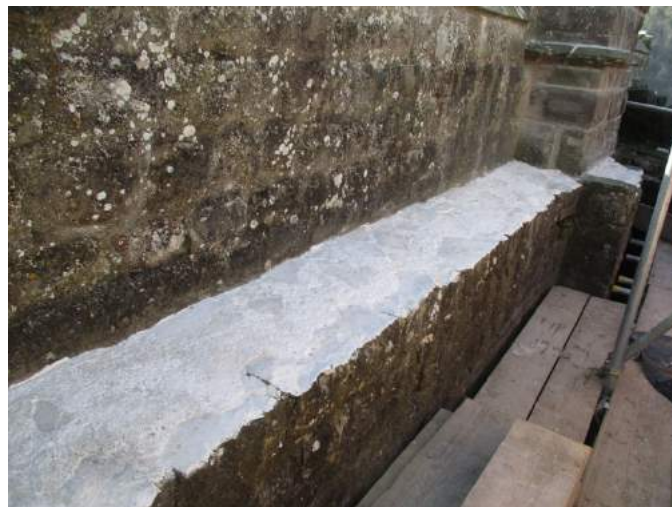
Figure 17: During contract works
(lime wash 'slip-plane' shown)

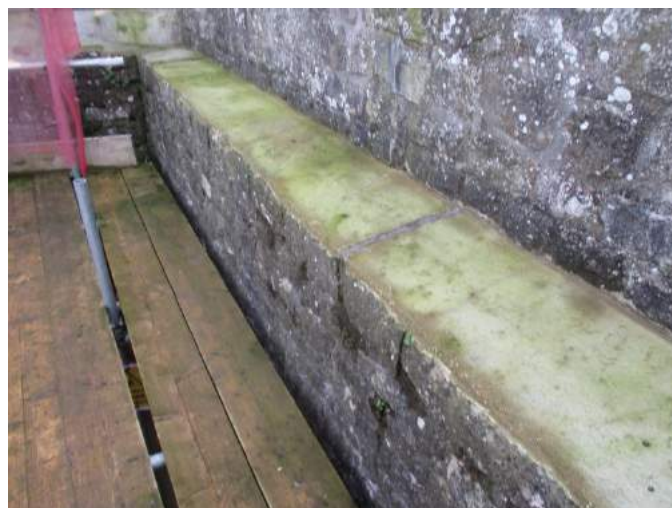
Figure 18: At completion
(‘patinating’ of Prompt natural cement capping shown)

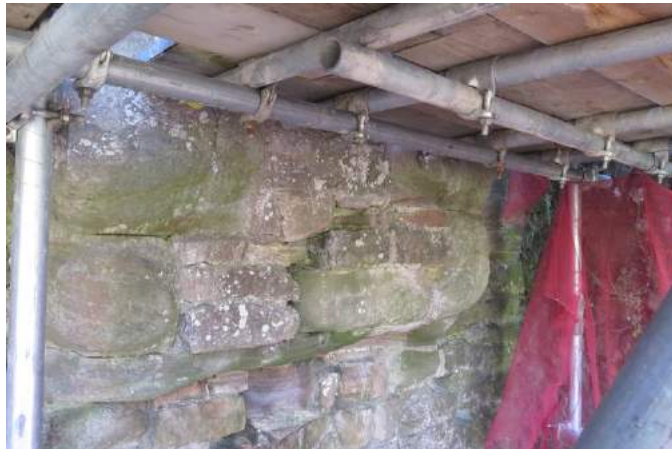
Figure 19: Pre-commencement

Detail of Chimney Base on North Elevation

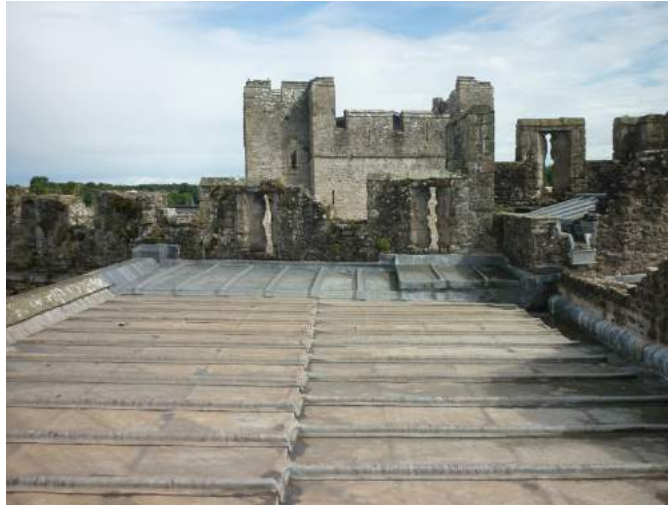
Figure 22: Pre-commencement

Main Roof (East-End)

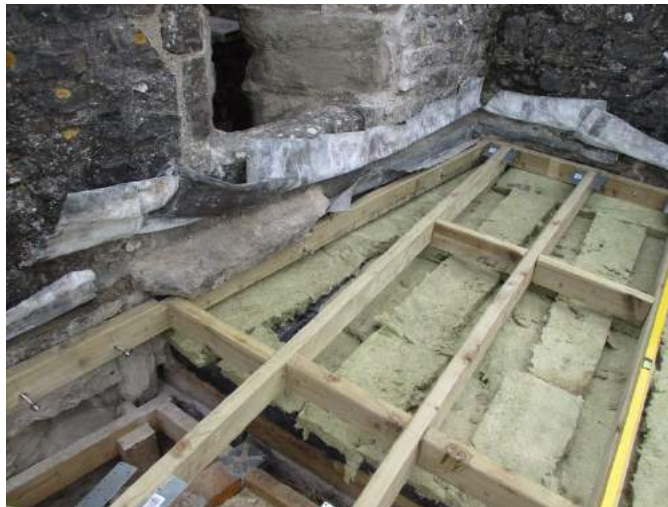
Figure 23: During contract works
(installation of new joists and insulation shown to roof over stairwell)

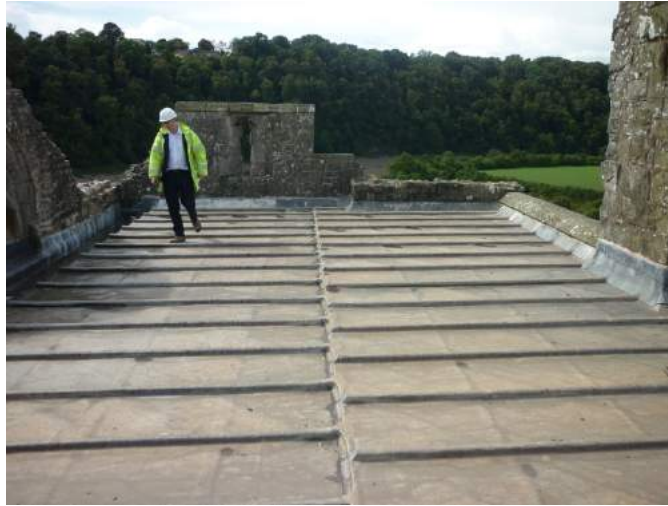
Figure 25: Pre-commencement

Main Roof (West-End)

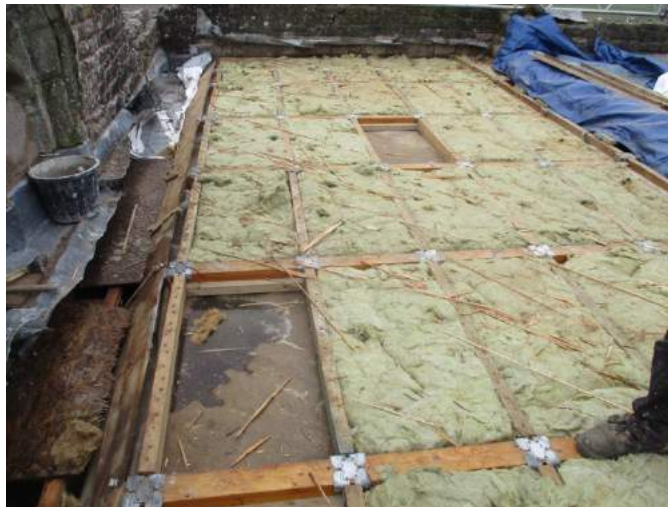
Figure 26: During contract works
(removal of existing full-fill insulation shown, i.e. no ventilation path)

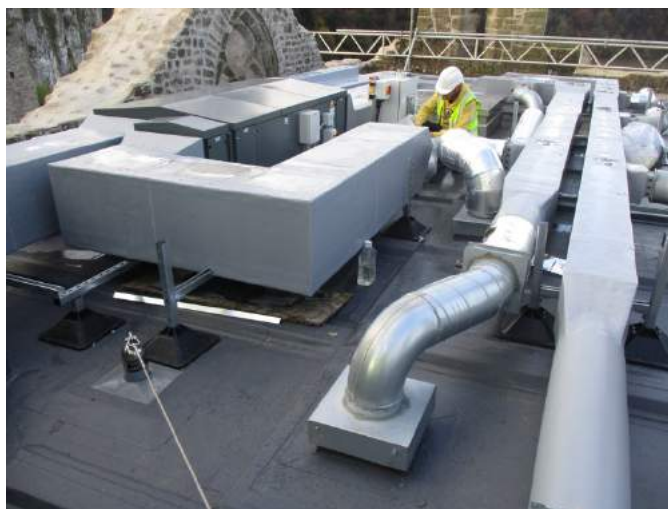
Figure 27: Nearing completion
(Remaining ductwork covering shown being installed)

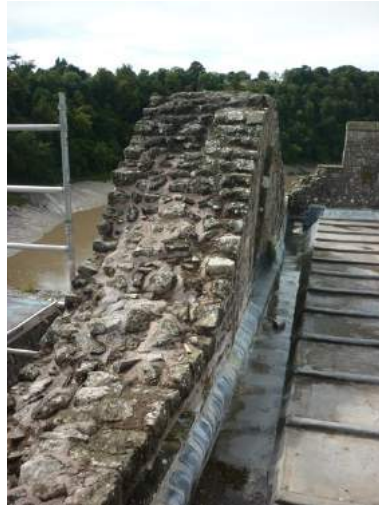
Figure 28: Pre-commencement

Detail of South Elevation Gable at Roof-Level

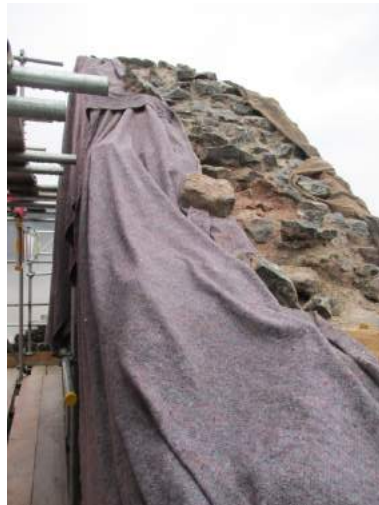
Figure 29: During contract works
(detail of repointing shown)

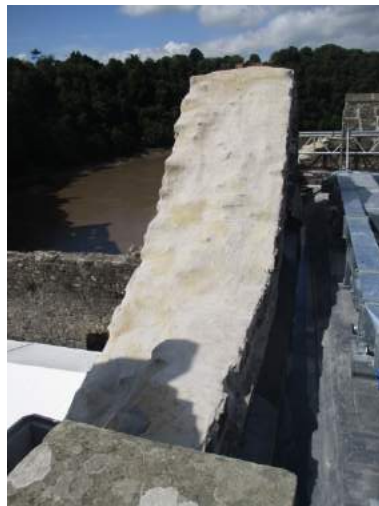
Figure 30: At completion
(‘patinating’ of Prompt natural cement capping shown)

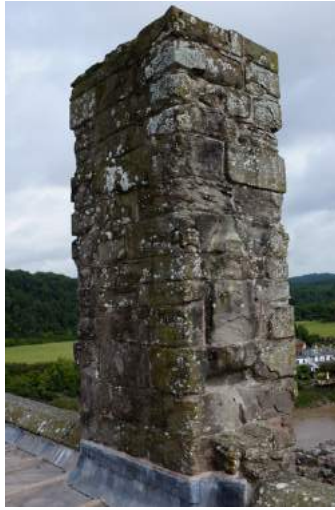
Figure 31: Pre-commencement

Detail of South Elevation Gable at Roof-Level

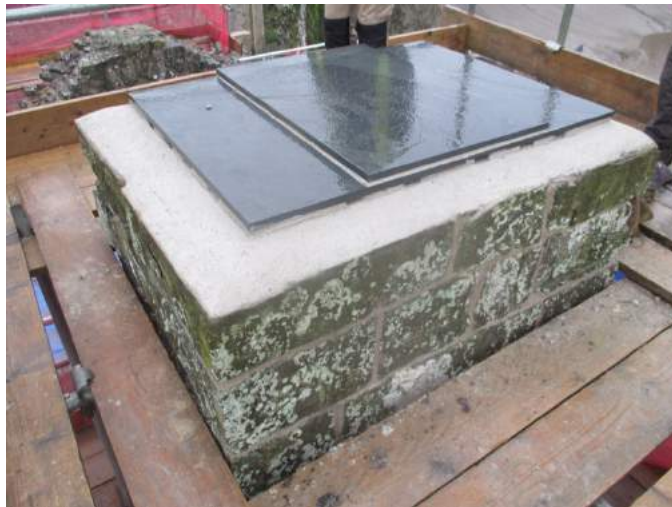
Figure 32: During contract works
(detail of natural slate capping & flaunching shown)

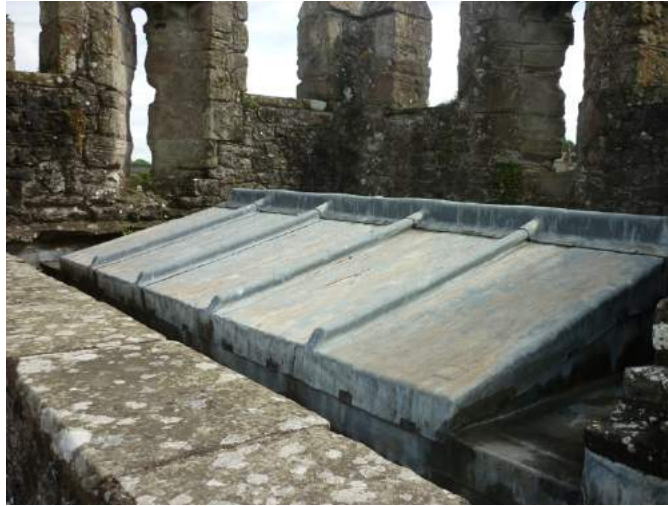
Figure 34: Pre-commencement

Great Hall Porch Tower Roof

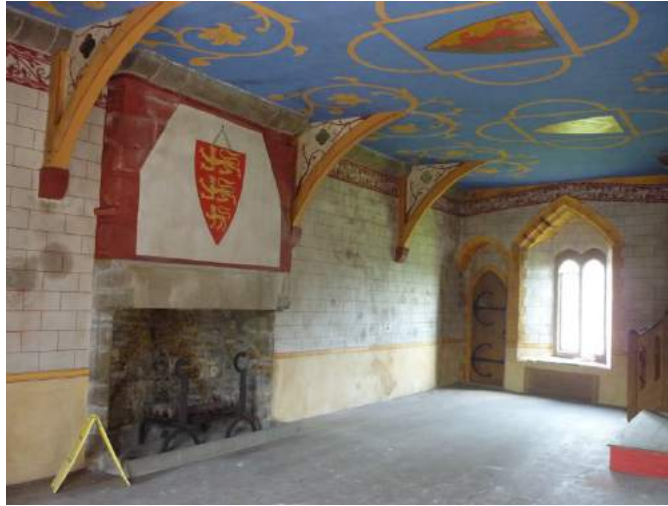
Figure 37: Pre-commencement

Interior of Earl's Chamber (East-End)

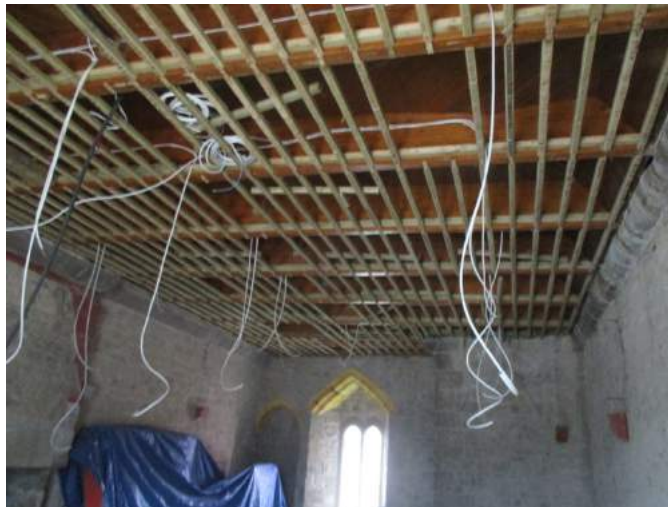
Figure 38: During contract works
(detail of ceiling electrical 'first-fix' shown)

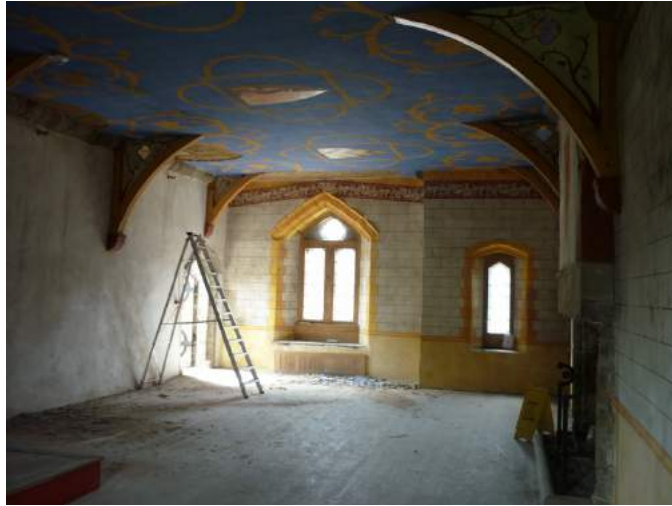
Figure 40: Pre-commencement

Interior of Earl's Chamber (West-End)

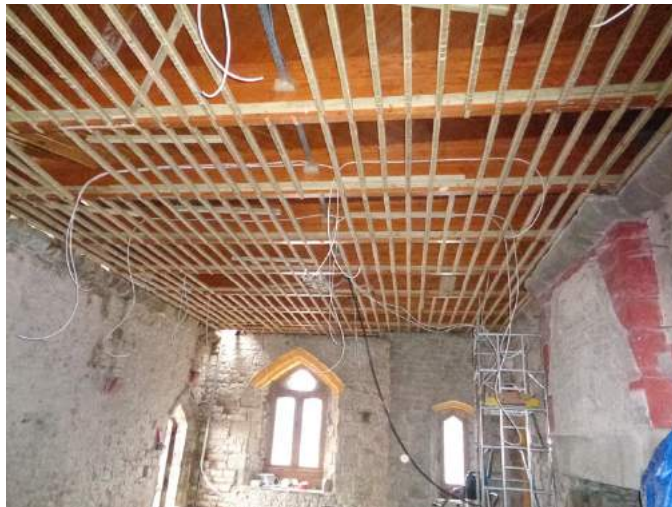
Figure 41: During contract works
(detail of ceiling electrical 'first-fix' shown)

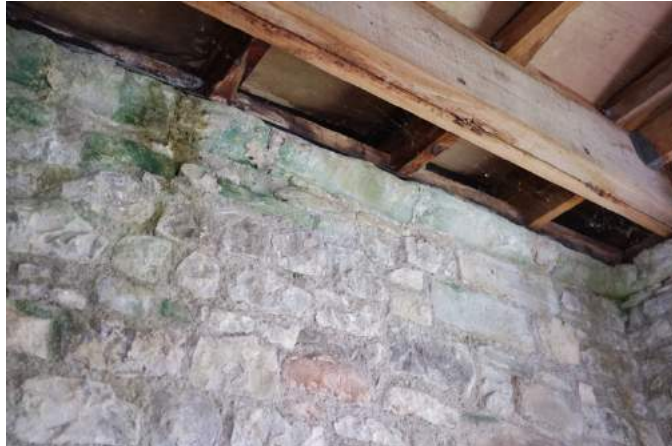
Figure 43: Pre-commencement
(wall visibly damp below northern gutter line & sustaining algae growth)

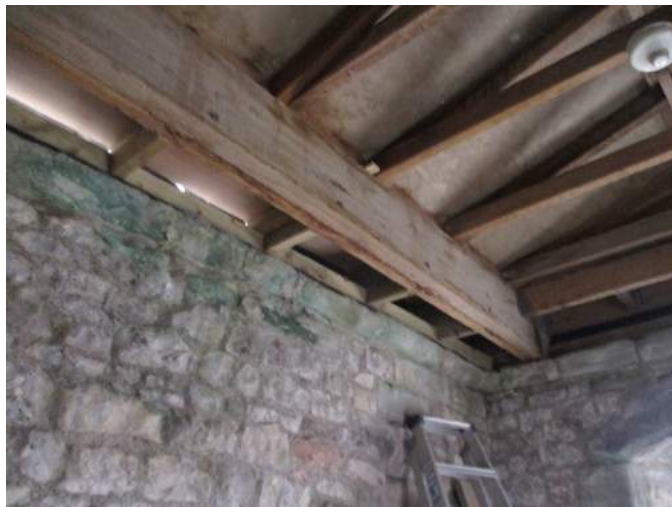
Figure 44: During contract works
(shown at introduction of gutter ventilation path detail)

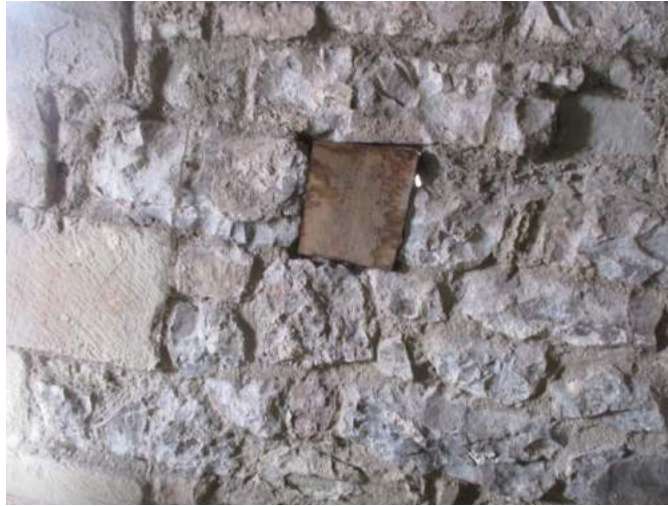
Figure 46: Pre-commencement

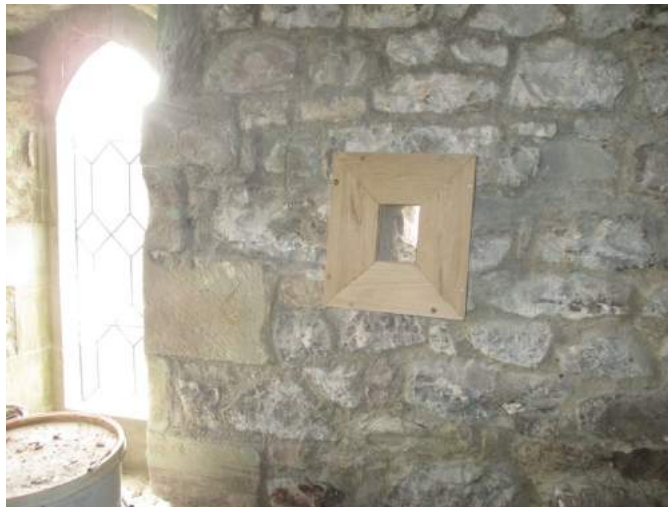
Figure 47: During contract works
(misinterpreted vent detail formed by Contractor shown, ultimately omitted)

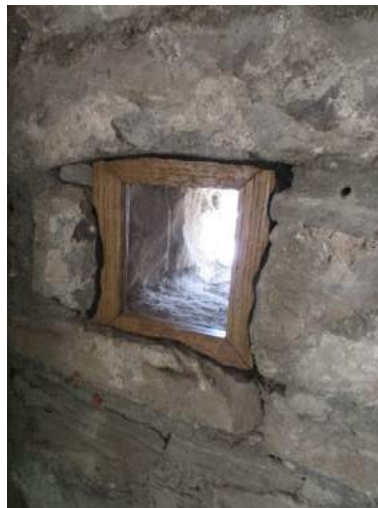
Figure 48: At completion
(visually unobtrusive, practical and non-intrusive installation)

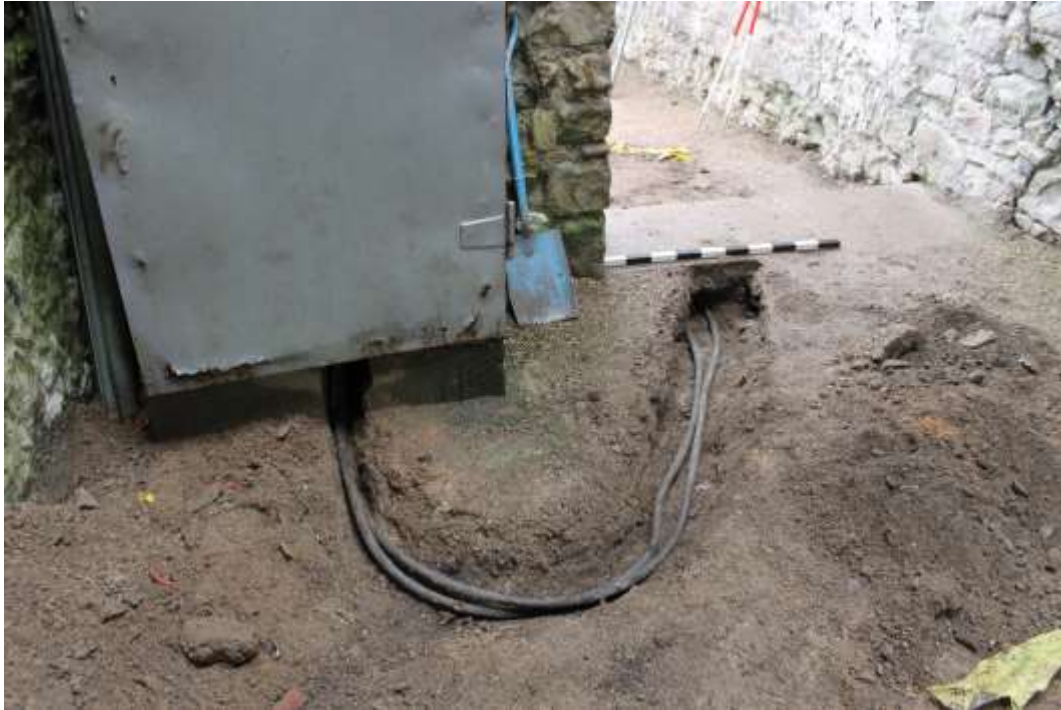
Figure 2. Existing cables exiting the junction box

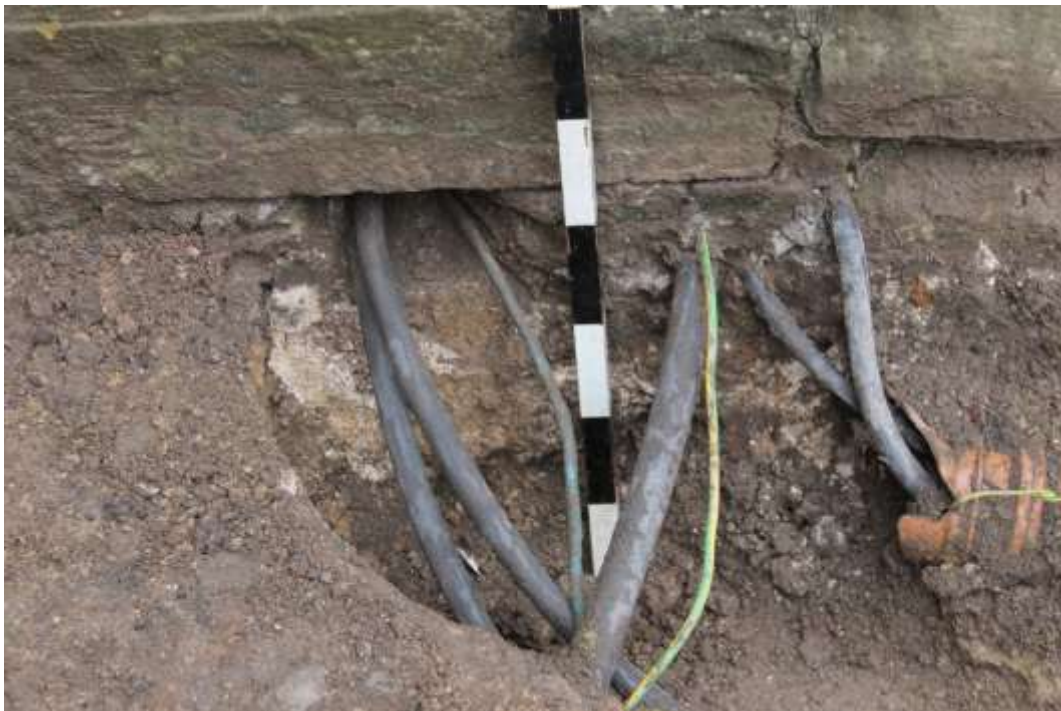
Figure 3. Cables fed through a hole in the mortar within the step between the tower and the Great Hall

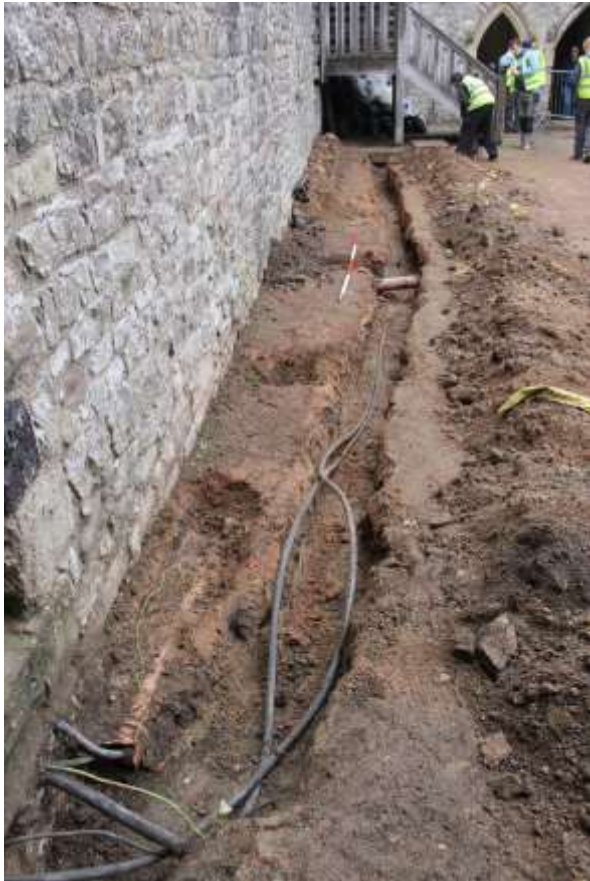
Figure 4. View NE along cable trench

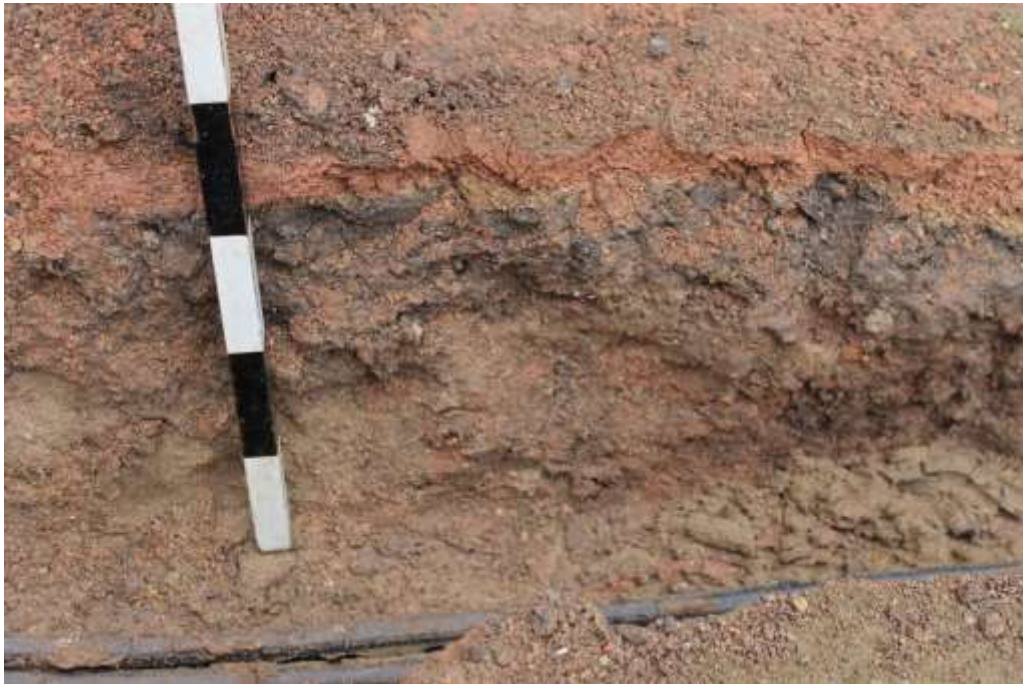
Figure 5. Section of cable trench

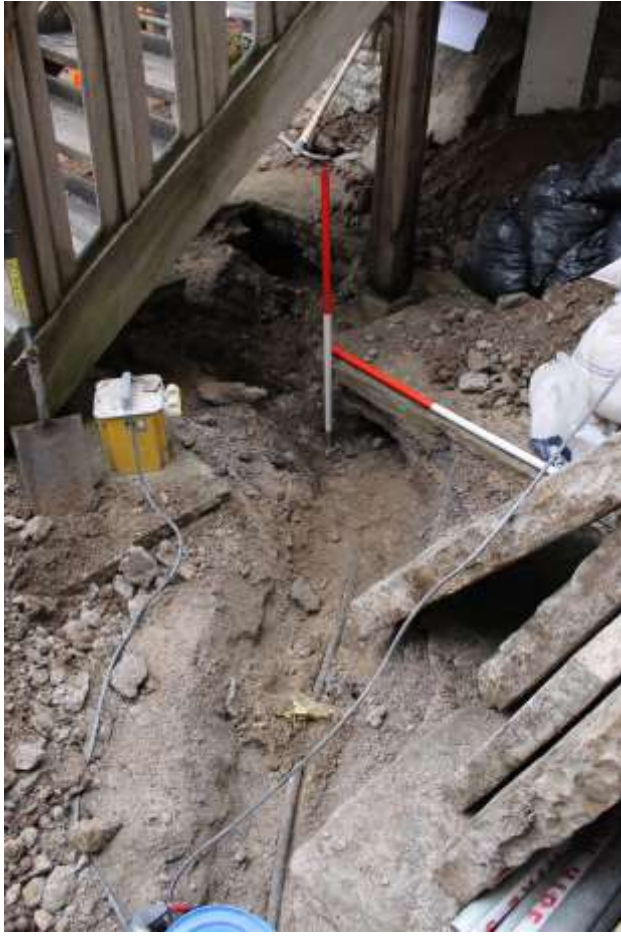
Figure 5. Cable trench under stairs showing slight deviation required to pass around the support post for the stairs.

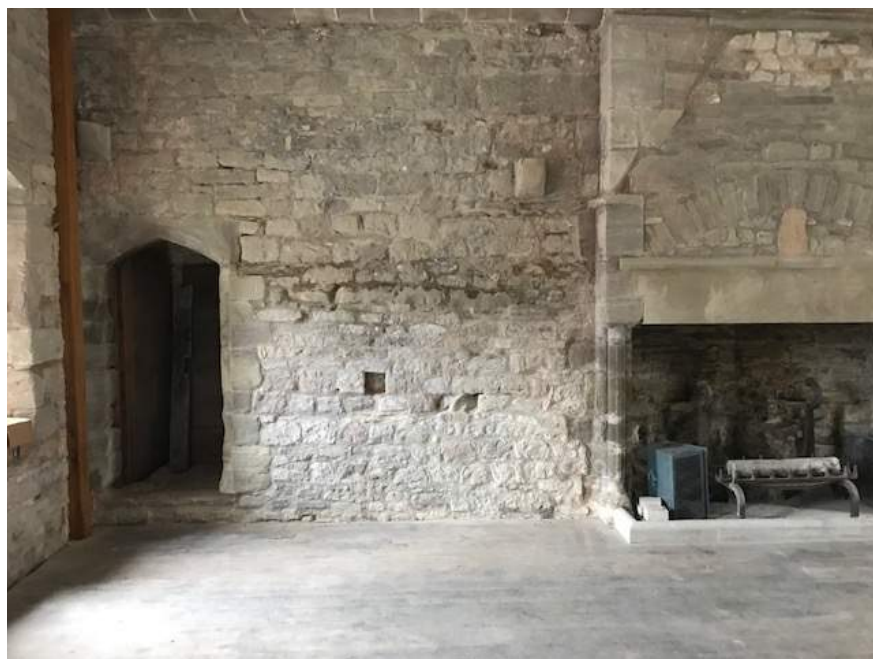
- 4.3 There was also a wet joint to the north west to the left side of the fire place in January 2018 where moisture was evident in the mortar joints - photograph 3. This joint has dried significantly by April 2018 with no moisture evident in the bedding joint - photograph 4. In January 2018 the moisture meter reading in the wet joint was 48% but this had reduced to 27% in April 2018, and therefore it could be concluded that the moisture penetration has stopped and the wall is drying out. We understand PDP Green have been investigating the cause of moisture penetration which is likely to be from the ledge above.

Photograph 4- reduced moisture penetration of bedding joint April 2018
