**A.P.A.C. Ltd.**

WATCHING BRIEF

WB/AONB3/10

**Angiddy Ironworks, Tintern.**

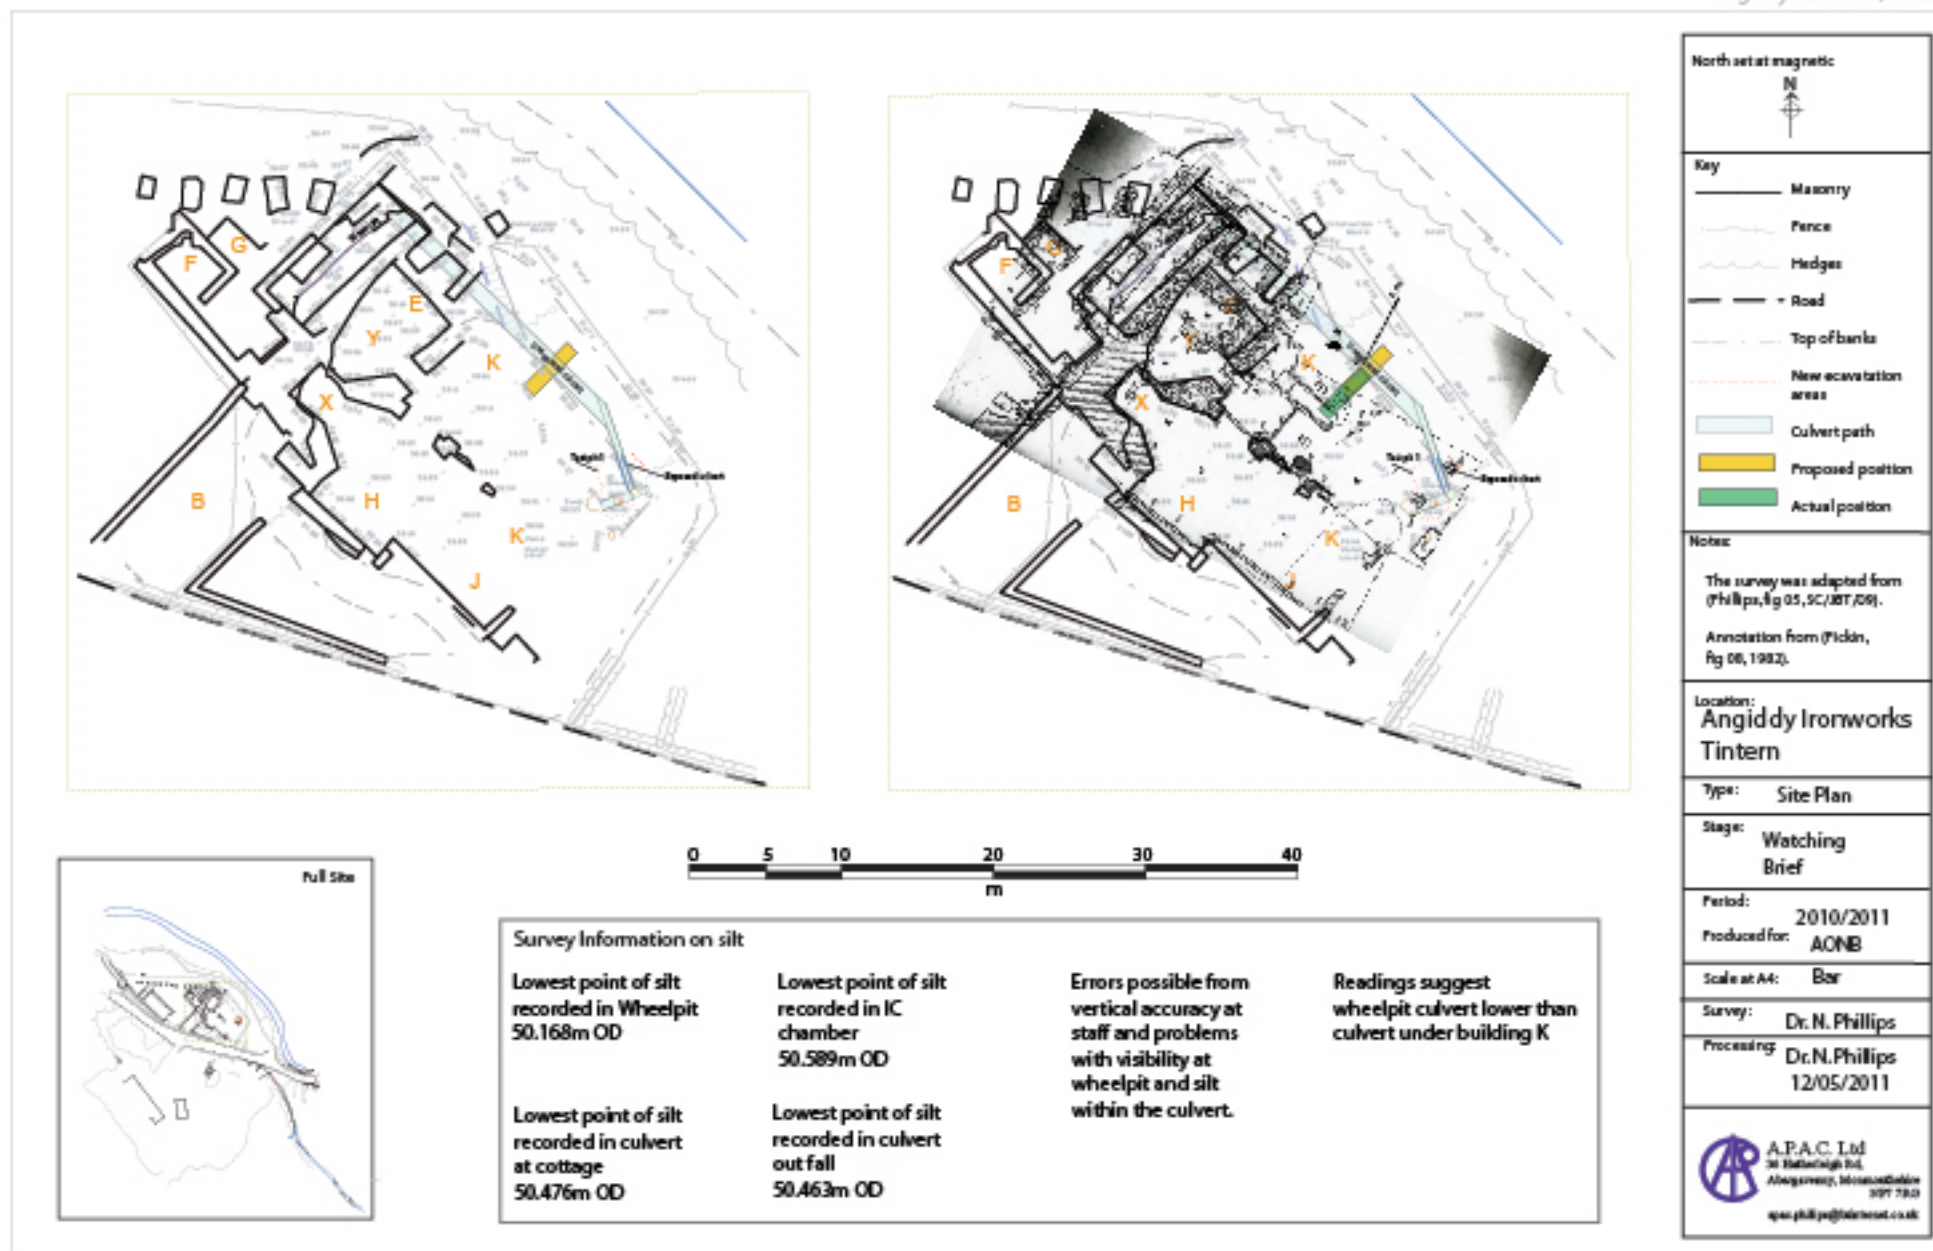
Figure 09: Proposed and probable positions for test pit 2

Test pit 2; an attempt to locate a further length of culvert, was excavated by mechanical digger. Very near to the surface, the excavation impacted on known archaeology; possibly 183 or 185, fig 05, and as a consequence, work was halted. Dr N Phillips was not required to be present for this work and so the pit was not recorded or accurately located, Plates 17, 18 & 19.

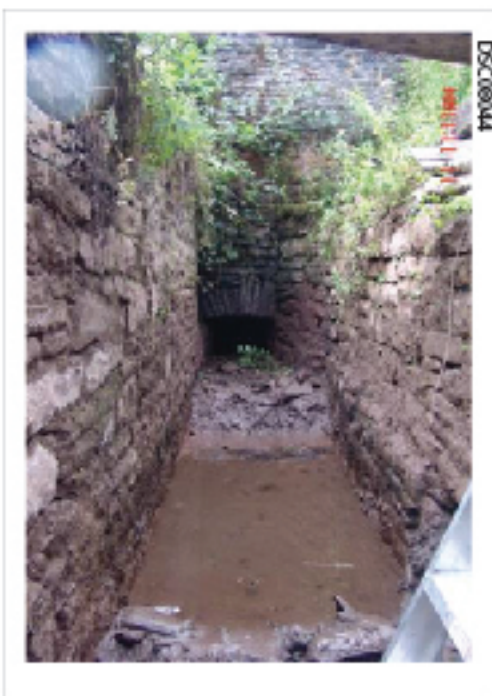
D5C08944

Plate 20: Drained wheelpit showing hutch under rear furnace wall

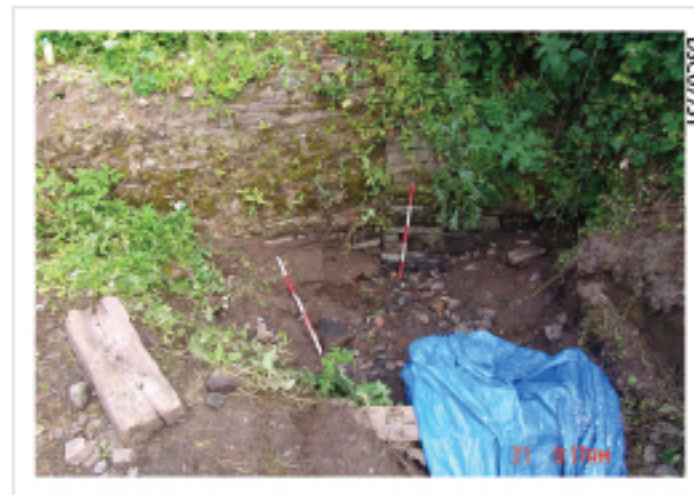
Plate 25: Culvert beside cottage, water levels reduced.

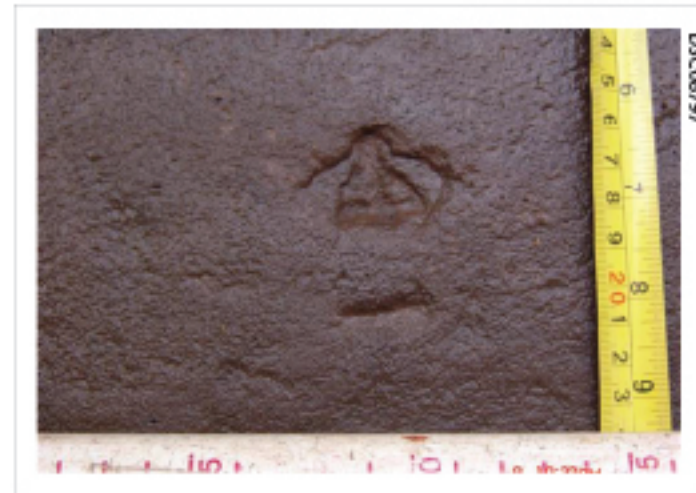
Plate 33: Mason mark on one of the culvert capstones, south east of cottage outfall

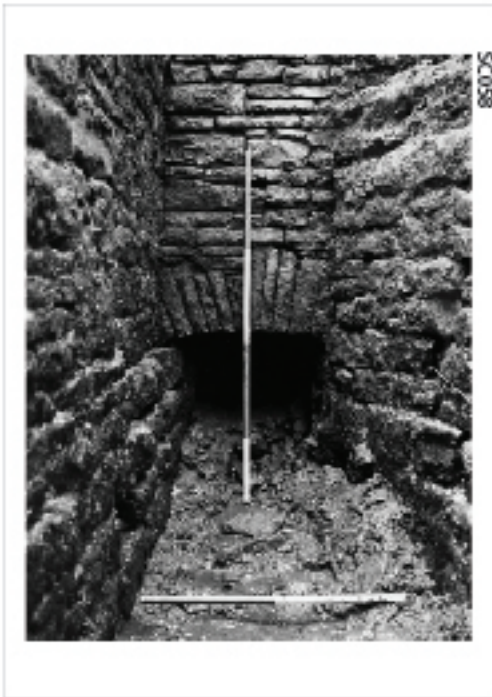
A feature of a narrow ledge; mid height, on the south west side of the wheel pit is also more apparent, now that it has been cleaned and repaired, Plates 50, 51, 53 & 54.

Plate 50: Wheelpit view SW showing drain 129.

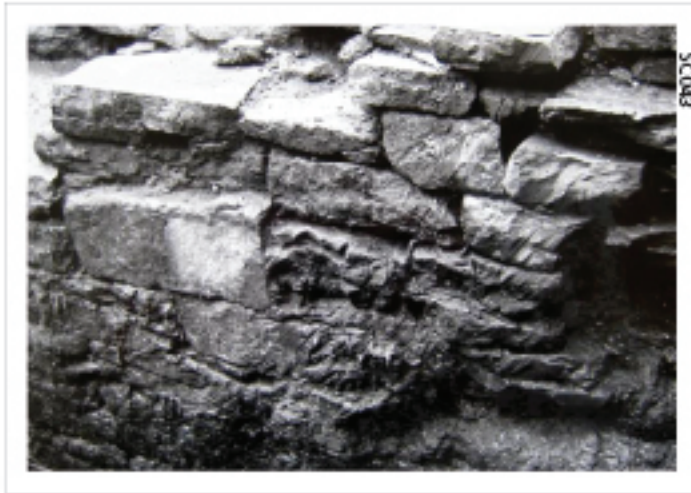
SC043

One casualty of the consolidation work has been the loss of some of the scouring detail caused by the water wheel to the wall of the wheel pit. Fig 10 shows the amount that was recorded during the 1979/81 excavations; bourn out in Plate 58 SC043. After consolidation work, some of the detail has been lost as can be seen by comparing Plates 58 and 59.

Plate 58: Wheel grooves 1.

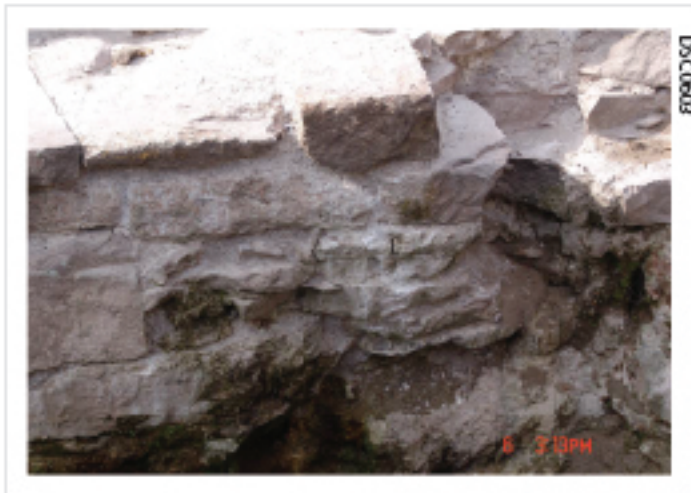
DS00603

Plate 59: Wheel pit water wheel rub marks

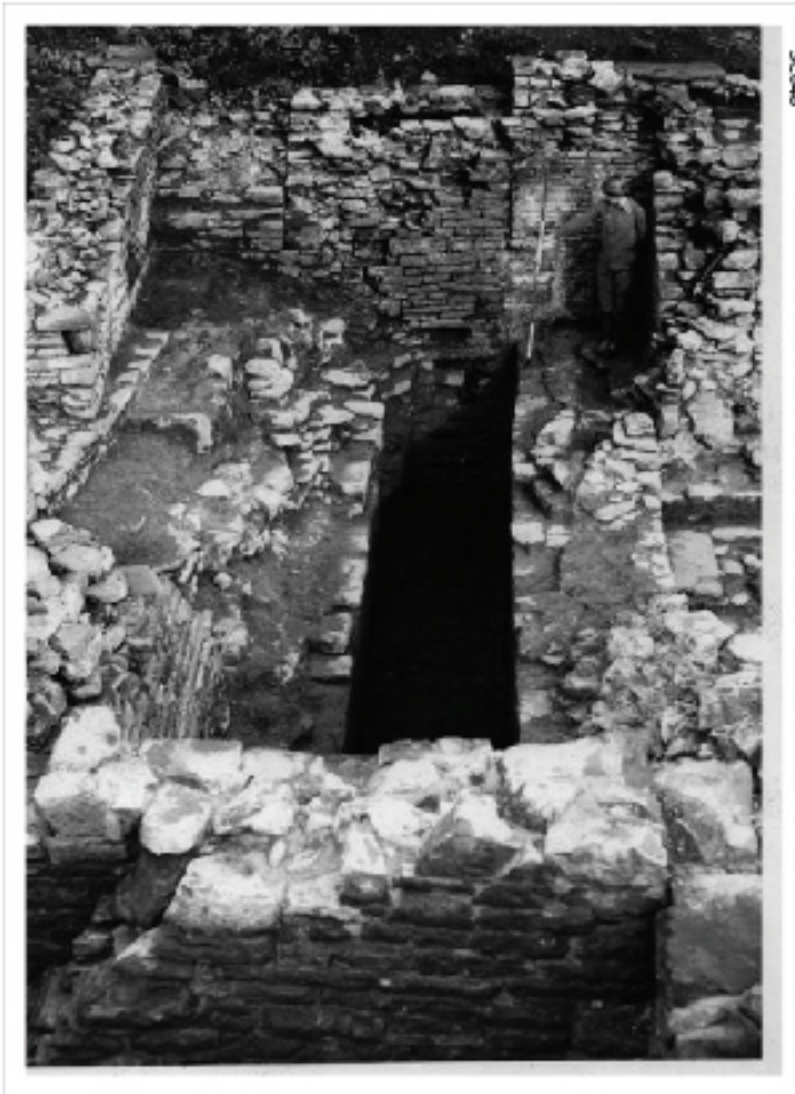
SC048

The upper surrounds of the wheel pit before the present work began was in a very bad state of repair, as has been shown in Plates 07, 22 & 49. Once clear of vegetation a comparison can be made between the excavation photographs of 1979/81, Plate 60 and 61. Such a comparison identifies areas where restructuring had been undertaken; particularly along the wheel pit edges and the construction of the barrelled buttress Plate 62.

Plate 60: Wheelpit after excavation summer 1979.

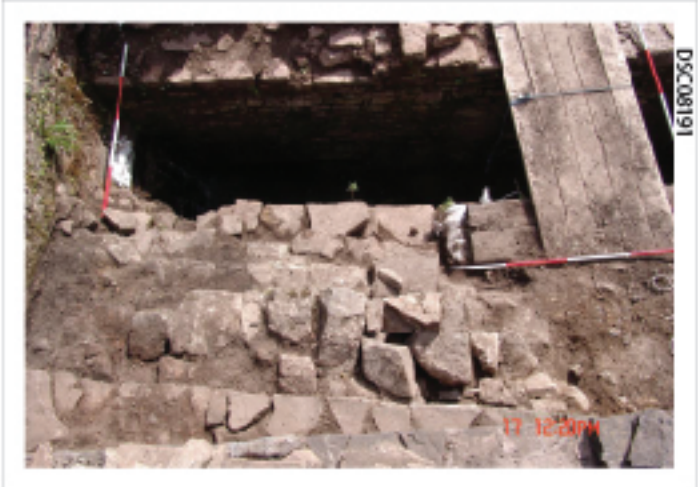
The photographic recording undertaken in September 2010 Plate 61 from which fig 11, 2, was drawn; shows feature 111 has not changed much but 112 is less well defined. One in the sequence of vertical photographs taken to record this area during clearing; shows the area of 112 as a jumble of mortared and loose stone Plate 64.

Plate 64: S1 Wheelpit.Measured photographic recording.

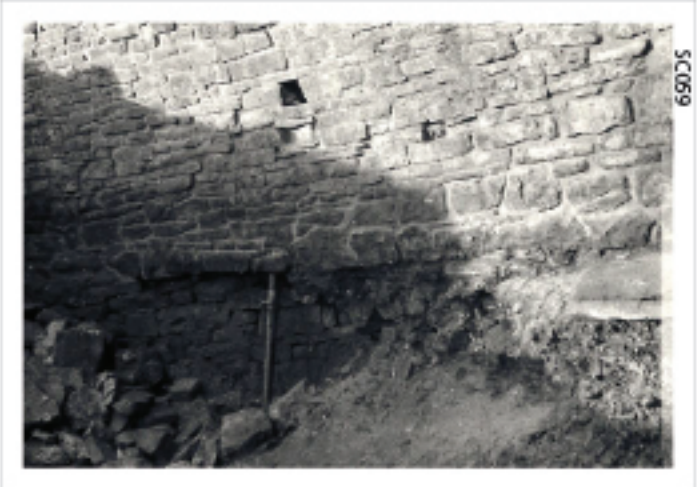
Base wall 111 is exposed for a distance of 3.7m, running from walls 210 & 115, fig 05, after which it continues a further 1.4m under 209, where it creates the undercut which prompted the 1979/81 construction of the supporting barrel buttress, Plates 65 & 66. Base wall 111 forms an 8 degree angle at its intersection with later wall 209. At the north end, it has a 0.55m width measured perpendicularly from 209 whereas at the south end, it undercuts by 0.12. It should be noted that the extent of the undercut has been obscured by the 1979/81 barrel buttress, Plates 62, 67 & 68.

Plate 65: Wheelpit, long wall0001.

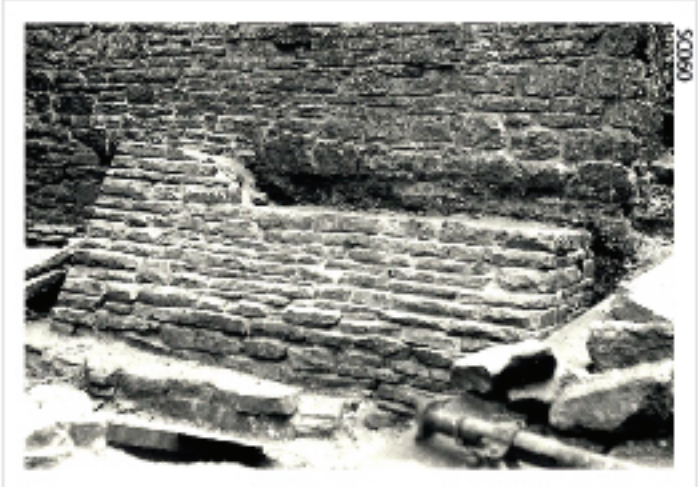
Plate 66: Wheelpit, long wall0002.

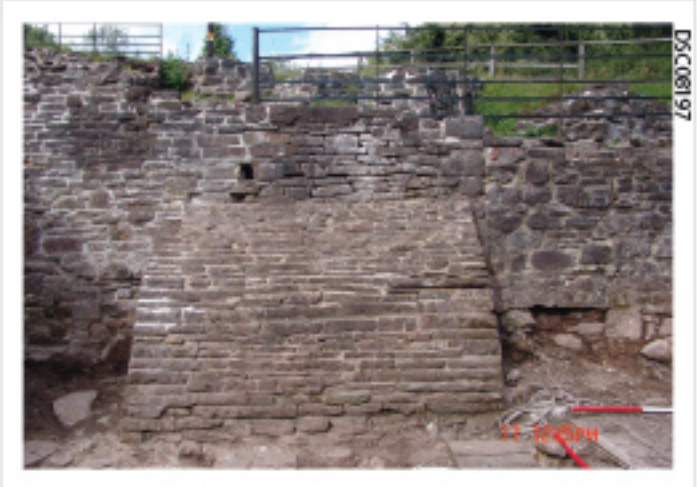
Close up photographs of the gap in 118/209, Plates 72 & 73 show that excavation had taken place revealing within; a set of steps. The former gap had therefore been an access point to and from the wheel pit, and the description of a three section wall a little misleading. Plate 74 shows the gap at some point prior to excavation in 1979, an interesting difference with that of plate 67 taken when the wall was first cleared in September 2010.

Plate 67: Wheelpit, upper wall. Photogrammetry sequence 2 of 6

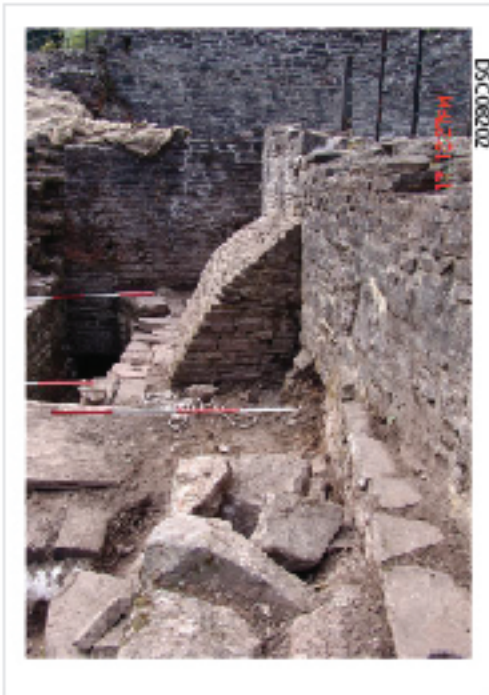
Plate 68: Wheelpit. Overview, measured photographic recording

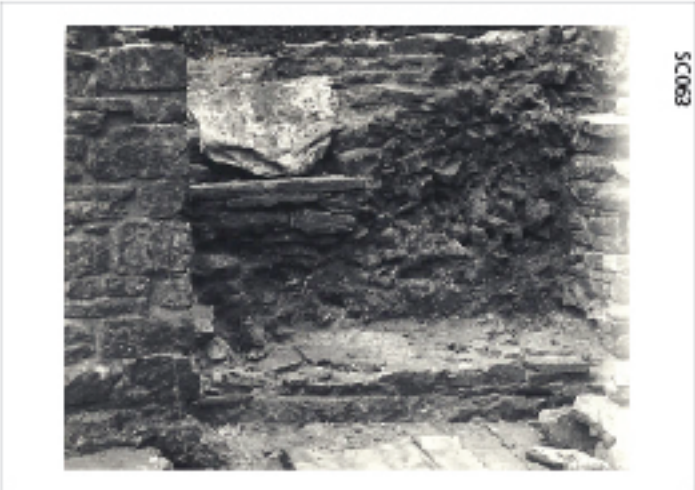
Plate 72: Wheelpit, long wall0005.

Furthermore, beyond the wall, and possibly obscuring the steps, are the remains of laundry support 119 and in the distance 118, figs 02 & 05, Plates 72, 73 & 75. The position of the laundry supports, and the photographic evidence would tend to suggest that the laundry had been built at a time when this entrance was no longer in use. Pickin records that the area west of the wheel pit was made up ground at the time when the culvert was realigned to the new laundry (Pickin 1982. 21, 22).

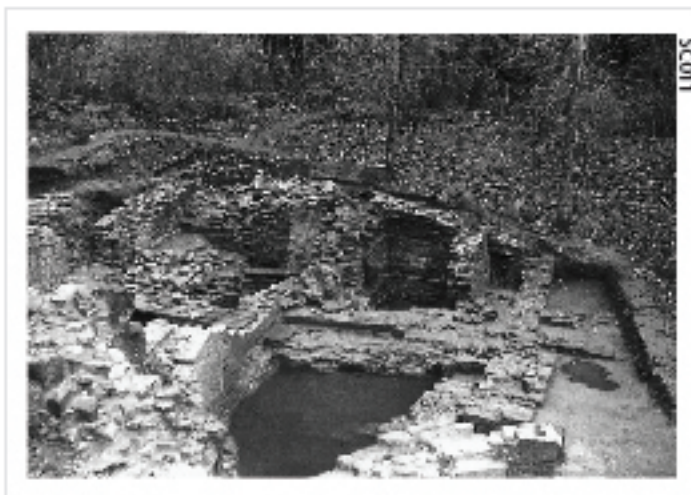
Plate 76: Buildings Y & E from Furnace top.

Another feature which escaped detailed interpretation is that of 115 fig 05 '...a set of steps butt-jointed to (210) and connecting with (114) by a cross wall (153), (ibid., 35). Unfortunately, there are few photographic records of this feature with which to compare changes. Probably the best would be Plates 76 and 77 which are not very detailed. The feature is still discernable now, if you know where to look.

In the Pickin report, the three sided enclosure 155,157,158, is briefly mentioned in an association with Building E. Along with its inclusion on fig 08 page 27 its is given nothing more than internal measurements and alignment, (ibid. 32& 40). Only one photograph was available of the work done in this area during the 1979/81 excavation, and that is centred more on the blowing house, E, in front of the enclosure, Plate 76, than the enclosure itself. The presence of the akrow props within the enclosure, Plate

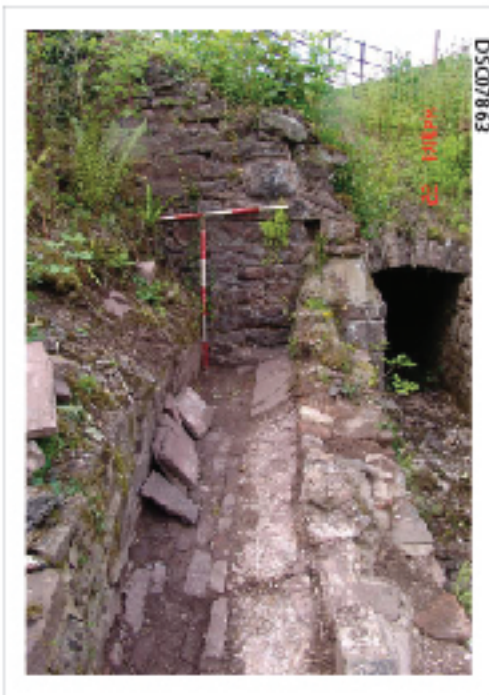
There are no early views of the drain for comparison but Plate 83, reveals its condition at the beginning of clearance work in July. The stone slabs had been cemented over the cobbled area obscuring it from view. Plate 84 shows a later view, once consolidation had been completed.

Plate 83: Cleared area no's: 225, 224, 137.  
(Pickin 1982) Detail

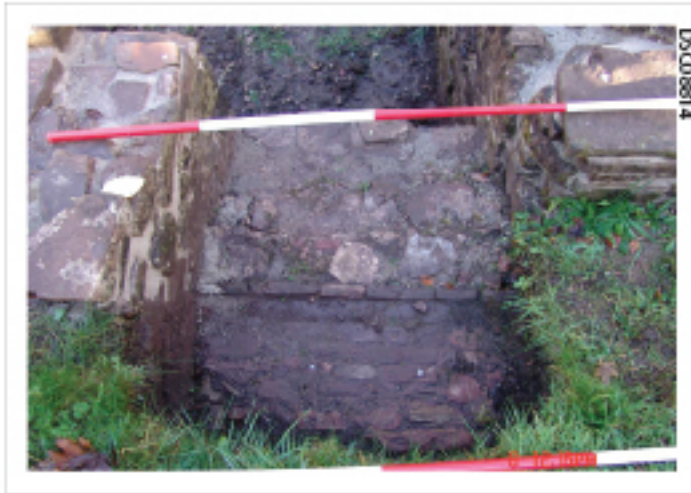
At the southern end of 224, some clearance to accommodate pointing work was undertaken and uncovered an area of cobbled surface. This has been left open to view Plate 85.

Plate 85: Step 202 (Pickin 1982)

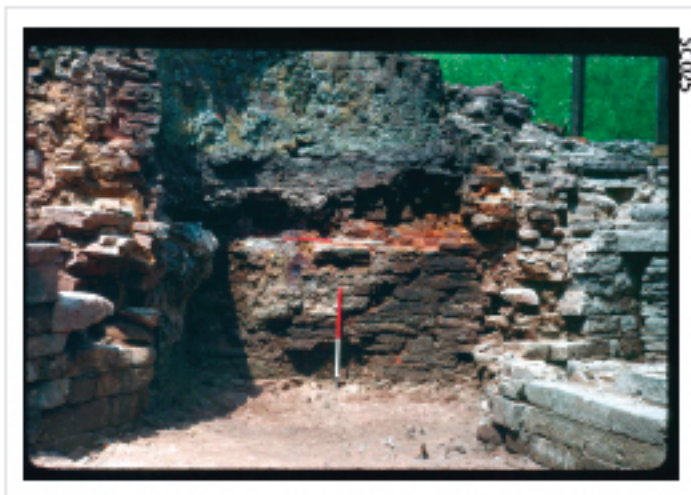
For comparison, a good photograph of the furnace during the 1979/81 excavation can be seen in Plate 86. The photograph shows west wall 148 with part of the hearth area at the bottom. The excavation report records:

Photographs taken at the end of clearance work illustrate some changes, although, it is not clear if these are a result of consolidation work or weathering. Plate 87 is taken in almost the same direction as Plate 86. Comparison shows that the blue/green glassy slag is no longer present neither is the burning to wall 148. There also seems to be a more defined line of repair brick, which did not exist on the earlier photograph.

Plate 86: Furnace during excavation July 1979
