Stabilisation Works at Ruperra Castle, Glamorganshire

Historic Buildings Record

Project #: AD042

March 2019

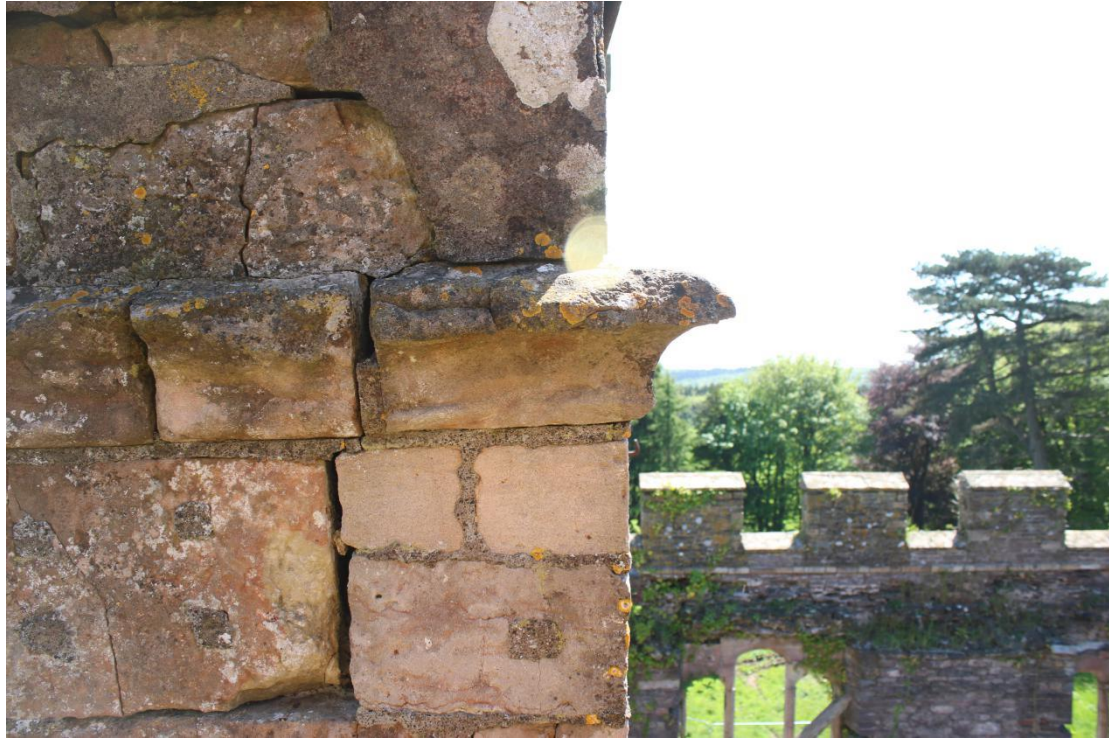
Plate 29 - AD042_WB_029 - North elevation, showing string course profile.

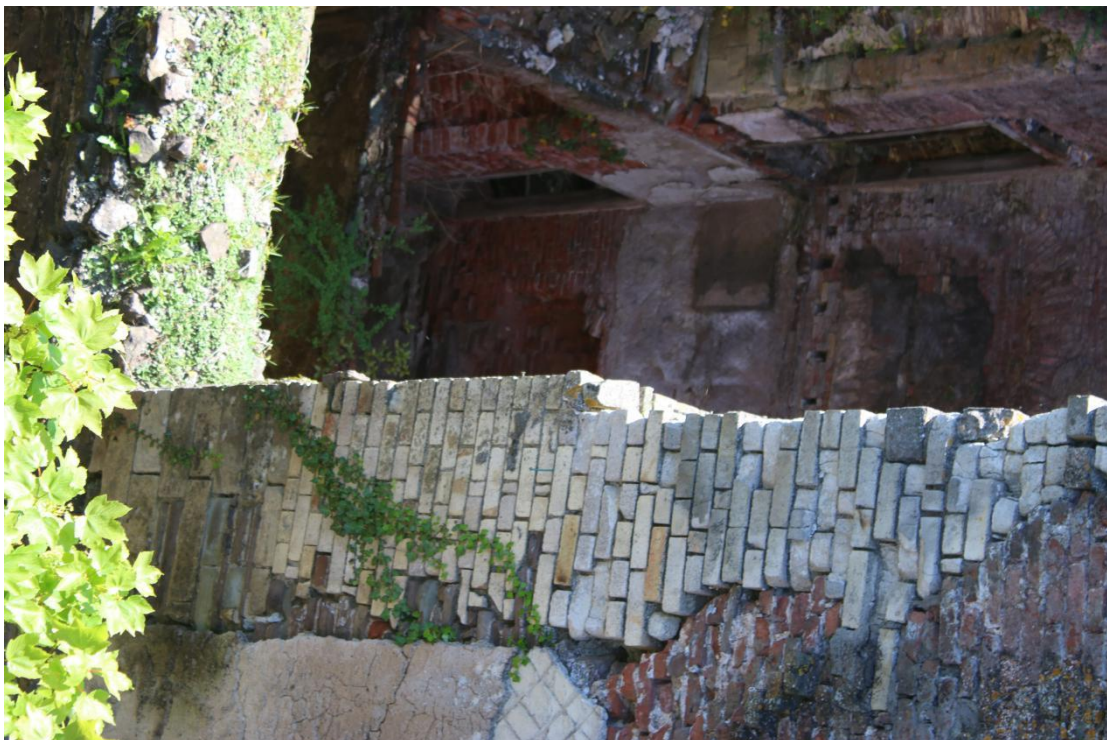
Plate 41 - AD042_WB_041 - East elevation, showing 1626 roofline, patches of lime plaster, crack and later inserted flue (white brick).

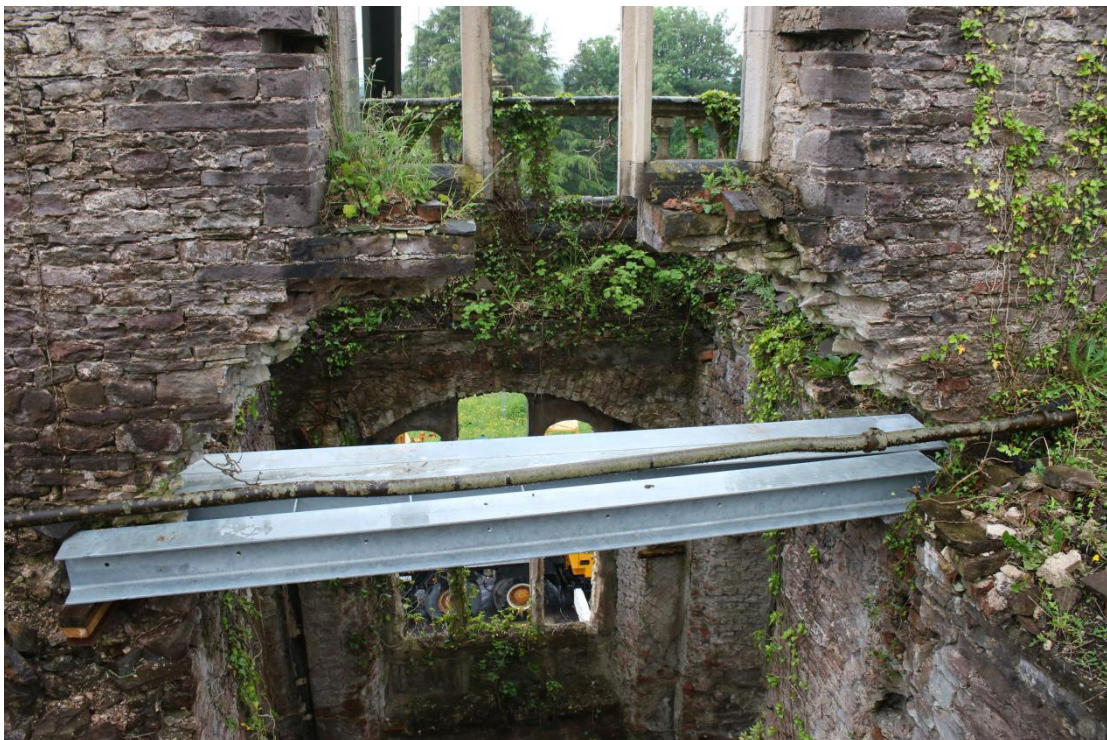
Plate 126 - AD042_WB_126 - South window interior, showing RSJs.

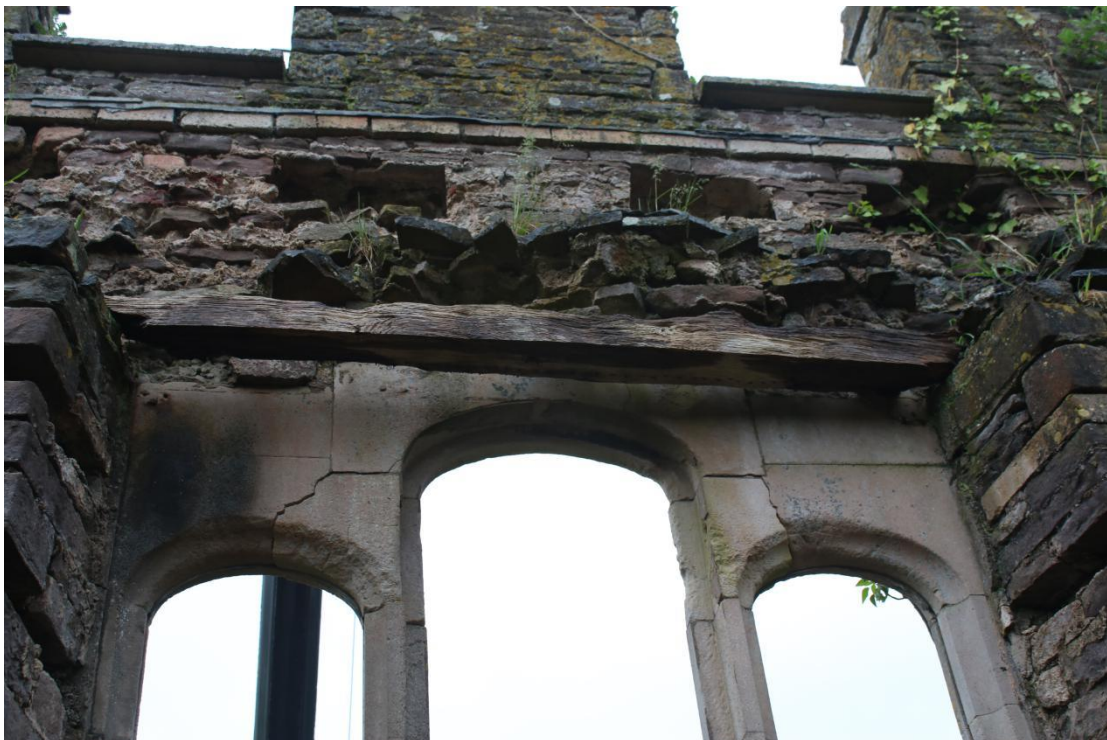
Plate 134 - AD042_WB_134 - South window interior, showing surviving timber lintel.

- 10.2.1 All timber surviving *in-situ* should be subjected to dendrochronological dating to ascertain to which time period it belongs, therefore supporting the record of historical interventions to the monument. If ring-width dendrochronology fails to date, other forms of dating should be considered, i.e. dendro-isotope dating.

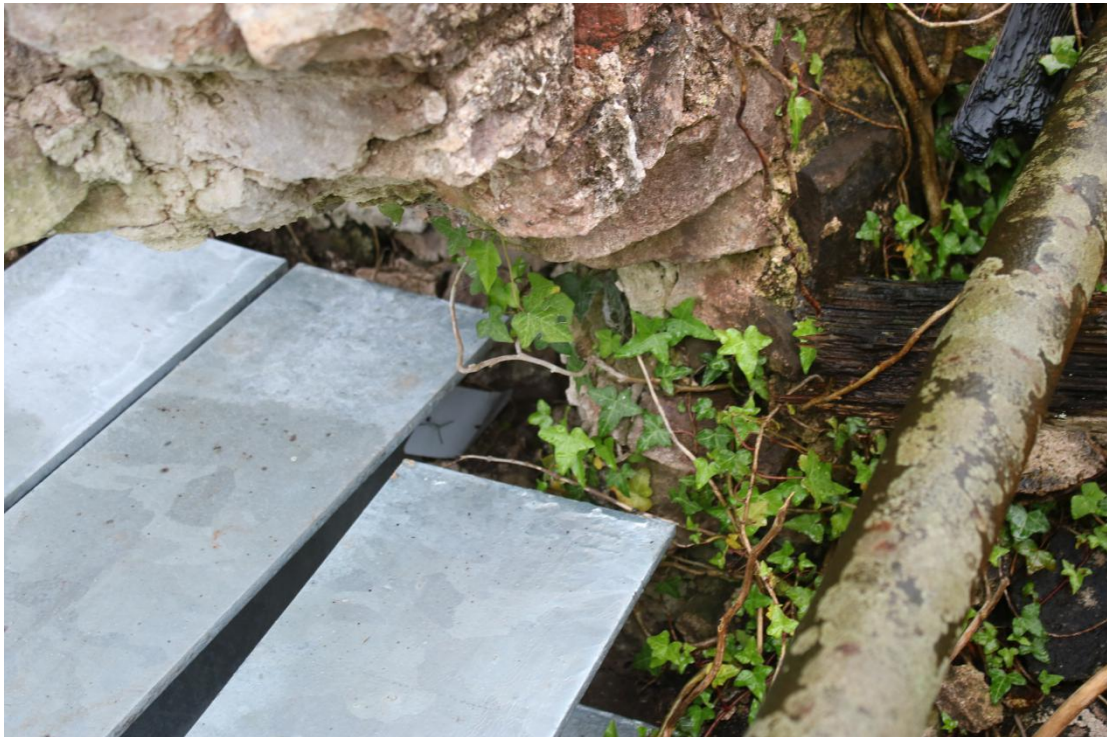
Plate 136 - AD042_WB_136 - South window interior, showing temporary RSJ siting and masonry to be removed.

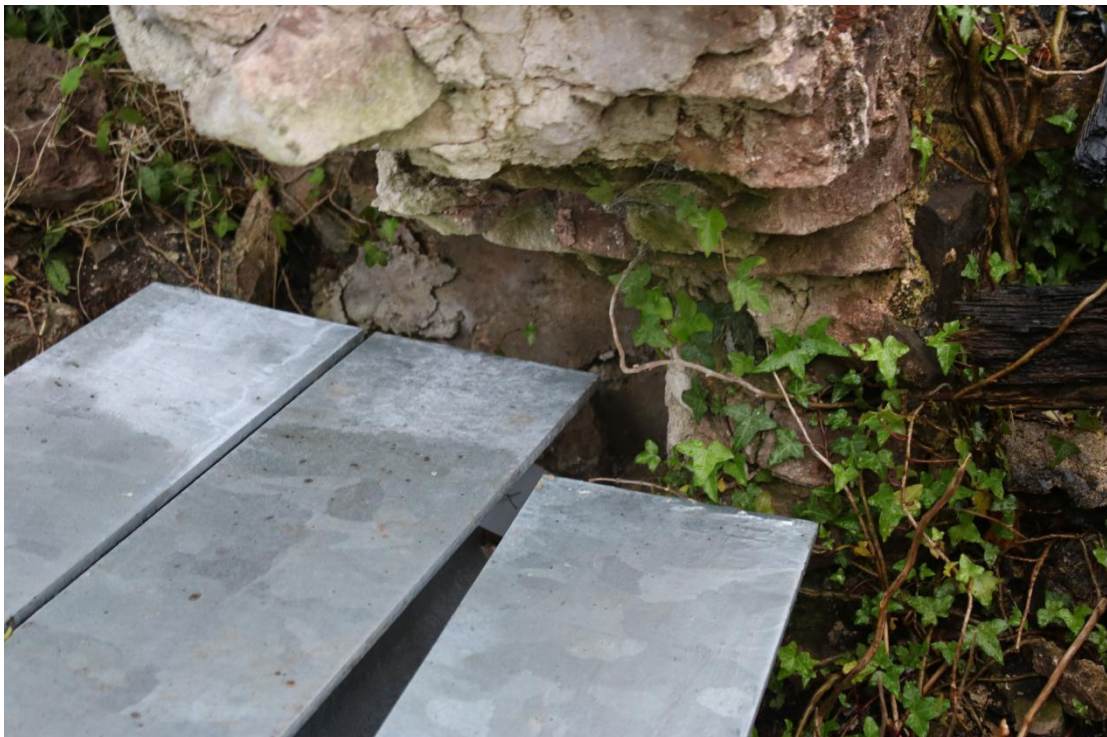
Plate 138 - AD042_WB_138 - South window, showing temporary RSJ siting and masonry to be removed.
