Former Coach House, Newport, Pembrokeshire

Archaeological Buildings Record & Watching Brief Report

Project #: AD010 25th May 2016

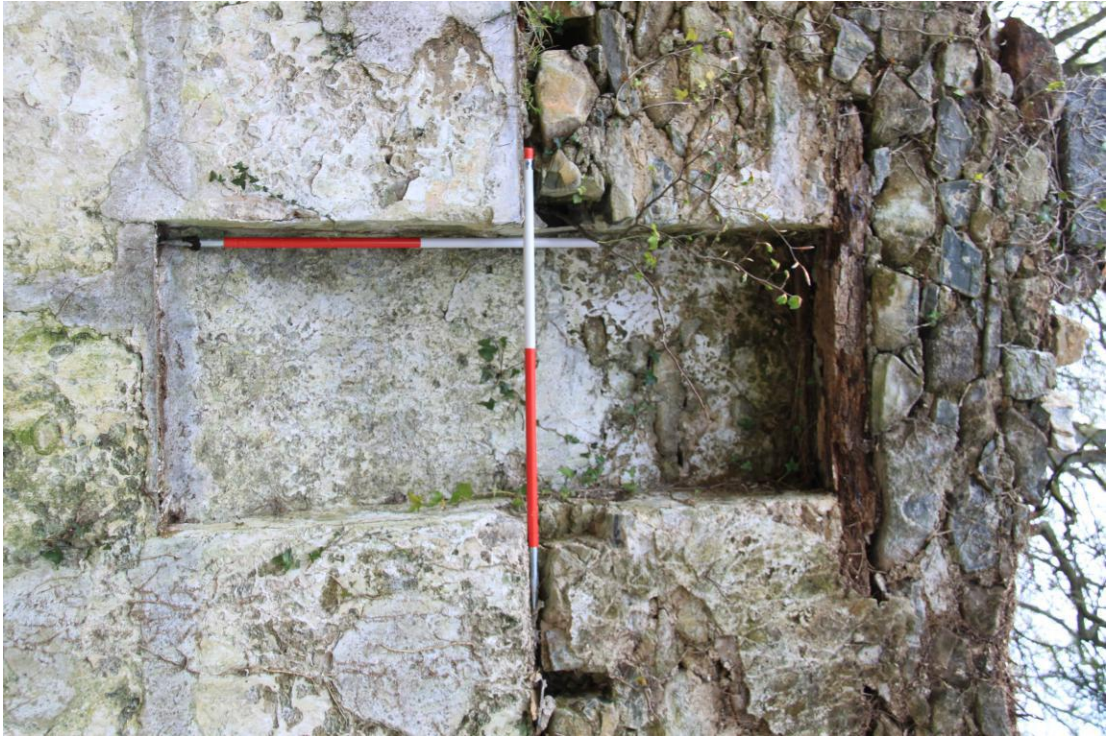
Plate 15 - AD010-BR-015 - Hay feeder shoot, internal, south wall.

The internal face of the southern elevation (**Plates 15, 19, 21 & 22**) is largely covered in lime plaster at ground floor level, but weathered away almost entirely at first. Four feeder shoots occupy the western end of the wall.

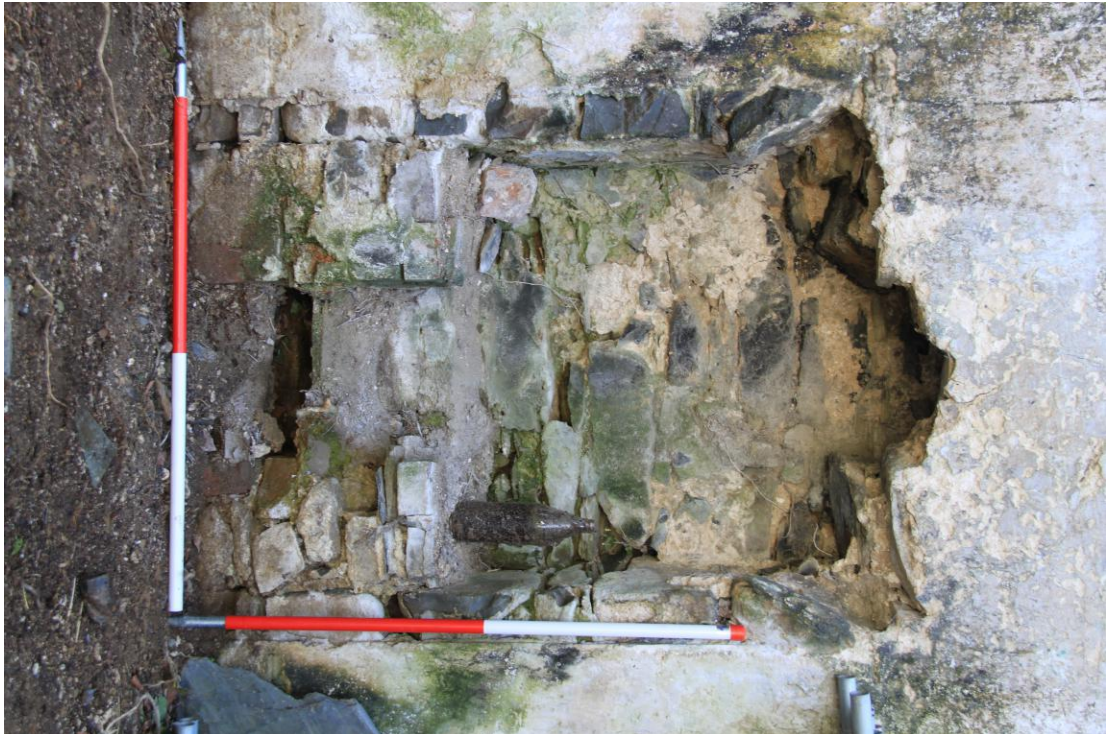
Plate 24 - AD010-BR-024 - Fireplace, internal east wall, Former Coach House.

At the east end, the gable of the Coach House (**Plates 24, 25 & 29**) has the remains of a small coal range at ground floor level and fire place at first floor, which rise to a stone stack. The chimney stack is of stone, and has a stone tray and the remains of its flaunching, although badly weathered. The wall is still largely covered in a lime plaster, with a break line indicating where the first floor level once was.

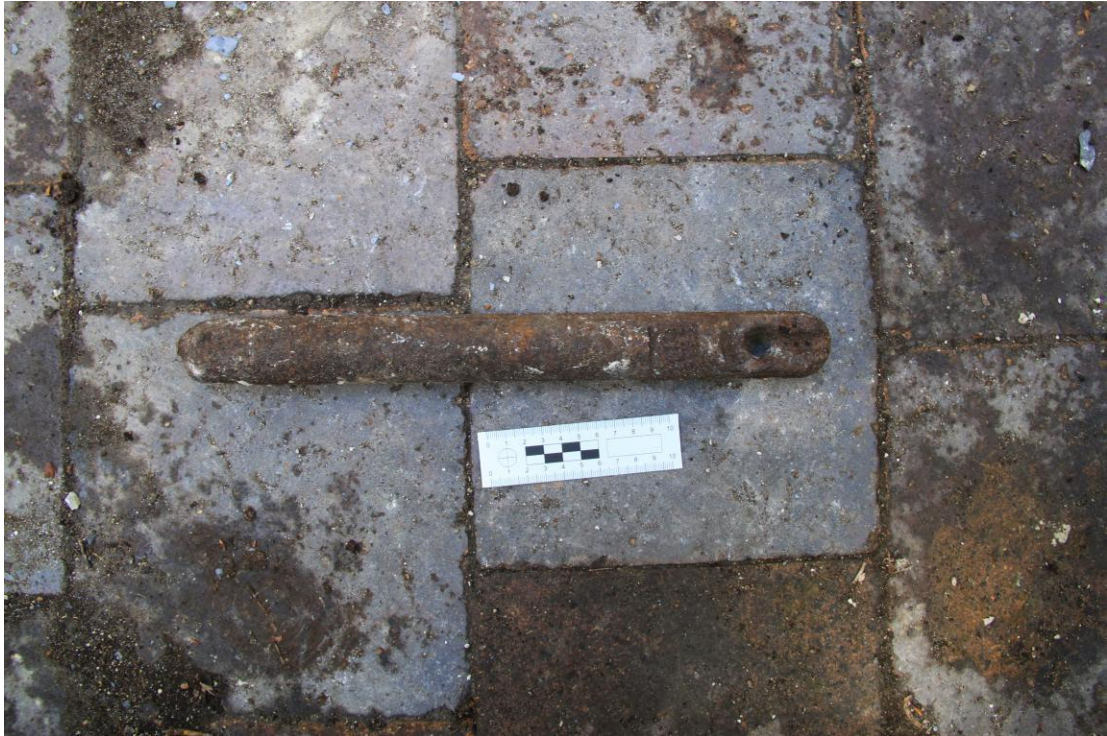
Plate 43 - AD010-BR-043 - Sash weight found in Extension A.

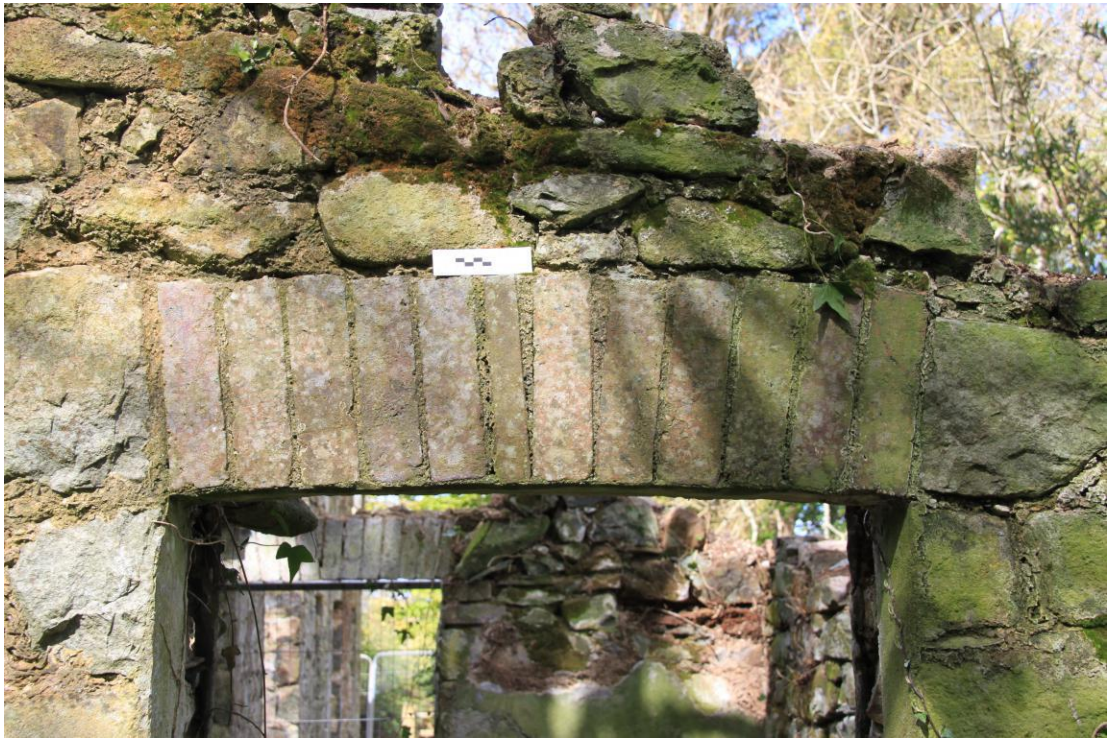
Plate 45 - AD010-BR-045 - Brick flat segmental arch window head, Extension B East elevation.

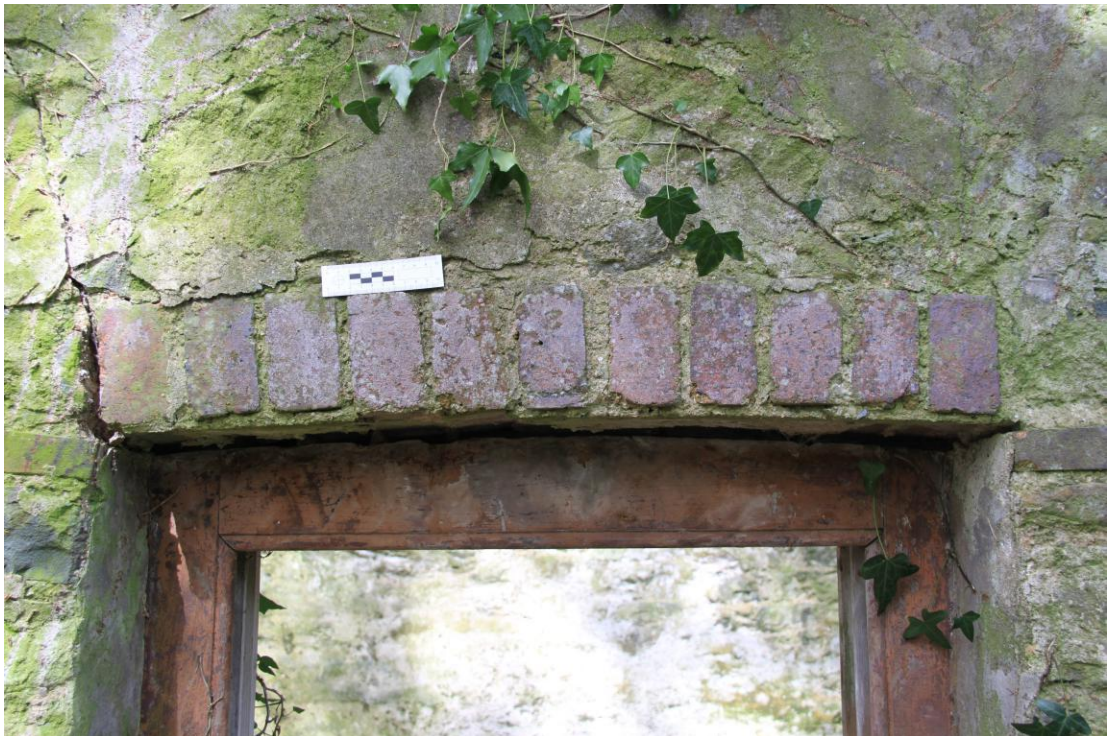
Plate 46 - AD010-BR-046 - Brick flat segmental arch window head, Extension A east elevation.

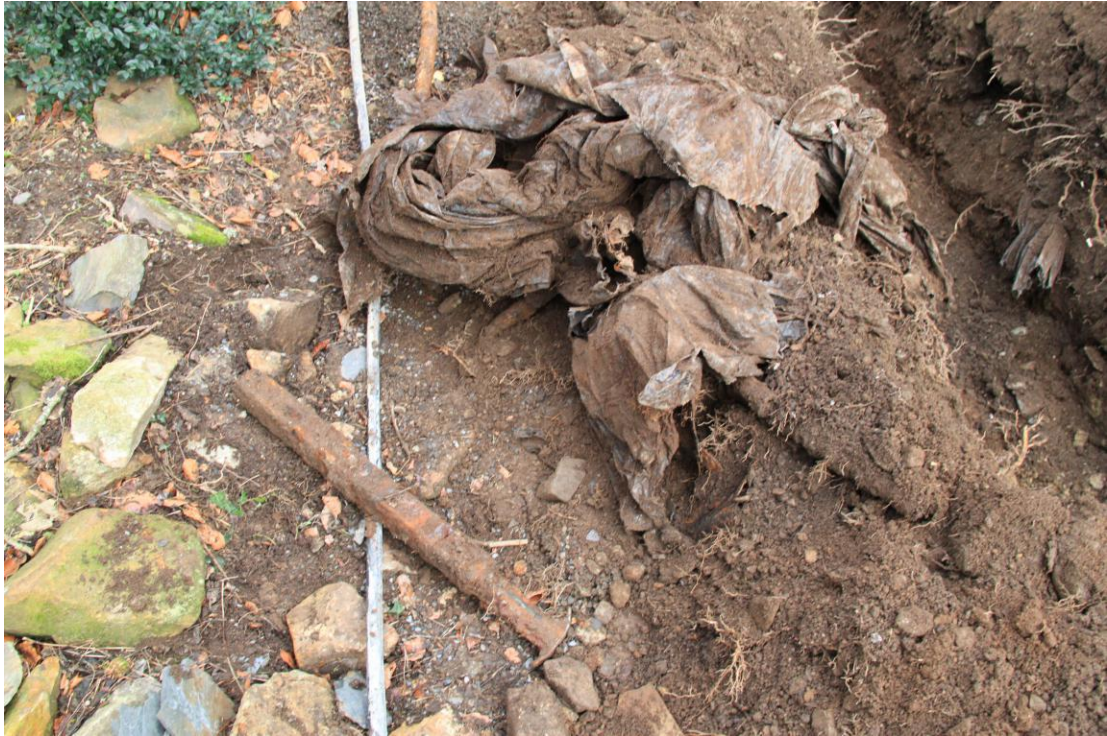
Plate 64 - AD010-D2-017 - Plastic and metal recovered.

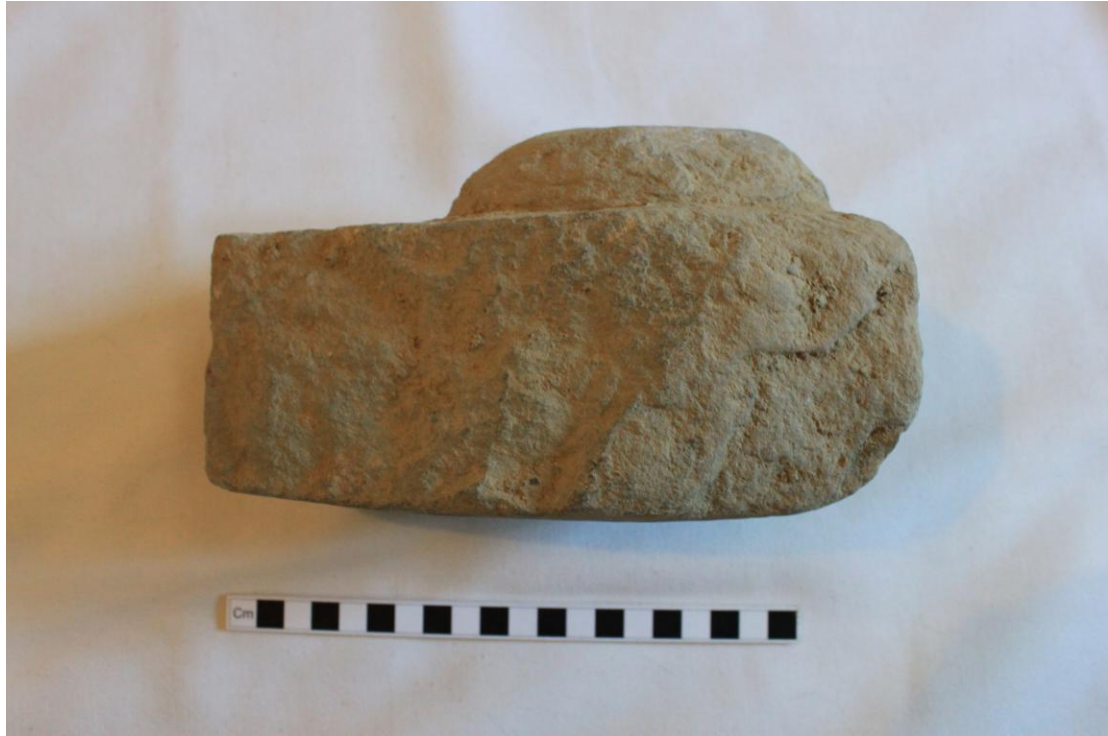
Plate 70 - AD010-FN001-1 - Unfinished carved stone, recovered Day 3.

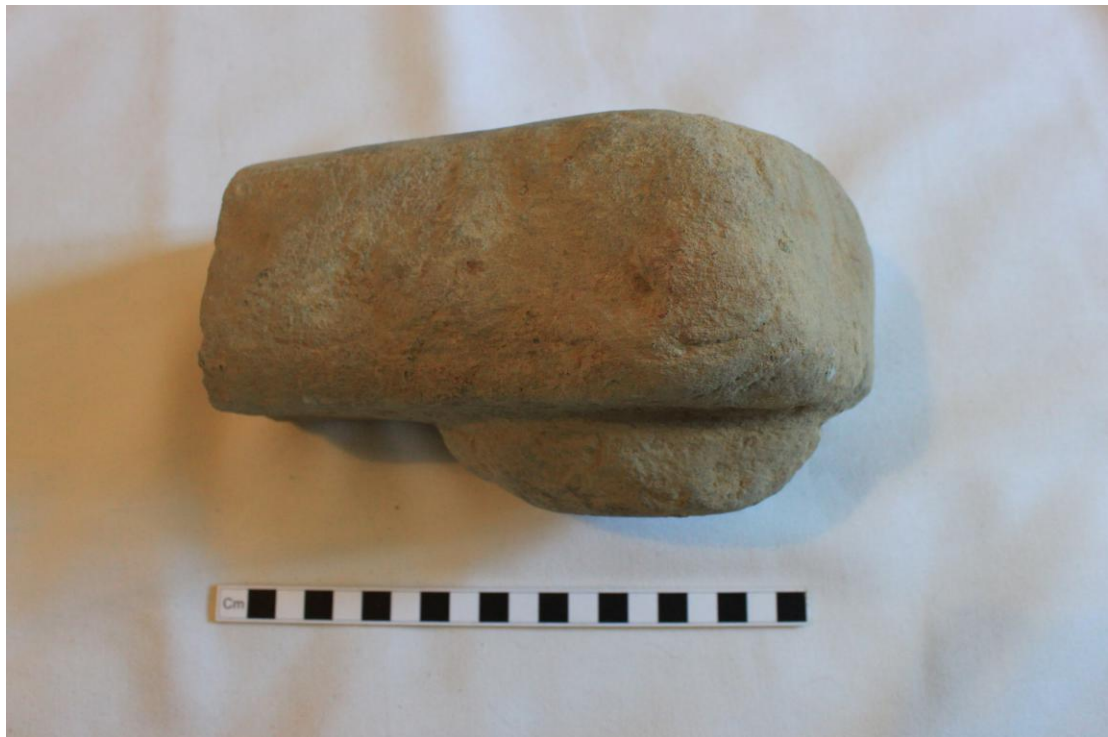
Plate 71 - AD010-FN001-2 - Unfinished carved stone, recovered Day 3.

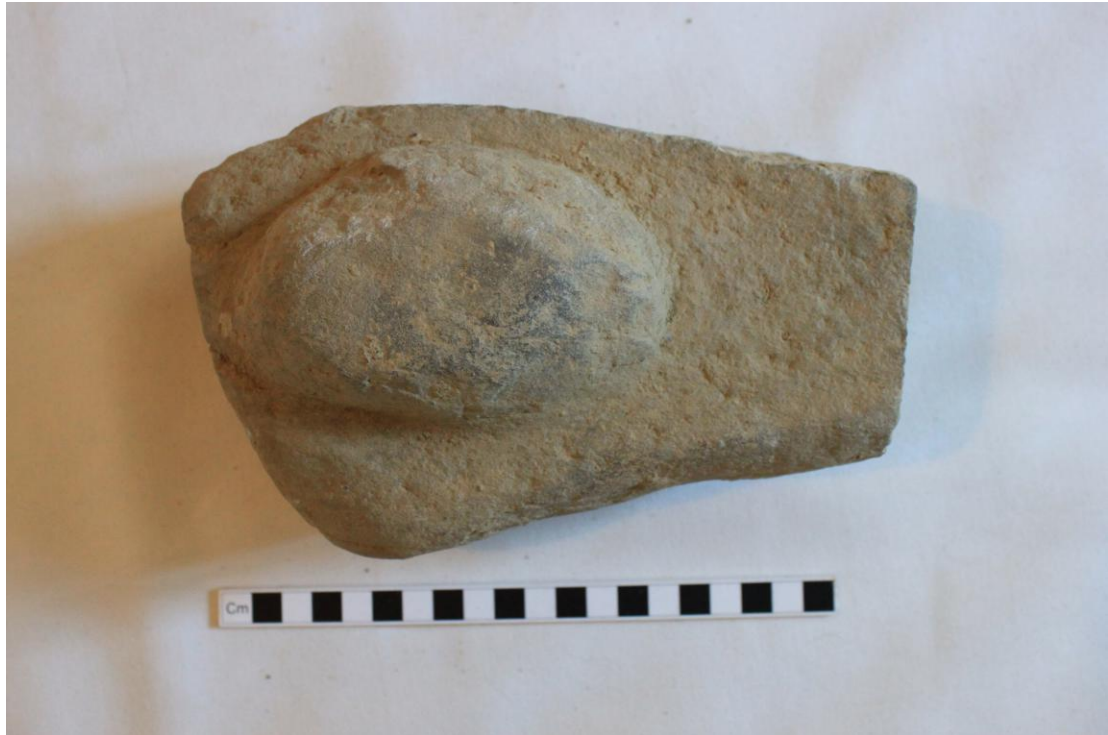
Plate 74 - AD010-FN001-5 - Unfinished carved stone, recovered Day 3.

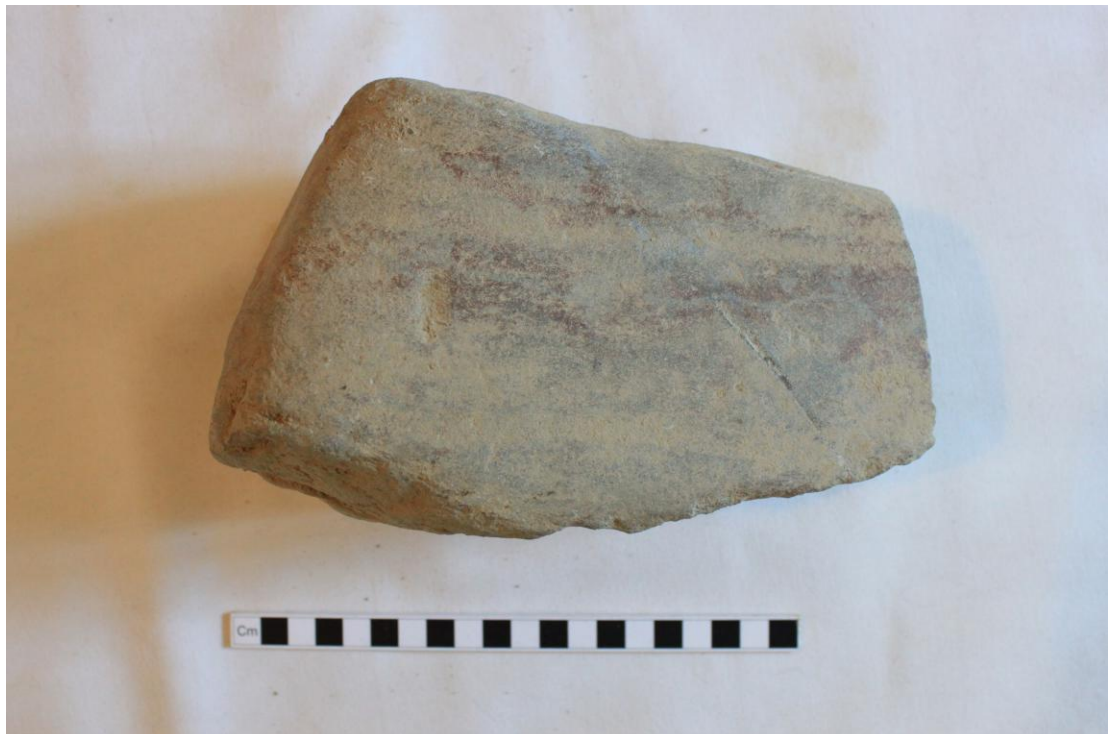
Plate 75 - AD010-FN001-6 - Unfinished carved stone, recovered Day 3.
